# Experimental Investigation of Traditional Clay Brick and Lime Mortar Intended for Restoration of Cultural Heritage Sites

**Abstract:** To properly restore masonry cultural heritage sites, the materials used for retrofitting can have a critical effect, and this requires standards for traditional Korean brick and lime mortar to be examined. This study experimentally investigated the material characteristics of Korean traditional bricks and two types of lime mortar (quicklime lumps and powdered hydrated lime) and the strength of masonry specimens made from those materials. Four different mixing ratios of lime, sand and white cement were considered as material parameters in this study. The experiment included uniaxial compressive testing and flexural testing to examine the mortars' mechanical properties, and compression tests, triplet shear tests and diagonal compression tests for the masonry specimens. The results found that the strength of the masonry specimens was not necessarily associated with the mortar's strength, but rather the cohesion between brick and mortar. In the material test, adding white cement had no noticeable effect on mortar strength. Meanwhile, in the masonry s

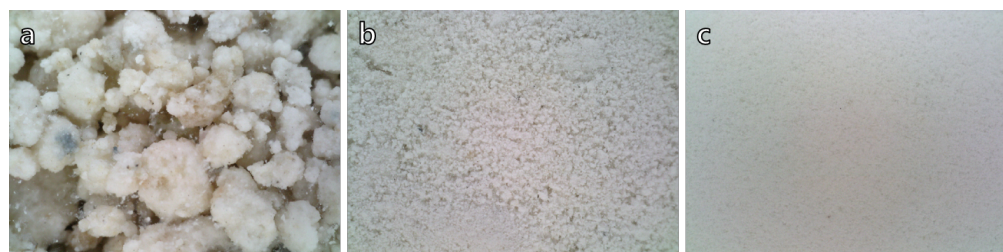
**Figure 2.** Materials used for experiments. (a) Quick lime lumps, (b) powdered hydrated lime, (c) white cement.

This study used Quicklime lump (LL) and Powdered Hydrated lime (PL) as the main mixing ingredients to create mortar binder for the masonry specimens. Each contained a different proportion of the calcium compound, 85% and 90% for the LL and PL, respectively. The main components of white cement in cement are limestone (CaO), quartzite (SiO<sub>2</sub>) and pyrophyllite (Al<sub>2</sub>O<sub>3</sub>), which account for 92% of white cement. Figure 2. presents images of the mixing materials used in this experiment observed under a 0.5 mm stereoscopic microscope. Figure 2a–c depict the agglomerated forms of LL, PL and white cement, respectively, and show their particle size in decreasing order.

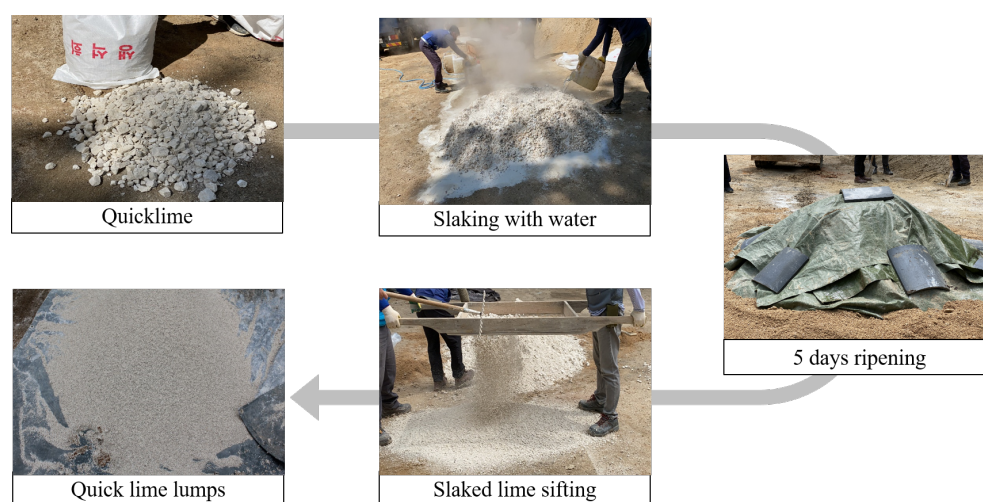
**Figure 3.** The quick lime lumps production process.

For the field application, LL was exclusively prepared and produced by the restoration organization of the Changdeokgung Palace Complex, under the guidance of the Cultural Heritage Administration of Korea. Figure 3 demonstrates the quick lime lump production process. Quicklime was piled up and slaked with water at a 1:1 proportion. The ratio was confirmed through a previous experiment. Water can be added to the quicklime by spraying through a nonwoven fabric to prevent overheating from the exothermic reaction. The lump lime pile was covered with tarpaulin sheets to prevent moisture evaporation, and left for 5 days for the maturing process. Afterwards, the slaked lime was strained using a 3 mm sieve to collect quicklime lumps. The final products can be used after a further month of ripening. Powdered hydrated lime (PL), which was used in this study, is manufactured by Baekkwang Mineral Products company under the same process as quicklime lumps.

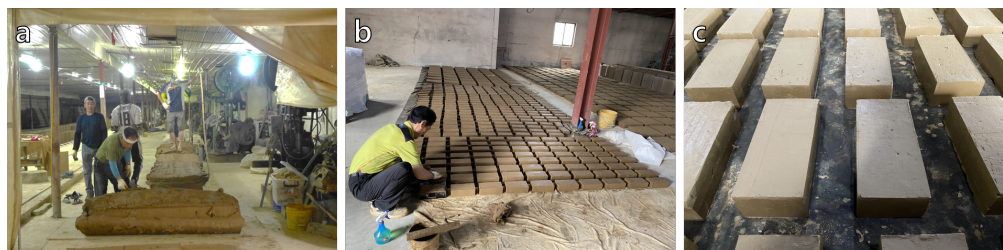
**Figure 5.** Traditional handmade bricks manufacturing process. (a) The soiling process using manpower. (b) Handmade bricks processed with a mold. (c) Demolded brick

Traditional handmade bricks were chosen to make the masonry specimens for the experiment. Figure 5 shows the process of traditional handmade bricks manufacturing. Bricks

are made manually according to the traditional manufacturing process of forming, heating and cooling. Figure 5a indicates the soiling process, and Figure 5b depicts forming of the brick using the mold. The average measured size of 60 samples was  $190 \times 90 \times 57 \text{ mm}^3$  ( $\pm 2.0 \times 2.0 \times 2.0 \text{ mm}$ ). The compressive strength of the brick was determined by compressive testing of five brick samples to fracture. Axial force was applied in the middle of the largest surface of the brick.

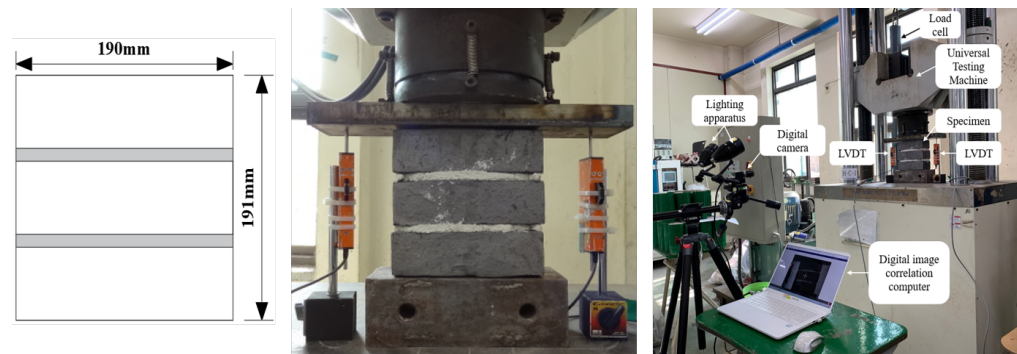
**Figure 6.** Experimental setups for compression test.

The masonry prisms consisted of three layers of bricks and two layers of mortar bed joints, which were 10 mm in thickness. The nominal dimensions of the masonry prism were  $191 \times 190 \times 90 \text{ mm}^3$ . The prism specimens were tested after curing for 56 days. The compression test was processed in accordance with ASTM C1314 [40], as shown in Figure 6. Displacement measurements were taken from two LVDTs (Linear variable differential transformers) set on both sides of the jig. Displacement control mode was used for the compression tests, where masonry prisms were loaded to failure by applying the load at a rate of 1.0 mm/min

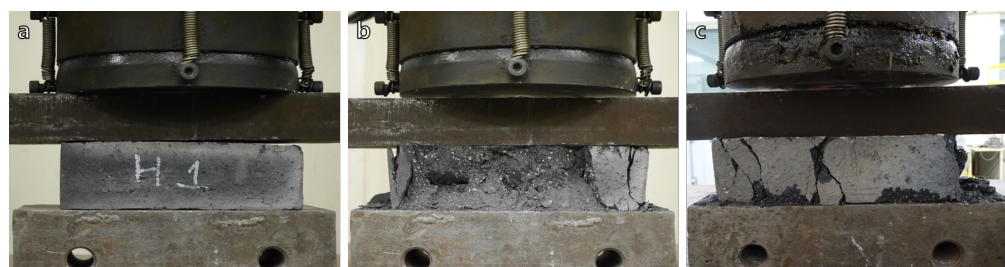
**Figure 9.** Brick compression test. (a) Before testing, (b) after testing—front view, (c) after testing—back side view.

Figure 9 illustrates a brick specimen before and after the compressive test. Brittle fractures can be observed in the bricks. Cracks occurred shortly after applying force and the brick exhibited sudden failure. Table 3 shows the brick compressive strength results. The minimum and maximum applied forces that caused brick samples to fracture were 766 kN and 1128 kN, respectively. The relative compressive strengths of the bricks were 44.81 MPa and 65.96 MPa. The deviation of the maximum load is 137 kN, which is considered to be an error caused by the soiling process and mold work [43,44]. The mean compressive strength was calculated to be 60.56 MPa, which is about four times stronger than the reference strength of 15 MPa for traditional hand-made bricks proposed in the Cultural Heritage Repair Standard Specification (2020) [45].
