# Experimental Wear Characterization and Durability Enhancement of an Aeronautic Braking System

**Abstract:** This paper is focused on the experimental wear characterization of an electromagnetic braking system used for helicopters. The characterization was performed through the evaluation of some monitoring parameters during endurance tests on a test bench and through the visual analysis of the worn surfaces after the tests. The monitoring parameters were the engagement threshold voltage, the release threshold voltage, the inductance, and the braking torque, which are directly correlated with the wear progress. The visual analysis allowed the assessment of the wear extent and the distribution of wear particles at the interfaces. The test performed on the initial base configuration, having ten springs and carbon fibers as friction materials, demonstrated that the braking system had insufficient durability in terms of actuation cycles. The results allowed the design of two new configurations based on different brake architectures and on different friction pairs. One of the new configurations was based on a reduction in the number of springs (eight-spring configuration), and the sec

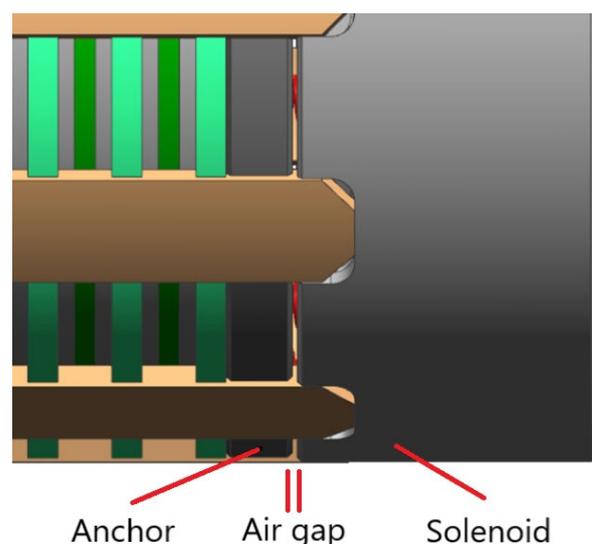
- Air gap, which represents the gap between the anchor and the solenoid when the brake is not powered and the magnetic field is absent, as represented in Figure 1. Once the solenoid is supplied, it engages the anchor, and the air gap previously located between the solenoid and the anchor is distributed between all the braking surfaces, which are free to rotate, and the system does not exert any braking torque. Therefore, the air gap must be properly dimensioned to avoid dynamic contacts and wear, even when the brake is not working [10].

**Figure 1.** Air gap.

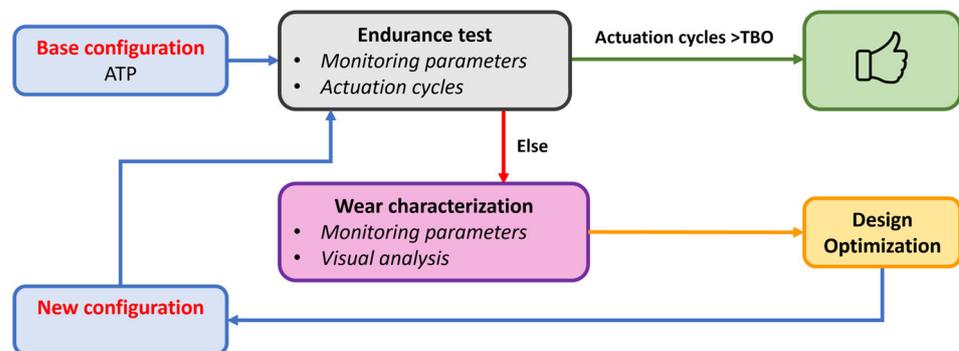
The experimental characterization was performed with the following steps, as summarized in Figure 2:

- A preliminary Acceptance Test Procedure (ATP) aimed at checking that the brake has no operational flaws and at defining a set of reference working parameters;
- The experimental characterization of the failure causes by monitoring specific working parameters during an endurance test of the base configuration until brake failure;
- The design of modifications to optimize the wear behavior;
- An endurance validation test after the redesign phase to investigate the effective optimization of the wear behavior and durability.

**Figure 2.** Experimental characterization and optimization procedure.

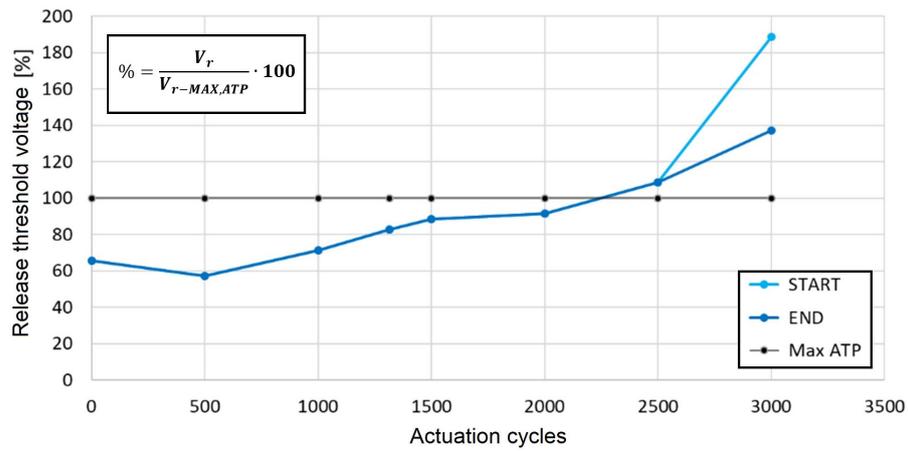
Figure 3 reports the trend of the release threshold voltage, which increases up to a value of about 200% of the maximum value obtained during the preliminary ATP. The start curve represents the values of the release threshold voltage when the anchor starts to be released, and the end curve reports the values of the voltage when the anchor's release stops. The start and end curves should be coincident if the anchor is uniformly released. Given that these two curves are not coincident after 2500 actuation cycles, the anchor's release is not uniform, and the air gap progressively increased during the test while the anchor was engaged.

Figure 3. Release threshold voltage in the base configuration.

The increase in the release threshold voltage suggests that particles of worn material from the disk pack are located between the solenoid and the anchor, and the difference between the start and end curves suggests that the worn material is not uniformly distributed at the interface, but a greater number of wear particles are located in a portion of the interface, which is also justified by the test rig slope.

The trend of the release threshold voltage (Figure 3) is strongly related to this evidence. In fact, as the stator disks are made of ferromagnetic materials, they release ferromagnetic particles, which are attracted by the magnetic field generated by the solenoid, and they crowd around the interface between the solenoid and anchor, causing the nonuniform release of the anchor, as also demonstrated by the visual inspection of the solenoid.

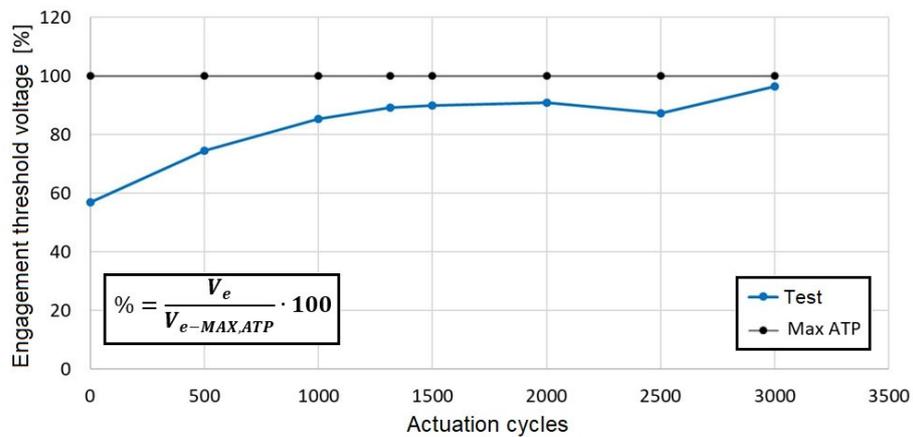
Figures 4 and 5 show the trend of the engagement threshold voltage and that of the inductance, respectively. These results suggest that the air gap increases due to the wear progress. In fact, the air gap increase implies both that the inductance decreased during the test and that the engagement threshold voltage increased because a greater power supply is necessary for the solenoid to generate a sufficient magnetic field to engage the anchor.

Figure 4. Engagement threshold voltage in the base configuration.

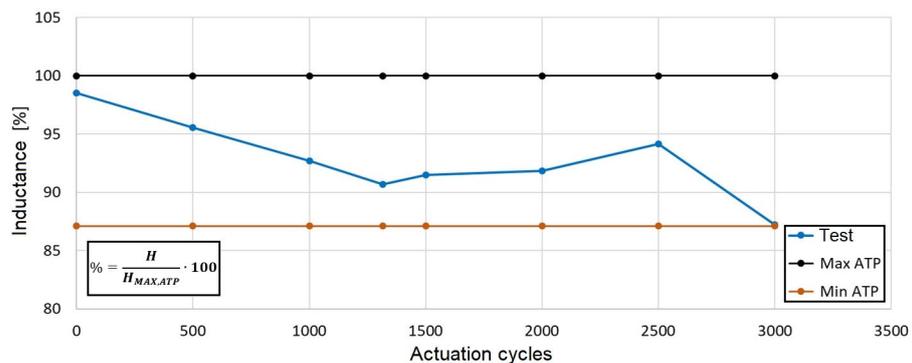
Figure 5. Inductance in the base configuration.

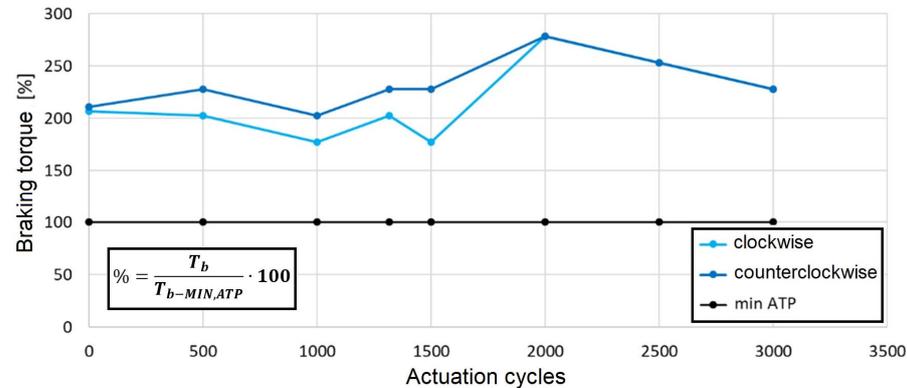
Figure 6 shows the trend of the braking torque, which is higher than the minimum value resulting from the ATP and reaches 300% of the reference maximum value. This result demonstrates that despite the short durability, the braking system maintains a sufficient braking capacity.

Figure 6. Braking torque in the base configuration.

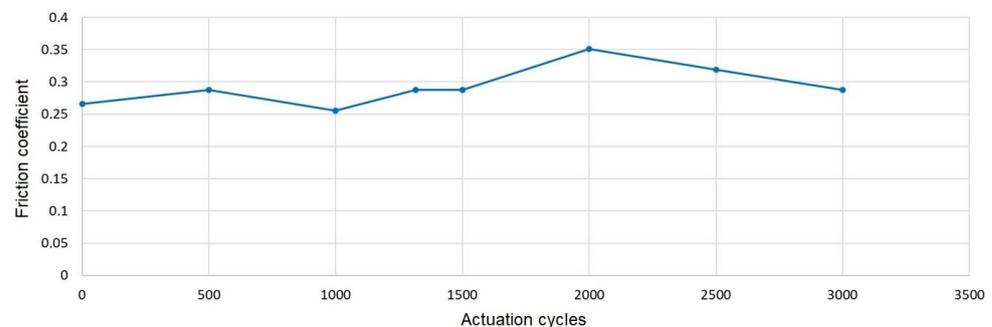
where  $N$  is the number of contact mating surfaces,  $F$  is the normal force on the disks,  $f$  is the friction coefficient, and  $D$  and  $d$  are the maximum and minimum diameters of the contact surface, respectively. The results are reported in Figure 7, where it is shown that the friction coefficient slightly fluctuates around an average value of 0.3.

Figure 7. Friction coefficient in the base configuration.

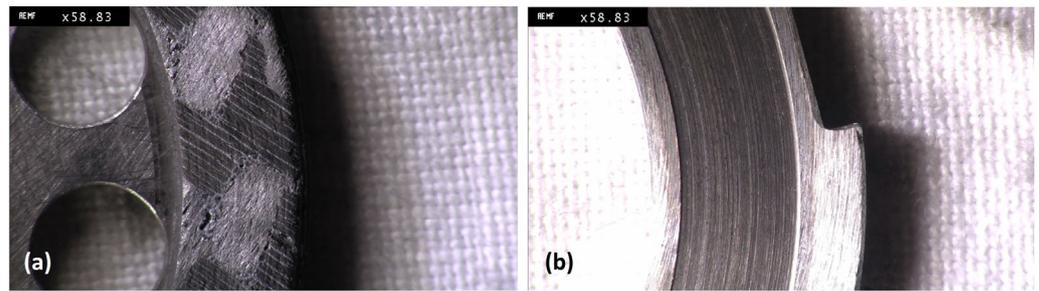
At the end of this endurance test, a visual analysis of the sample braking components was conducted using a digital microscope. When the brake was dismantled from the test rig and opened, a large number of wear particles were evident, and a visual inspection highlighted that the stator disks were more worn than the rotor disks, as can be observed in Figure 8.

Figure 8. Worn disks: (a) rotor; (b) stator.

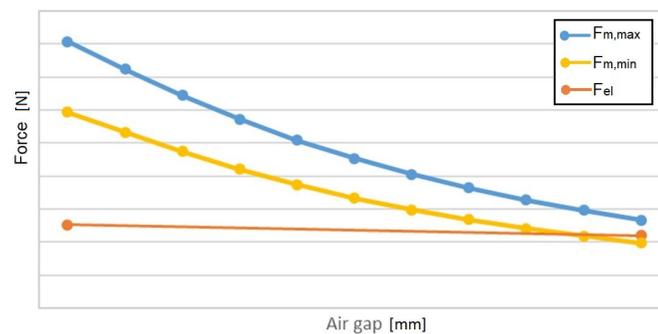
The anchor can be released when the elastic force  $F_{el}$  exerted by the springs is greater than the magnetic force  $F_m$  exerted by the solenoid. Figure 9 shows the force trend vs. the airgap thickness, where  $F_{m,max}$  represents the force exerted by the solenoid at the maximum supply voltage necessary to engage the anchor, and  $F_{m,min}$  is the magnetic force when the solenoid is supplied with a reduced voltage after the anchor’s engagement.

Figure 9. Forces vs. air gap.

The failure of the brake occurs when the worn material interposed between the anchor and solenoid generates an airgap increase, and the  $F_m$  necessary to keep the anchor engaged becomes lower than the elastic force  $F_{el}$ . In this condition, the supply voltage is not sufficient to keep the anchor engaged, and the anchor’s release occurs.

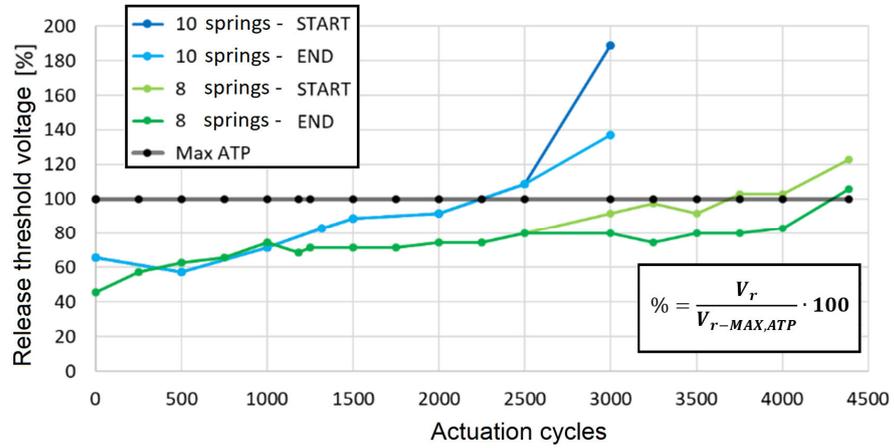
Figure 10. Release threshold voltage in the 8-spring and 10-spring (base) configurations.

Figure 10 compares the release threshold voltage for the 8-spring and base configurations (10 springs), also showing that, in the 8-spring configuration, the anchor starts undergoing partial and nonuniform engagement after around 2500 actuation cycles. The release threshold voltage trend again suggests that particles of worn material from the disk pack are located between the solenoid and the anchor and that the worn material is not uniformly distributed at the interface.

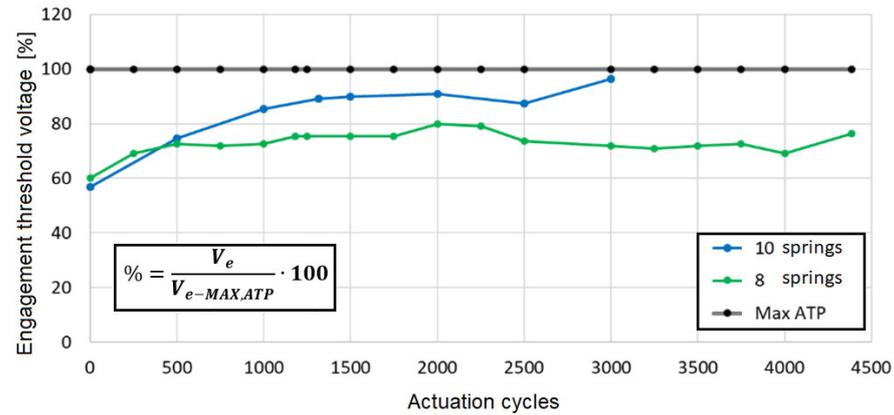
Figure 11. Engagement threshold voltage in the 8-spring and 10-spring (base) configurations.

Figures 11 and 12 compare the engagement threshold voltage and inductance in the eight-spring and base configurations, respectively, suggesting that wear progress also occurs in the eight-spring configuration. Nevertheless, the engagement threshold voltage always remains less than the reference maximum ATP value.

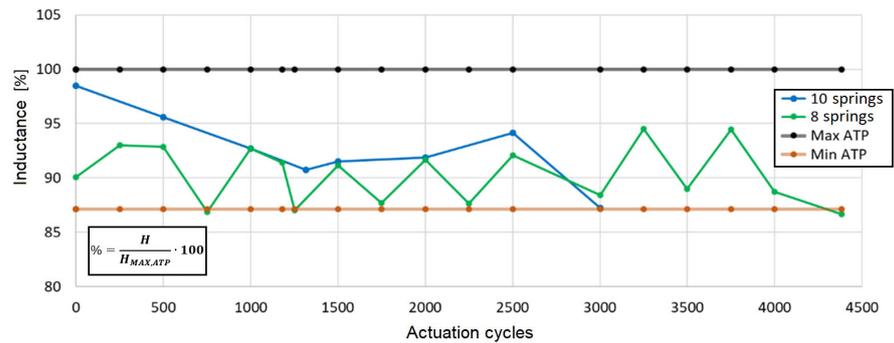
Figure 12. Inductance in the 8-spring and 10-spring (base) configurations.

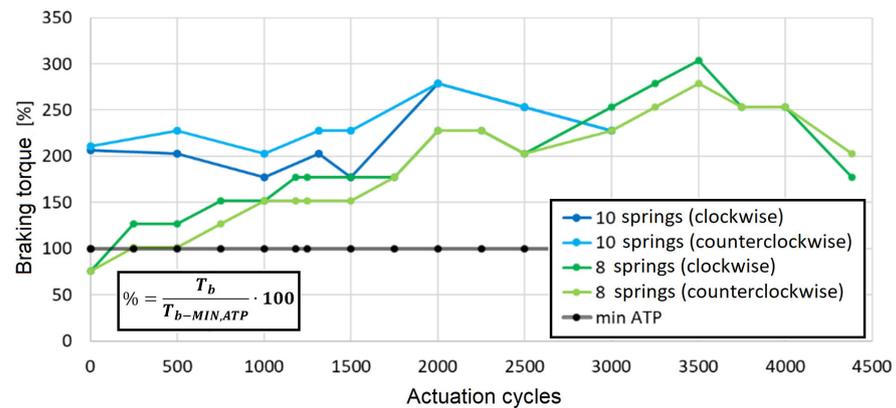
**Figure 13.** Braking torque in the 8-spring and 10-spring (base) configurations.

Figure 13 reports the braking torque comparison for the eight-spring and base configurations. The results show that in the eight-spring configuration, the initial braking torque is less than the minimum value established with the ATP, but it rapidly reaches acceptable values, although less than in the base configuration, as was expected.

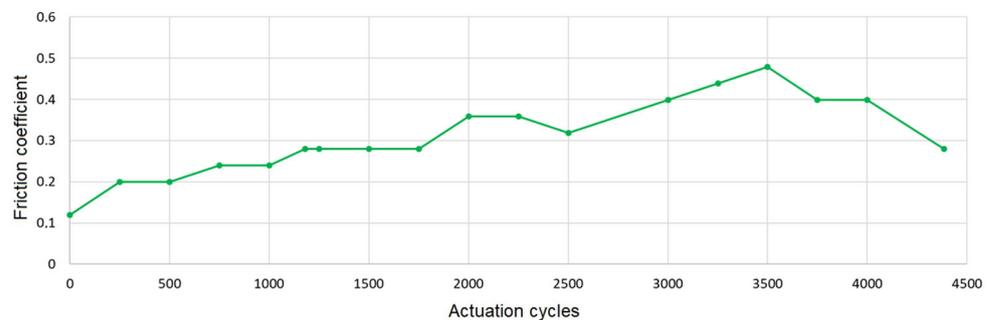
Figure 14 shows the trend of the friction coefficient during the test, which varies from a relatively low value of around 0.1 to a high value close to 0.5.

**Figure 14.** Friction coefficient in the 8-spring configuration.

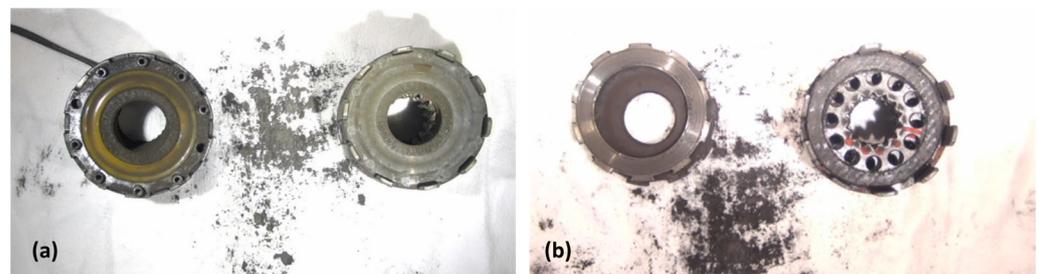
Again, in this case, the visual analysis of the sample braking components at the end of the endurance test demonstrated the presence of a large number of ferromagnetic particles, as can be observed in Figure 15.

**Figure 15.** Eight-spring configuration after test: (a) solenoid and anchor; (b) stator and rotor.

Therefore, the failure of the braking system is due to the accumulation of ferromagnetic particles between the anchor and solenoid, mainly originating from wear progress on the stator disks. These results lead to the conclusion that possible further optimization in terms of the wear resistance and durability of the system lies in a reduction in the ferromagnetic wear material and thus in a change in the friction pair materials.

The carbon fiber used as friction material for the rotor disks could be identified as possibly responsible for the severe wear phenomenon on the stainless-steel stator. This could be due to different factors, such as the low operating temperature of the brake and the different wear behaviors of the matrix and reinforcement of carbon fiber. For this reason, a different friction material was analyzed.

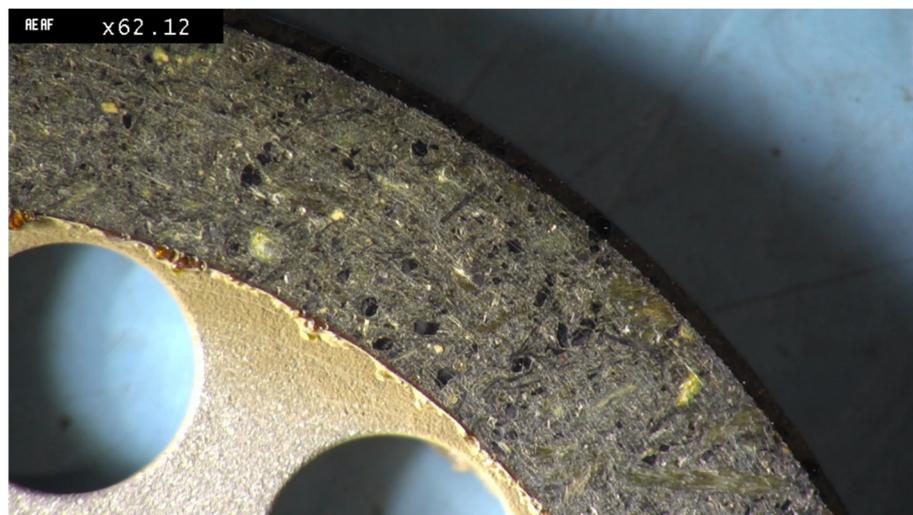
The new friction material used for the rotor disks was a non-asbestos organic (NAO) friction composite, which is a polymer-reinforced material (Figure 16).

**Figure 16.** Rotor disk with NAO as friction material.

This material is mainly composed of a phenolic resin combined with nitrile butadiene rubber (NBR), short-fiber reinforcement, fillers, and metallic particles, with 15–40% ferrous materials. From a mechanical point of view, this material is rigid with high hardness and mechanical resistance.

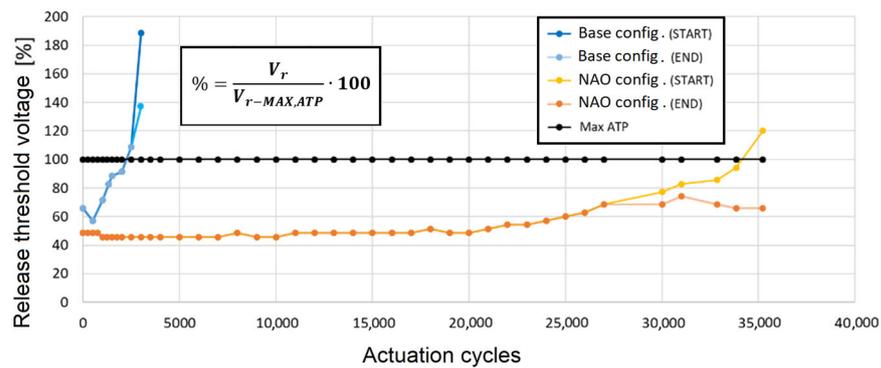
Figure 17 shows the release threshold voltage of the anchor in the NAO configuration compared with the same voltage measured in the base configuration. The trend is stationary for up to 20,000 actuation cycles, and it shows an increasing trend afterward, suggesting that the air gap starts to widen, probably due to the presence of wear particles.

Figure 17. Release threshold voltage in the base and NAO configurations.

After 27,000 actuation cycles, the anchor is released nonuniformly, which suggests that the wear particles are mainly crowded in a portion of the interface, probably the lower portion due to the slope. The failure of the brake occurs at 35,000 actuation cycles.

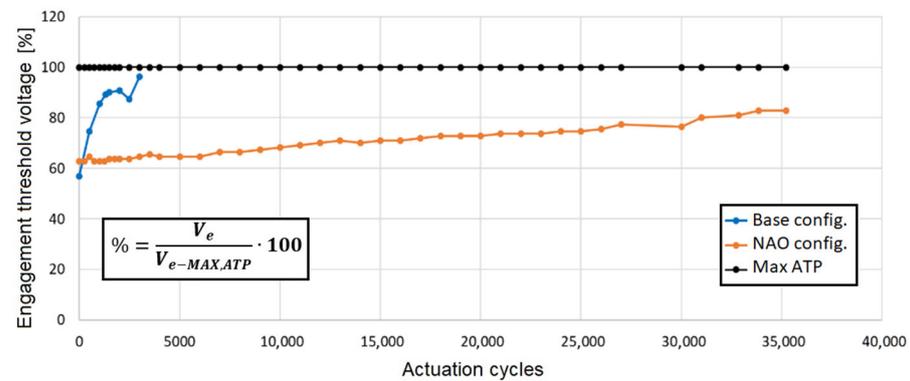
Figure 18. Engagement threshold voltage in the base and NAO configurations.

In Figure 18, the engagement threshold voltage of the NAO configuration is shown in comparison with the same voltage measured in the base configuration. In this case, one can observe that the engagement voltage increases with the number of actuation cycles, which suggests some wear progress, but it remains lower than the ATP value.

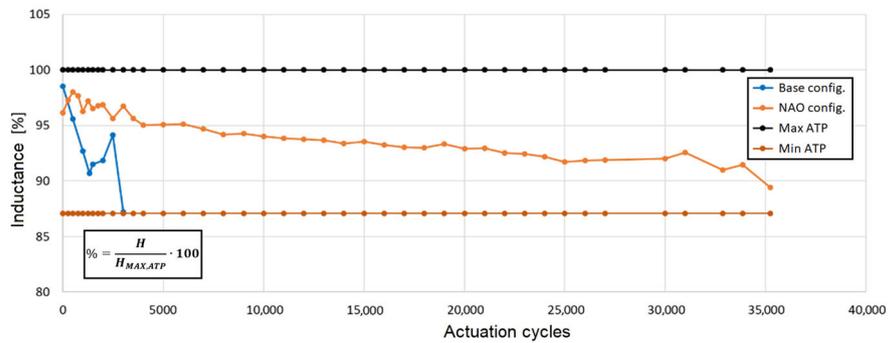
Figure 19. Inductance in the base and NAO configurations.

These results are also confirmed by the monitored inductance (Figure 19) compared with the inductance measured in the base configuration, which presents a decreasing trend compatible with an increase in the air gap due to wear.

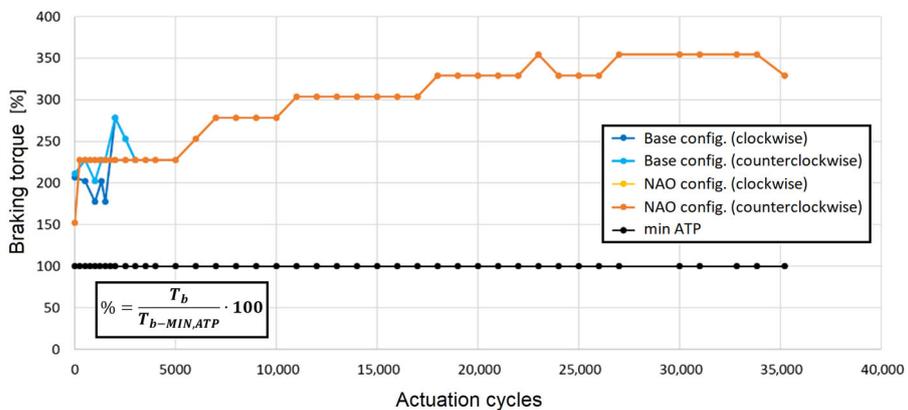
Figure 20. Braking torque in the base and NAO configurations.

The trend of the braking torque in the NAO configuration (Figure 20) shows higher values than the minimum value to guarantee an efficient braking effect.

Its increasing trend with respect to the actuation cycles depends on the stabilization of the tribological system, which implies an increase in the effective contact area at the interface and an increase in friction. The tribological stabilization of the system allows a friction coefficient of 0.45 to be reached, as reported in Figure 21.

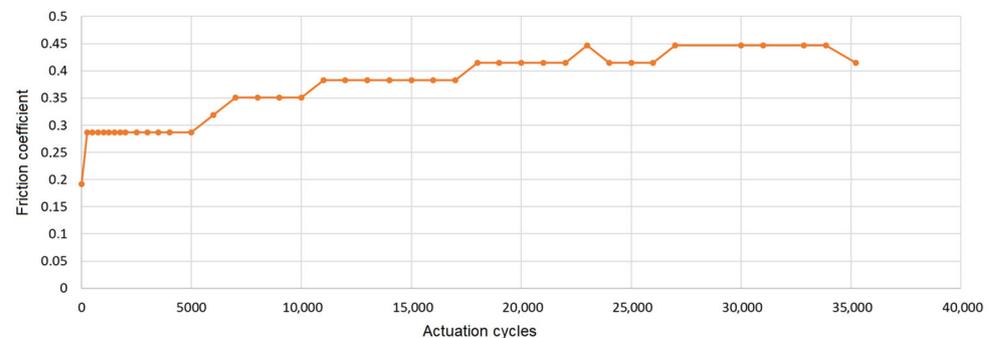
**Figure 21.** Friction coefficient in the NAO configuration.

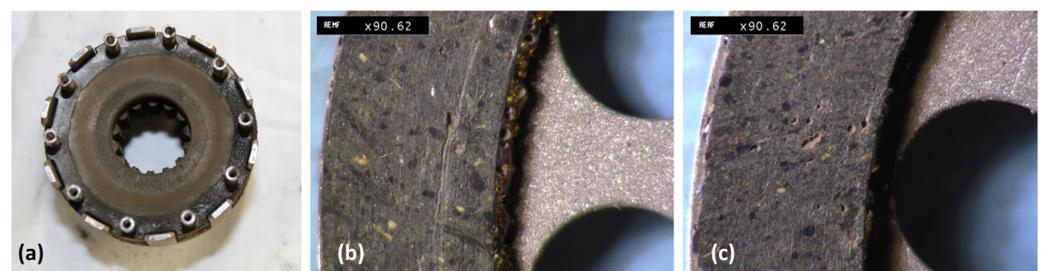
Figure 22 shows the superficial condition of the NAO friction material. The presence of cavities and scratches is due to the removal of reinforcement splinters, which causes the wear and weakening of the surfaces. The number of ferromagnetic wear particles at the interface is still lower than in previous configurations. In this case, in contrast to the previous configurations, the rotors are the main worn components; therefore, the ferromagnetic wear particles derive from the NAO friction material, which is a more desirable condition.

**Figure 22.** Worn components: (a) solenoid; (b) rotor 1; (c) rotor 2.
