# Pitting Corrosion of Steel Pipes in Water Supply Systems: An Influence of Shell-like Layer

**Abstract:** The research was aimed at studying pitting corrosion, which precedes the appearance of fistulas in steel and cast-iron pipelines in water supply systems and leads to significant expenditures. The process of fistula formation is accompanied by the formation of tubercles and craters on the surface of a corroding metal. The study focused on examining the qualitative and quantitative composition of the solution, which is generated inside the tubercles during their growth. It was found that, during the operation of water pipelines, the concentration of aggressive chloride ions inside the tubercles increases significantly compared to the chloride content of the source water. The increase in chloride concentration leads to an accelerated corrosion rate, potentially causing the formation of fistulas over time. As a result of the study, a mechanism for changing the mineral composition of the solution inside the tubercles has been proposed. This is due to the manifestation of selective properties by a dense layer of tubercles. The study also examined the appearance of crystalline forms

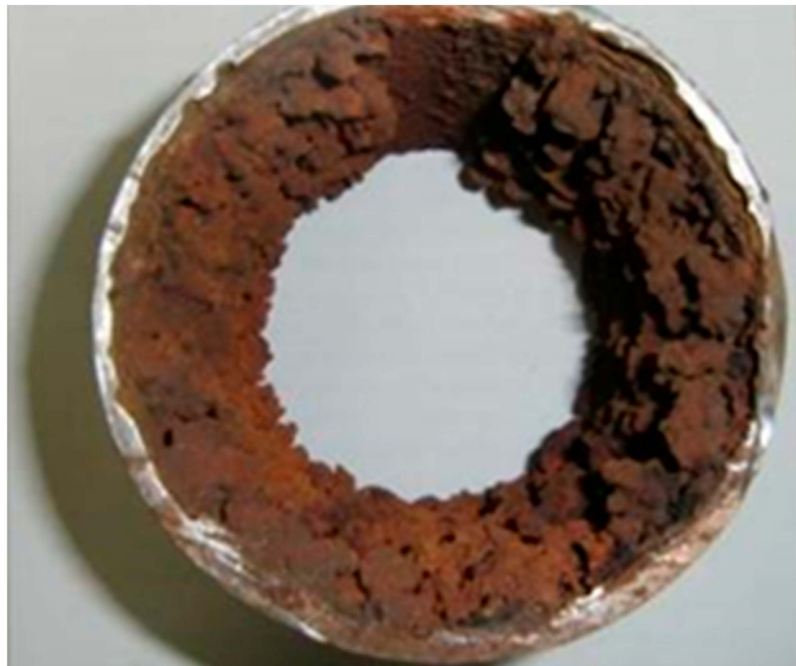
**Figure 1.** A fragment of steel galvanized pipe with corrosion tubercles.

Figures 1 and 2 reveal photographs of pipes with different tubercle structures. Since the corrosion in the formed tubercle occurs in an area bound by the contour of the tubercle, iron accumulates inside the tubercle. At the same time, favorable conditions occur for the precipitation of iron oxides, which have low solubility. Figure 6 shows the sizes of crystal structures that can be used to calculate the density of the corrosive current according to Equation (2).

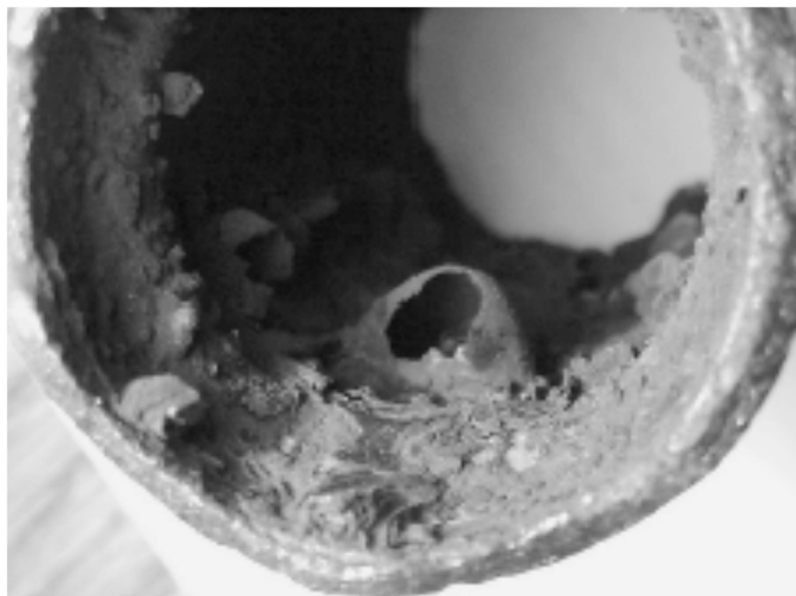
**Figure 2.** A fragment of steel pipe (from the fire-fighting water supply system) with corrosion tubercles [6].

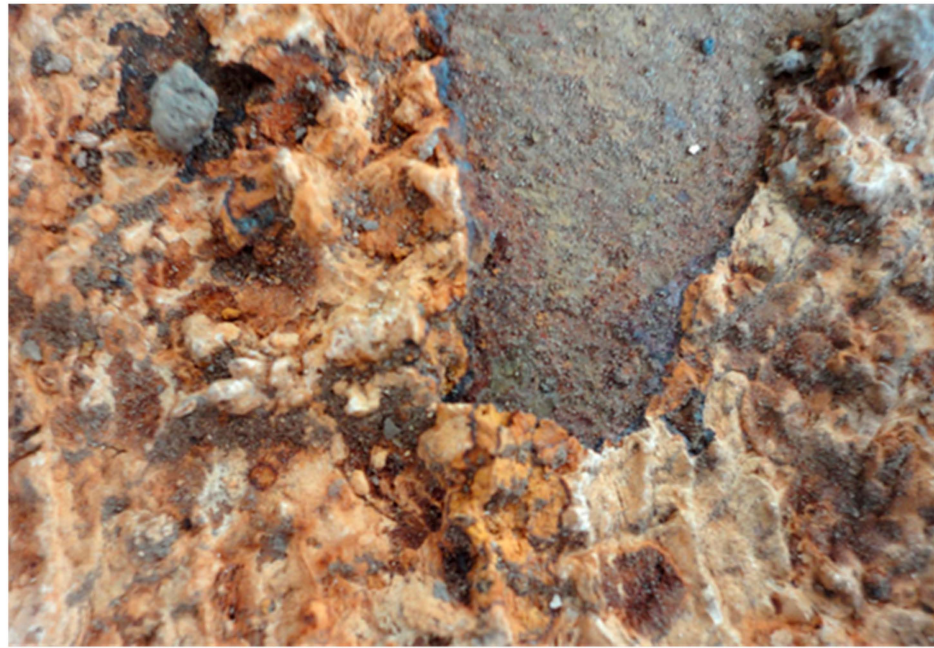
**Figure 3.** Inner surface of the pipe (d = 300 mm, carbon steel).

Studies of the structural features of the tubercles were carried out on the pipes after being in operation. The inner surface of a fragment of an uncoated steel pipe DN 300, extracted from the water supply system in Moscow, is shown in Figure 3. Corrosion deposits on the surface of the pipe are solid, dense, and durable, with oval tubercles measuring from  $5 \times 5$  to  $10 \times 10$  mm and with a height of 5–8 mm. The pipe service life was 36 years. The tubercles were divided into three groups according to the following criteria. Tubercles with a full set of structural differences were assigned to Group 1: surface layer, shell layer, core, and base. The second group of tubercles was without a base, and the third group included the most deformed tubercles removed from the pipe. Figures 3 and 4 show photographs of the inner surface of the pipe.

The surface of the pipe under the layer of corrosive deposits has traces of entire ulcerative corrosion and spot damage on the background of flat traces. The depth of spot damage was from 1.0 to 3.0 mm, and the diameter was from 2 to 5 mm. There are also traces of extensive corrosion; the thickness of the corroded metal can be estimated from the remaining sections at 0.5–1.0 mm.

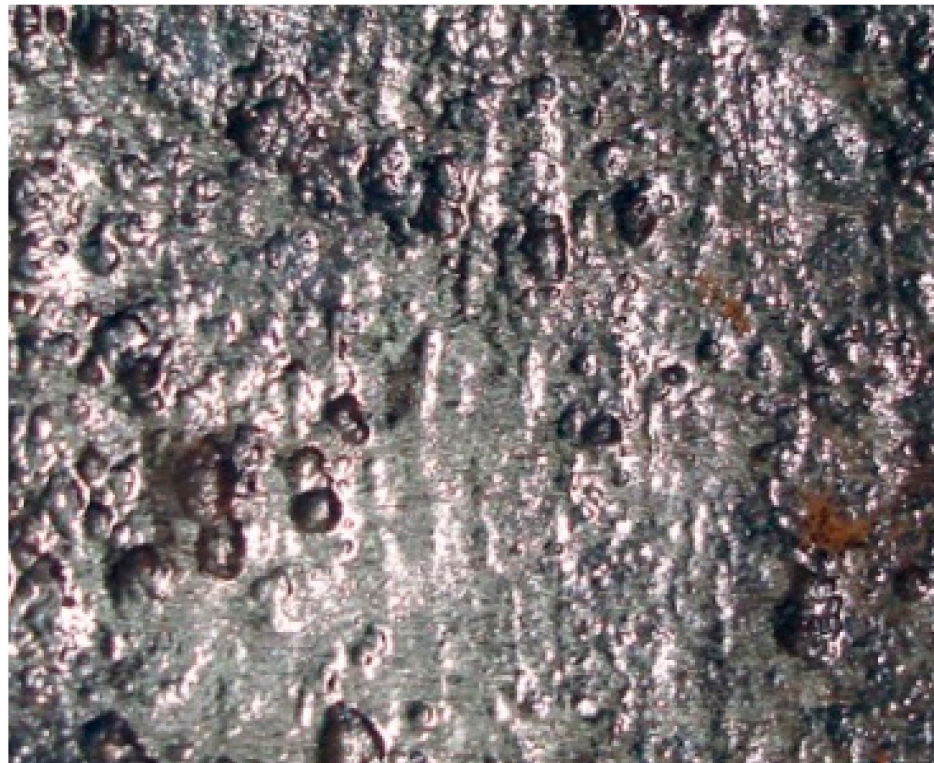
**Figure 4.** Photo of the pipe inner surface after removal of corrosion deposit layer (zoom 2x).

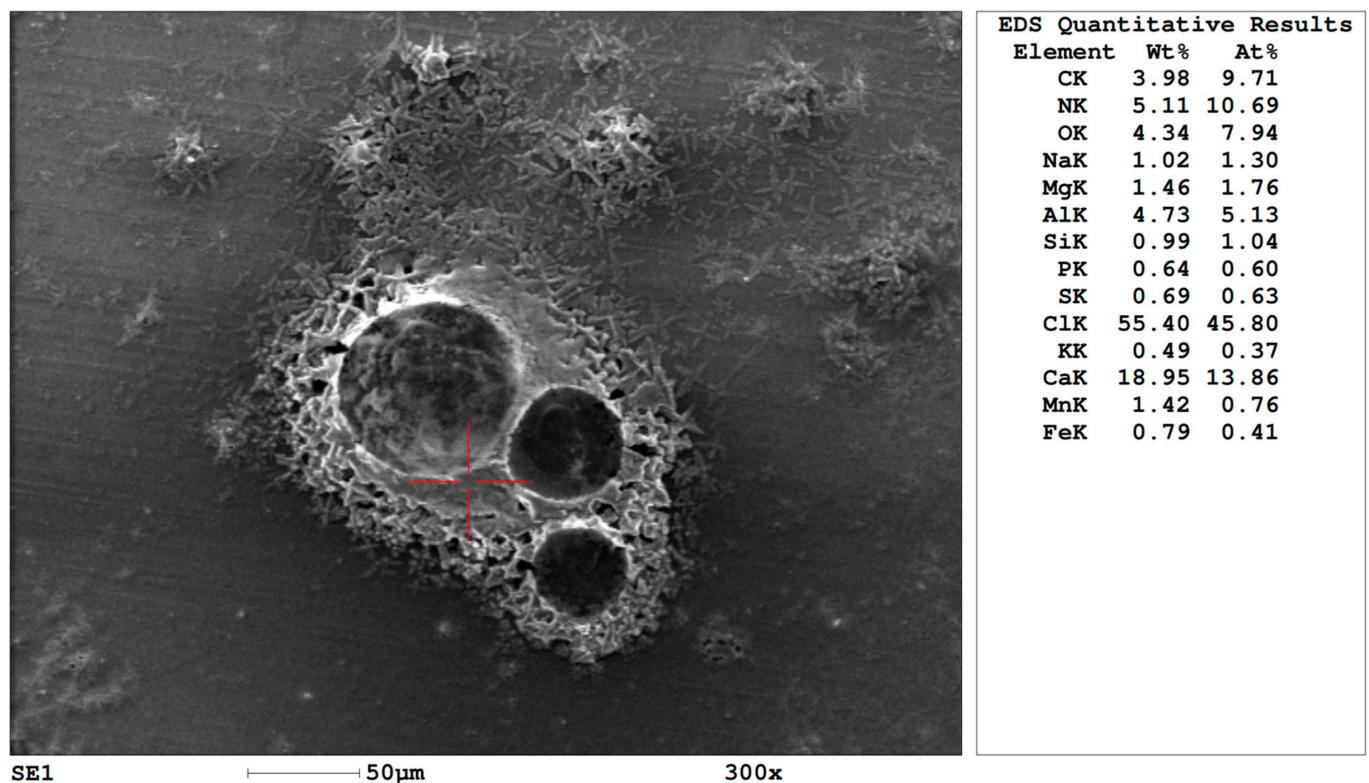
**Figure 5.** Spectrogram of the elemental composition (in the area marked by a red cross) of desorbed water.

In addition to determining the composition of water, the qualitative composition of desorbed salts was evaluated. For this purpose, 3 mL of water was evaporated on an aluminum foil substrate in a drying cabinet at a temperature of 80 °C. The dry sediment was studied using a Quanta FEI 250 scanning electron microscope and an EDAX (Gatan, Pleasanton, CA, USA) energy dispersion spectral analyzer (Figure 5).

The data obtained using the electron microscope show that the main components of the solution are chlorides, nitrates, and calcium. The contribution of each of the other elements is estimated at 0.3–1.5%. The acidic medium of the solution is determined by the presence of hydrogen cations.

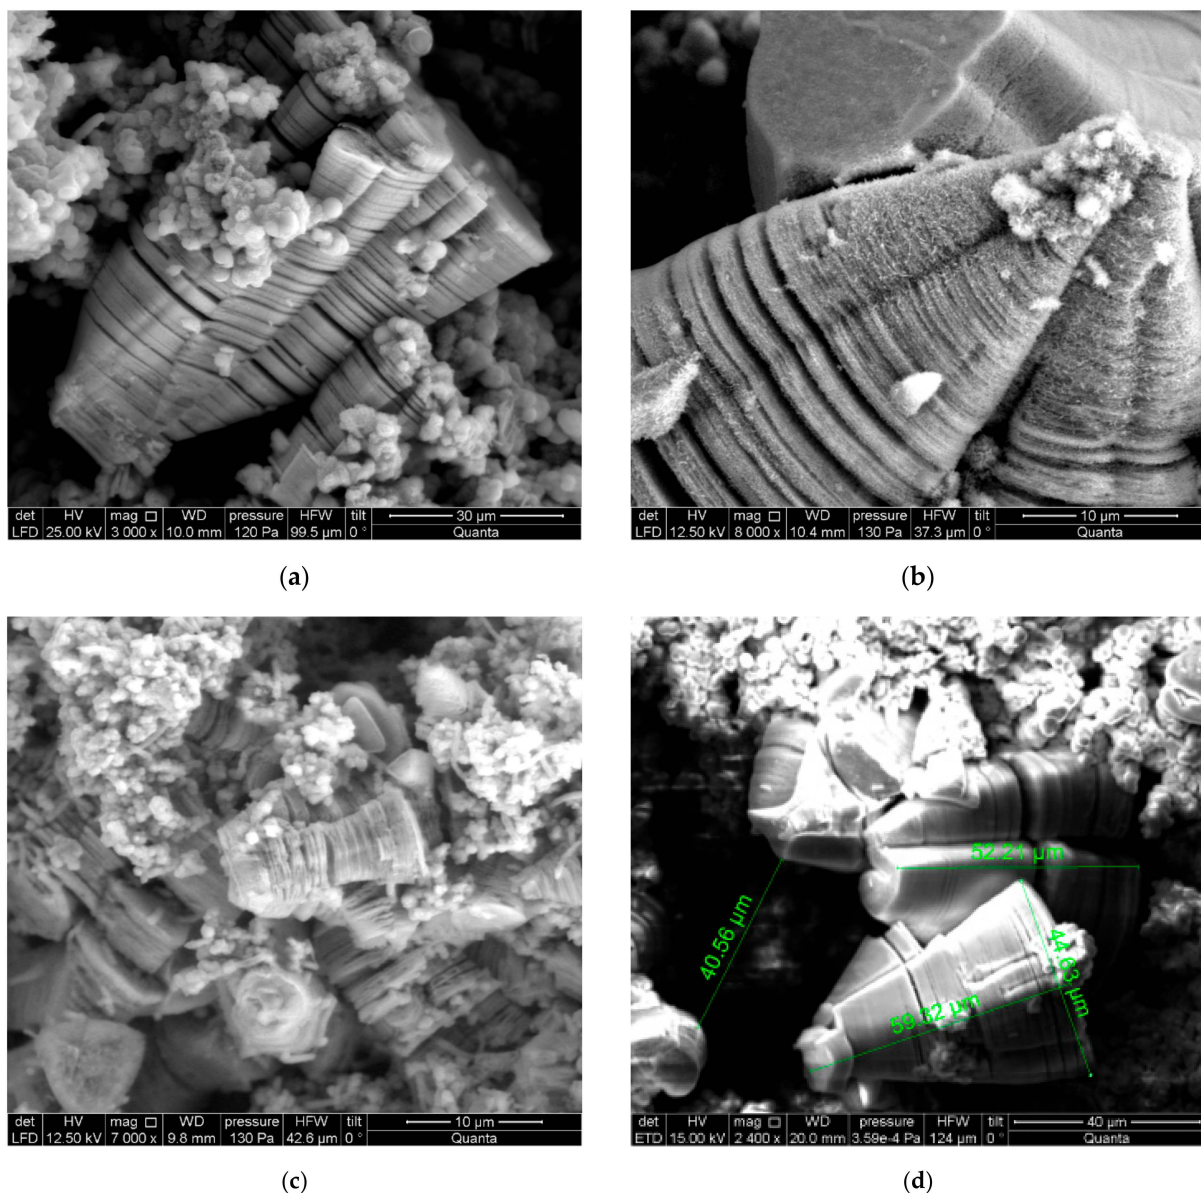
**Figure 6.** Forms of scale in steel pipes within fistulas formation under different magnification: (a) 3000 $\times$ ; (b) 8000 $\times$ ; (c) 7000 $\times$ ; (d) 2400 $\times$ .

Figure 6 shows photographs that explain the last stage of the development of pitting corrosion. The metal under the tubercle collapses and forms crystalline conical structures, which duplicate the shape of the pitting. This happens due to the lack of water inflow into the tubercles through a dense layer or a limited amount of water in the pitting structure.

Figure 6 shows the formation of a large number of conical elements. The chaotic location of separate crystals indicates the mutual movement of crystal structures inside the core of the tubercle with continued corrosion. If the volume of water is sufficient inside the tubercle, then the shallow pit can turn into a deep one. Otherwise, the corrosion may stop completely or be suspended for a while in accordance with external conditions. Crystal structures fill the inner volume of the tubercle during the entire life of the pipeline; therefore, the presence of dense tubercles is characteristic of pipes that have been in operation for a long time.

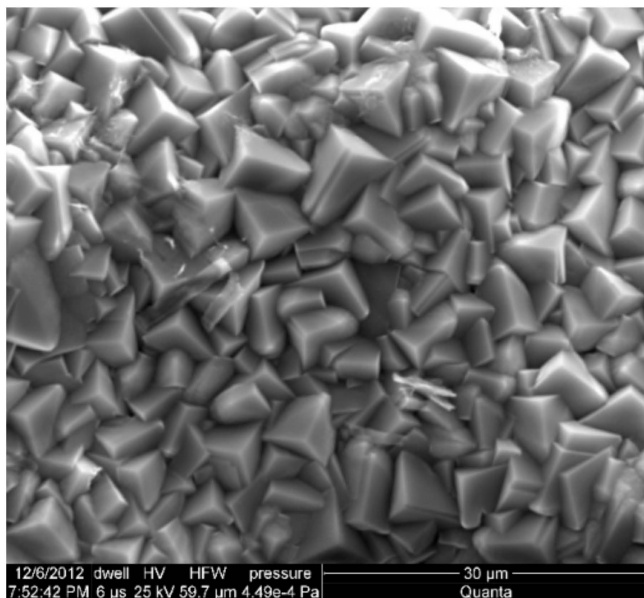
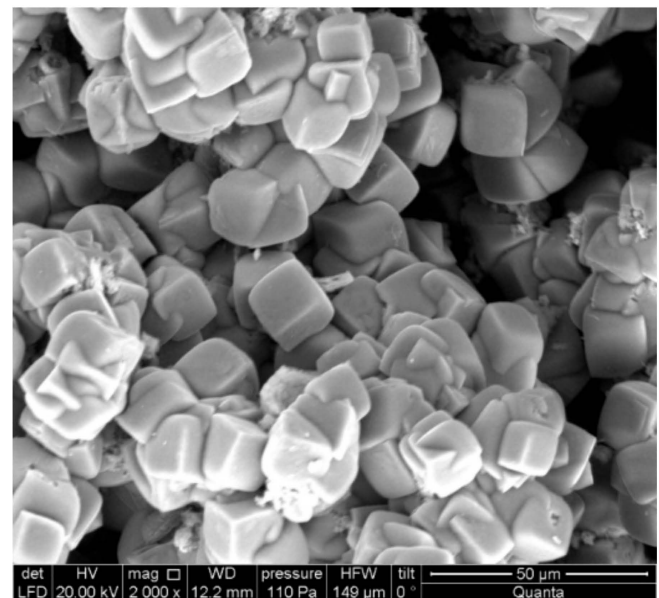
**Figure 7.** Microphotographs of corrosion scales in cold water pipes (a) and hot water pipes (b).

Additional information about the process of scale formation in pipes can be provided by the analysis of photographs obtained after the extraction of tubercles. Figure 7 shows micrographs of corrosion scales removed from an uncoated steel pipe of the cold water supply system DN 900 mm (a) and a galvanized steel pipe DN 100 from the hot water supply system (b).

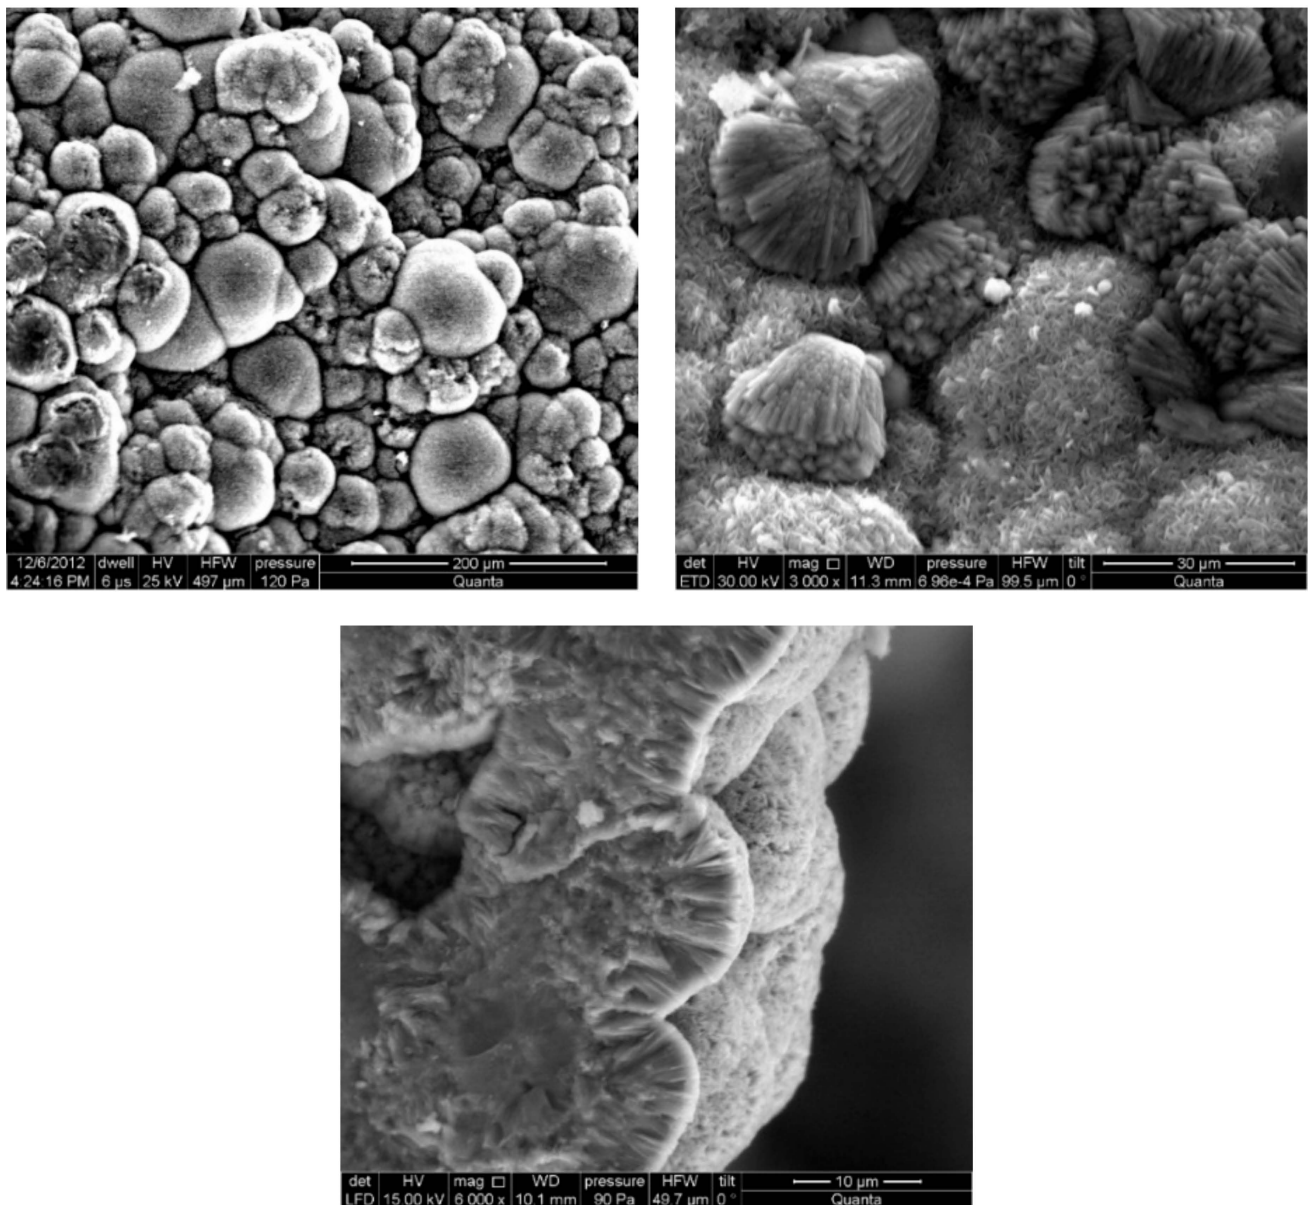
**Figure 8.** Microphotographs of corrosion scale, which forms a dry layer of the metal base of the pipe.

Hemispherical scale crystals, which copy the metal surface, are formed with a significant oversaturation of the solution. The second condition is the absence of spatial restrictions confirming the presence of a high concentration of iron salts in the inner volume of the tubercles (Figure 8).
