Article

Structural Health Monitoring for Prefabricated Building Envelope under Stress Tests

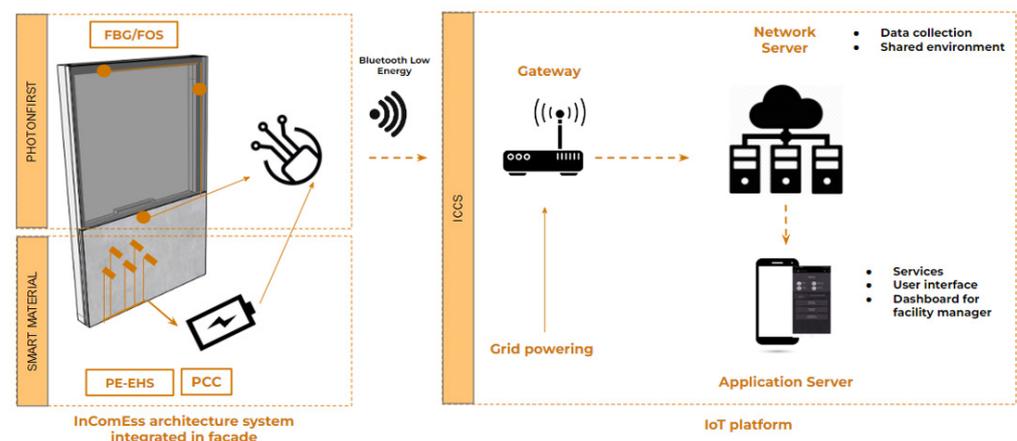
Figure 1. Scheme of InComEss system architecture with components integrated into façade and communication to IoT platform.

In line with these research and technological scenarios, the EU-funded InComEss project [27] aims to define a stand-alone solution for SHM using Piezoelectric Energy Harvesting Systems (PE-EHS) for façade monitoring [28], and this paper presents the structural health monitoring sensing solutions within the InComEss architectural system [29]. The architectural design of the InComEss system is geared towards harnessing the potential of Piezoelectric Energy Harvesting Systems (PE-EHS) to supply energy to a fiber optic sensor, MonadGator. This interrogator reads data from FBG and communicates with a Power Conditioner Circuit (PCC) seamlessly integrated with a Printed Circuit Board (PCB) powered by a locally implemented Supercapacitor (SC). The connection between the PCC/PCB, an Internet of Things (IoT) gateway, and a cloud-based IoT monitoring platform facilitates data collection and analysis. The overarching objective is to showcase the practicality of Wireless Sensor Networks (WSNs) for structural health monitoring (SHM). Based on the InComEss system architecture conceptualization, the PE-EHS and FBG sensors are designed to demonstrate their integrability within a prefabricated façade. Figure 1 shows the InComEss architecture underlining the components embedded within the façade and the digital components.

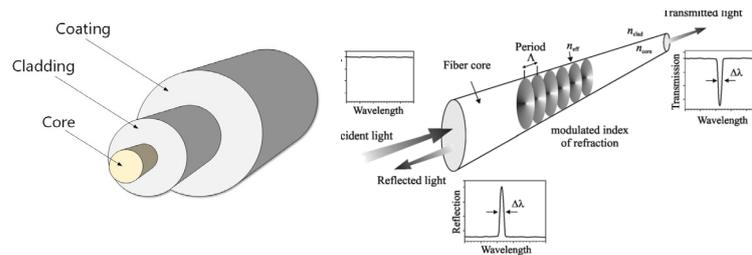
Figure 2. Schematic representation of a fiber and Fiber Bragg Grating inscribed into the core of an optical fiber.

The first considerations presented are related to physical components such as the FBG sensors. This product represents an application for the façade demo case, and during the InComEss project, it will demonstrate the potential of its applicability for SHM in the building envelope market. An optical fiber consists of a core and cladding. The cladding of the fiber has a typical diameter of 125 μm while the core has a diameter of typically $\sim 10 \mu\text{m}$. The core has a higher refractive index than the cladding, such that the light is captured in the core. A Fiber Bragg Grating is a periodic modulation of the refractive index in the fiber core. A representation can be seen in Figure 2.

The period of the refractive index modulation determines the wavelength of light that is reflected. Due to temperature or strain, the period of the modulation, and thus, its reflected wavelength, will change. Due to this principle, FBG sensors serve dual roles as both strain and temperature detectors. When mounted within a hollow capillary, an FBG sensor exclusively detects temperature changes, disregarding strain. The sensor's wavelength indicates temperature variations through a fixed, linear conversion based on glass material properties. The MonadGator interrogator is the measurement device developed to measure the shift in Bragg wavelength of the FBG sensors. The system uses a light source that emits a broadband wavelength spectrum through the fiber toward the FBG sensors. The reflected wavelength is measured by the MonadGator and converted to a strain or temperature. This MonadGator is designed to operate with low power consumption. Figure 3 reports the InComEss architecture, showing how the energy generated powered the MonadGator for the FBG sensors.

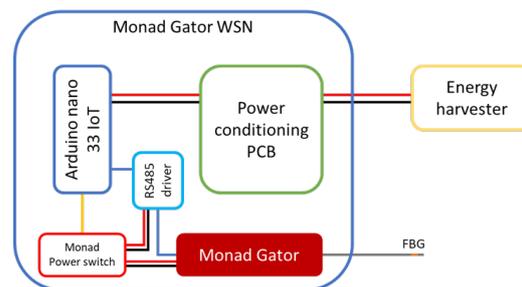
Figure 3. Scheme of InComEss architecture.

An Arduino nano is used to rapidly start up the MonadGator and execute a measurement of the FBG wavelength. The broadband light source is turned on for a period of 70 ms. In that time span, the FBG sensor is read, and the data from the photodiodes are acquired by the Arduino. These data are transferred using a Bluetooth Low Energy (BLE) connection to the IOT gateway. The Arduino is powered by a power conditioning circuit, which is charged with the energy that is harvested from the energy harvester connected to this circuit. A total measurement cycle, including wireless data transfer, takes less than 150 ms and uses only 0.08 J of energy per measurement.

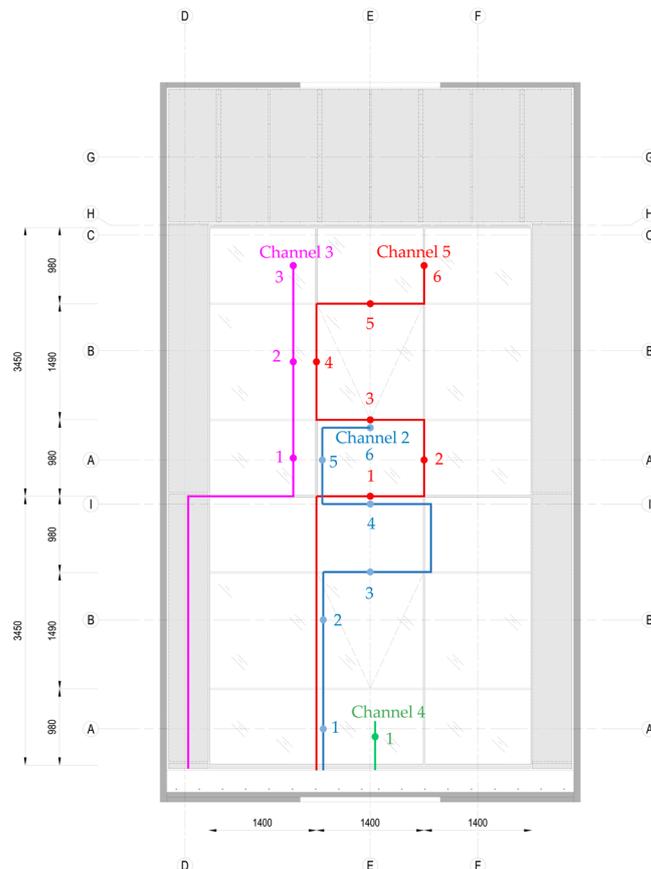
Figure 4. Scheme of FBGs channel position.

According to the previous outcomes, the fiber optic cables were applied to the glass surface and the aluminum profiles in specific positions. The FBG sensors monitor the direction of its application; thus, two fiber cables were installed to monitor the *x* and *y* direction, while one monitored the *z* direction. Figure 4 shows the cable path and the FBG positions within the façade.

- Channel 2—central glazed panel for temperature;
- Channel 3—slightly central glazed panel for strain (to avoid the impact test);
- Channel 5—aluminum central profiles (x direction);
- Channel 6—aluminum central profiles (z direction).

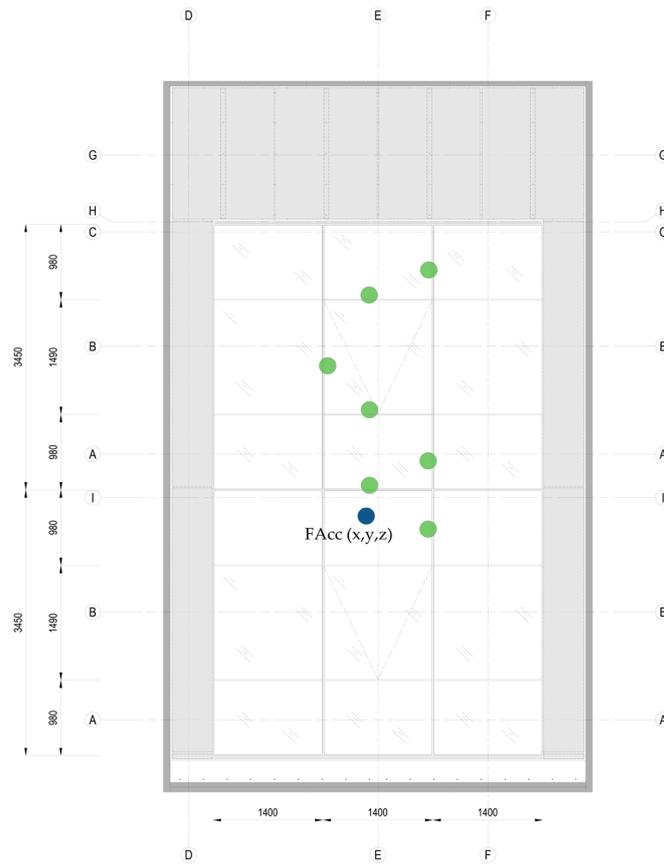
Figure 5. Accelerometer positions—façade external view.

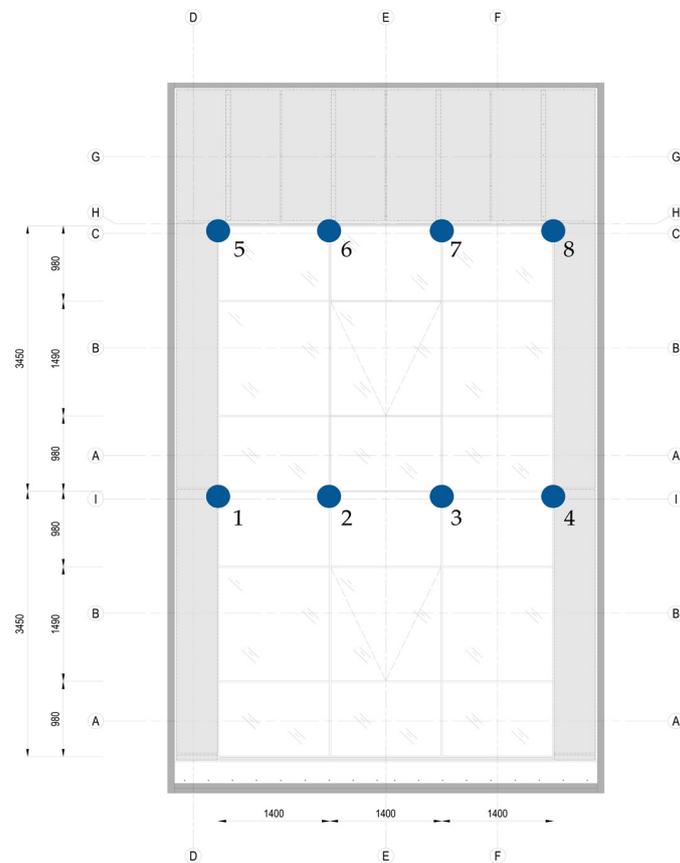
Figure 6. Force washers' positions.

Figure 6 shows the No. 8 force washer positions located in the façade brackets bolt to monitor the behavior of each bracket position.

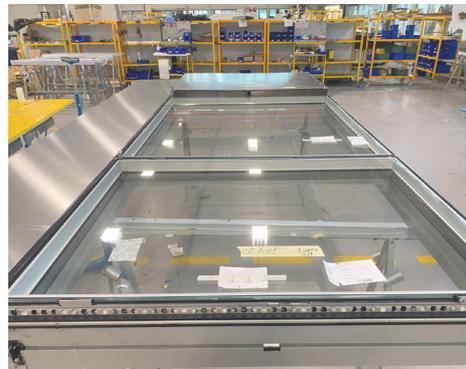
Figure 7. Façade manufacturing process.

The sample preparation involved manufacturing and installation of façade modules and then integrated sensors within the façade. Figure 7 shows the off-site process of façade manufacturing, and Figure 8 shows the on-site installation.

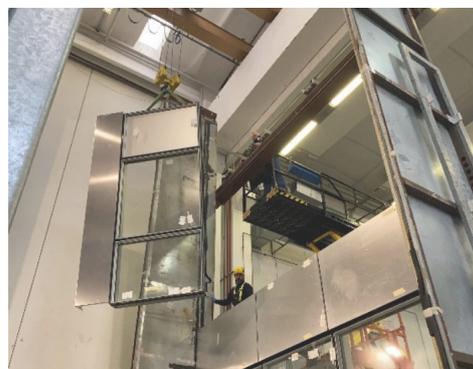
Figure 8. Façade installation process.

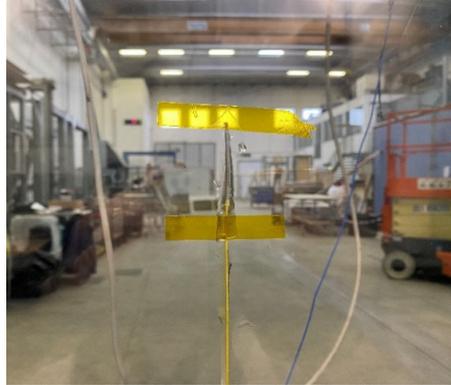
Figure 9. FBGs sensors applied on the glass surface for temperature monitoring.

For FBG, 4 different cables were installed within the façade: 2 in the glass panel and 2 on the aluminum profiles. Indeed, two cables were fixed on the glass surface through epoxy resin DP125 for bonding on glass (Figure 9), while DP410 was used for bonding on aluminum profiles (Figure 10).

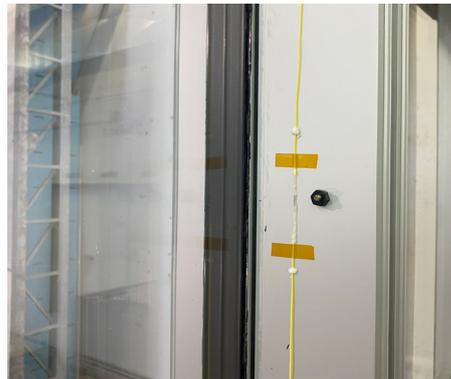
Figure 10. FBGs application on the aluminum profile for strain monitoring.

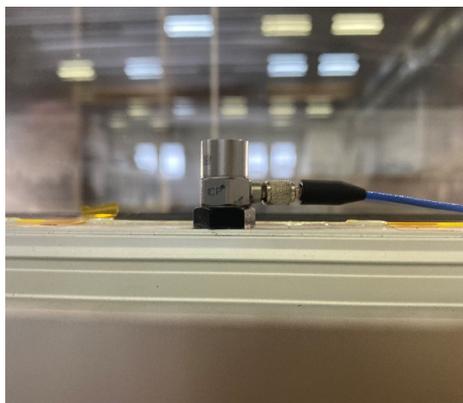
Figure 11. Accelerometer applied on aluminum transom.

Accelerometers were installed on the curtain wall façade to acquire vibrational phenomena. A triaxial accelerometer was integrated in the external façade side, while 6 monoaxial accelerometers were positioned in the internal façade's side along the central module of the façade as shown in Figures 11 and 12. The triaxial sensor, positioned in the ventilated cavity (thick 67 mm), is fully integrated and not visible from the outside due to its compact dimension ($27 \times 21 \times 11$ mm), while the internal monoaxial sensors are visible and not completely integrated into the façade aluminum profiles due to their dimensions.

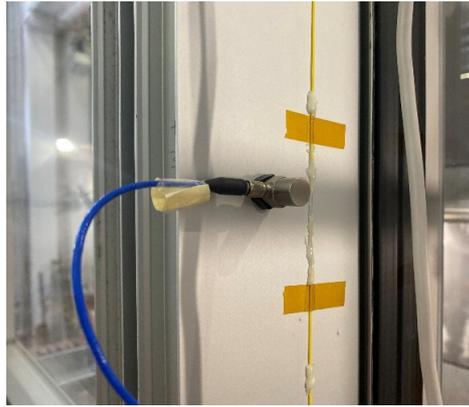
Figure 12. Accelerometer applied on aluminum mullion.

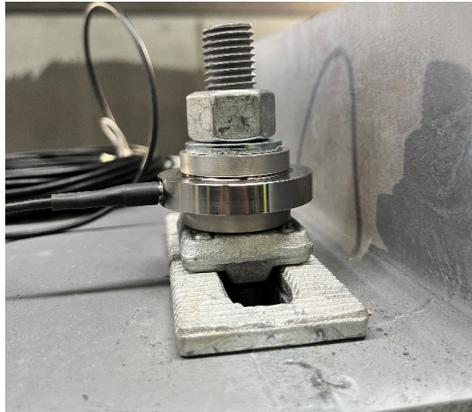
Figure 13. Zoom on the force washer installed on the bracket's bolt.

Strain gauge-based force washers were installed on the façade bolts. There were 8 sensors installed, one on each façade bracket. The integration of force washers is shown in Figures 13 and 14.

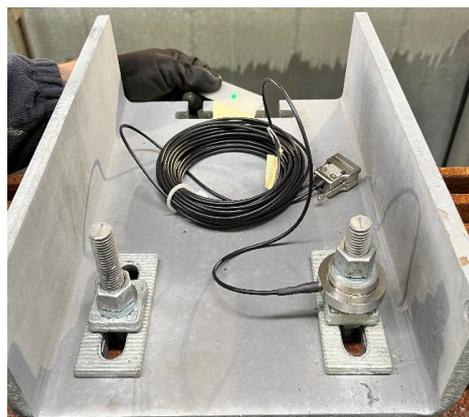
Figure 14. Façade bracket with force washer installation.

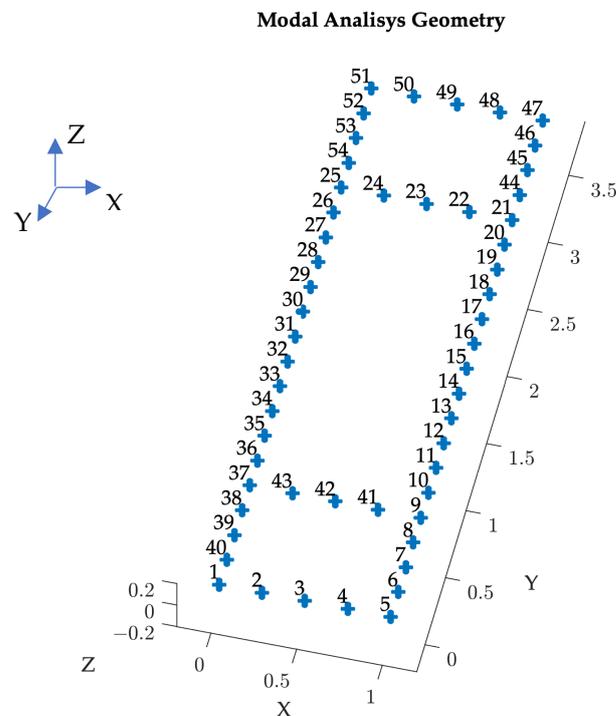
Figure 15. Modal analysis geometry consists of 54 nodes representing the modulus of the facade used for performing modal analysis.

Two modal analyses were conducted to assess any changes in structure that might have occurred due to the conformance tests explained in Appendix A. The procedure for the evaluation of the structure was applied to the central module of the wall façade, and the geometry was configured based on the dimension of the module of interest: 54 nodes were created, as shown in Figure 15.

An instrumental hammer was used for the excitation of the surface, and the dynamic response at the nodes reported in Figure 15 was measured with monoaxial accelerometers installed for measuring in Z, moved all over the nodes. The force exerted by the hammer and the acceleration were collected by means of a SIEMENS acquisition system (SCADAS). At each node, the frequency response function was calculated as a response over force ratio. The sum of all the FRFs acquired is reported in Figure 16.

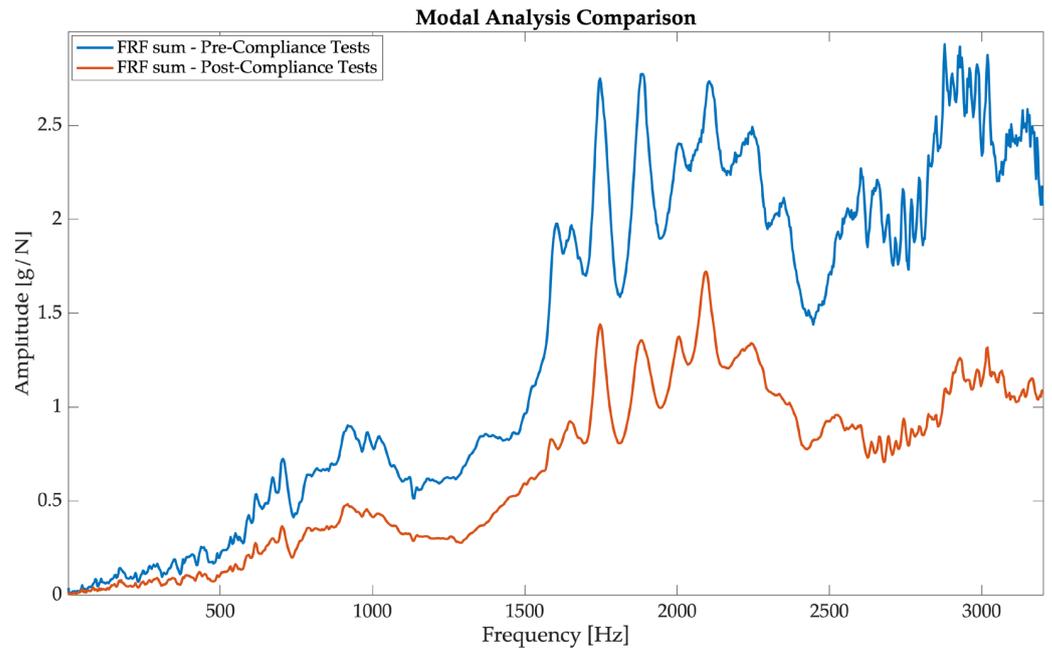
Figure 16. FRF sum comparison between pre- and post-compliance tests.

- This was also confirmed by the monitoring accelerometers and observing the power spectra of the time histories registered during rain (static) between day 1 and day 2 (Figure 16, where the shift towards lower natural frequency is evident)
- Force washers evidenced that between day 1 and day 2, the bolts undergo loosening, especially concerning the bolt registered by the sensor installed on channel 2 (a decrease in the tension of that bolt of about 8% was registered).
- Integration of FBGs into building envelopes for temperature monitoring prevents thermal shock damage, offering compact size and multiplexing capabilities. FBGs also excel in strain, ensuring longevity and structural integrity, with potential applications in façades to improve safety during the entire life of the structure.

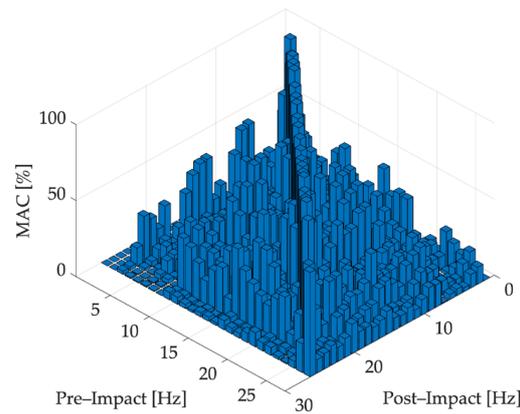
Figure 17. MAC (Modal Assurance Criterion) between the two performed modal analysis.

A modal analysis was performed on the FRF dataset collected to estimate the dynamic parameters of the structure under test (natural frequencies, damping loss factors, and mode shapes). A comparison between those parameters was estimated in the modal tests performed before and after the stress tests were performed. To compare mode shapes, the Modal Assurance Criterion (MAC) was used; to compare the variation in the natural frequencies, the Natural Frequency Difference (NFD) was estimated. The MAC and the SFD are reported in Figures 17 and 18, respectively.

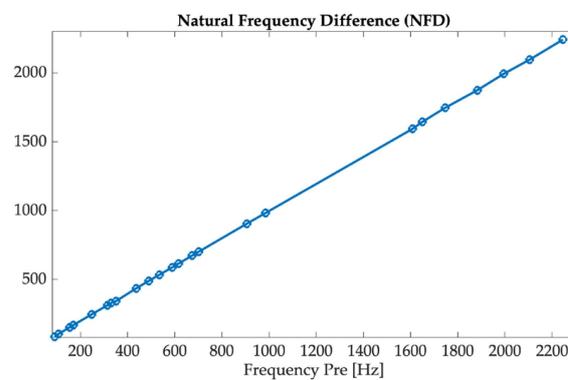
Figure 18. NFD (Natural Frequency Difference) between the two performed modal analysis.

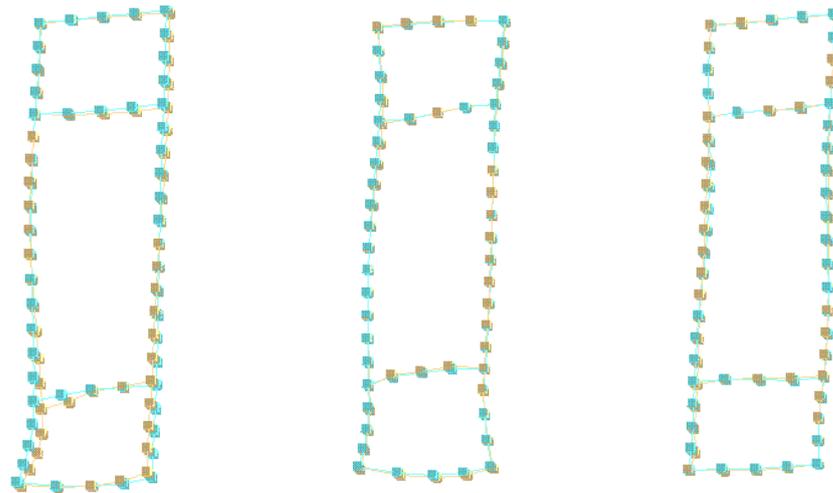
Figure 19. Three modal shapes comparison between pre-compliance test and post-compliance test: Yellow markers represent the mode shape estimated before the compliance test and the cyan ones represent the mode shape estimated after the compliance test.

Two modes were selected to have an example of the structure movements at selected frequencies, as reported in Figure 19.

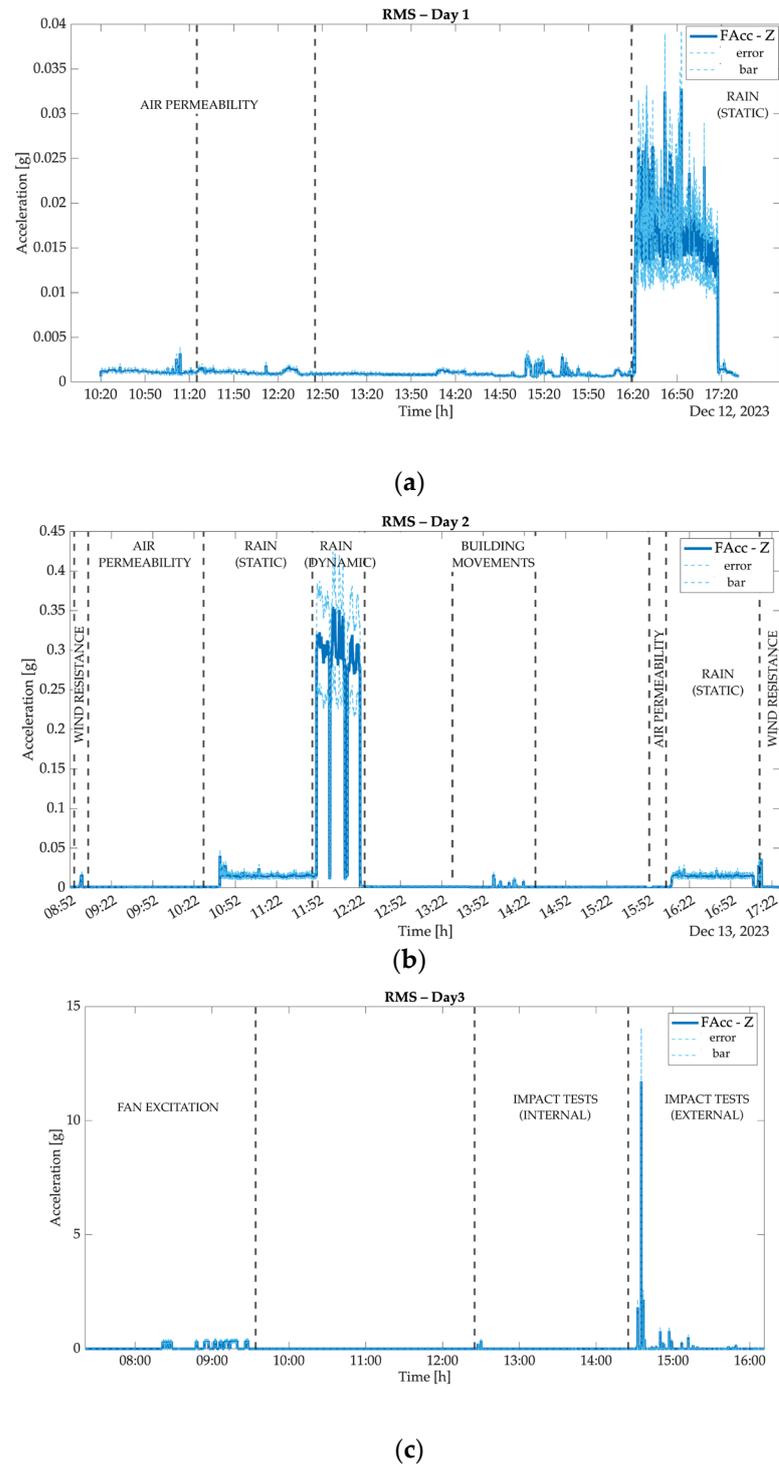
Figure 20. Signal RMS analysis. In sequence, top figure: RMS of day 1 (a); middle figure: RMS of day 2 (b); bottom figure: RMS of day 3 (c).

At first, the analysis of the signal over time was performed to understand the global response of the accelerometers subjected to the compliance tests. In fact, a Root Mean Square (RMS) analysis of the signal over time was performed for each test day, as reported in Figure 19. In the following figure (Figure 20), the error bar is shown on RMS data for each day. This value was calculated by applying the accelerometer sensitivity value of $\pm 10\%$ to the accelerometer signals. The error band is outlined by a dashed line surrounding the accelerometer signal curve.

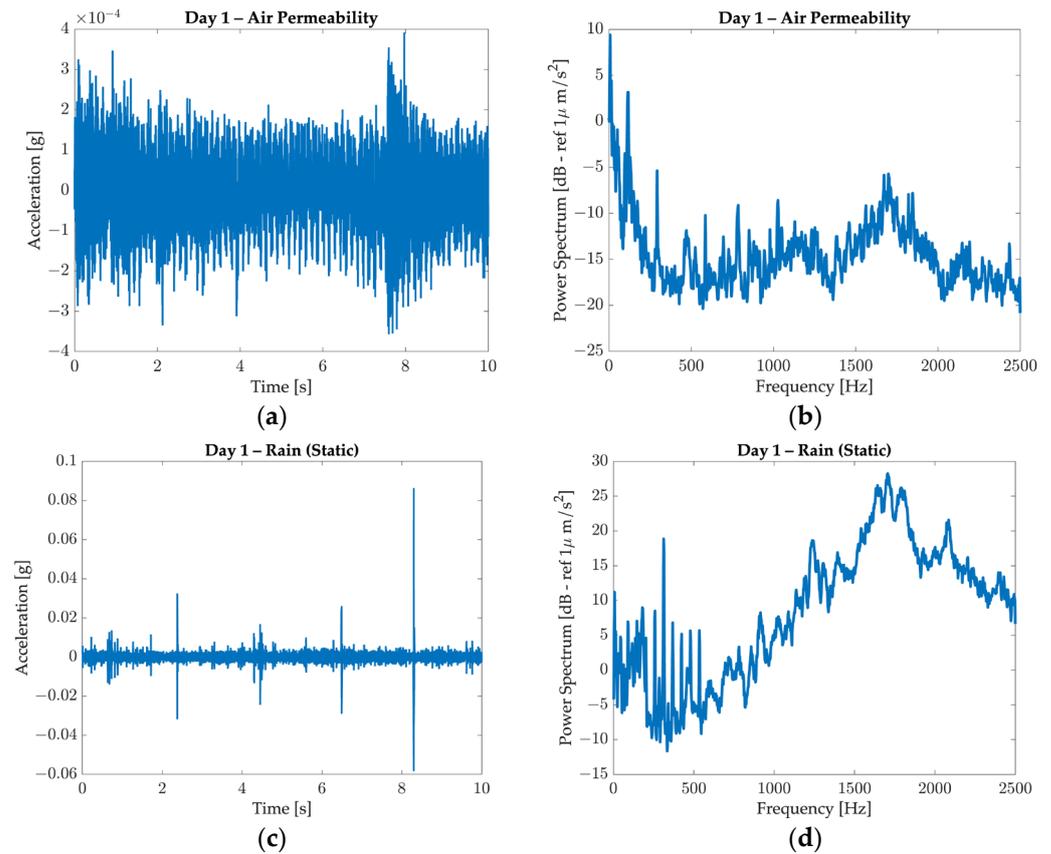
Figure 21. Day 1 tests: respectively, story time and power spectrum for each test: air permeability acceleration/time (a); air permeability power spectrum /frequency (b); rain (static) acceleration/time (c); rain (static) power spectrum /frequency (d).

The tests performed during day 1 were acquired and are shown in Figure 21. During this day, air permeability and rain were performed. The power spectrum estimation function was used to reduce the signal noise and better evaluate information. Each 10 s time history was divided into 0.8 s chunks with a 50% overlap to obtain 25 averages.

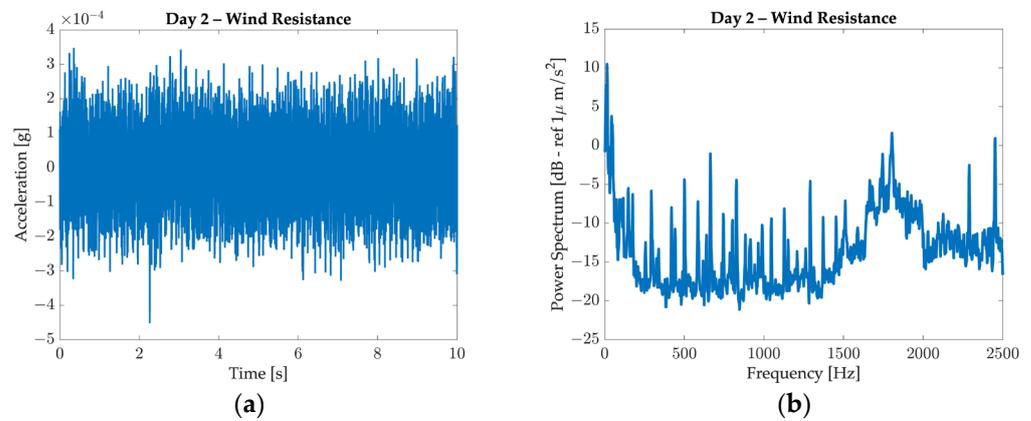
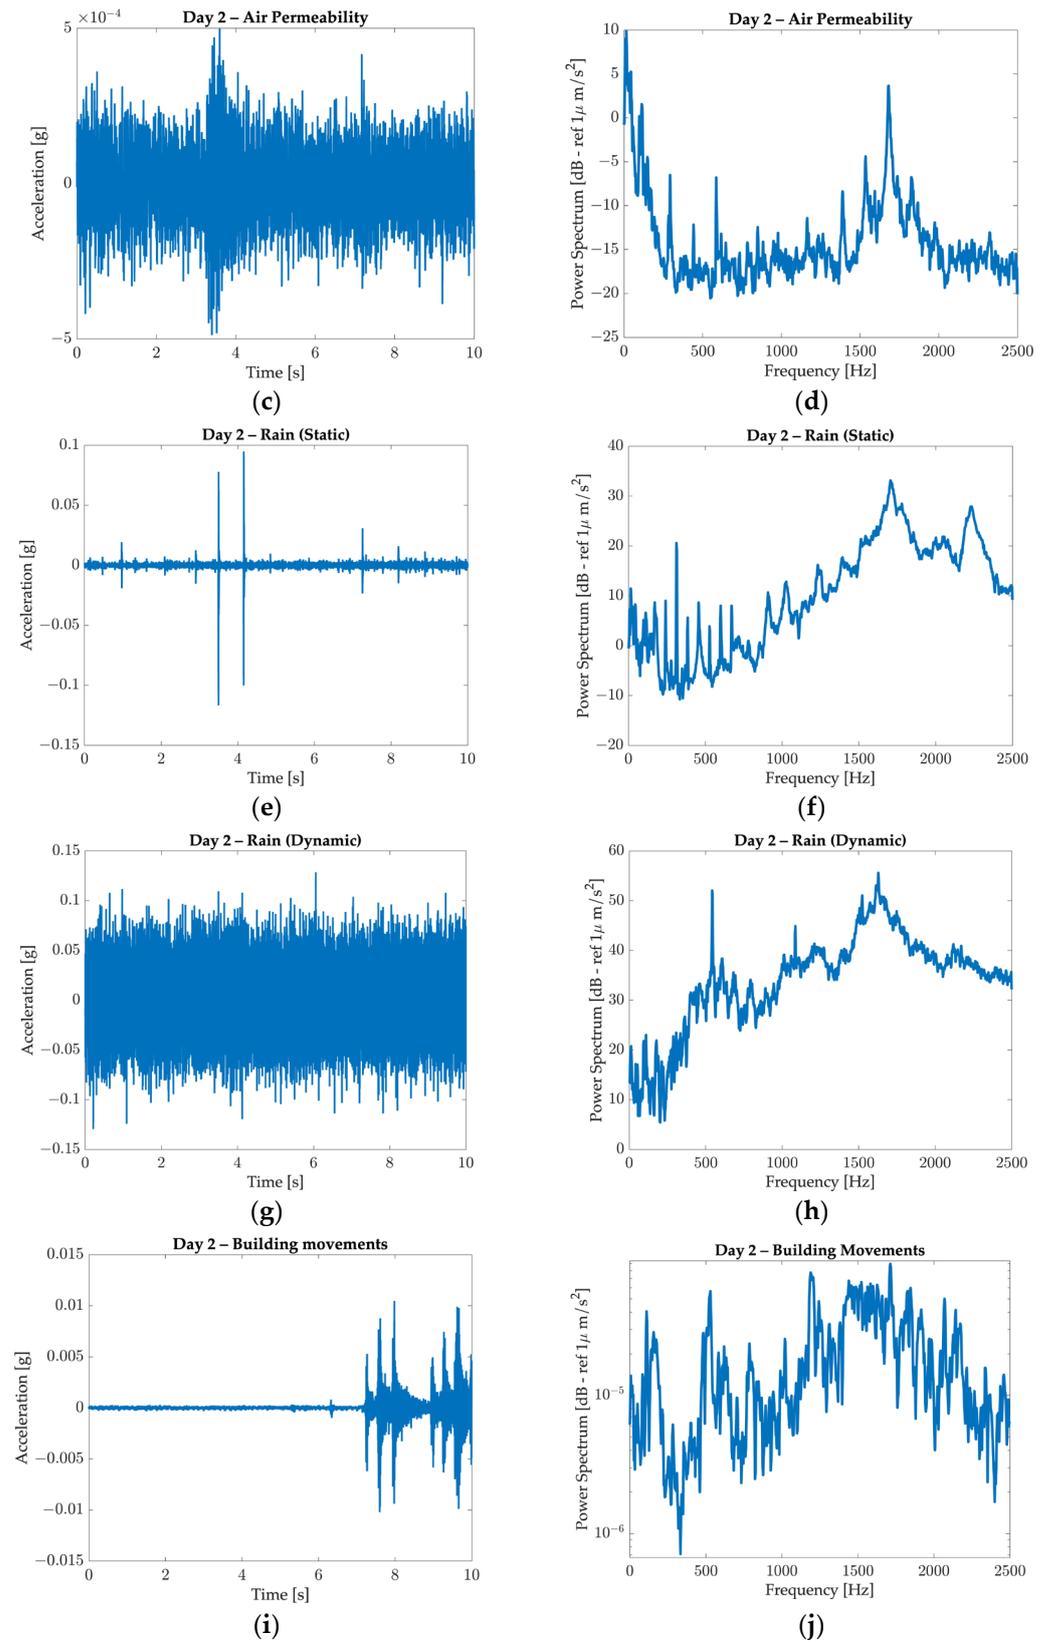
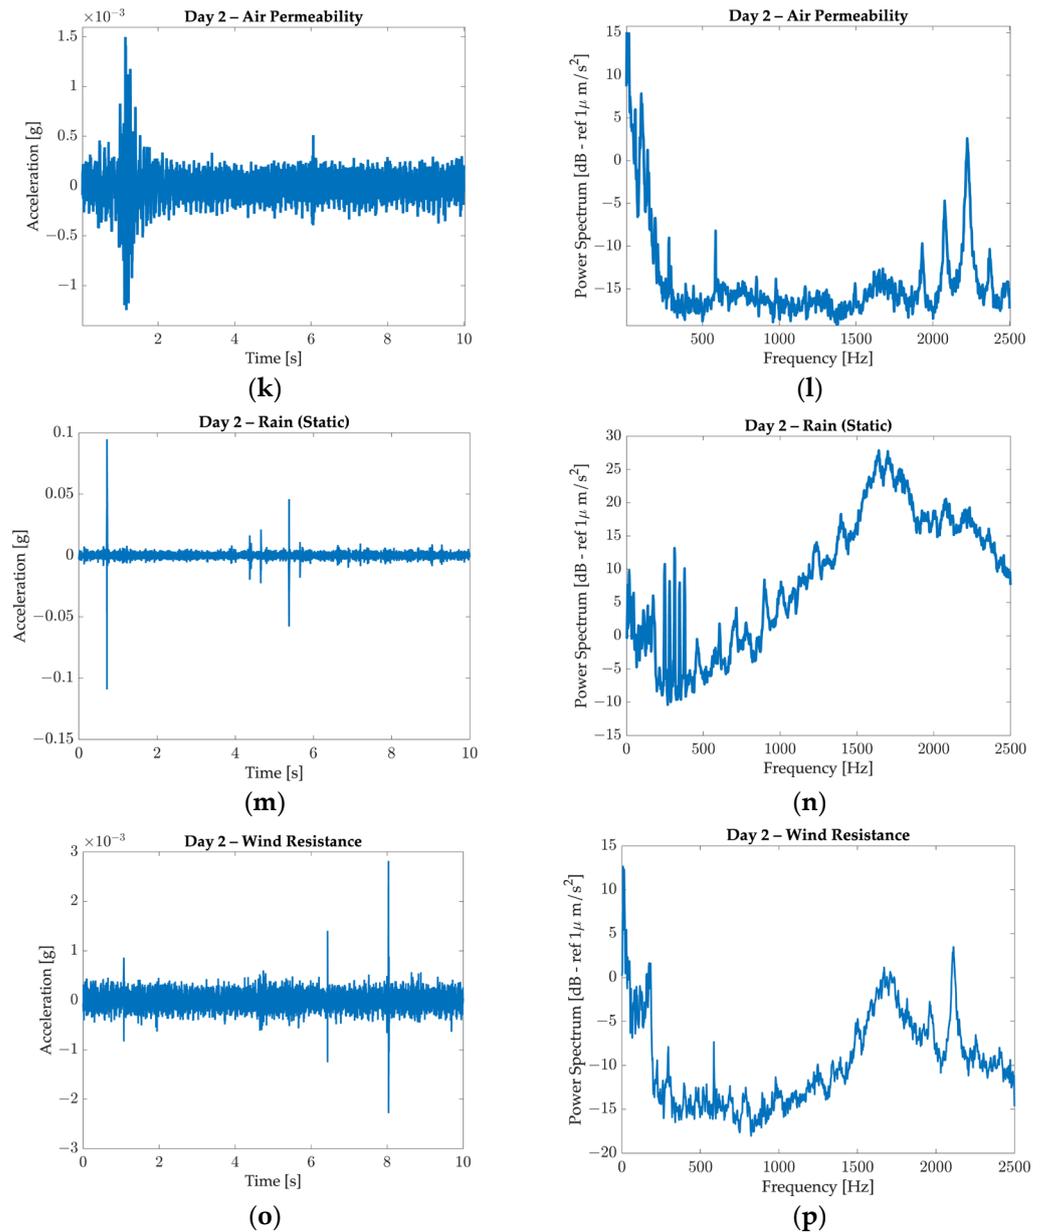
Figure 22. Day 2 tests: respectively, story time and power spectrum for each test: wind resistance acceleration/time (a); wind resistance power spectrum/frequency (b); air permeability acceleration/time (c); air permeability power spectral power spectrum/frequency (d); rain (static) acceleration/time (e); rain (static) power spectrum/frequency (f); rain (dynamic) acceleration/time (g); rain (dynamic) power spectrum/frequency (h); building movements acceleration/time (i); building movements power spectrum/frequency (j); air permeability acceleration/time (k); air permeability power spectrum/frequency (l); rain (static) acceleration/time (m); rain (static) power spectrum/frequency (n); wind resistance acceleration/time (o); wind resistance power spectrum/frequency (p).

The tests performed during day 2 were acquired and are shown in Figure 22, are presented following the chronological order of the appearance of events. During this day, wind (repeated), air permeability (repeated), rain (repeated), and building movements were performed. To reduce the signal–noise ratio, the power spectra of the signals were calculated using a frequency-domain averaging procedure. The 10 s time histories were divided into 0.8 s chunks with a 50% overlap to obtain 25 averages.

The time history registered during the building movement test Figure 22i is evidenced by several transients. The power spectrum of each transient signal was calculated and then averaged to improve the signal-to-noise ratio.

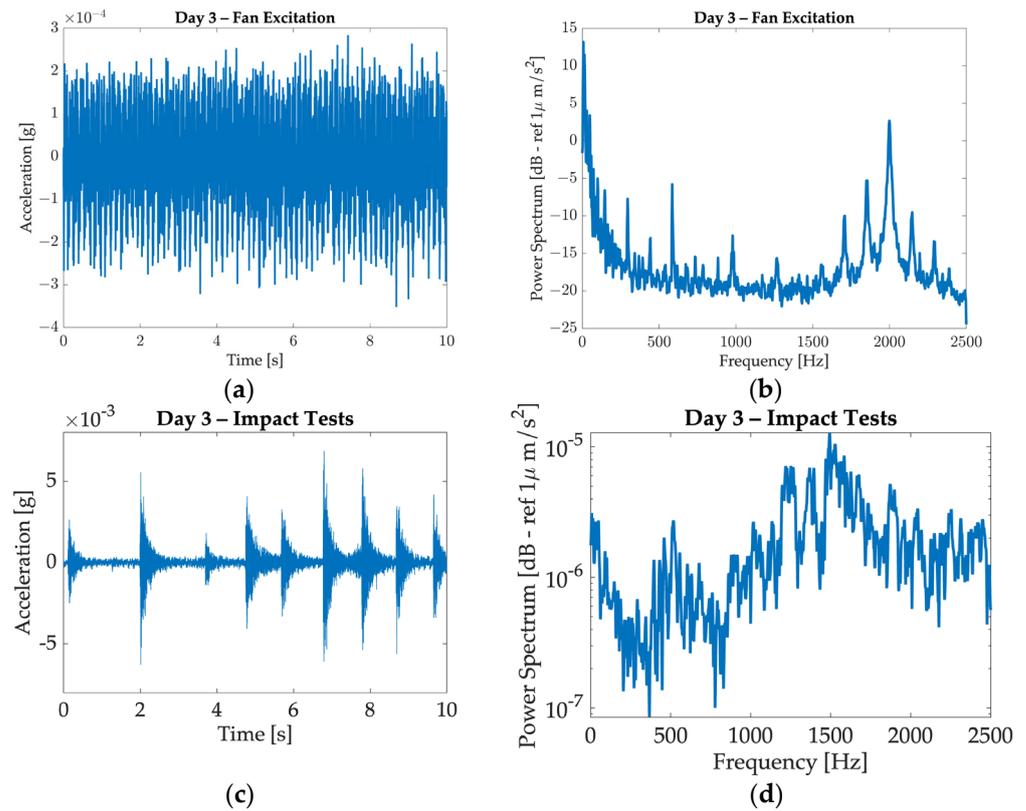
Figure 23. Day 3 tests: respectively, story time and power spectrum for each test: fan excitation acceleration/time (a); fan excitation power spectrum/frequency (b); impact test acceleration/time (c); impact test power spectrum/frequency (d).

The tests performed during day 3 were acquired and are shown in Figure 23 and are presented following the chronological order of the appearance of events. During this day, fan excitation and impact tests were performed. The power spectrum estimation function was used to reduce the signal noise and better evaluate information. Each 10 s time history was divided into 0.8 s chunks with a 50% overlap to obtain 25 averages.

The time histories registered during the impact tests show transient signals typical of impact excitation. The power spectra of these time histories were computed by selecting only three transient signals and averaging their power spectra to improve the signal-to-noise ratio.

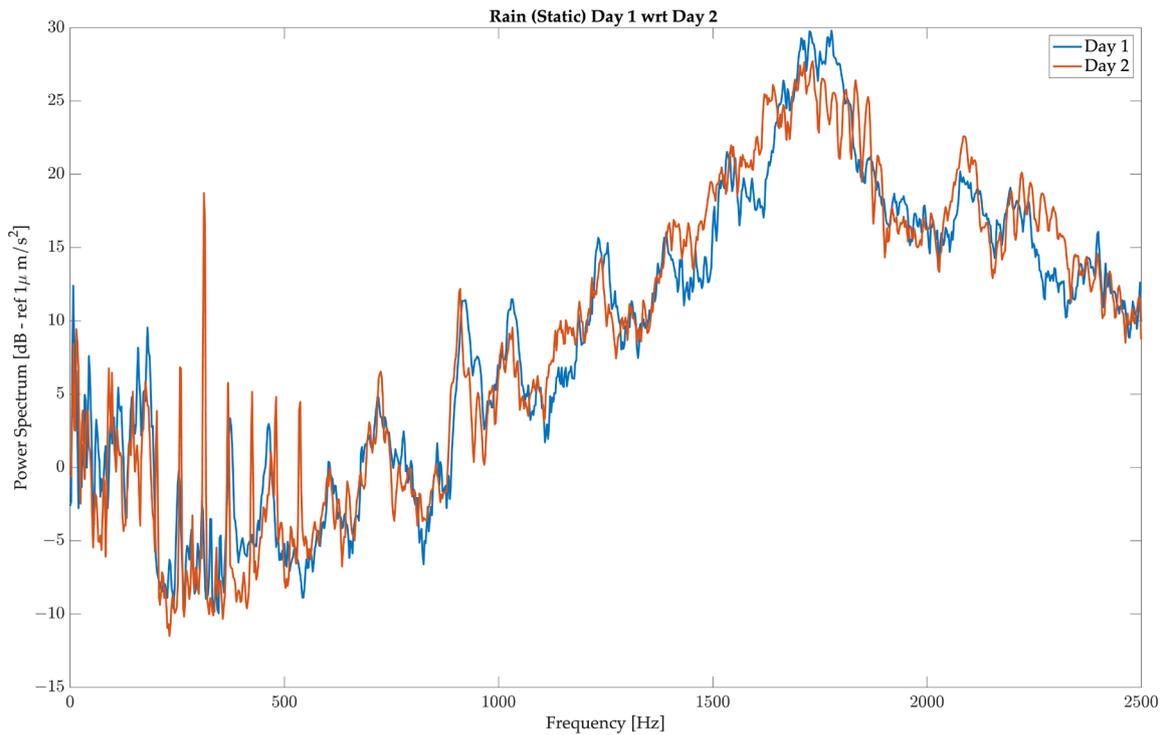
Figure 24. Power spectrum comparison between rain (static) test of day 1 and test of day 2.

The physical phenomenon is demonstrated with the example shown in Figure 24, in which two comparable tests—rain (static)—between two different days (day 1 and day 2) are presented. By comparing the power spectrum acquired during the first rain test (blue line) and the one acquired during the second rain test (red line), it is evident that the resonances excited by the simulated environmental dynamic load (represented by the impacting rain) are shifted towards lower values. This allows the inference that the structure underwent a stiffness decrease, which can be due to structural yielding.

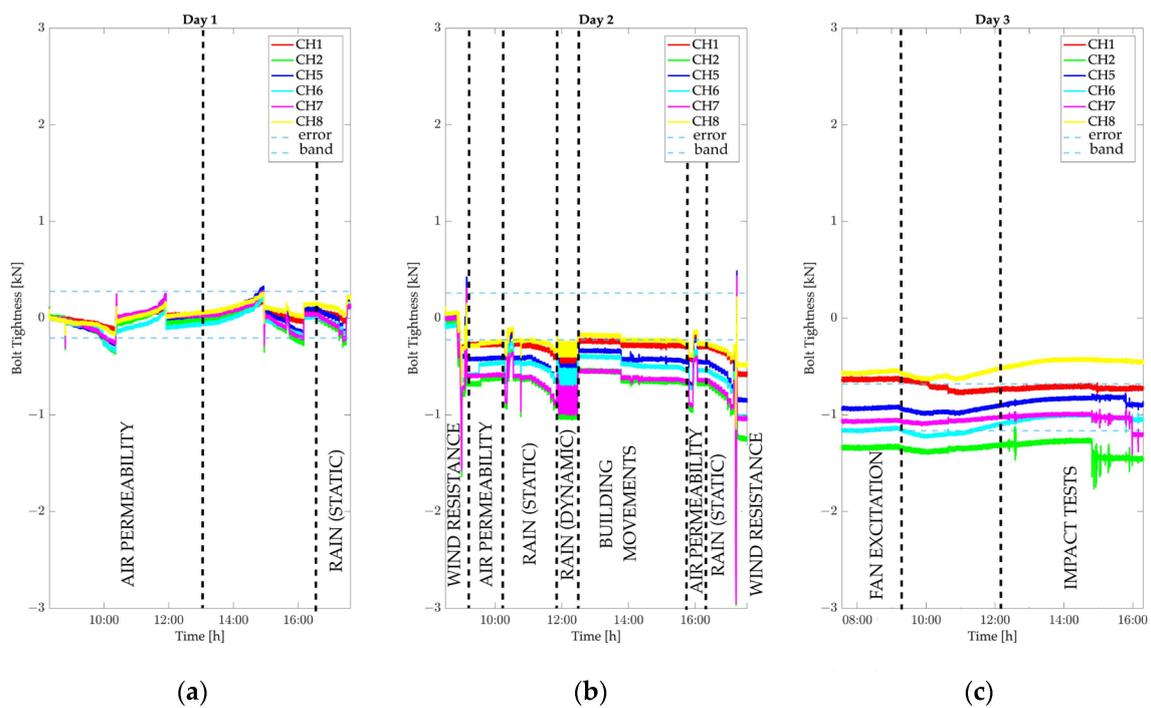
Figure 25. Strain gauge-based force washer data collected during the 3 days: day 1 (a); day 2 (b); day 3 (c).

This paragraph reports structure behavior during the stress test analysis of the forces. The results obtained are evident in the graphs below (Figure 25). The error bar is delineated by a light blue dashed line surrounding the force washer’s signal curves. This band was computed considering the uncertainty related to the sensitivity deviation declared by the washer constructor, which is 1.5%.

By observing the trend of the bolt’s tightness during day 1, it is possible to notice that the tightness at the end of the test is equal to the tightness measured before starting the test; this means that the structure did not experience any modification. On the contrary, during the second day, a negative trend of the bolt’s tightness is evident. Table 4 reports the value of the tightness measured by all the washers at the beginning and at the end of the tests performed during day 2 and their difference. It is possible to see that all the washers experience a decrease in tightness, particularly those connected to channels 2 and 7 (see Figure 4) for the force channels position. An important drop in the bolt tightness is visible immediately after the first test (wind resistance). As for day 1 and day 3, the tightness of the bolts remains almost constant.

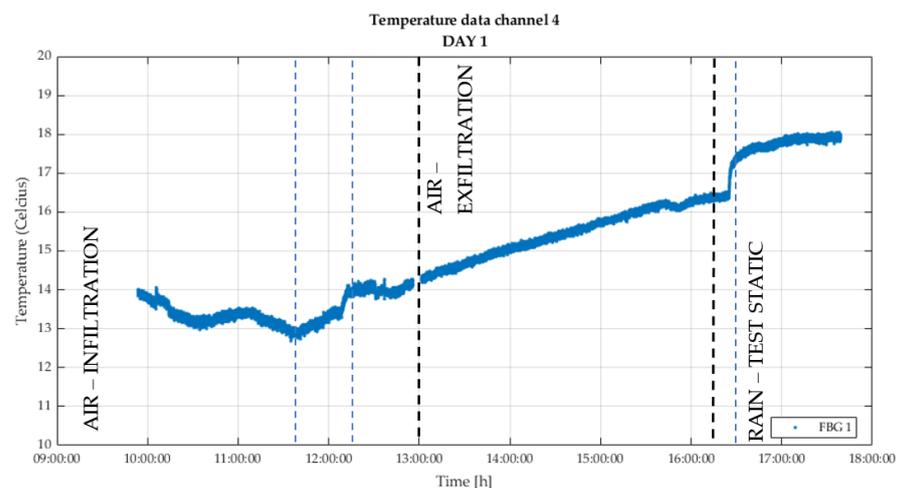
Figure 26. Day 1 FBG for temperature—Channel 4.

FBGs for temperature—Figure 26 displays the results obtained by the FBG sensor for temperature (Channel 4) associated with the InComEss architecture. A noticeable increase in temperature was recorded during the first day of testing, indicating the correct procedure for data collection. The markable timestamps are as follows: 11.50 h—temperature decrease recorded during the air exfiltration test (−600 Pa) (i); 12.10 h—temperature increase of 0.5 degrees can be observed during the test since a heat lamp was placed near the temperature sensor (ii); 16.30 h—rapid temperature increases from 16 to 18 degrees due to the rain test likely due to the water temperature (iii).

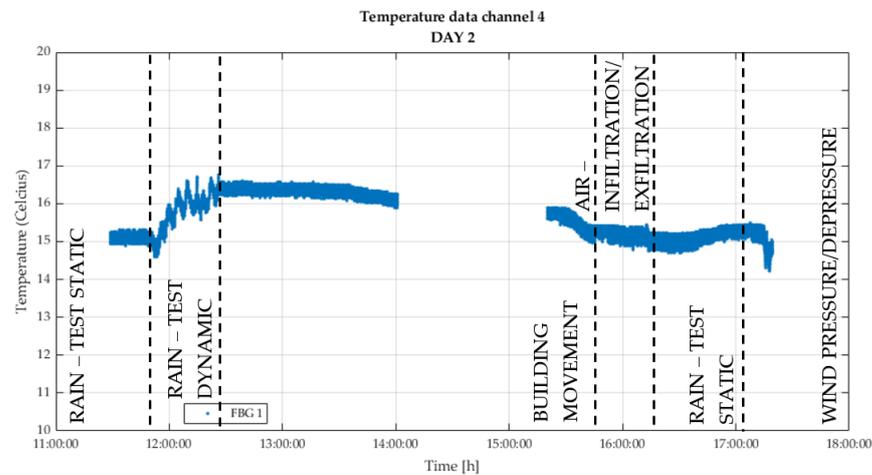
Figure 27. Day 2 FBG for temperature—Channel 4.

The temperature on this test day was much more stable throughout the second day, as recorded by the temperature sensor reported in Figure 27.

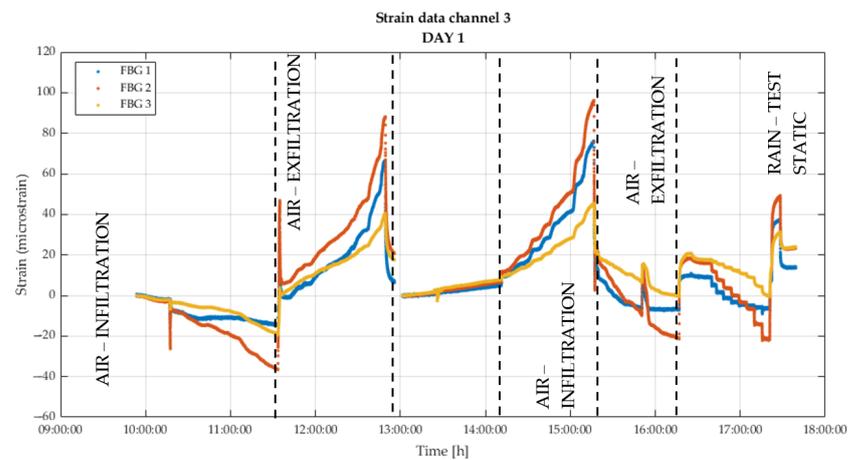
Figure 28. Day 1 FBG for strain—Channel 3.

In this paragraph, the FBG for strain’s test results are reported. In Figure 28, the strain results obtained by the cable applied on the glass panel during the first day can be observed. The test started with air infiltration followed by exfiltration, repeated twice. The glass surface reached negative values of strain during the increasing pressure and positive ones during the negative pressure. Indeed, the FBG sensors in the first case were compressed, while in the second, they were expanded.

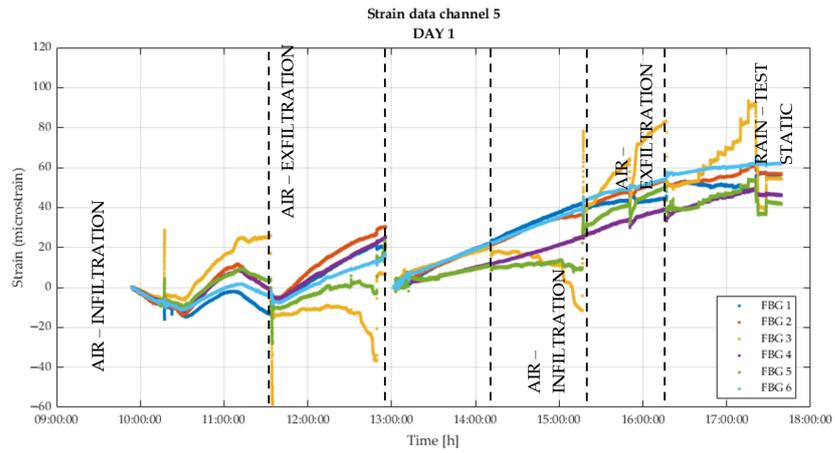
Figure 29. Day 1 FBG for strain—Channel 5.

The strain levels on channel 5 (the cable on the aluminum profile) are minor because the sensors are applied on the aluminum profile where the façade strain due to deformation is contained (Figure 29).

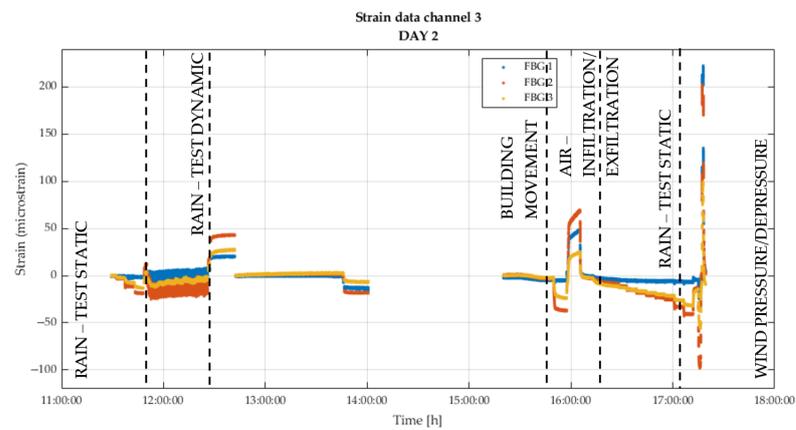
Figure 30. Day 2 FBG for strain—Channel 3.

The highest strain levels were measured at the end of the second day in channel 3 (z) when the wind pressure and depression were executed; indeed, in less than 5'', the façade was stressed from 0 to +2625 Pa, and from 0 to −3000 Pa (Figures 30 and 31).

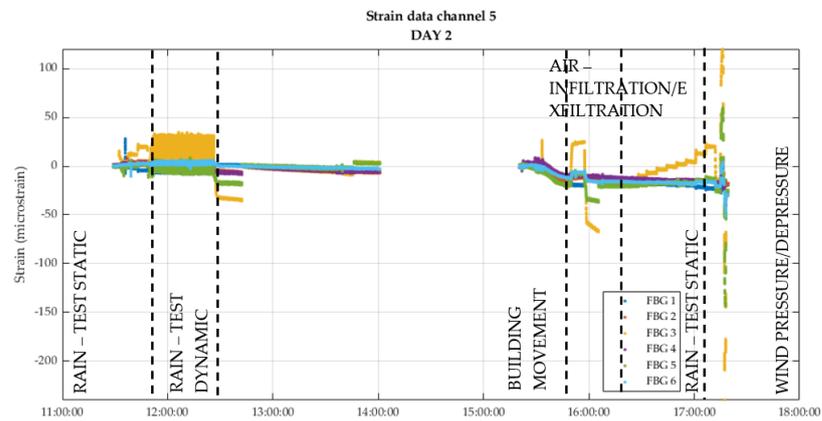
Figure 31. Day 2 FBG for strain—Channel 5.

Figure 31 displays the result obtained for channel 5 (x, y) during day 2.

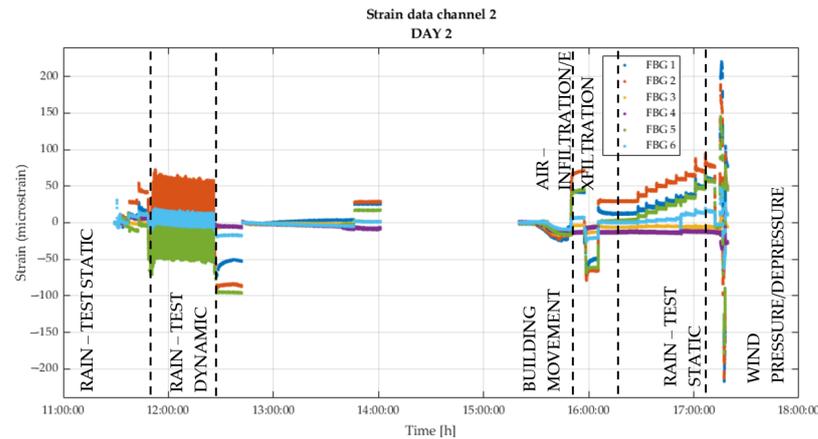
Figure 32. Day 2 FBG for strain—Channel 2.

Figure 32 reports the result obtained for channel 2 during day 2. Strain results obtained from channel 2 (z direction monitoring) are higher than channel 5 (x, y). This can clearly be observed in the rain—dynamic test, which executes from 11:50 h to 12:20 h, and the rain—test static, which executes from 16:20 h to 17:20 h, where the strain level is raised in steps following the pressure curve increasing (+600 Pa).
