# Nearshore Dynamics of Storm Surges and Waves Induced by the 2018 Typhoons Jebi and Trami Based on the Analysis of Video Footage Recorded on the Coasts of Wakayama, Japan

**Abstract:** In this study, field surveys along the coasts of Wakayama Prefecture, Japan, were first conducted to investigate the coastal damage due to storm surges and storm-induced waves caused by the 2018 Typhoons Jebi and Trami. Special focus was placed on the characteristic behavior of nearshore waves through investigation of observed data, numerical simulations, and image analysis of video footage recorded on the coasts. The survey results indicated that inundation, wave overtopping, and drift debris caused by violent storm-induced waves were the dominant factors causing coastal damage. Results of numerical simulations showed that heights of storm-induced waves were predominantly greater than storm surge heights along the entire coast of Wakayama in both typhoons. However, computed gradual alongshore variations in wave and surge heights did not explain locally-concentrated inundation and run-up heights observed along the coasts. These results indicate that complex nearshore hydrodynamics induced by local

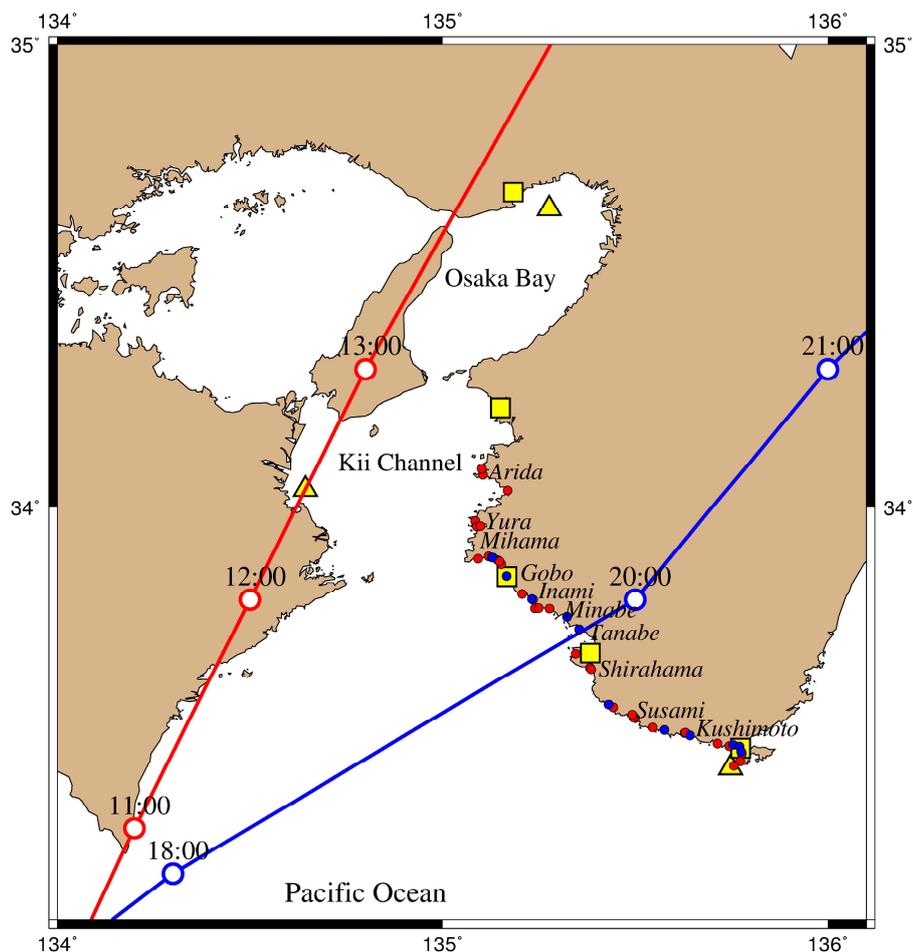
**Figure 1.** Typhoon paths (indicated by lines) and surveyed locations (indicated by colored circles) in Wakayama Prefecture. Red and blue indicate Typhoons Jebi and Trami, respectively. The typhoon paths were based on Japan Meteorological Agency, JMA [16]. The yellow squares indicate tide gauge stations at Kushimoto, Shirahama, Gobo, Wakayama, and Kobe from the south, and the yellow triangles indicate Nationwide Ocean Wave information for Port and HarborS (NOWPHAS) stations at Shionomisaki, Komatsushima, and Kobe from the south.

The authors visited the coasts of Kushimoto, Susami, Shirahama, Tanabe, Minabe, Inami, Gobo, Mihama, Yura, and Arida (Figure 1). Tide gauge stations, operated by Japan Meteorological Agency, JMA, at Kushimoto, Shirahama, and Gobo, observed peak surge levels of TP + 1.7 m, TP + 1.6 m, and TP + 3.2 m, respectively, at these locations during Jebi [13,14]. A substantial amount of debris was deposited onshore and covered most parts of the coast for several weeks after the typhoon. Figure 2 shows debris deposited on a coastal dike with a crown height of TP + 9.2 m, observed at Tonda Beach in Shirahama; large amounts of debris were also found behind the dike. Inami Town, located in the middle of Wakayama, (Figure 1) observed the highest witnessed watermark elevation, TP + 13.2 m, at a fishery harbor [13]. Furthermore, still images and video footages, recorded by a resident, captured large waves 1–2 km north of the port (Figure 3), and these videos clearly indicated that waves repeatedly splashed over the dike with a crown height of TP + 7.0 m. These videos captured that water splashed to such a height that it was likely to reach the tops of trees on the dike and that significant water mass with debris flowed with a long-wave component. In Yura Town, located north of Gobo, where the peak surge level was TP + 3.2 m (Figure 1), no inundation was observed in the area behind seawalls, while some residents witnessed inundation at a small harbor. According to witnesses, the inundation height and depth were approximately TP + 3.5 and 1.7 m, respectively. Debris also remained on a small coast near the harbor, and the ground level of the debris was nearly TP + 3.5 m. Minatomachi, in Arida City (Figure 1), was severely inundated with a ground level of approximately TP + 3 m, and the city was protected by a seawall with a crown height of around TP + 5–7 m [13,18]. Based on photographs taken during and after the typhoon, Yamanaka et al. [18] determined that the maximum inundation depth in the area was 0.6 m and also mentioned that wave overtopping was the primary cause of inundation.

The authors visited the coasts of Kushimoto, Susami, Shirahama, Tanabe, Minabe, Inami, Gobo, and Mihama (Figure 1). Tide gauge stations at Kushimoto, Shirahama, and Gobo indicated peak surge levels of TP + 2.5 m, TP + 2.0 m, and TP + 3.0 m during Trami, respectively [15]. Similar to Typhoon Jebi, a considerable amount of debris was carried onshore and covered the coasts after Trami. Structures and houses near the coast were severely damaged by storm-induced waves during the typhoon. Figure 4 shows a damaged breakwater observed at Suganohama fishery harbor in Kushimoto. In the harbor, debris remained at a ground elevation of TP + 3.6 m, and a resident witnessed waves running up to the same elevation. However, the crown height of the breakwater was TP + 5.1 m, and it collapsed only on the inside slope, as shown in the photograph. There were few witnesses to the high surge and wave elevation during Trami because most of the damage caused by the typhoon was at night; however, important evidence was recorded by a resident at Mirozu station, where a part of a small station building had collapsed at a ground elevation of around TP + 9.3 m. The resident witnessed watermarks in/around the station buildings at 6:30 on 1 October, 10 h after the typhoon's landfall. This station is located on a coastal cliff and thus waves might have splashed up to the elevation of the station. The Mera area, located on Shimohaya Bay in Tanabe, on which the typhoon made landfall, suffered damage from waves. Inundation was dominantly caused by overtopping waves during Jebi [13] and was more severe during Trami. A witness stated that the inundation depth during Trami in the area

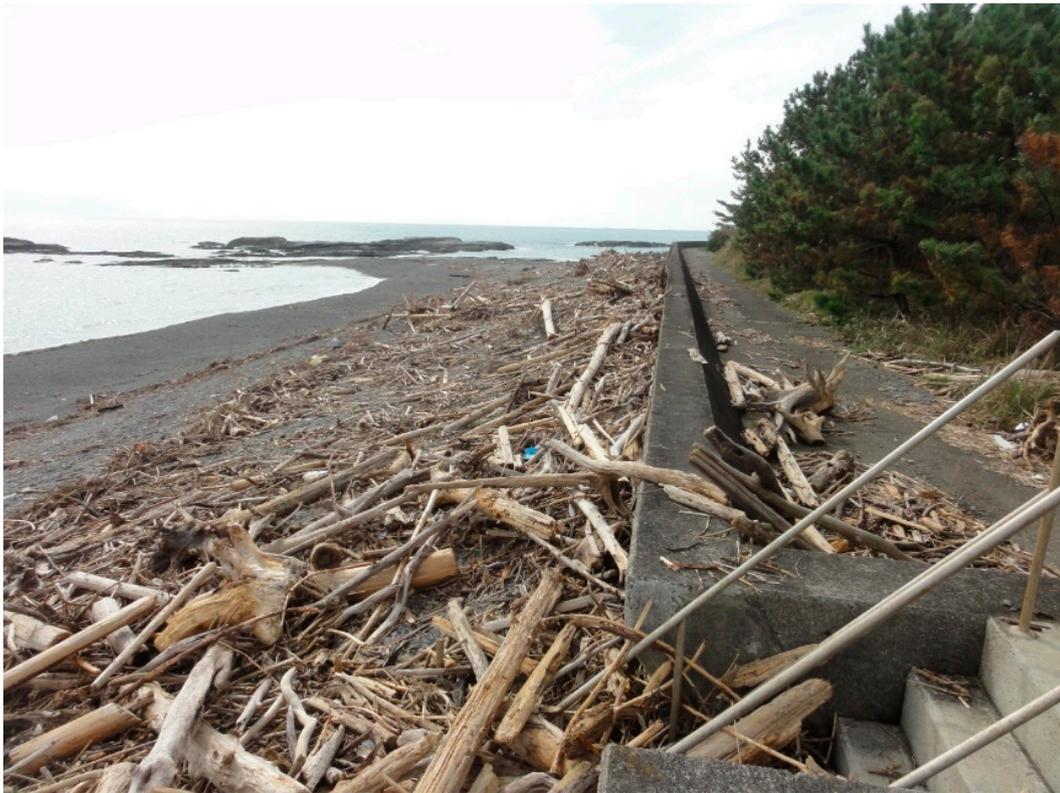
**Figure 2.** Photograph of debris observed on Tonda Beach with a seawall having a crown height of + 9.2 m from the mean sea level near the head of Tokyo Bay (i.e., Tokyo Peil, TP), taken by the authors on September 21, 2018.

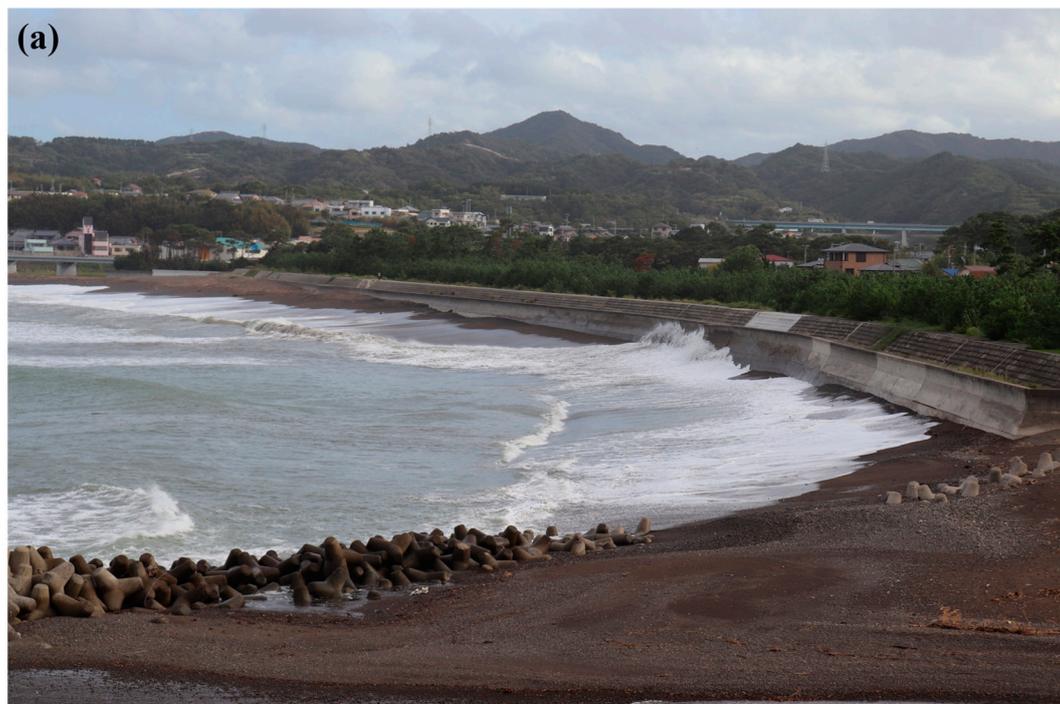
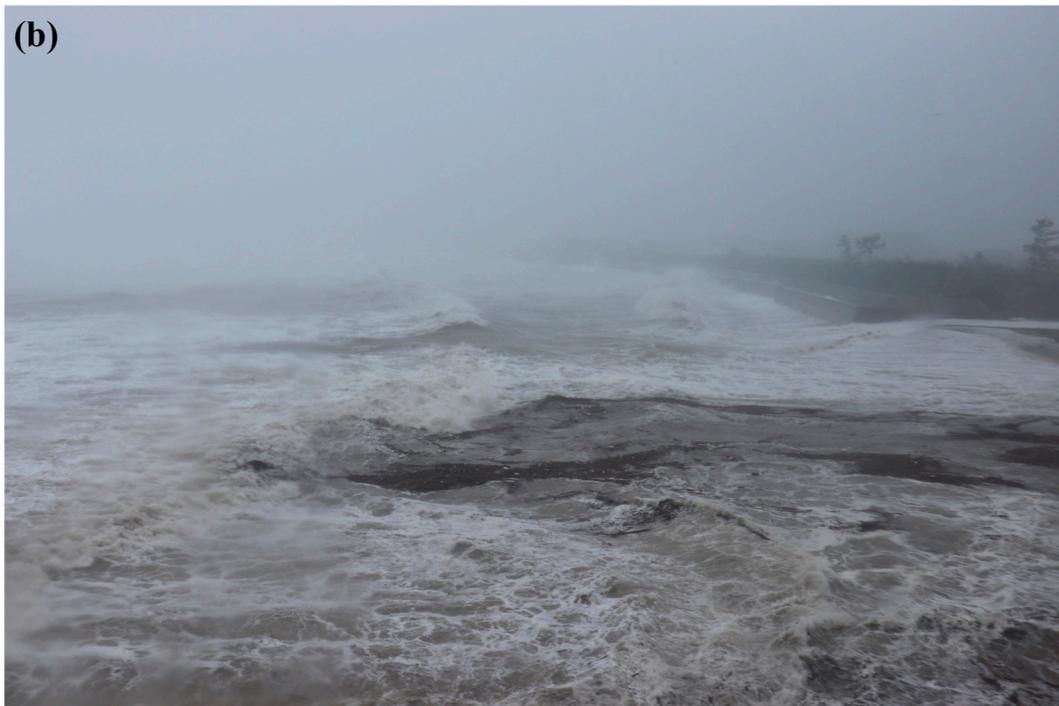
**Figure 3.** Photographs recorded by a resident (a) at 07:13 and (b) at 12:12 (i.e., before and during Typhoon Jebi), on September 4, 2018, at a site in Inami.

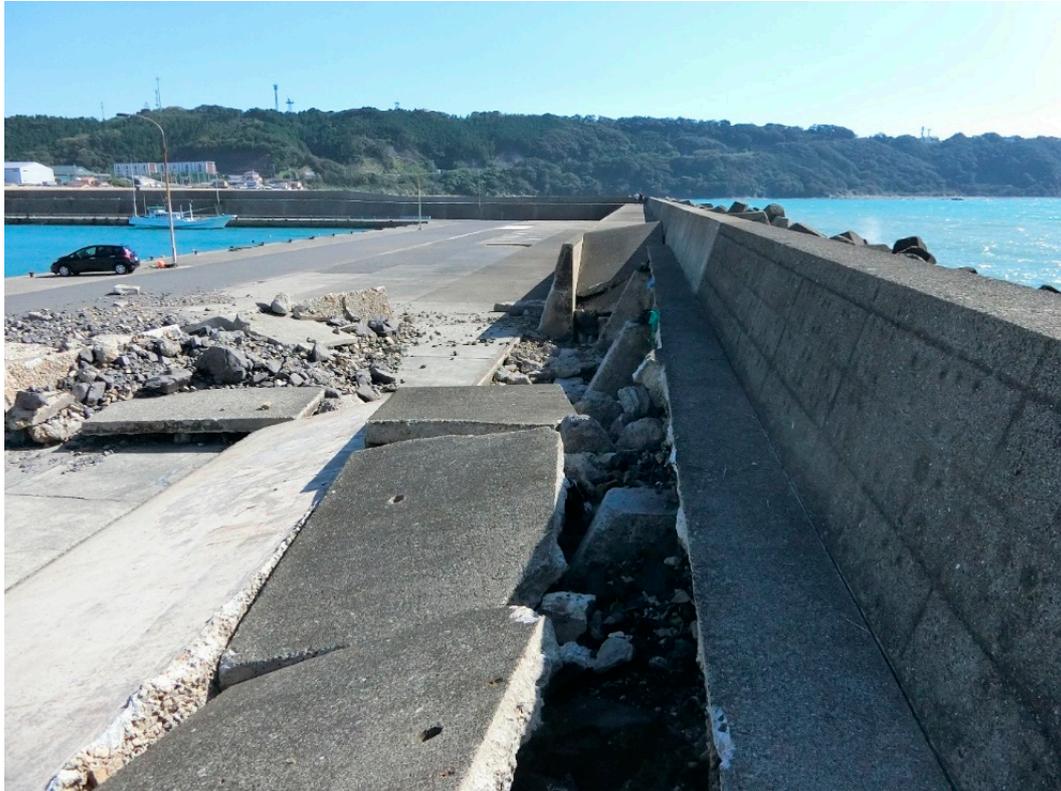
**Figure 4.** Photograph showing the damaged breakwater observed at Suganohama fishery harbor in Kushimoto, taken by the authors on 2 October 2018.

was approximately 1 m. Furthermore, the inundating flow razed a tree behind the seawall, and part of the tree hit and significantly damaged a nearby house. Therefore, the influence of waves was significant in this area. However, these waves were expected to dissipate because of their geometries [13].

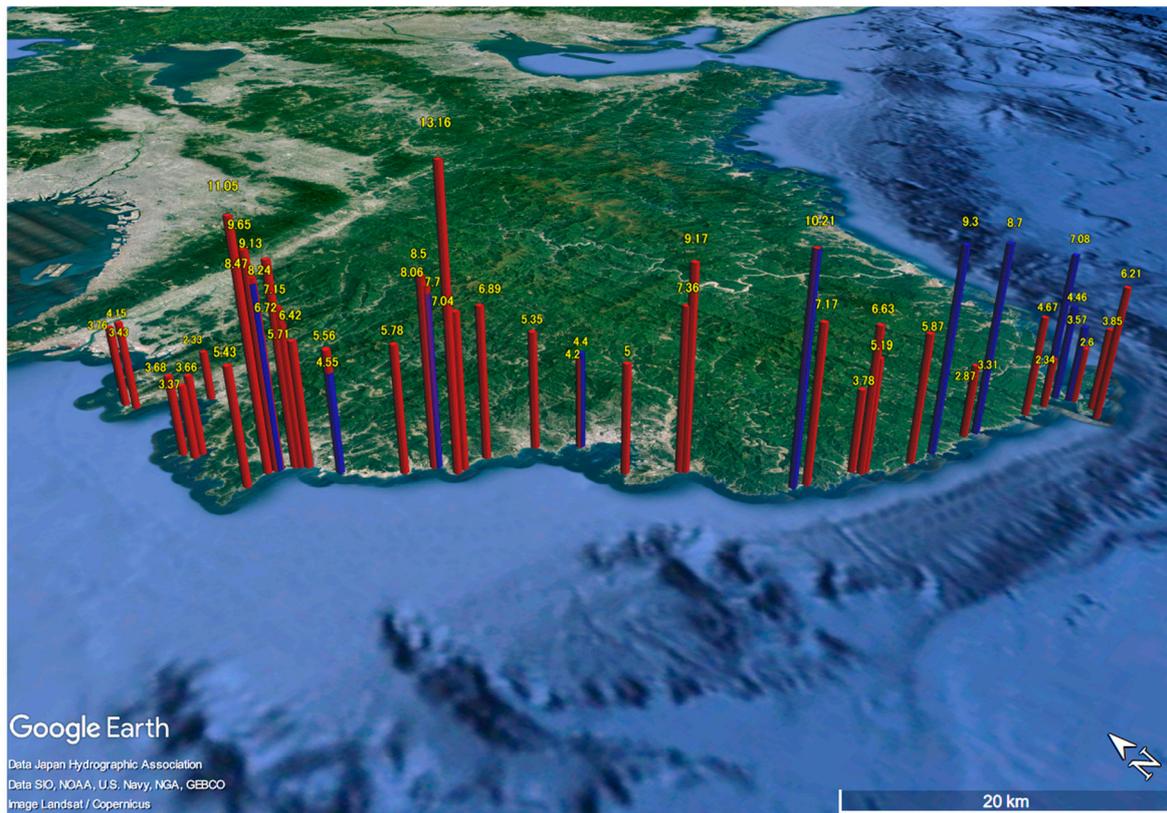
**Figure 5.** Elevations of remaining debris and witnessed watermarks during Typhoons Jebi and Trami [TP m], indicated by red and blue, respectively (Google Earth; Mori et al. [13]).

Figure 5 shows the elevations of the witnessed watermarks, debris, and destroyed structures observed along the coasts of Wakayama from both typhoons. Most of these elevations are equivalent to the run-up height of the inundating flows, primarily induced by overtopping waves. The maximum elevations of these watermarks due to Typhoons Jebi and Trami were TP + 13.2 m at Inami and TP + 10.2 m at Shirahama, respectively. As seen in Figure 5 with Figure 1, the observed elevations of the watermarks after Typhoon Jebi were relatively higher along the coasts from Shirahama to Mihama, located in the middle of the coast of Wakayama, than those along the northern and southern coasts. Furthermore, the relatively higher elevations were locally concentrated around Shirahama, Inami, and Mihama. The highest observed watermarks caused by Typhoon Trami were in a different location from those caused by Typhoon Jebi. Relatively high watermarks were found both on the east and west sides of the typhoon path. Although survey data of the run-up heights after Trami were not enough to fully capture their alongshore variation, some of the relatively higher run-up heights were observed in identical locations (e.g., Shirahama, Inami, and Mihama after both Jebi and Trami). The recorded peak tide levels during these two typhoons were much lower than the elevations of the watermarks and debris, and this feature clearly indicates the dominant influence of storm-induced waves rather than storm surges themselves along the coast of Wakayama. Additionally, the observed elevations for both typhoons were locally concentrated, and the sites showing high elevations were identical for both typhoons. Therefore, it is important to estimate nearshore wave dynamics to understand the local concentration characteristics of waves and surges.

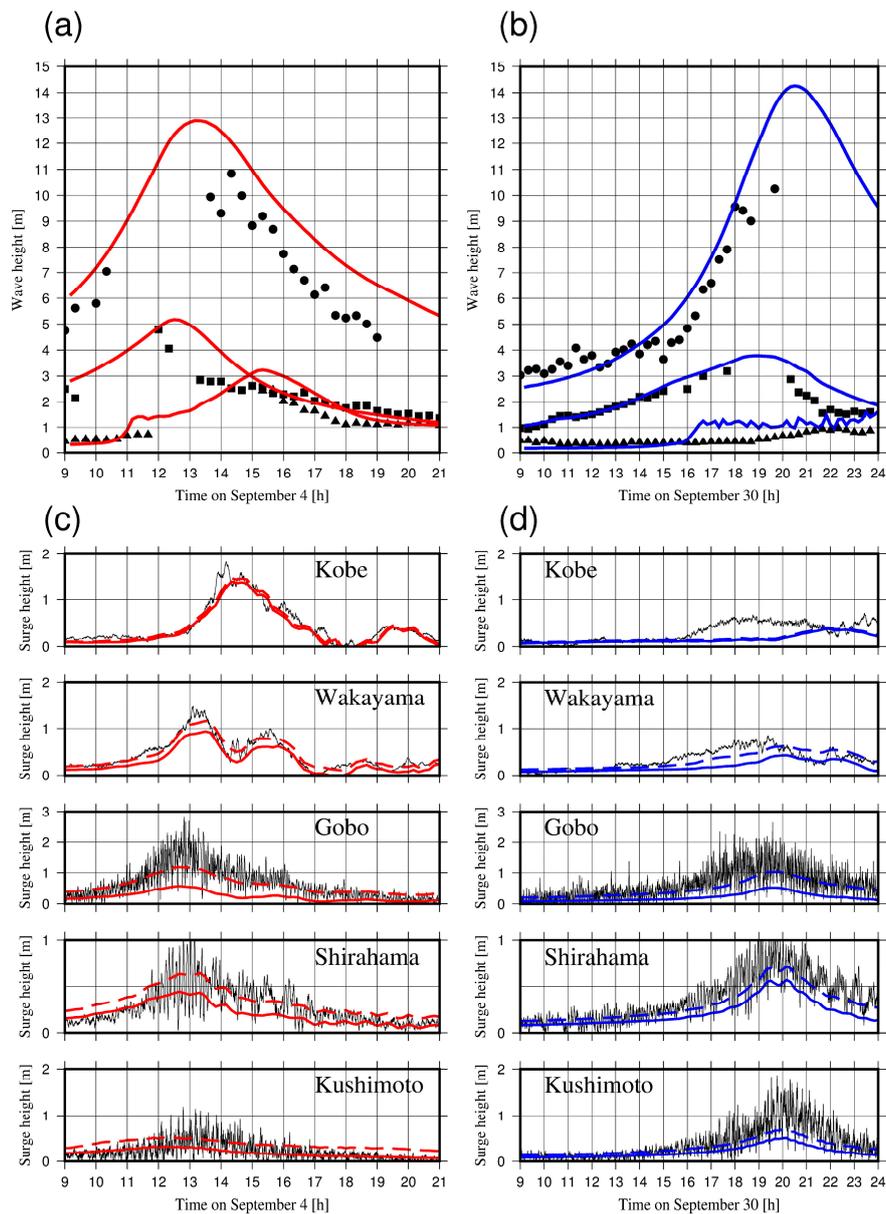
**Figure 6.** Comparisons of observed data and simulation results for Typhoons Jebi and Trami. The observed and simulated significant wave heights are, respectively, indicated by symbols and solid lines at NOWPHAS stations for (a) Jebi and (b) Trami; the triangles, squares, and circles, respectively, indicate observations at Shionomisaki, Komatsushima, and Kobe; observed surge height, simulated surge height, and simulated surge height with 5% of the simulated significant wave height at tide gauge stations, respectively, indicated by solid black, solid red, and dashed red lines for (c) Jebi and (d) Trami.

Figure 6 compares the simulation results with the observed data obtained at NOWPHAS and at tide gauges (Figure 1) for Typhoons Jebi and Trami. While some of the wave data are missing, the simulation results moderately reproduced the observed time series of significant wave heights for both Jebi and Trami. As the simulated surge heights are insensitive to the roughness values (Figure A1), Figure 6 presents the surge waveforms simulated by assuming a Manning’s roughness of 0.025  $m^{-1/3}s$ . In the comparison of storm surges, the observed data show the difference between the observed tide level and the corresponding astronomical tide so that it can be compared with the simulated surge heights. To roughly account for the influence of the wave setup, Figure 6c,d shows the simulated

instantaneous surge heights and the ones with a height equal to 5% of the nearshore significant wave height simulated by WW3. As seen in these figures, the simulated surge heights reasonably reproduce the observed storm surge height. The simulation results showed better predictions by considering the roughly estimated wave setup (i.e., 5% of nearshore wave heights) compared to the tide gauge data, particularly at the tide gauge stations of Kushimoto, Shirahama, and Gobo. This feature indicates the significant impact of storm-induced waves on the total increase in water surface elevation along the coast of Wakayama.

As shown in Figure 6c, d, the tide gauge records obtained at Kushimoto, Shirahama, and Gobo show relatively small surge heights during both typhoons, while significant fluctuations in the lower components, other than the wind-wave component, were influential on the coasts. The Power Spectrum Density of fluctuations in the water level recorded at each Tide Gauge (PSDTG) was then estimated based on the Fourier transform, with a sampling data length of  $2^6$  and sampling time step of 15 s (corresponding to 16 min window length), to determine if the lower components of the wave amplitude were significant (Figure 8). Figure 8 indicates that the largest PSDTG peak appears for all components lower than  $5.0 \times 10^{-3}$  Hz, independent of the locations and typhoons; its peak component for each site is similar for both typhoons. The figure also shows that all PSDTGs have peaks for components higher than  $5.0 \times 10^{-3}$  Hz. For example, the PSDTGs of Gobo, Shirahama, and Kushimoto for Jebi and Trami have peaks around  $2.2 \times 10^{-2}$ ,  $1.2 \times 10^{-2}$ , and  $1.6 \times 10^{-2}$  Hz, respectively. These components are within the range of infragravity wave components ( $5.0 \times 10^{-3}$ – $4.0 \times 10^{-2}$  Hz); therefore, these could result from the amplification of waves during nearshore propagation involving reflection and wave breaking. However, the peak components are different for the three sites; this result implied that local bathymetry selectively amplified specific infragravity wave components during propagation independent of storm event. Figure 9 shows the estimated wave height corresponding to the spectral components of the infragravity wave ranging from  $3.6 \times 10^{-3}$  to  $3.3 \times 10^{-2}$  Hz; it is compared with low-pass filtered waveforms obtained from observed waveforms of the surge heights, corresponding to those in Figure 6c,d, for visualizing average surge heights over time. As seen in the figure, the peak of the estimated wave height matches with that of the averaged surge height, especially at Gobo, where wave heights during both typhoons reached approximately 2 m. Therefore, these waves may have largely contributed to the transport of debris to the high elevations behind the dike. Additionally, most cases indicate that wave heights were significantly large compared to average surge heights. Consequently, infragravity wave components largely impacted the nearshore water surface fluctuations, especially along the coasts from Kushimoto to Gobo.

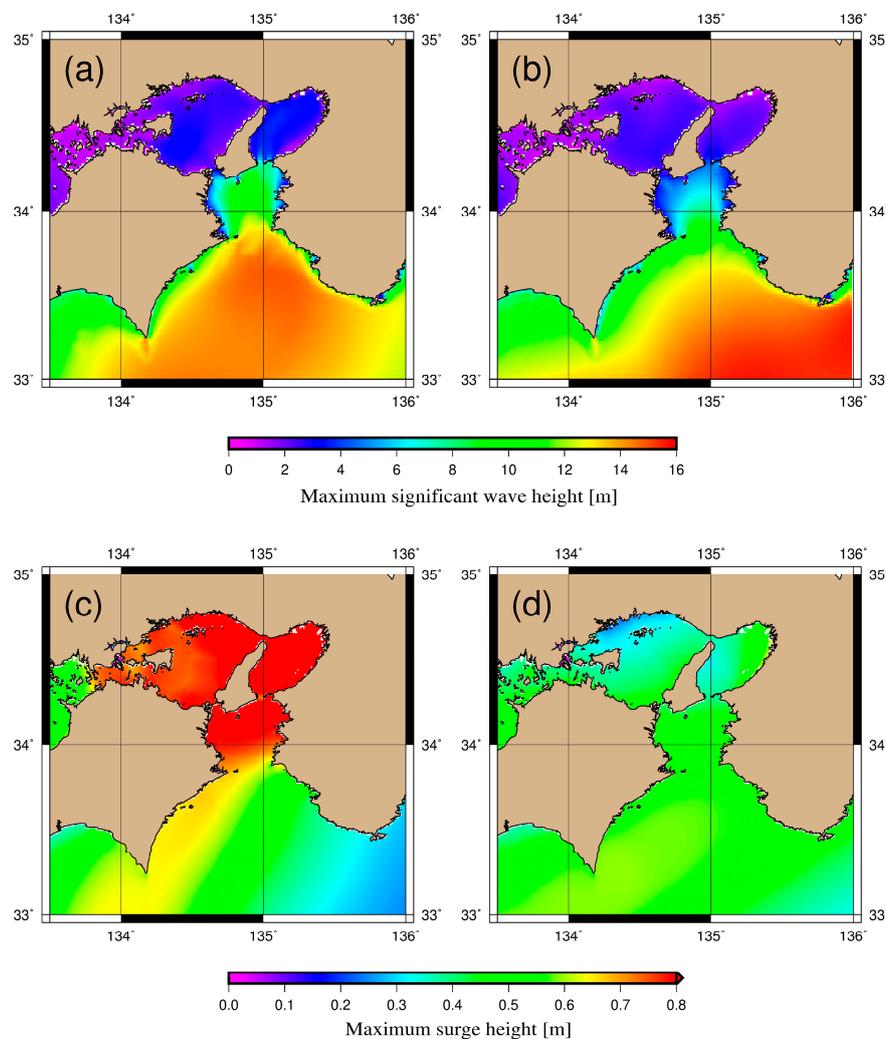
**Figure 7.** Distribution of the maximum simulated wave heights during Typhoons Jebi and Trami. Significant wave height for (a) Jebi and (b) Trami; surge height for (c) Jebi and (d) Trami.

Figure 7 shows spatial distributions of the simulated maximum values of significant wave heights and storm surge heights during Jebi and Trami. As seen in Figure 7a,b, significant wave heights gradually decrease toward Kii Channel and Osaka Bay, where fetch-limited waves are dominant, and peaked around the middle coasts from Shirahama to Mihama for Jebi and at the south of Kushimoto for Trami. According to the simulation results shown in Figure 7c,d, surges in Jebi were locally concentrated around confined sea areas such as Osaka Bay because of the typhoon path and geometry; on the other hand, insignificant concentration appeared in Osaka Bay during Trami because it was located to the west of the typhoon path. These results yielded the large contrast between Figure 7c,d. The computed maximum surge heights on the coast of Wakayama have a peak in the north for Jebi and around Tanabe for Trami because of their proximities to the typhoon paths. Additionally, the model predicts smaller storm surges to the west of Typhoon Trami path than those to the east, as evidenced by the observations such as at Wakayama located to the west and Shirahama located to the east (Figure 6). However, local variations in significant wave heights and surge heights along the coast of Wakayama were not noteworthy, while elevations observed in the field surveys showed substantial variations along the coast (Figure 7). Therefore, this feature indicates the importance of local wave geometry in alongshore variations.

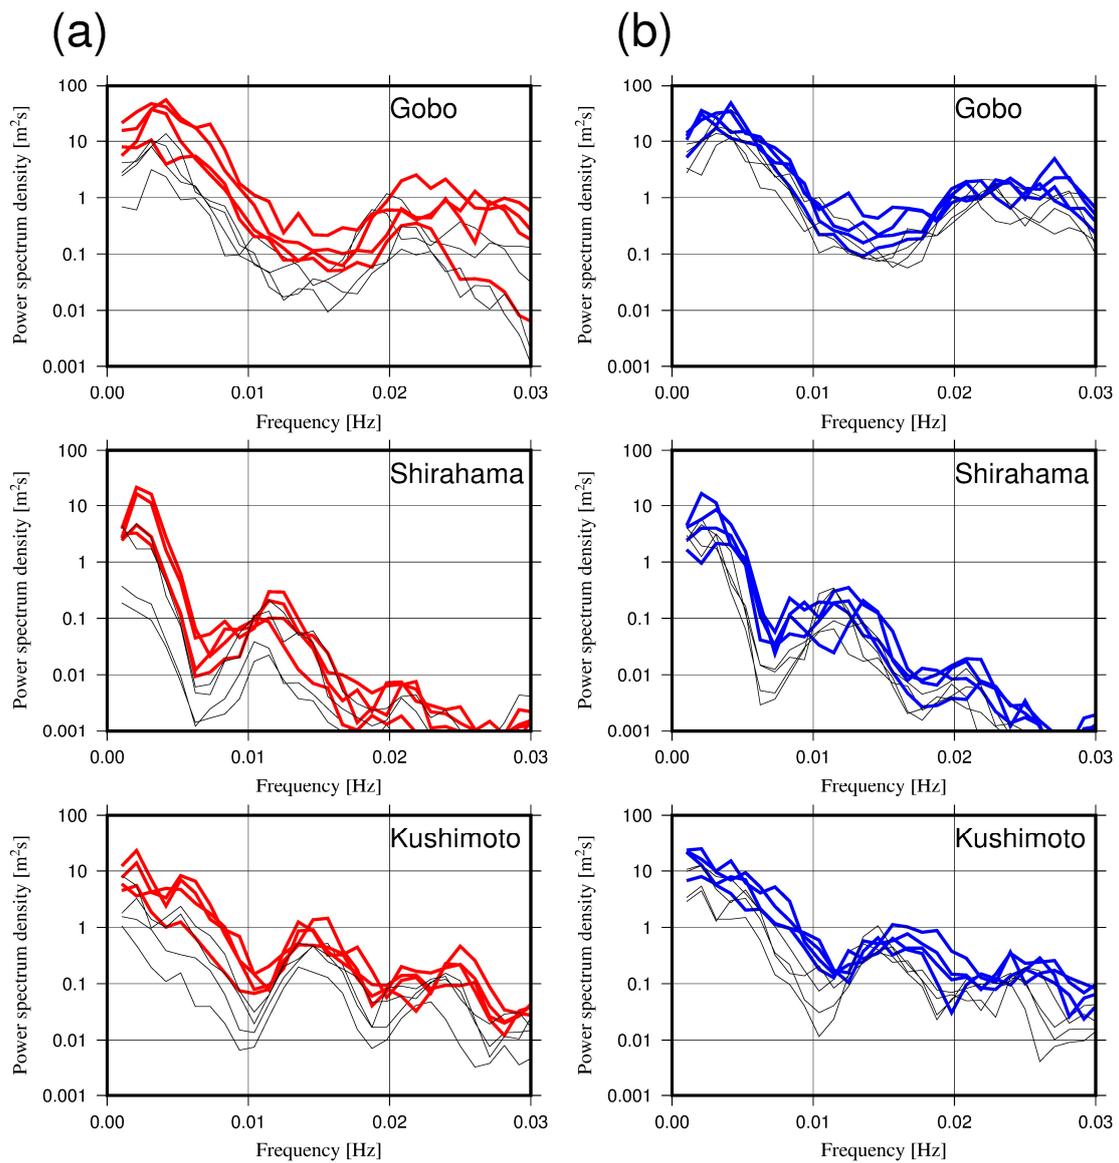
**Figure 8.** Power spectrum density of water surface fluctuations observed by tide gauges for (a) Jeji and (b) Trami. Eight power spectrum densities are shown for Jeji based on water surface fluctuations observed within time bands of 9:00–10:00, 10:00–11:00, 11:00–12:00, 12:00–13:00, 13:00–14:00, 14:00–15:00, 15:00–16:00, and 16:00–17:00 and for Trami based on observations within time bands of 16:00–17:00, 17:00–18:00, 18:00–19:00, 19:00–20:00, 20:00–21:00, 21:00–22:00, 22:00–23:00, and 23:00–24:00. The results for time bands 11:00–15:00 and 18:00–22:00, when Typhoons Jebi and Trami significantly impacted the coasts, respectively, are highlighted in red and blue, respectively.

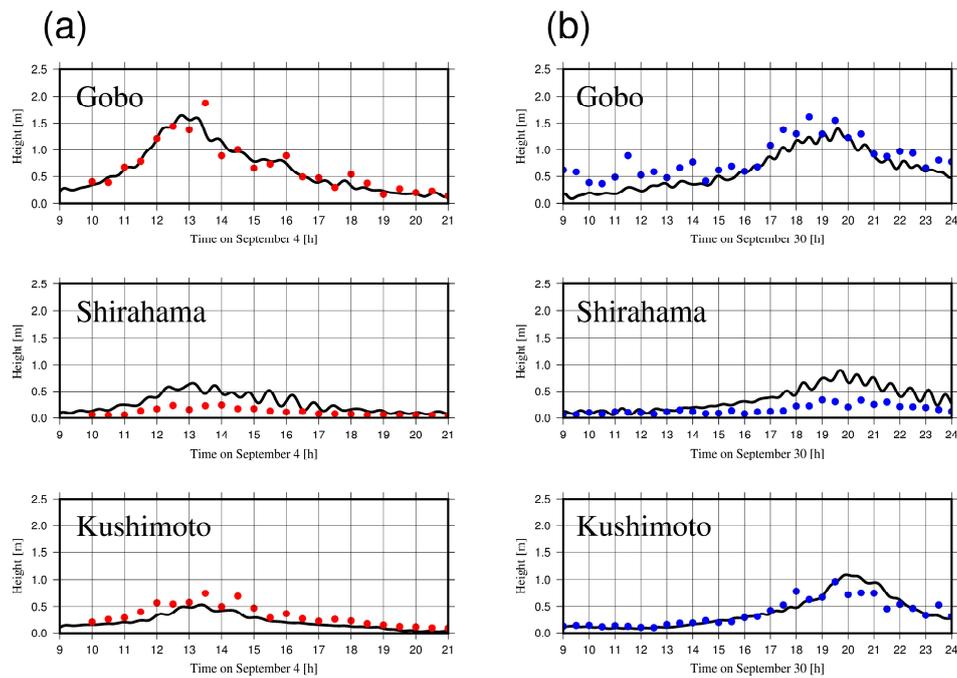
**Figure 9.** Significant wave heights for infragravity wave components (circle) and low-pass filtered waveforms (solid line) from observed waveforms of surge heights with components lower than  $5.6 \times 10^{-4}$  Hz (30 min) for (a) Jebi and (b) Trami. Significant wave heights,  $H_{m_0}$ , were calculated as  $H_{m_0} = 4 \sqrt{m_0}$ , where  $m_0$  is the zeroth-order moment of power spectrum densities of water level fluctuation; estimation of power spectrum density was based on Fourier transform with a sampling data length of  $2^7$  and sampling time step of 15 s (corresponding to 32 min window length).

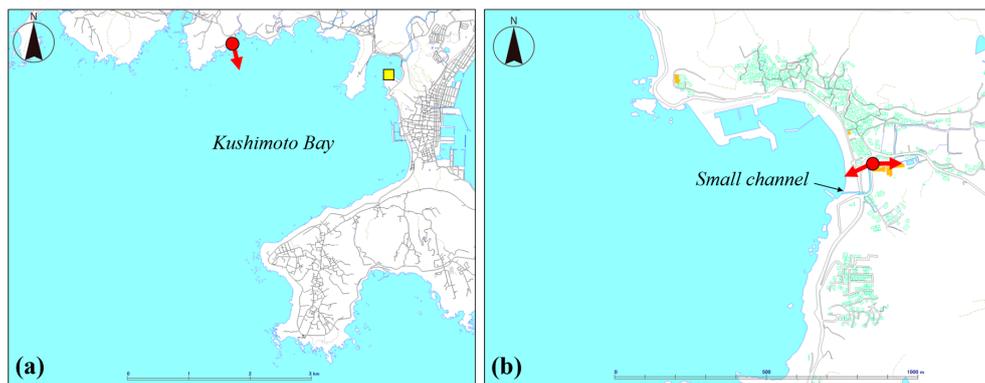
**Figure 10.** Overview of the geometry based on the Geospatial Information Authority of Japan [28] and locations video site; (a) Kushimoto (Kushimoto Marine Park) and (b) Obiki area in Yura Town. The red circles and red vectors indicate video locations and video angles, respectively.

The first video was recorded on the coast in front of Kushimoto Marine Park in Kushimoto (33°28'51"N, 135°44'42"E) from approximately 11:00 to 12:00 on 4 September (Figure 10a). The video camera was fixed outside the building. Violent winds slightly vibrated the fixed camera, and drops of rain and waves on the camera affected the quality of some recordings. We carefully investigated the video quality and selected a 12-min continuous footage at approximately 11:40 when the influences were not significant. Figure 11a,b shows still images of the water surface and pier with the steel poles. Because the vertically-installed poles were nearly parallel to the column of the image pixels, line images

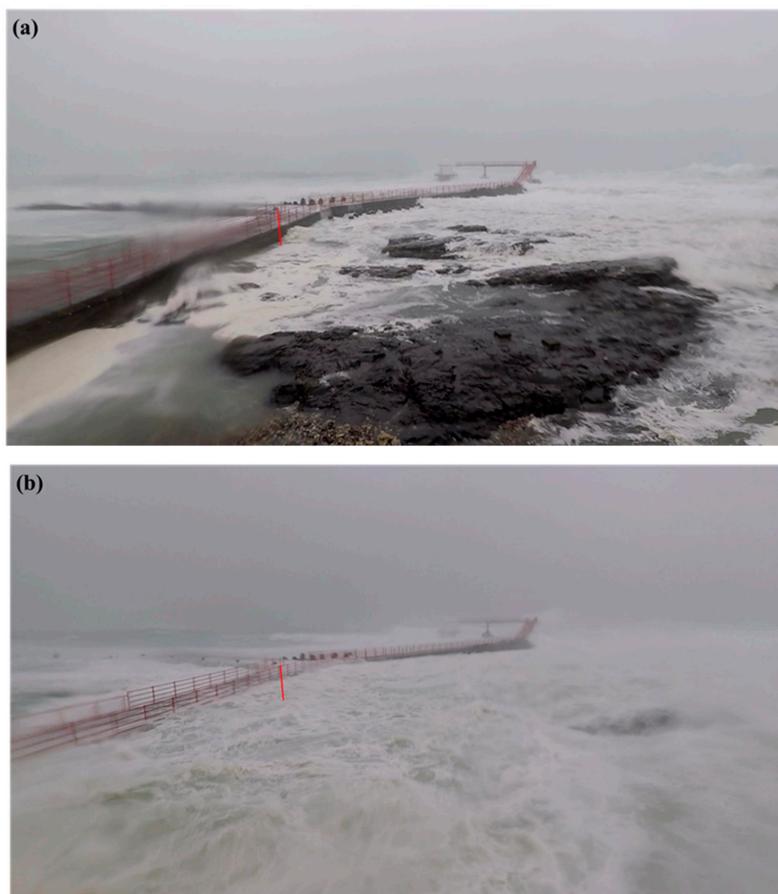
**Figure 11.** Still images from the video footage when the water level (a) decreased and (b) increased, respectively, taken at Kushimoto Marine Park Ltd. around 11:45 on 4 September 2018. The red lines in the images indicate the pixels for creating the time stack image.

along the column at a pole location were extracted from succeeding still images of the video, and the extracted line images were horizontally placed in the order of the recorded time to create a time stack image of the fluctuating water surface levels (Figure 12a). Figure 11a,b indicates blackish and whitish colors of the pier and water surface in the recorded images; thus, water surface elevation along the sidewall of the pier and pole can be easily detected as the boundary between the blackish and whitish pixels (Figure 12a). Time,  $t$ , refers to the elapsed time from the first image of the selected video; the height and elevation in the time stack image were based on the pole's height and elevation.

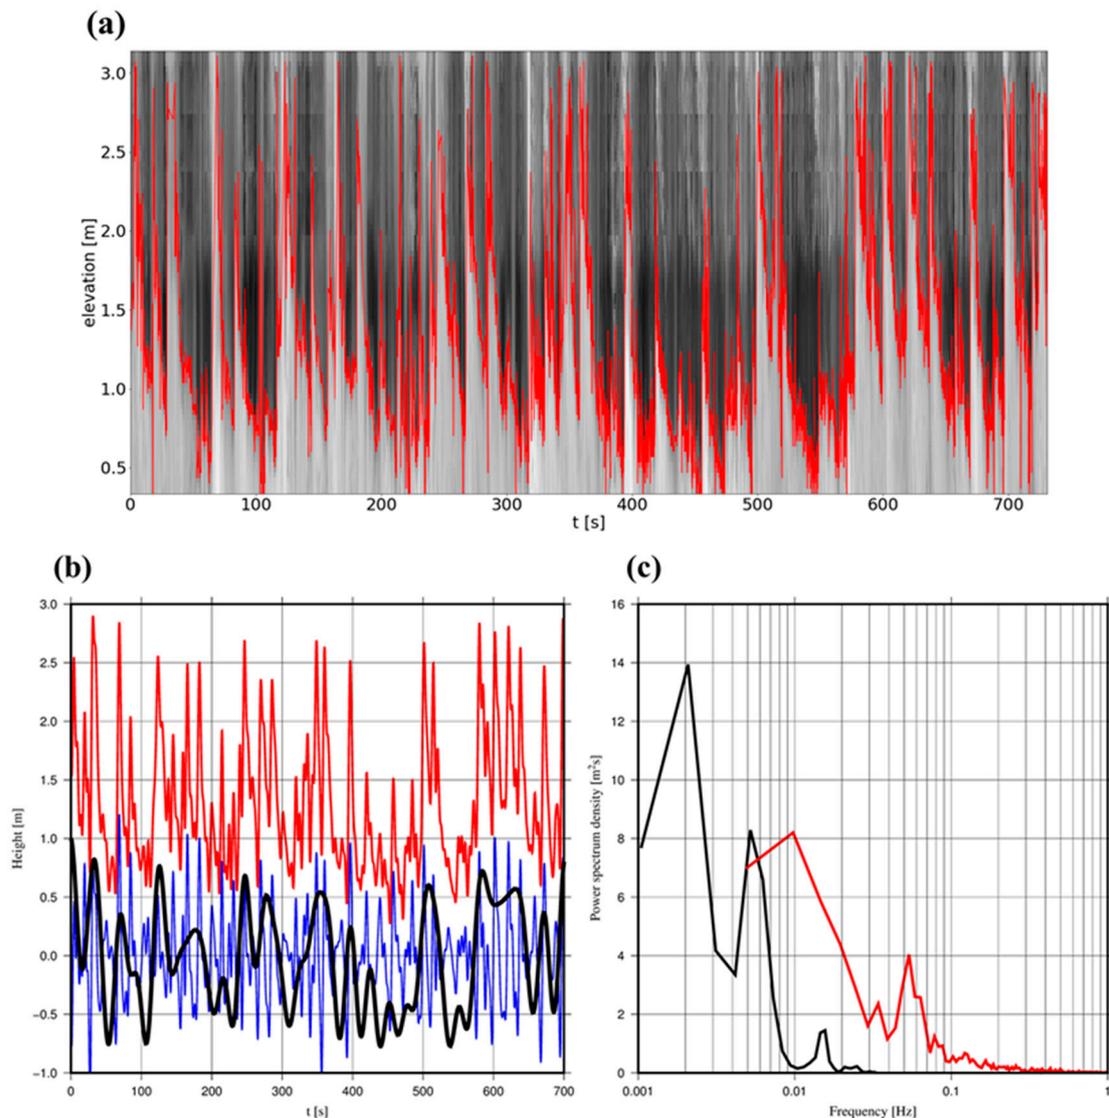
**Figure 12.** (a) Time stack image for estimating water-level fluctuations indicated by red lines; (b) estimated water-level fluctuations based on Figure 12a with synthesized waveforms comprising wind-wave and infragravity wave components, respectively, indicated in red, blue, and black; (c) Power Spectrum Densities based on Tide Gauge data and water-level fluctuations extracted from Video Footage, PSDTG (black) and PSDVF (red).

Figure 12b indicates the extracted water level fluctuations from the time stack image (Figure 12a) and its frequency components from  $4.0 \times 10^{-2}$  to  $5.0 \times 10^{-1}$  Hz and lower than  $4.0 \times 10^{-2}$  Hz, respectively, based on spectral analysis. Each component respectively represents the wind wave and infragravity wave components. Figure 12c compares the Power Spectrum Density of water surface fluctuations extracted from the Video Footage (PSDVF) and PSDTG of Kushimoto, located 3 km east of the park, from 12:00 to 13:00, as displayed in Figure 8. A Fourier transform for estimating the PSDVF was conducted with a sampling data length of  $2^{11}$  and sampling time step of 0.1 s. First, as shown in Figure 12b, the amplitude of the low-frequency components (i.e., infragravity wave components) was approximately 1 m; this amplitude was as high as that of the wind-wave components and thus had a significant impact on inundation or wave run-up along the coast of Kushimoto. Furthermore, as shown in Figure 12c, three peaks appear at  $2.1 \times 10^{-3}$ ,  $5.0 \times 10^{-3}$ , and  $1.4 \times 10^{-2}$  Hz in PSDTG. Endoh et al. [29] investigated a resonant oscillation excited in Kushimoto Bay and determined the predominant component (i.e., the first mode bay-scale resonance period) to be  $7.75 \times 10^{-4}$  Hz. Endoh et al. [29] also

showed that the frequency components ranging from  $1.0 \times 10^{-3}$  to  $2.0 \times 10^{-3}$  Hz, corresponding to the peak at  $2.1 \times 10^{-3}$  observed in PSDTG, were amplified. The other peak frequencies of PSDTG ( $5.0 \times 10^{-3}$  and  $1.4 \times 10^{-2}$  Hz) were higher than the first peak component and this may be due to the resonance of infragravity waves in local bathymetry. On the other hand, PSDVF showed two peaks at  $1.0 \times 10^{-2}$  and  $5.0 \times 10^{-2}$ – $6.0 \times 10^{-2}$  Hz (Figure 12c). The latter frequency was equivalent to the significant wave period of 14–15 s simulated by WW3 and thus should represent wind wave components. The former frequency was similar to the frequency of one of the PSDTG peaks, at  $1.4 \times 10^{-2}$  Hz. However, PSDTG at  $1.4 \times 10^{-2}$  Hz was much smaller than the one for PSDVF at  $1.0 \times 10^{-2}$  Hz. Tide gauge data were recorded with time intervals of 15 s, and the high-frequency components of water-level fluctuations were physically dissipated by a conduit connecting the tide gauge and open sea. Namegaya et al. [30] also indicated that tide gauge data tend to underestimate water-level fluctuations for relatively shorter frequency components, including tsunami waves. Considering the estimated results into account, the infragravity wave components, at approximately  $1.4 \times 10^{-2}$  and  $5.0 \times 10^{-3}$  Hz, were enhanced by local geometry of Kushimoto and might dominate nearshore wave dynamics there.

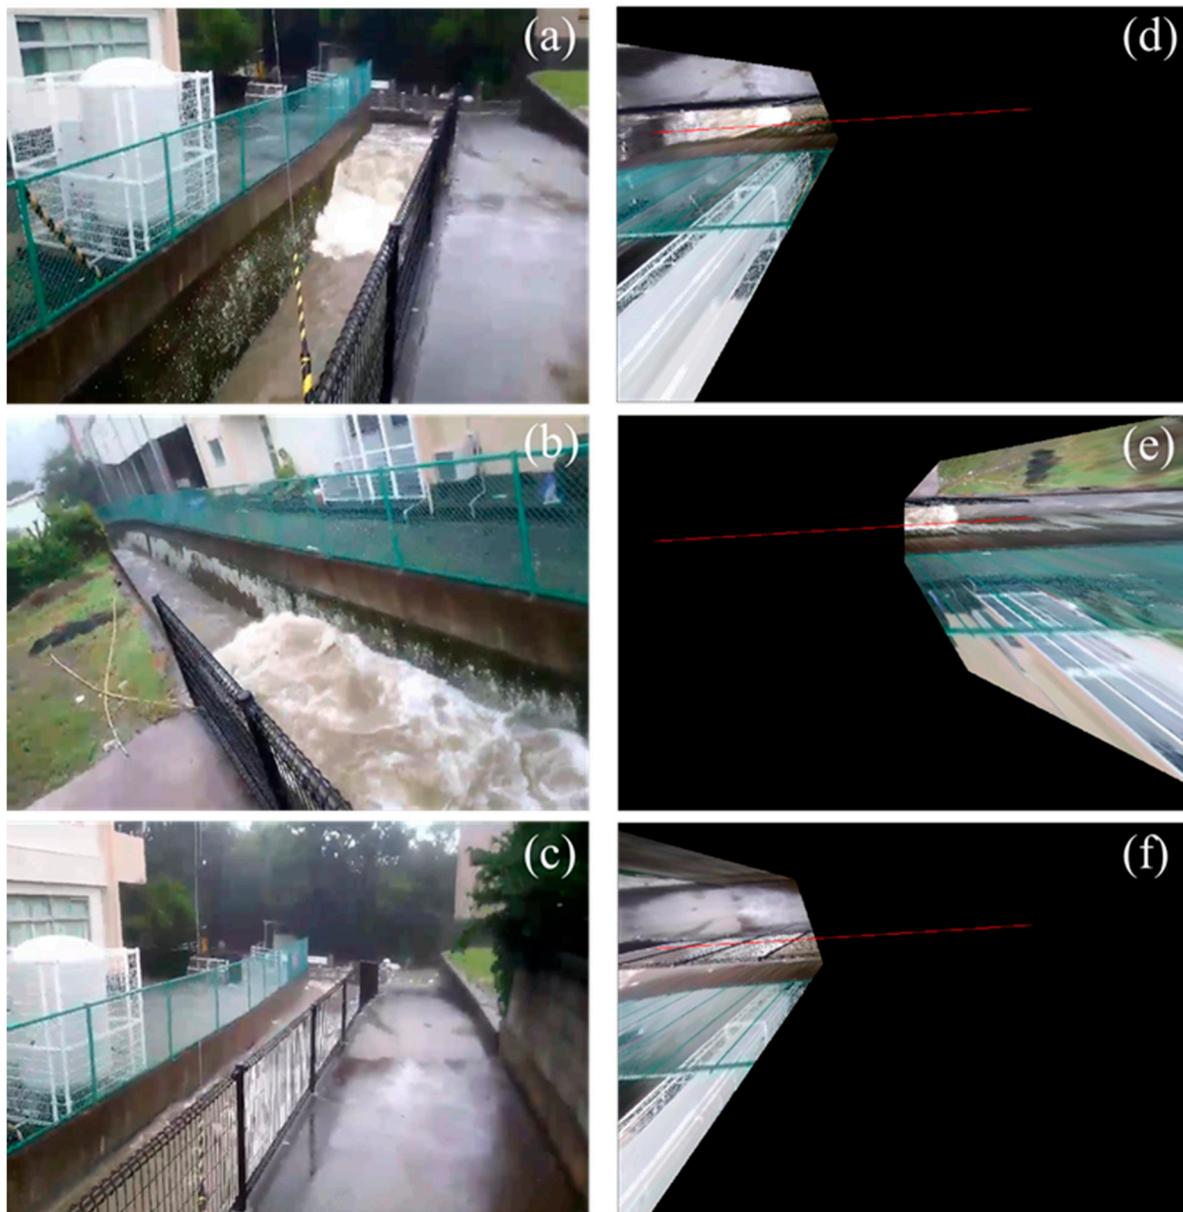
**Figure 13.** Still images from the recorded video at (a)  $t = 12.9$  s, (b)  $18.8$  s, and (c)  $t = 26.9$  s, and (d–f) top-view images obtained by rectifying the images in (a–c), respectively, with the control line.

Figure 13d–f shows top-view images for Figure 13a–c, respectively, obtained by converting the pixel coordinates into Cartesian  $XY$  coordinates using the estimated geometric parameters. As seen in Figure 13, the camera changed to completely different angles very quickly to capture the wave front and wave flows; such situations make tracking same control points difficult. Therefore, the video was divided into three sections with similar camera angles, and different control points were tracked in each section (Figure 13a–c). Figure 13 shows that the front face of the bore-like wave in the channel appears white owing to turbulence. Therefore, all the image frames were rectified into top-view images and a control line, indicated by the red lines in Figure 13d–f, was determined; RGB brightness on the line was extracted to visualize the bore-wave propagation in time and space, as a time stack image (Figure 14). In Figure 14, the horizontal axis indicates the distance along the channel,  $l$ , positive in the landward direction, and the vertical axis indicates time, positive in the downward direction. Therefore, the right-downward line of the bore front demonstrates that the bore-like wave propagated landward along the channel, and the propagating speed of this wave was approximately  $4.2$  m/s.

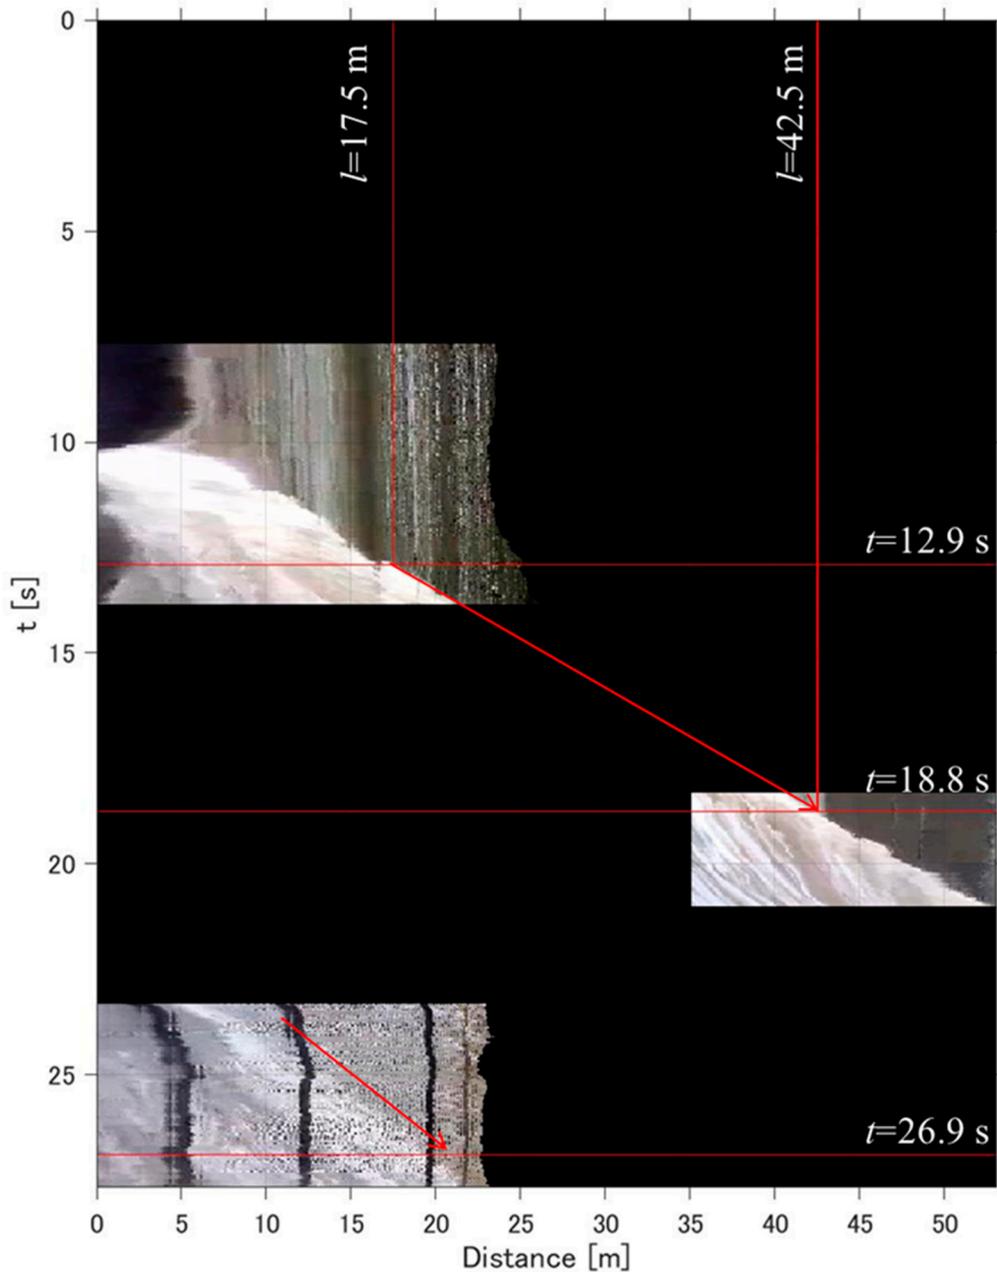
**Figure 14.** Time stack image along the control line, as indicated in Figure 13d–f.

Furthermore, with  $l = 0\text{--}20$  m and  $t = 24\text{--}27$  s, the water surface was still moving landward. Based on this figure, the bore-like wave continuously progressed landward for more than 15 s. As seen in Figure 10b, the channel curved, and the along-channel distance from the sea to the video-recording site was more than 150 m. The observed 1.8 m-high bore-like wave propagating more than 150 m along the open channel also indicates that significantly high infragravity wave components were generated around the coast of Yura.

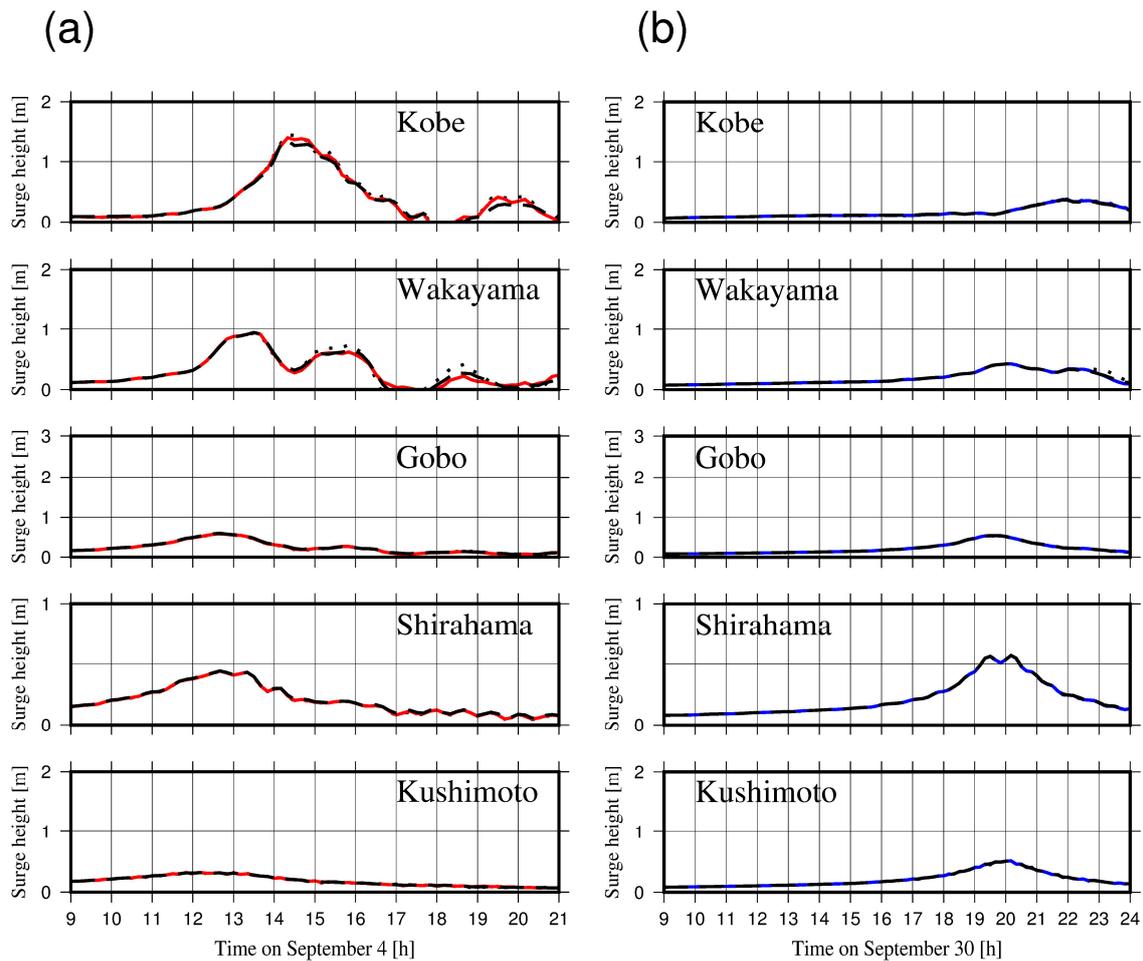
**Figure A1.** Comparisons of simulation results for storm surges in (a) Jebi and (b) Trami. Solid red and blue lines indicate waveforms simulated with a Manning’s roughness of  $0.025 \text{ m}^{-1/3}\text{s}$ , corresponding to waveforms displayed in Figure 6. Dotted black lines and dashed black lines indicate simulated waveforms with the Manning’s roughness of  $0.010$  and  $0.050 \text{ m}^{-1/3}\text{s}$ , respectively.
