Corrosion Hazards in Urban Infrastructure Structures Using the Example of the Al Bayt Stadium in Katar

Abstract: A significant aspect of corrosion failures and catastrophes originate from trivial mistakes in either the choice or connection of different materials, as well as from inaccurate evaluation of the compatibility between materials and the environment. The example shown in the present paper summarizes several wrong solutions due to a lack of knowledge of the basic rules of corrosion control. By chance, the consequences of these errors already appeared during construction; therefore, they were not able to cause damage during operation. This paper is the third in a series devoted to enhancing the need for professional corrosion control design for infrastructures.

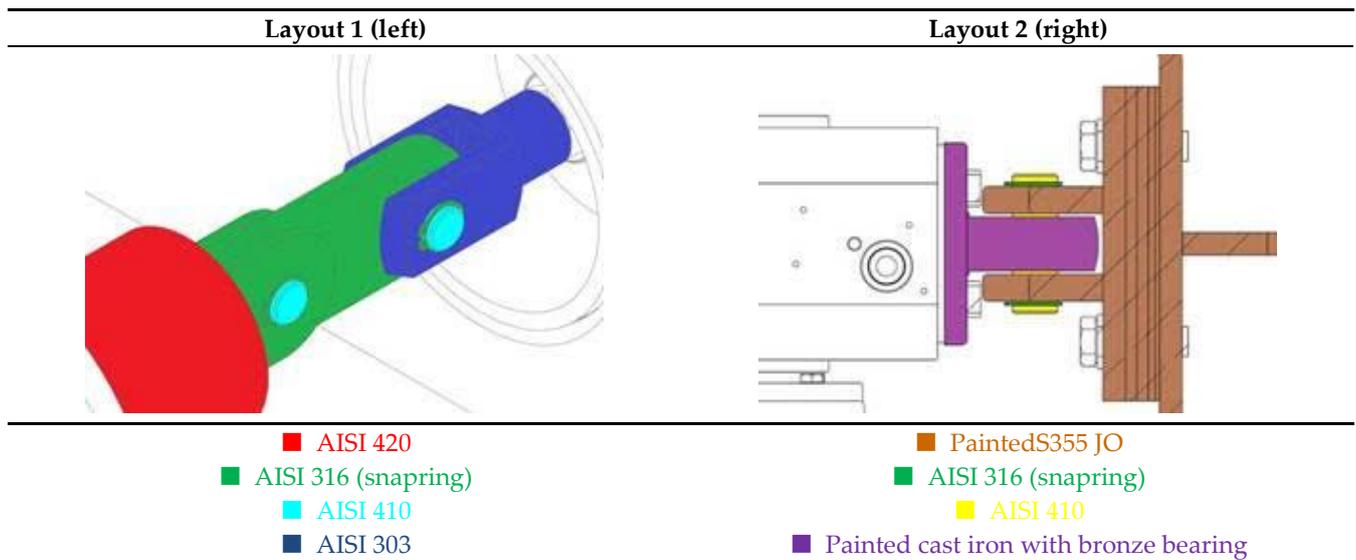
Figure 4. Details of the actuator showing the locations of the snap rings.

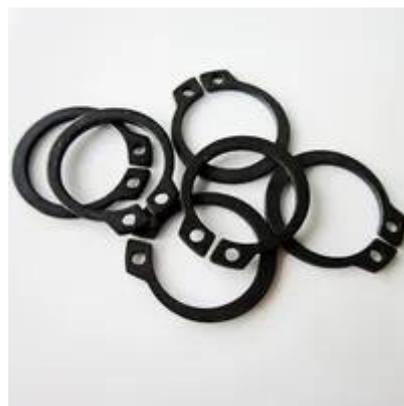
Figure 5. Snap rings or circlips.

Regardless of the above-mentioned phenomena, the most pressing problem concerns the behavior of the snap rings located in a narrow groove carved on the support roller

for the movement of the mechanism (Figure 5), which is built from AISI 410 steel with good resistance characteristics, even if it is not recommended to use in highly corrosive environments. It is, however, anodic with respect to the material used for the snap rings (AISI 316), and, in principle, it might provide the snap ring with some form of cathodic protection. The galvanic chain is, however, irrelevant in this case, in view of another phenomenon much more serious and directly responsible for the early breaking of the snap rings. It is dependent on construction and the aggressiveness of the environment and is called crevice corrosion. Crevice corrosion [21,22] occurs in those hidden sites where oxygen does not circulate freely (Figure 8).

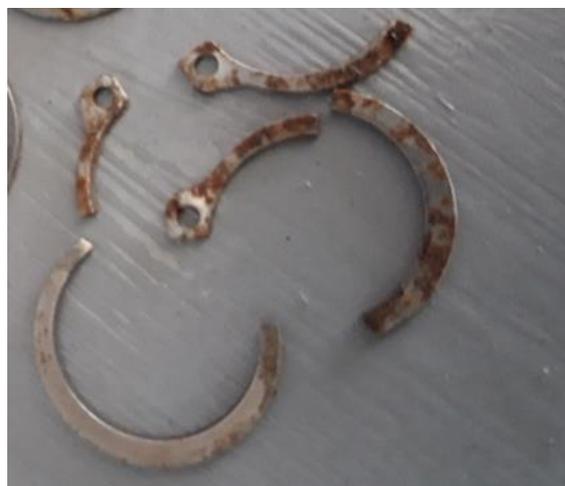
By design, the 384 pins (six in each actuator) were made from AISI 316 stainless steel. It was observed that many of them showed signs of corrosion and break after a relatively short service period (less than 1 year) (Figure 6).

Figure 6. Examples of stress corrosion cracked snap rings.

Considering the critical role of the snap rings, the safest possible solution is the use of beryllium bronze, a non-passivated material with a much greater resistance to generalized corrosion than spring steel. However, the problem of the cavity remains, which causes the differential aeration cell to act. Stressed bronze, although not passivated, nevertheless presents areas with less noble potential where the tension accumulates, and the risk of preferentially localized breakage remains.

Luckily, all of the above-mentioned negligence were venial sins without significant effects on durability but undoubtedly affecting aesthetics. Luckily, again, the fracture of the AISI 316 snap rings was so quick that it happened while the stadium was still under construction, and a remedy was found without harm.

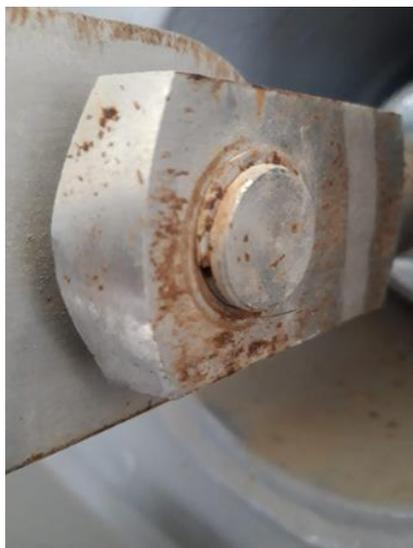
Figure 7. Detail of the support roller showing the snap ring located in a carved narrow groove. Localized corrosion and rusting are shown.

Figure 7 shows that the object is affected by the presence of generalized rusting and widespread pitting phenomena, denoting a particularly aggressive environment, the effects of which are enhanced by some mistakes in both design and construction, namely:

- (a) The object is composed of a chain of different stainless steels of different compositions and structures with obvious differences in behavior in terms of corrosion [5,12]: AISI 316 steel is the noblest one and acts as a cathode compared to AISI 303 steel, which is not recommended for use in highly corrosive environments due to the presence of sulfur in the composition.

- (b) The electrochemical corrosion due to the presence of a galvanic chain of different corrosion potentials of the differently “noble” components might have been minimized by the peculiar property of stainless steels to be “passivable alloys”: the main feature of all stainless steels is that they are suitable for building a nanometric surface layer consisting mainly of chromium oxide, named the passive layer. It is self-healing, and the rate of restoring passivity after damage is a feature of the quality of the alloy. Thus, the stability of the passive film is the result of a compromise between two kinetic processes: film growth and film dissolution [17]. Moreover, the surface stationary electrochemical conditions are driven mainly by adsorption/desorption equilibria of external substances rather than via redox electrochemical reactions, the reason why for passive stainless steels an electrochemical corrosion potential does not exist. In the active state, on the other hand, stainless steels have an often higher corrosion rate than carbon steels. Nevertheless, heat treatments, mechanical working, and handling produce many surface defects, hence reducing the corrosion resistance of the passive layer. To increase and optimize the formation of the chromium oxide layer, it is necessary to perform a repassivation procedure. The immersion of stainless steel in an acid bath dissolves free iron or other foreign substances from the surface while leaving the chromium intact, according to ASTM380 [18]. The acid chemically removes the free iron, leaving behind a uniform surface with a higher proportion of chromium than the underlying material [19]. This treatment was not performed on the structure. In our case, the AISI 303 s.s., both for the galvanic coupling and for the poor finish, is subject to widespread pitting.

- (c) Poor surface finishing is the third construction mistake. Both reliability and durability of the passive layer are strictly connected with the smoothness of the surface; it is not obviously possible to reach a perfectly planar surface, and at the crystallographic level, all surfaces are rough. Hence, passivity is a dynamic situation where activation phenomena happen in a very high number of sites, quickly followed by repassivation. The speed of reestablishing passivity is a function of both surface uniformity and quality. All functional accessories of the actuator (the colored parts of Figure 4) have been produced in the mechanical workshop leaving the degree of finish produced by the tool. However, this roughness deviation from the optimum could have been minimized by a suitable repassivation process.

- (d) All edges should be rounded, not only to allow more uniform distribution of possible coatings but also to avoid the accumulation of current density on sharp edges, enhancing both localized rust and pitting, as clearly shown in Figure 7.

It is then possible to try to inert all the elements of the cell by means of surface protection. By covering both the slot and the snap ring, both the anode and cathode can be disengaged. The problem now remains limited to the duration of protection provided by the coating. The operating conditions exclude any painting, with the risk of staining the white tissue of the ceiling.

The only possibility is the use of viscous protecting creams widely used in automotive building procedures, for example, in spot-welded sheets or in the hidden underbody. Those creams are very adherent, do not drip, and contain products such as Teflon and lithium soaps, which ensure its stability over time, therefore allowing for five-year monitoring.

- Disassembly of the snap ring;
- Cleaning the seat and adjacent areas with a bronze brush;
- Spraying of the entire surface area of the roller;
- Spraying or immersion of the snap ring;
- Assembly of the snap ring.

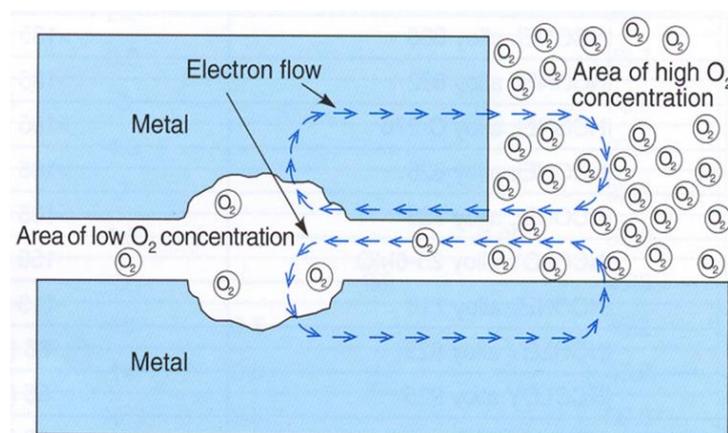
Figure 8. Mechanism of crevice corrosion.

In these areas, oxygen is progressively consumed and cannot be renewed by diffusion or convection. Outside the confined area, the cathodic reaction of oxygen reduction still occurs on the metal surface, whereas, in the confined area, the metal surface becomes the anode. The corrosion processes lead to the modification of the chemical composition of the electrolyte in the crevice with simultaneous acidification and an increase of chloride ion concentration. When the pH and the Cl^- concentration in the crevice solution reach critical values, depassivation of the stainless steel with active dissolution occurs, which is localized to the points where passivation is weakest, i.e., in the anodic areas. In this specific case, the snap ring was designed to be built using AISI 316, a passive alloy that critically depends on the passive ceramic oxide layer that covers it and which, by default, should reform itself in a very short time in case of damage. The ring is inserted under tension in the thin groove engraved on the cylinder. Inside the cavity, the conditions described above are very suitable for crevice corrosion. The metal attack occurs in those more anodic areas, that is, where the oxide is most damaged and the metal structure most weakened. These areas are located where the effects of the applied mechanical tension are more pronounced, and localized self-stimulating corrosion will begin until (in a very short time) the crack formed does not produce the fracture of the arc according to the mechanism of corrosion under tension (stress corrosion). This mechanism has been thoroughly explained by J.C Scully in a classic publication [23], showing that the events occurring at the tip of a propagating stress corrosion crack depend on the relative prevailing contribution of the strain rate and repassivation rate (Figure 9). It is argued that the strain rate and repassivation rate interact to maintain an acidified solution at the tip of a propagating crack in halide solutions just below the pitting potential. If the strain rate is too low or the repassivation rate too large, repassivation will occur, resulting in crack arrest. On the contrary, the crack will form and proceed at a rate that is self-accelerated due to the corrosion cell produced by the anodic tip and the other cathodic repassivating surfaces.

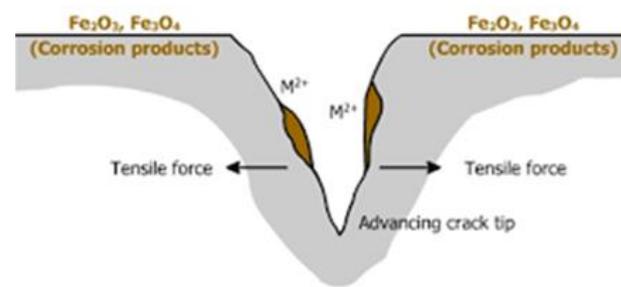
Figure 9. Mechanism of stress corrosion.

Therefore, there is an overlap between the most dangerous corrosion conditions: a cell with differential aeration: oxygen-rich external cathodic areas, asphyctic, acidic, chloride-rich anodic internal areas; breakdown of local passivity producing pitting; and applied mechanical tension giving rise to stress corrosion. Under such conditions, it could be deduced that a non-passivated spring steel snap ring could resist longer because the attack would be distributed over the entire surface of the snap ring with lower current density and much less risk of stress corrosion. The unknown factor is given by the corrosion rate (rust and general thinning) of the metal. It is, therefore, better to choose an alternative alloy with a low corrosion rate.
