Article

The Use of PVD Coatings for Anti-Wear Protection of the Press-In Connection Elements

Abstract: Press-in connections are the commonly used methods for connecting machinery components. In relation to that wide use, those connections are liable to various types of damage and wear. Therefore, this article proposes one of the methods which may improve the life of the press-in connection. CrN+OX, TiN, and ZrN coatings made in the PVD technology were used. The coatings were applied on shafts mating with sleeves and subjected to a rotational bending moment. Tests and observations were conducted that enabled the assessment of the influence of those coatings on the development of wear, in particular fretting, in the tribological kinematic pair. The tests showed the development of wear on all the observed shaft surfaces, with a lower intensity of damage recorded on coated shafts compared to uncoated ones. The traces of fretting wear were noted each time at the edges of the connection, which is due to the mechanism of wear development under rotational bending conditions. In the case of uncoated shafts, wear occurs at the entire circumference of the axle seat in the form of a 3–4 mm w

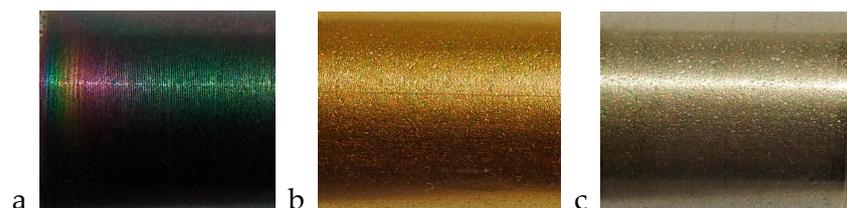
- CrN+OX (thickness: $9 \mu\text{m}$, colour: rainbow);
- TiN (thickness: $3.5 \mu\text{m}$, colour: yellow–gold);
- ZrN (thickness: $2.5 \mu\text{m}$, colour: golden white).

Figure 1. The view of the shaft surface with a coating applied; (a) CrN+OX, (b) TiN, (c) ZrN.

The macroscopic images of the coated shaft surfaces are shown in Figure 1.

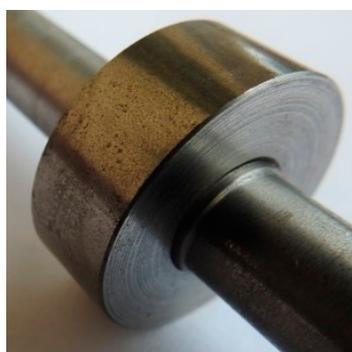
The tolerance was taken at 0.02 mm, for which the surface pressure is 130.8 MPa. The calculated surface pressure is close to the value of surface pressures in the real wheel set. Figure 2 shows the photo of the sleeve and shaft press-in connection for wear tests.

Figure 2. The view of the tribological kinematic pair.

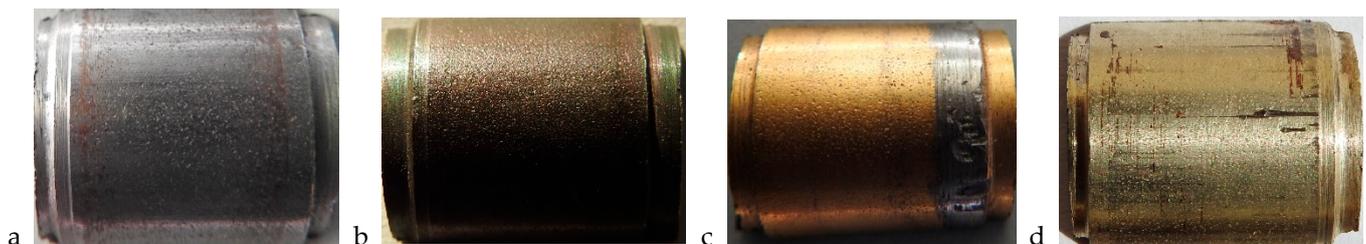
Figure 3. Macroscopic images of shaft surfaces after wear tests, (a) shaft without coating, (b) shaft with CrN+OX coating, (c) shaft with TiN coating, (d) shaft with ZrN coating.

The macroscopic images of uncoated shafts depict fretting wear on either side of the shaft axle seat. Wear occurs at the entire circumference of the axle seat in the form of a 3–4 mm wide ring; however, that width is different on either side. The traces of wear at the edge of the connection follow from the fretting-wear development mechanism in press-in connections, which is discussed in detail by Guzowski S. in his publications, and which may be presented in the following way. As a result of model rotation during operation, and due to the occurrence of oscillatory tangential displacements, the products of the press-in process, present at the connection edge, are removed towards the outside. Due to that, direct contact between the shaft and sleeve surfaces takes place, which creates advantageous conditions for the development of adhesive bonds that cause the destruction of the top layer.

The traces of wear are brown, which is a colour typical of the atmospheric corrosion of iron, that being the evidence of the damaged area's oxidation. Oxide formation is linked to the existence of a gap between the shaft and sleeve surfaces, which comes into being as a result of sample bending, thus enabling contact of the damaged areas with oxygen.

The images of the shaft surface with a CrN+OX coating indicate fretting wear in the form of a regular ring comprising the entire hub and axle-seat circumference, especially on the right side of the sample. The colours of wear traces and of the coating applied onto the shaft merge with each other, thus causing difficulties with the correct interpretation of the shaft surface wear. Under operation conditions, this situation is all the more dangerous as unnoticed fretting wear can, over time, contribute to the development of fatigue wear.

The use of an oxide layer on the coating surface has had the effect of reducing the fretting wear of the shaft. The ring of wear traces observed on the right side of the sample starts at a distance of 2 mm from the edge of the axle seat and is 3 mm wide. The left side of the sample is distinguished by lower wear intensity. In that case, the wear ring width varies between 2–2.3 mm, and the ring also starts at a distance of 2 mm from the edge.

All the analysed shaft surfaces with the TiN coating are noted for considerable damage. The first, and most conspicuous instance of damage, is the destruction of the surface on the left side of the sample. This is distinguished by coating tearing or a considerable build-up of material from the sleeve top layer. The nature of the damage may be studied in detail during microscopic observations. The following causes of damage were considered. As the first cause, errors in shaft or sleeve manufacture were pointed out, in particular the lack of the required dimensional tolerance. However, all the components were made on CNC machines with high accuracy; therefore, that assumption may be disregarded. In turn, the incorrect manufacture of the components would affect the assembly of the connection. During forcing in, too close a fit could lead to the destruction of the top layer in a way similar to that shown in the figure. The wear trace direction, however, does not indicate assembly damage. In that case, the traces would have been perpendicular to the shaft axis.

Most probably, damage occurred at the operation stage (during the wear tests). The traces indicate the reduction of assembly pressures, which come into being during sleeve forcing onto the shaft, as a result of the connection becoming loose. The sleeve rotating on the shaft during operation could cause similar damage. If this assumption is taken as the most probable one, a question arises as to why similar damage does not occur on the other side of the sample or at any other place. At this stage of research, it is difficult to explain the cause and mechanism of damage in a rational way. That is why the analysis of that damage will be the subject matter of relevant research in the future.

At the axle seat and sleeve surfaces, visible are also traces resembling fretting wear. They occur at a distance of 40–50 mm from the edge of the connection, on either side, as a 2 mm ring comprising the entire sleeve circumference. On the left side of the sample, the traces are more conspicuous, and the areas of higher wear intensity appear in places. In accordance with the fretting-wear development mechanism in press-in connections, the maximum slide amplitude occurs close to the edge of the connection and is near zero at the place of the visible traces. Therefore, the noted wear traces are not the effect of fretting wear.

In the case of shafts with the ZrN coating, fretting-wear traces are visible on either side of the shaft axle seat over the entire shaft circumference, at a distance of 8–10 mm from the edges. The distribution of fretting-wear traces is random in nature. On the right side of the sample, the local occurrence of wear traces is noted, with periodic high wear intensity. The area of the greatest wear region is approximately 0.75 cm², and it can be seen on the right side of the axle seat. On the left side of the sample, wear is less intensive and, like on the right side, is distinguished by irregular shapes. Moreover, on the left side of the sample, wear micro-traces extending towards the shaft centre may be noted.

In addition to damage related to fretting wear, on the right side of the shaft, there is visible damage, which most probably occurred during the assembly of the connection. A dozen or so scratches of various lengths appear around the entire shaft circumference,

perpendicular to the axis of symmetry of the shaft. The groove depth varies and generally is not greater than several micrometres, but one of them is very peculiar. Over five centimetres, the scratch depth is the biggest and it reaches as far down as the base surface of the coating, thus exposing the steel surface; then, the depth decreases to micrometres until the scratch disappears completely. This situation is undesirable because of the strength of the connection. During operation, additional focuses of fatigue, which may accelerate the development of fretting wear and lead to shaft cracking, may come into being at that place.

In Figure 3, the results of macroscopic observations of the shaft surfaces are presented with a coating and, for comparison, the uncoated shaft surface.

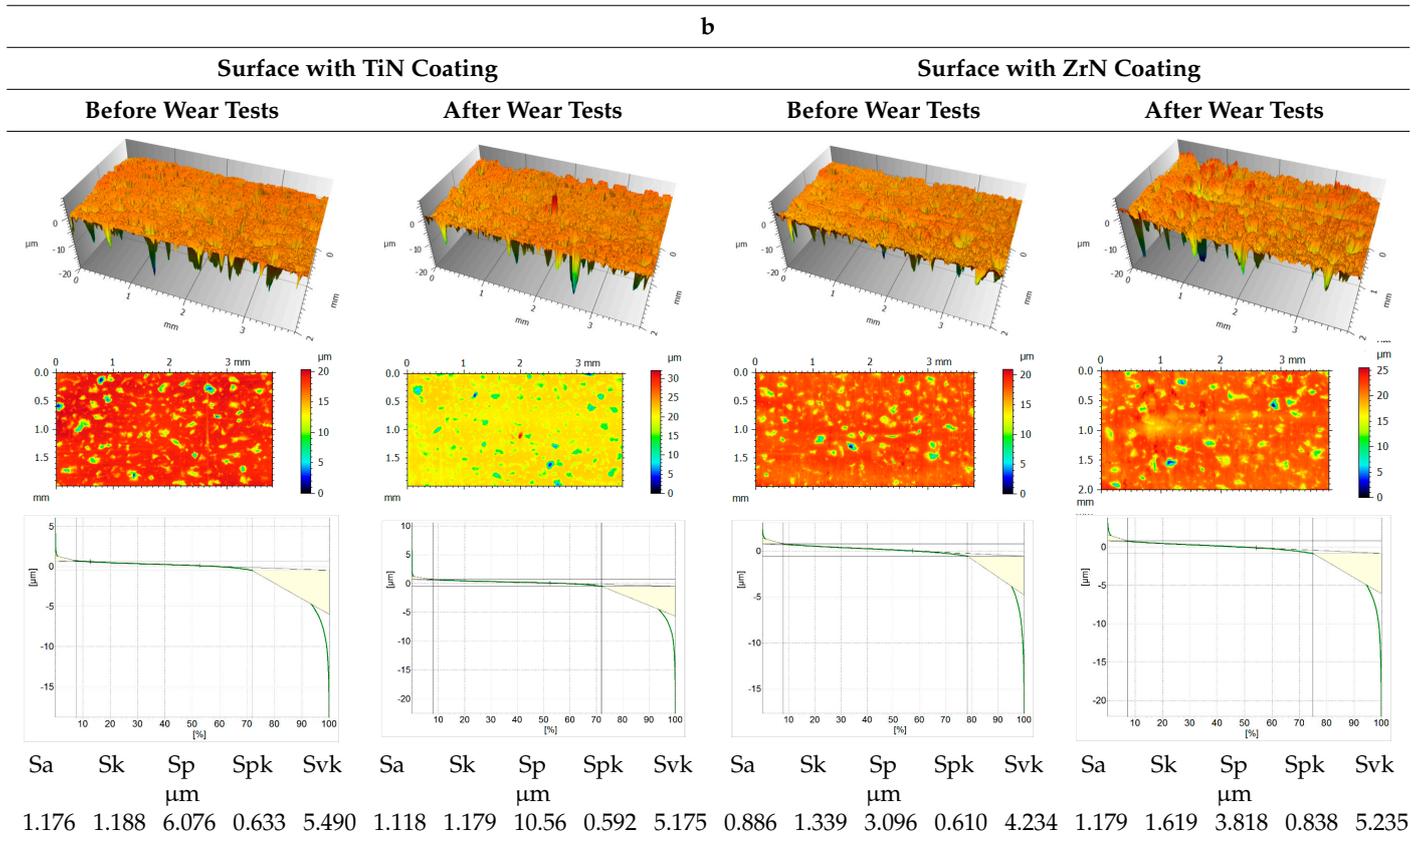
Table 2. Cont.

The results of the shaft surface-roughness measurement before and after wear tests are summarised in Table 2a,b. The surface-roughness measurements after wear tests were performed in the fretting-wear zone. The roughness measurement was carried out on the shaft surface, using a measurement section of 2 × 4 mm.

The topographies of all the surfaces and all the roughness parameters change their appearance and value after wear tests in relation to the surfaces before testing. Both the dimensions and the position of local elevations and cavities change.

When analysing the diagrams showing the surface-roughness spatial profile and contour maps, it is possible to note changes in the position of local elevations and cavities. The size and density of the single fields visibly changed. As regards the analysed section covered by the measurements, more elevations are noted on the shaft surface after wear tests. The change in shaft surface topography is due to the formation of new areas covered with micro-irregularities, which originate from the abrasion of protrusions located on the surfaces of the mating components. Displaced wear products stick to the surface, thus creating uneven areas filled with build-ups.

In the case of coated shafts, clear changes in volume are visible. It is noted that micro-holes in the coating are filled with powdered wear products displaced by micro-vibrations. Those products most likely originate from the shearing of the surface irregularities on the sleeve. This statement may be justified by the significant difference in the hardness of the mating surfaces. In Figure 4, the surface hardnesses of the shafts and sleeves analysed in this article are compared.

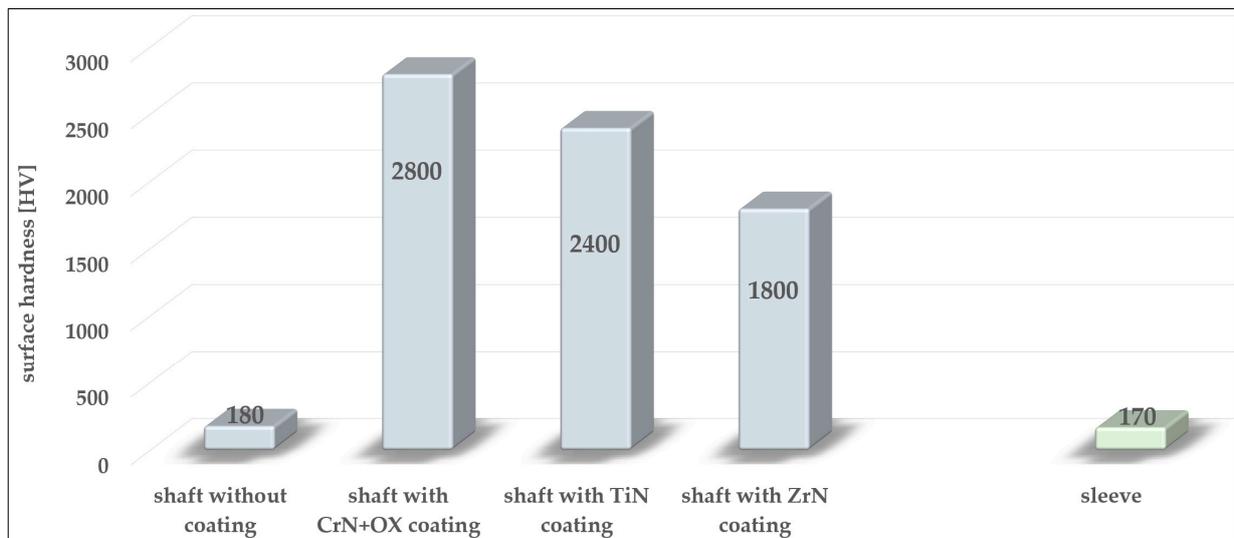
Figure 4. Shaft and sleeve surface hardnesses.

The shaft with a CrN+OX coating is distinguished by the biggest difference in surface hardness, that being 2800 HV. That value follows from the presence of oxides on the surface of the coating. A difference in hardness of at least ten times between the surfaces of the coated shafts and the surfaces of the sleeves will cause sleeve wear in the first place. Therefore, the build-ups on the shaft surfaces will mostly originate from the shearing of micro-irregularities on the sleeve surface.

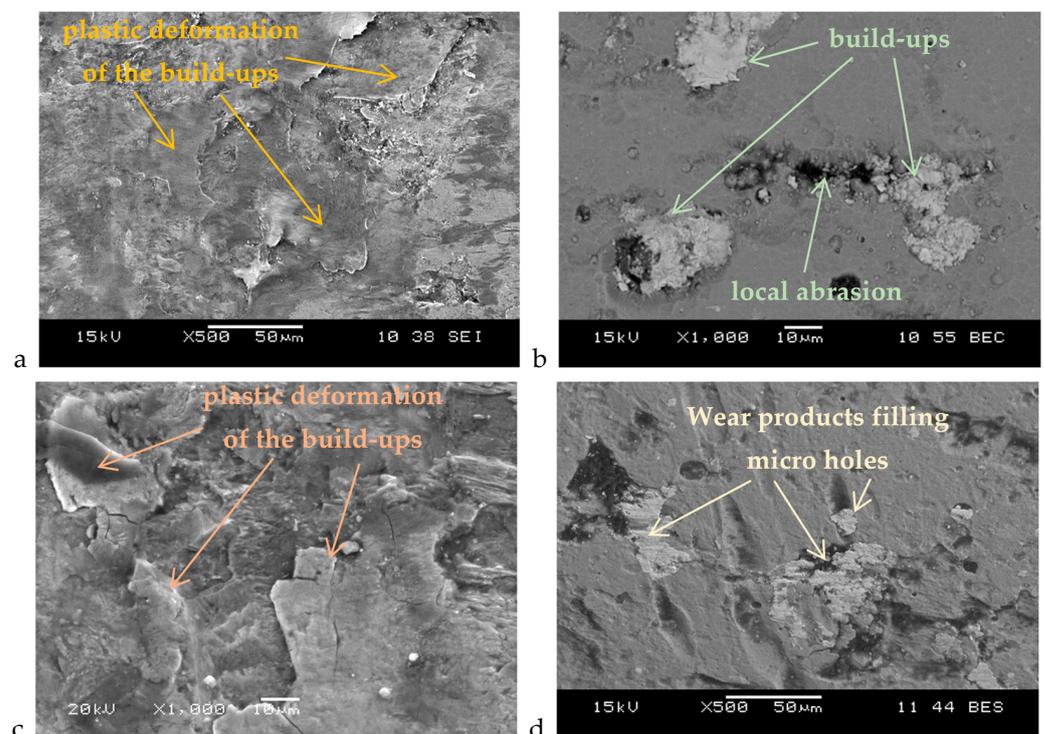
The wear-affected areas on the shaft surfaces were subjected to microscopic observations. The sample results of those observations are shown in Figure 5. The most frequently noted image shows material build-ups. They occur on all observed surfaces and occupy 80% of the worn-out area. The build-ups are of various sizes and colours. The colour of the build-ups depends on the degree of their oxidation. Those with a lower degree of oxidation have a lighter colour, and those more oxidised are darker.

Figure 5. The sample microscopic images of shaft surfaces, (a) the uncoated shaft, (b) the shaft with a CrN+OX coating, (c) the shaft with a TiN coating, and (d) the shaft with a ZrN coating.

During wear tests, the mating components are subjected to oscillatory tangential displacements which are conducive to the plastic deformation of the build-ups trapped between those components. Some of those build-ups tend to crack and move to other areas of the shaft surface.

In addition to the material build-ups mentioned previously, it is also noted that the micro-holes occurring at the coating surface are filled with wear products, which are mainly made up of the shorn micro-irregularities on the sleeve surface. The filling of micro-holes with wear products causes the surfaces of the shafts to become “smoother”, thus reducing roughness parameters. This is not an advantageous phenomenon because, in the case of a tribological kinematic pair subjected to loads following from rotational bending; a bigger contact area of the mating components means that adhesion may develop. Adhesive bonds will then be another factor conducive to further damage to the mating components.

The images of the worn-out surface, as mentioned and discussed above, concern all the shafts under analysis. In the case of uncoated shafts, more damage in the form of local abrasion and micro-pits is visible. Surface abrasion may be the result of micro-machining

processes, where oxidised wear products, distinguished by greater hardness than the sleeve or shaft surface, are the cutting element.

The above images were not observed in the case of coated shafts, as the hardnesses of their surfaces prevented the “weaker” wear products originating from shearing the micro-irregularities of the sleeve surface from grooving or scratching those surfaces.

The analysis of the chemical composition also confirmed that the wear products filling the micro-holes on coated shaft surfaces mainly originate from shearing the micro-irregularities on the sleeve surfaces. That phenomenon is particularly well visible on the surface of the shaft with a CrN+OX coating (Figure 5b, Table 3b) and of the shaft with a TiN coating (Figure 5c, Table 3c), where the wear products are made of oxygen and/or iron atoms.

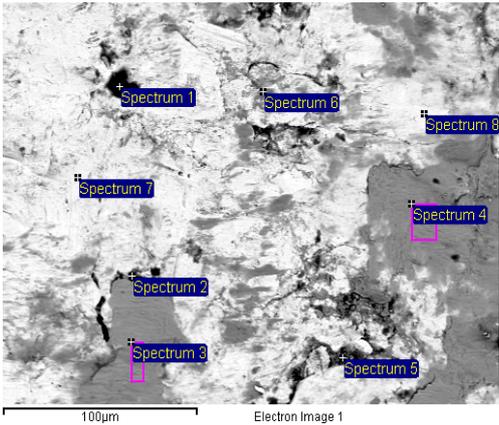
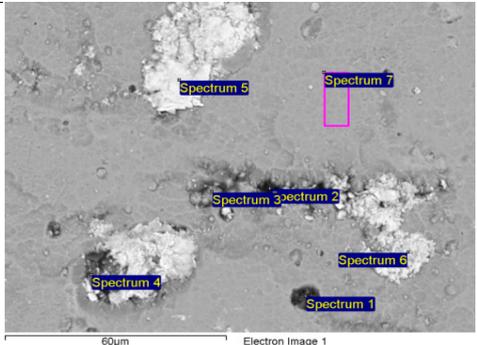
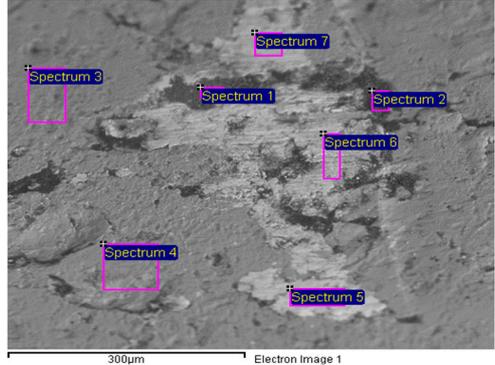
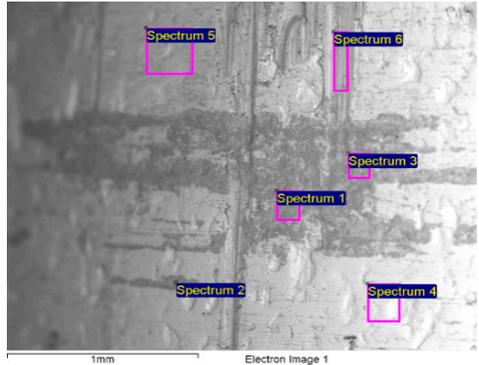
In order to quantify the chemical composition of the wear products found on the surfaces of the shafts, an EDS micro-analysis was performed. Table 3a–d summarises the percentage content of chemical elements present in the fretting-wear zone, including the wear products.

The results of the analysis of the chemical composition of wear products on the shaft surfaces confirm their oxidation. That statement is proven by oxygen atoms displayed on each sample that has been examined. Those atoms, together with iron, form very hard iron oxides, Fe_3O_2 . It is precisely those oxides, among others, that are responsible for damage to the top layer of the mating components, such as scratches and micro-cracks.

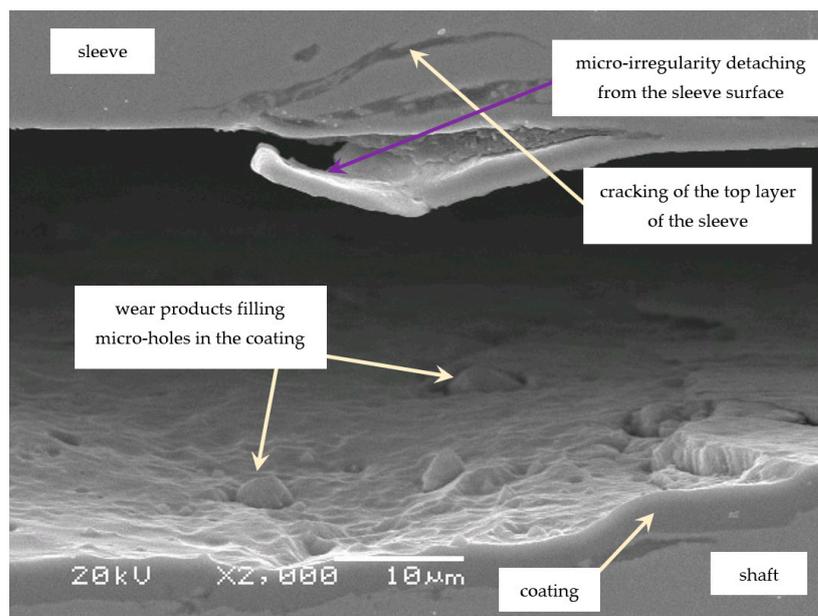
Figure 6 shows the connection between the sleeve and shaft depicting the tearing mechanism for micro-projections and their travel along the connection during wear tests.

Figure 6. The image shows the sleeve and shaft connection with visible wear products.

Micro-projections are shorn mainly during the assembly of the connection, i.e., when the sleeve is pressed onto the shaft, thus generating wear products. During the wear tests, oxidised products travel along the connection, causing the damage to both mating surfaces, with the sleeve surface being more exposed to wear, as its hardness is lower. Due to the activity of oscillatory tangential displacements of the elements of the tribological kinematic pair, the displacement and disintegration of the wear products take place. Some of them fill the micro-holes in the surface and, thus, make the surface smooth. A greater contact area between the mating components will be conducive to the formation of adhesive bonds affecting the life of the top layer of the components. Weakened due to adhesion and scratches, the surface will, over time, be liable to fatigue cracks, whose initiation starts at the surface of the component. In the next stage, the cracks develop and move deeper into the top layer at approximately 36° .
