Article

Corrosion Resistance of Pipeline Steel with Damaged Enamel Coating and Cathodic Protection

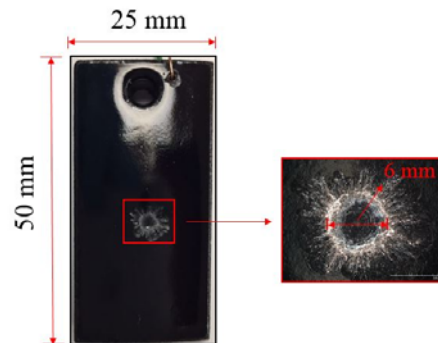
To study the effect that damage has on the corrosion resistance of enamel coating, one damage area, as shown in Figure 1, was created at the center of each enamel-coated sample using an impact test

apparatus according to the ASTM Standard G14 [12]. The apparatus consists of a 0.91 kg steel rod with a hemispherical head and a vertical section of hollow aluminum tubing to guide the rod. The weight rod was dropped from a height of 84 cm to damage the coatings. A close-up view of Figure 1 shows the detail around the damaged area.

Figure 1. Impact-induced coating damage.

The coating microstructure was characterized with scanning electron microscopy (SEM, Hitachi S4700, Tokyo, Japan). As shown in Figure 1, each damaged enamel-coated sample was cold mounted in epoxy resin (EpoxyMount, Allied High Tech Products, Inc., Rancho Dominguez, CA, USA). A 10 mm-thick cross section was cut from the damaged coating area of the sample and abraded with carbide papers with grits of 80, 180, 320, 600, 800, and 1200. After abrading, all samples were cleansed with deionized water and dried at room temperature prior to SEM imaging.

structures with isolated air bubbles. Gaseous CO, CO₂, and H₂ are generated during the firing process of enameling. When cooled down, these gases were trapped as a thick layer of enamel solidifies; this generated the isolated air bubbles [13,14]. Figure 4a,b represents the stitched images of five SEMs taken along a radial direction of the damaged coating, as shown in the detailed damaged zone in Figure 1. Due to chipped coating falling off after impact tests, the coating thickness decreased gradually from 244 to 4 µm for samples tested under the OCP, and from 190.48 to 4 µm for samples tested under −1.15 V/SCE. However, the substrate surface is still covered with a thin layer of enamel coating at the center of damaged area, as indicated in Figure 1.

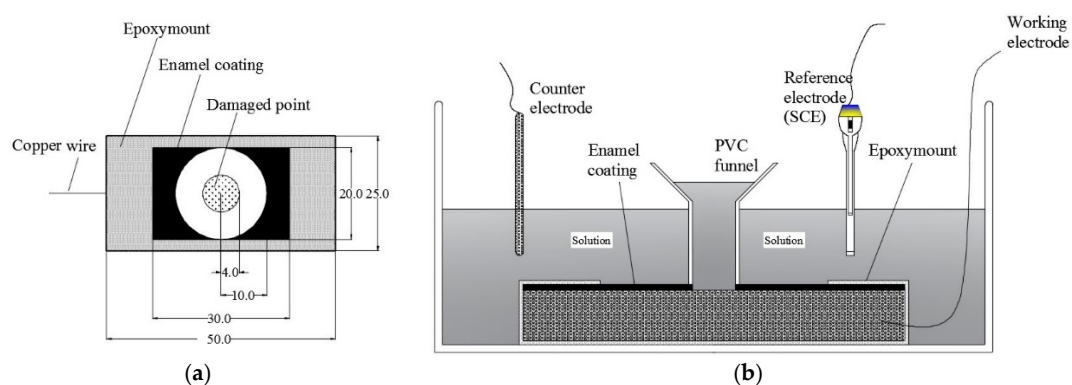
As shown in Figure 2a, except for the surface of the enamel coating, each coupon sample was embedded into the epoxymount to test corrosion performance. The epoxymount was over 2 mm thick to ensure that the surface of the enamel coating was the response site during the electrochemical tests. As shown in Figure 2b, a PVC funnel (1 cm in diameter) was attached onto the coating surface, covering the damaged area. The sample was placed in a large plastic container with the funnel faced up. The funnel and container were filled with 3.5 wt % NaCl solution to ensure that the funnel was completely submerged. The solution was prepared by adding purified sodium chloride (Fisher Scientific, Inc., Waltham, MA, USA) into distilled water. CP was introduced for the entire coated area.

Figure 2. Schematic representation of the double electrochemical cell (unit: mm): (a) planar view of the sample with damaged coating and attached funnel; (b) side view of the electrochemical cell immersed in the bulk solution.

During electrochemical tests, the 3.5 wt % NaCl solution around the damaged coating area was separated, by the funnel, from the solution around the remaining intact coating area. If it were otherwise, the electrochemical responses would have been concentrated on the damaged area since its impedance would be much lower than that of the other area. Thus, the measured responses would be representative to neither the damaged coating area nor the other intact coating area. For the same reason, the damaged and intact coating areas were tested up to 10 and 70 days, respectively.

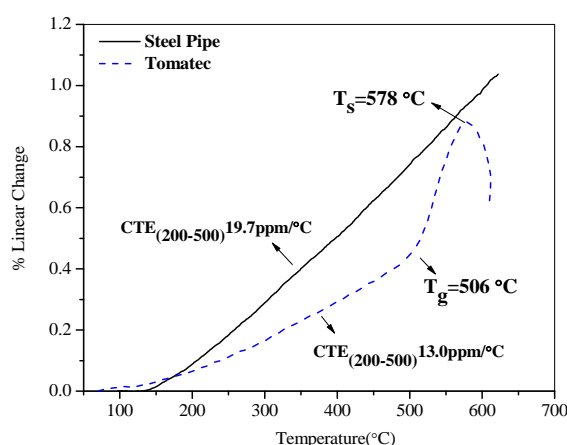
Figure 3 shows the thermal elongation of the enamel coating and pipe steel as a function of temperature. The steel has a measured CTE of $19.7 \text{ ppm}/^\circ\text{C}$, while the enamel coating T-001 has a measured CTE of $13.0 \text{ ppm}/^\circ\text{C}$. The CTE of the steel remained constant over a temperature range of 100 – 600°C , while the CTE of the enamel coating was only constant over a range of 200 – 500°C . The difference between the CTE of steel and enamel coating lead to an initial compressive stress on the coating during cooling; this can reduce cracking in enamel and is desirable in engineering applications. The glass transition temperature for enamel slurry T-001 is 506°C , which allows the enamel-coated pipeline to operate at temperatures up to 400°C , considering a safety factor of approximately 1.25.

Figure 3. Thermal properties of enamel coating and pipe steel.

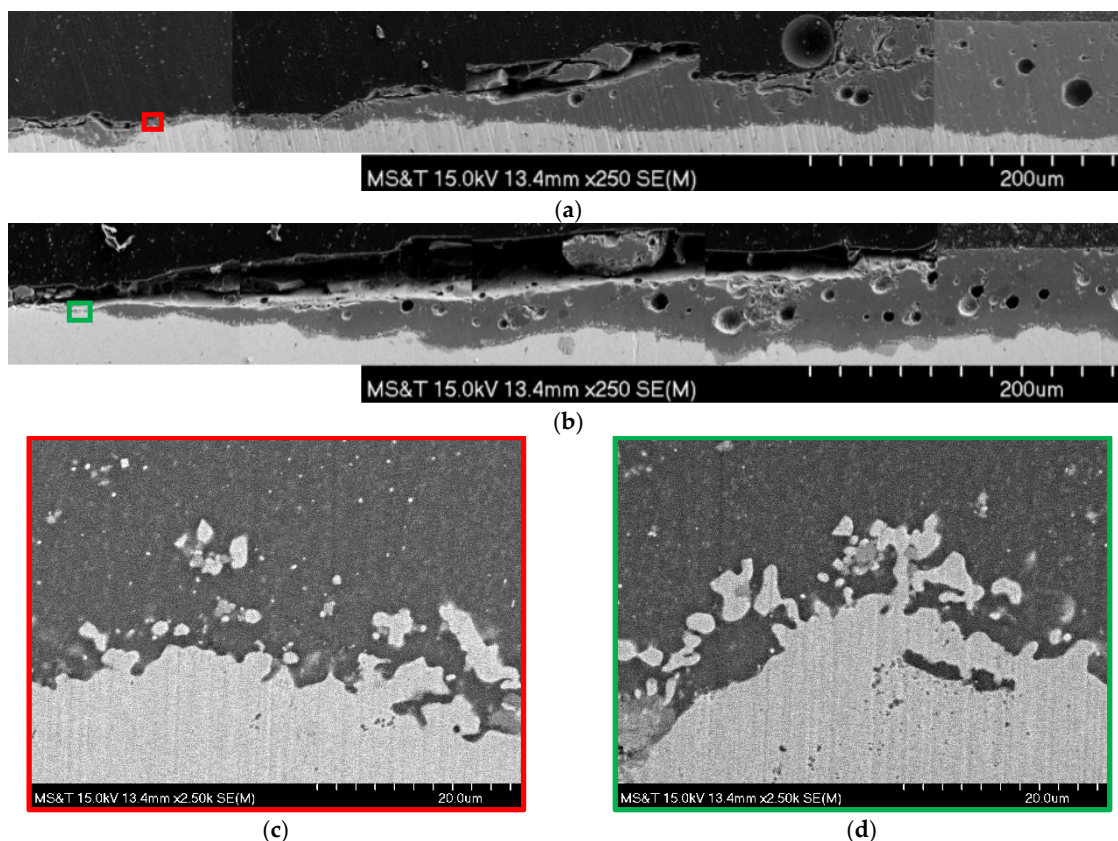
Cross-sectional SEM images of enamel-coated steel samples, tested under the OCP and CP (-1.15 V/SCE) conditions, are presented in Figure 4. In general, the enamel coatings have amorphous

Figure 4. Cross-sectional SEM images of enamel-coated samples under the OCP (a,c) and −1.15 V/SCE (b,d) with a magnification of 250× (a,b) and 2500× (c,d).

Figure 4c,d shows magnified details of the enamel–steel interfaces from Figure 4a,b. They show the extensive formation of an island-like structure in the enamel coating, during the firing process. In essence, a durable steel enamel interface transition zone was formed [15]. The island-like structure is iron-alloys, formed as a result of the chemical reactions of metal oxides in the enamel and the carbon and iron in the steel. No delamination was found after the corrosion tests; thus, the CP did not affect the mechanical condition of the interface between the enamel coating and steel substrate.

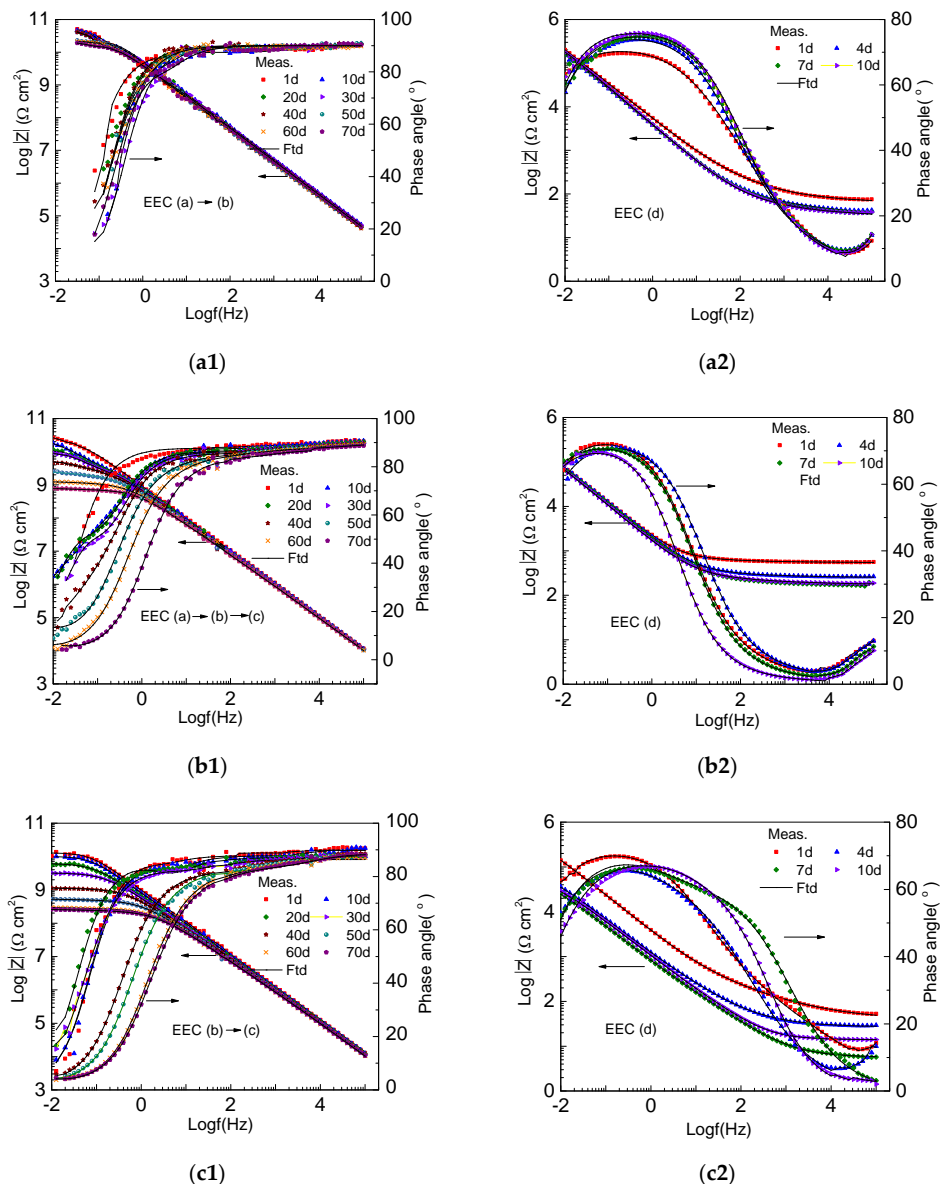
Figure 5 shows the EIS Bode diagrams of 3 representative samples tested under a cathodic potential of −1.15 V/SCE and −0.85 V/SCE, and an OCP, respectively in intact enamel coating (Figure 5(a1,b1,c1)) and damaged enamel coating (Figure 5(a2,b2,c2)). Both the measured (Meas.) data in various symbols and their fitted (Ftd.) curves are presented in Figure 4.

On a log–log scale, the impedance of the sample tested under −1.15 V/SCE in the first 40 days decreased linearly with the frequency; this relation was independent of the day of testing, as indicated in Figure 5(a1). Starting from the 50th day, the impedance experienced a gradual decrease at a low

frequency but remained over $10 \text{ G}\Omega \text{ cm}^2$ at a frequency of 0.02 Hz . The phase angles in the high and middle frequency ranges were close to 90° during the entire immersion time and increased with the frequency in the low frequency range.

Figure 5. Bode diagrams of enamel-coated samples immersed in 3.5 wt % NaCl solution up to 70 days at (1) intact coating zone, and up to 10 days at (2) damaged coating zone under a cathodic potential of (a) -1.15 V/SCE , (b) -0.85 V/SCE , and (c) the OCP. d: day.

For the sample tested under a cathodic potential of -0.85 V/SCE , as shown in Figure 5(b1), the impedance on a log-log scale decreased linearly in the first 10 days and then, over time, showed a gradually-expanding horizontal platform in the low to middle frequency range. The impedance at a frequency of 0.02 Hz decreased from $24 \text{ G}\Omega \text{ cm}^2$ at the beginning to $0.76 \text{ G}\Omega \text{ cm}^2$ at the end of the test. The phase angle increased with the frequency from the low to middle frequency range and remained 90° until 70 days of immersion time in the high frequency range. The phase–frequency curves in the low frequency range shifted towards the middle frequency range over the immersion time.

The impedance and phase angle of the sample tested under the OCP, as shown in Figure 5(c1), showed a similar trend to the sample tested under a cathodic potential of -0.85 V/SCE , particularly

towards the end of the corrosion test. However, the horizontal platform was further extended to the middle frequency range and the impedance at a frequency of 0.02 Hz was $0.26 \text{ G}\Omega \text{ cm}^2$ after 70 days of testing.

Figure 5(a2,b2,c2) shows the Bode diagrams of the samples tested in the damaged coating zone. Overall, the Bode diagrams of the samples tested under the CP and the OCP are similar, indicating comparable corrosion performances of all samples in the damaged zone. The impedance became stable after 4 days of immersion in the solution. Because of the damage made to the coating, the impedance at 0.02 Hz was approximately $0.1 \text{ M}\Omega \text{ cm}^2$, which is 10^6 times smaller than that of the samples tested in the intact coating zone. On a log-log scale, the impedance linearly decreased in the low frequency range and gradually approached an asymptotic value in the high frequency range. The maximum phase angle, lower than 80° , appeared in the low frequency range, indicating that corrosion had already taken place in the steel substrate.

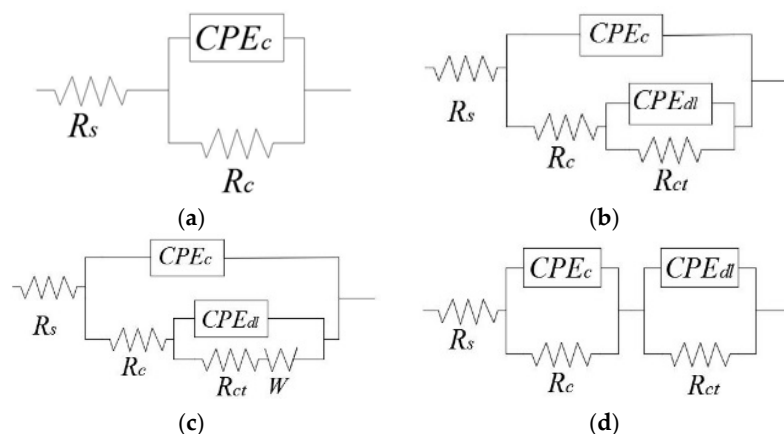
Figure 6 shows four equivalent electrical circuit (EEC) models used to fit the EIS test data taken from different samples under various test conditions. In this study, a constant phase element (CPE) was used instead of a pure capacitor due to non-homogeneity in coating thickness and roughness [16,17], or the electrochemical reactivity of the steel substrate [18]. A CPE is defined by two parameters, Y and n , and its impedance is represented by:

Figure 6. Equivalent electrical circuit (EEC) models for the samples tested (a) in the first 45 days under a cathodic potential of -1.15 V/SCE and in the first 10 days under a cathodic potential of -0.85 V/SCE on the intact coating zone; (b) from the 45th day to the end of test under a cathodic potential of -1.15 V/SCE and from the 15th day to the 45th day under a cathodic potential of -0.85 V/SCE on the intact coating zone; (c) from the 45th day to the end of test under a cathodic potential of -0.85 V/SCE on the intact zone; (d) on the damaged coating zone.

The EEC models used to fit into the EIS data from various tested samples are included in Figure 5. Model (a) [19,20] was used for the samples with intact coating tested under -1.15 V/SCE up to 40 days, taking into consideration the decrease in coating resistance and increase in coating capacitance as water begins to seep through the channels in enamel coating. Here, R_s represents the solution resistance, R_c and CPE_c represent the pore resistance and capacitance of the coating, respectively. After 40 days of immersion, when water and oxygen molecules arrived at the substrate surface and reacted with the steel substrate, the EIS data was fitted with Model (b) till the end of the corrosion tests [19–21]. Here, R_{ct} is the charge transfer resistance and CPE_{dl} is the double layer capacitance at the steel-electrolyte interface. However, only one capacitive loop was observed in the phase-frequency diagram. This is

likely because the time constant associated with the dielectric properties of enamel was difficult to distinguish from that of the electrochemical reaction at the steel-electrolyte interface [20,22].

For the intact enamel coating zone under -0.85 V/SCE, Model (a) was used in the first 10 days of immersion, Model (b) was applied from the 15th day to the 45th day, and Model (c) was used till the last day of the test. A Warburg impedance W in Model (c) was included to take into account the diffusion behavior, which was induced by the accumulation of corrosion products at the active corrosion sites. For the intact coating zone under the OCP, Model (b) was used for tests up to 40 days and Model (c) for the remaining tests.

For all the damaged coating zones, two time constants can clearly be observed in the phase-frequency diagram, and thus Model (d) was used to fit the test data [23]. While Model (b) was applicable for the intact coating zone when the solution had penetrated through the channel in the coating and was in contact with the steel substrate, Model (d) was more appropriate for the damaged-coating zone, since the coating layer became thinner and the solution could penetrate into the coating more easily. The electrochemical reactivity occurred uniformly on the damaged coating surface.

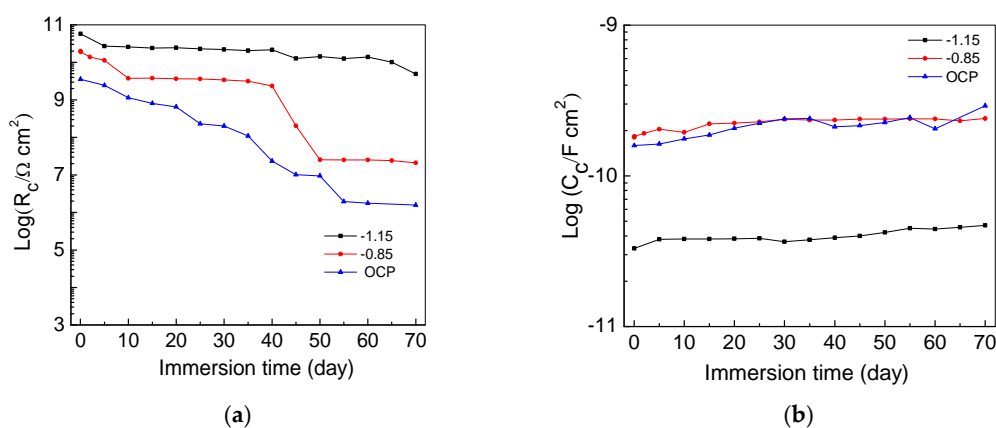
Figure 7 shows the change of pore resistance R_c and capacitance CPE_c of the intact coatings. In general, pore resistance measures the ease of electrolyte penetration into the coating, which is related to the number and distribution of open pores and pinholes in the enamel coating. The coating capacitance indicates the extent of electrolyte diffusion into the coating, which is associated with the thickness and dielectric properties of the coating [24]. The R_c value of the samples tested under -1.15 V/SCE decreased from 57.6 to 4.92 $G\Omega\text{ cm}^2$, while the R_c value of the samples tested under -0.85 V/SCE and the OCP decreased more rapidly from 20.9 to 1.57 $M\Omega\text{ cm}^2$ over 70 days. The coating capacitance of all the samples increased with immersion time, since the electrolyte solution gradually penetrated into the coating, thus increasing the coating capacitance. All the samples tested under the CP have larger coating resistances than the samples under the OCP. Thus, the CP improved the coating performance [2]. The sample tested under -1.15 V/SCE had a larger coating resistance and a smaller coating capacitance than the respective values of the sample under -0.85 V/SCE. This result indicates that a higher cathodic potential used in tests does not adversely affect the coating properties; it can decelerate the degradation process of the coating.

Figure 7. Properties of intact coating under various CP levels: (a) pore resistance R_c and (b) capacitance CPE_c .

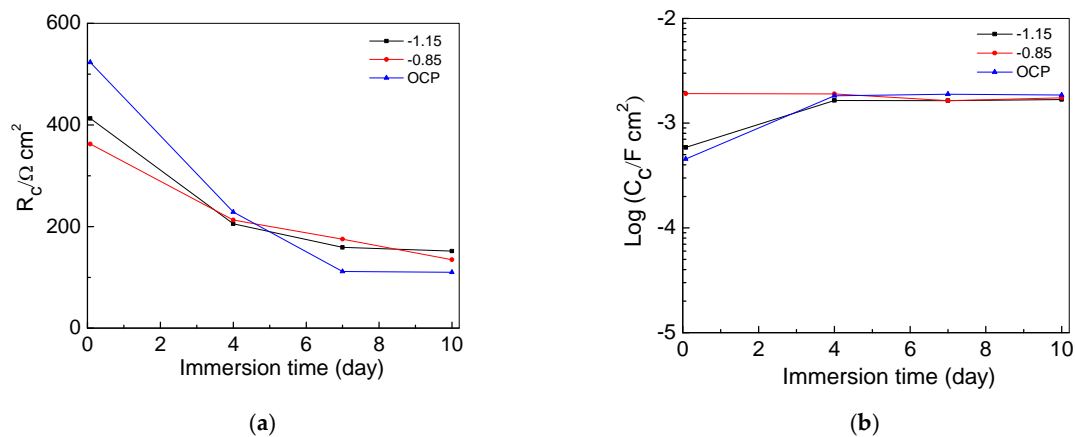
The R_c values of the damaged coating decreased rapidly over the immersion time as shown in Figure 8, which was measured in days (d). Specifically, the R_c value of the samples under the CP dropped from approximately 400 to 150 $\Omega\text{ cm}^2$, while the R_c value of the samples under the OCP reduced more dramatically from 500 $\Omega\text{ cm}^2$ in one day, to 110 $\Omega\text{ cm}^2$ in 10 days; indicating the failure of coating in protecting the steel substrate. The CPE_c values of all the tested samples reached nearly the same value of 2 $\text{mF}\cdot\text{cm}^2$ after 4 days of immersion. Therefore, after coating has been damaged, the CP has little effect on the coating performance.

Figure 8. Damaged coating properties: (a) pore resistance R_c and (b) capacitance CPE_c .

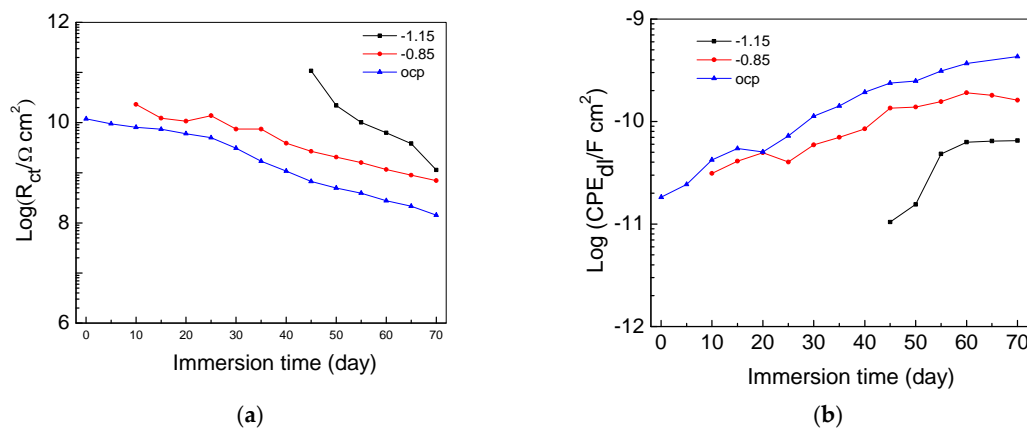
Figure 9 displays the properties of the steel-electrolyte interface under intact coating: charge transfer resistance R_{ct} and double layer capacitance CPE_{dl} . Charge transfer resistance is the resistance against electrons transferring across the steel surface, which is inversely proportional to the corrosion rate [24]. For the samples tested under -1.15 V/SCE , -0.85 V/SCE and the OCP, the charge transfer resistances were reduced to 1.13 , 0.7 , and $0.14 \text{ G}\Omega \text{ cm}^2$, respectively, at the end of testing, after 70 days. This comparison indicated increasing electrochemical reactions on the steel-electrolyte interface over time, as the level of CP decreased. The double layer capacitance CPE_{dl} is also a measure of the ease of charge transfer across a steel-electrolyte interface. The CPE_{dl} of the samples tested under -1.15 V/SCE , -0.85 V/SCE and the OCP were increased to 6.523×10^{-11} , 1.613×10^{-10} , and $4.314 \times 10^{-10} \text{ F cm}^{-2}$, respectively, at the end of testing, after 70 days. The sample tested under -1.15 V/SCE had the highest charge transfer resistance and the lowest double layer capacitance. Thus, the higher the cathodic potential, the more effectively the electrochemical reactions can be delayed at the steel-electrolyte interface [2].

Figure 9. Properties of the steel-electrolyte interface under intact enamel coating: (a) charge transfer resistance R_{ct} and (b) double layer capacitance CPE_{dl} .

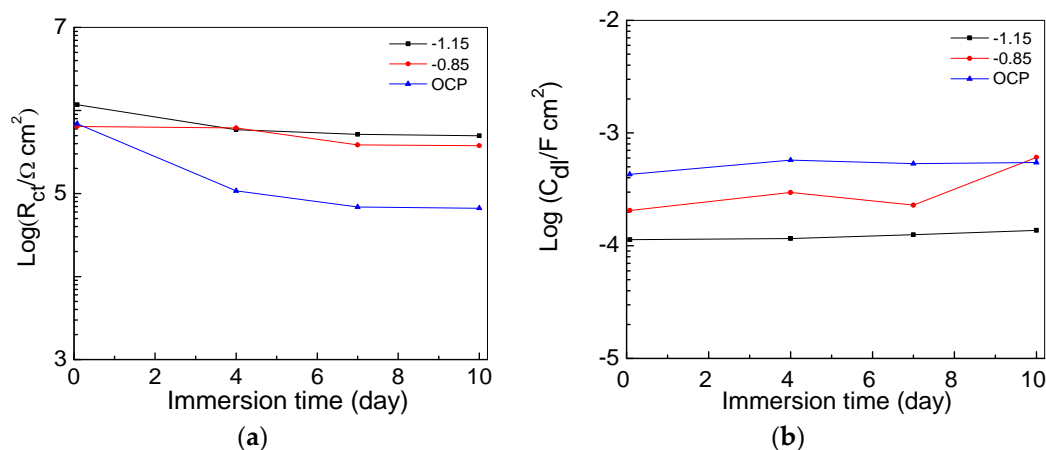
After the enamel coating was damaged, the charge transfer resistance of the samples tested under -1.15 V/SCE , -0.85 V/SCE and the OCP slightly decreased to 4.96×10^5 , 3.78×10^5 , and $6.67 \times 10^4 \Omega \text{ cm}^2$, respectively, after 10 days of immersion as shown in Figure 10. This is about 10^4 times smaller than that of the intact coating tested after 70 days of immersion. The double layer capacitances of the samples tested under -1.15 V/SCE , -0.85 V/SCE and the OCP also changed slightly, they were 1.37×10^{-4} , 6.08×10^{-4} , and $5.48 \times 10^{-4} \text{ F cm}^{-2}$ after 10 days of immersion, respectively. They were approximately 10^6 times larger than those of the samples with intact enamel coating tested after 70 days of immersion.

Figure 10. Properties of the steel-electrolyte interface under damaged enamel coating: (a) charge transfer resistance R_{ct} and (b) double layer capacitance CPE_{dl} .

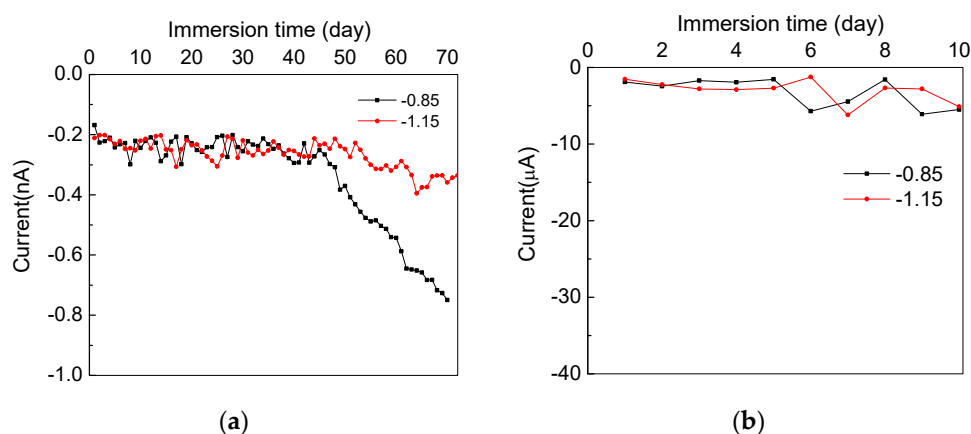
Figure 11a shows the variation of currents taken from the intact enamel coating zone under -0.85 vs. SCE/V and -1.15 vs. SCE/V. Each dot represents one measurement of data per day till the end of testing, after 70 days. For both samples the current fluctuated around -0.2 nA from the beginning to 45 days of immersion. Then, the sample tested under -1.15 V/SCE decreased slowly to approximately -0.3 nA at the end of testing, while the sample tested under -0.85 V/SCE decreased dramatically to approximately -0.8 nA at the end. Similarly, Figure 11b presents the variations of currents on the samples with damaged enamel coating. The currents of both samples eventually reached approximately -5 μA after 10 days of immersion, which are about 10^4 times larger than those of the respective test samples with the intact enamel coating. This is because more electrochemically reactive spots were generated. In all test cases, the measured current is always negative, implying that the CP current can flow through the coating along electrolyte pathways to reach the metal substrate and protect the steel from corrosion [25].

Figure 11. Variations of currents applied to various samples under -0.85 vs. SCE/V and -1.15 vs. SCE/V: (a) intact coating zone and (b) damaged coating zone.

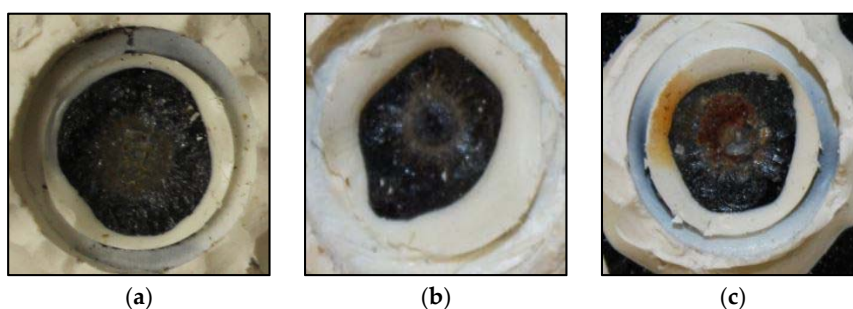
At the conclusion of the corrosion tests, the damaged spots of all tested samples were visually examined. No corrosion products were observed on the damaged surface under a cathodic potential of -1.15 V/SCE as shown in Figure 12. Brown corrosion products can be clearly seen on the damaged point of the sample tested under the OCP.

Figure 12. Damaged surface conditions of the samples tested under (a) -1.15 vs. SCE/V, (b) -0.85 vs. SCE/V and (c) the OCP after corrosion tests.
