Article

Preservation of Distemper Painting: Indoor Monitoring Tools for Risk Assessment and Decision Making in Kvernes Stave Church

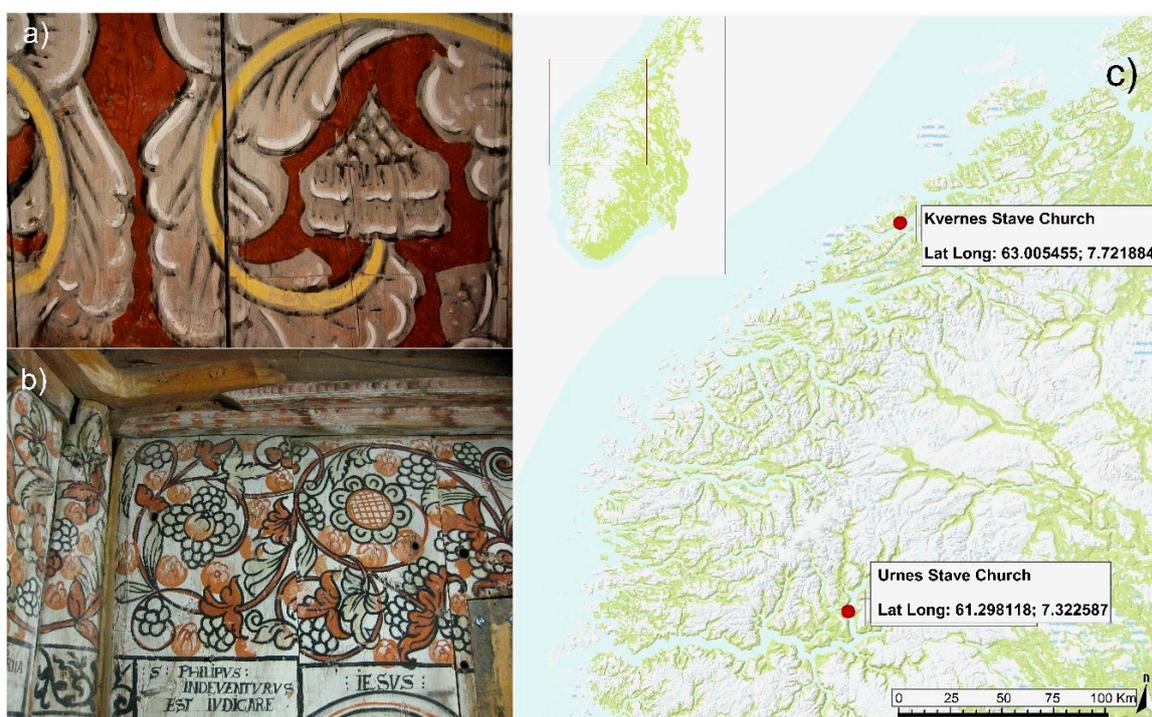
Figure 4. (a) Close up of the distemper decorative paint in the nave in Kvernes stave church (date: 9 April 2013) Photo © NIKU 2013; (b) detail from the decorative pattern of the Urnes stave church (date: 30 April 2011) Photo © NIKU 2011; (c) details of the locations of Kvernes and Urnes stave churches with values of latitude and longitude.

Artists' exact process for painting decorative wall paintings in stave churches is unknown, however, through observation, analysis, and literature review, key concepts of artists' technique are elucidated. The painters did not put much effort into having the woodworkers prepare a smooth wooden surface to paint upon, as tool marks are often seen through the paint layers. However, the surface may have been primed with glue before the base paint was applied. A sketch on the base layer of paint, and the use of a compass and etched lines were observed in several distemper paintings from the 1600s. In post-Reformation distemper decorative paintings, the distinct local colors of the elements are painted on the surface of the dry background color, which was usually white; then any shadowing or colors that add shape, and finally the contours were painted. Color details could be added after the contouring. The paintings in the nave and baptistery in Kvernes stave church follow this general painting method (Figure 4).

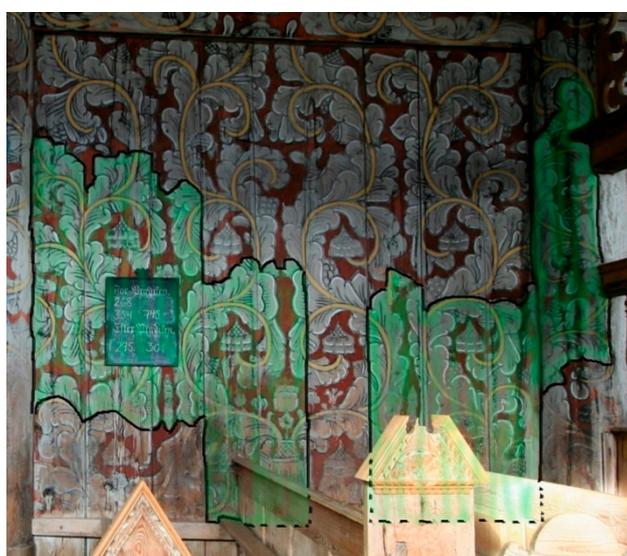
Figure 5. Example of mapping of conservation treatment in Kvernes stave church. The image shows the eastern part of the north wall in the nave of Kvernes stave church. Areas marked with green were consolidated with sturgeon glue (date: 5 April 2013). Photo © NIKU 2013.

An assessment of these treated paintings was made in 2013–2014. In several cases, the paint was found to lack proper adhesion to the underlying support; this was also found for those which were treated just a few years earlier. The examination was a follow-up of the assessment of consolidation methods for distemper decorative paints, as an answer to the constant need for greater knowledge on sturgeon glue as a consolidation material, and more specifically, for understanding which parameters are essential for successful results in consolidation treatments. In addition, the survey of conservative conditions of decorative distemper painted surfaces was also implemented in another recent project: “Environmental monitoring of the impact of climate change on protected buildings” started in 2017 and coordinated by NIKU [6]. An example of the mapping of conservation treatments obtained by the survey inside Kvernes stave church is depicted in Figure 5.

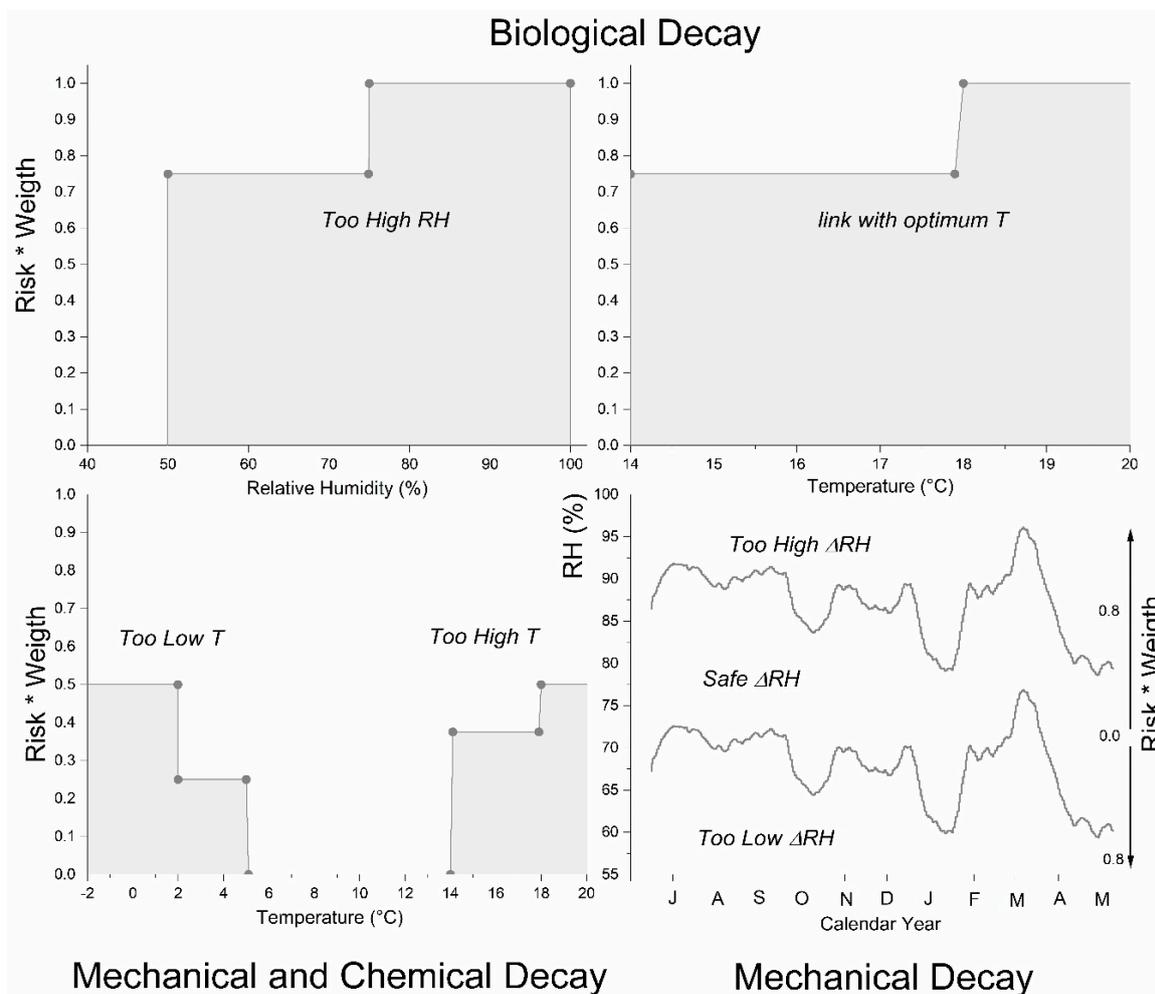
Figure 6. Conversion dose-response and/or threshold functions to prioritize the agent of decay and calculate the level of risk. (top-left) relative humidity (RH)-induced biological decay in the case of both RH-sensitive insects as woodworm and mold infestation with their link with temperature (T) conditions (top-right). Bottom-left: T-induced mechanical (too low T) and chemical risk of decay (too high T). Bottom-right: RH-induced mechanical decay caused by wider RH fluctuation than the historic climate as stated in the EN15757:2010 standard [26].

Figure 6 displays in the ordinate the weight per risk caused by risk agents (i.e., relative humidity (%) and temperature (°C)), which cannot be too low, too high, or with excessive fluctuations without increasing the risk of damage. In this study, Figure 6 represents the RAT to estimate three different categories of risk: biological decay (top plots), mechanical and chemical decay (bottom, left plot), and mechanical decay only (bottom, right plot). These risks are estimated following the approach introduced in a study by Anaf and co-workers [7] by comparing the data logger measurements recorded in Kvernes, with the corresponding risky target values/thresholds available in the literature [22,24,25]. Risk thresholds of unsafe RH fluctuations (bottom-right plot, external areas to the safe band) are obtained by the standard EN15757:2010 [26]. The SyMBoL project, with the implementation of two long-term monitoring campaigns in Heddal (latitude: 59.57° N; longitude: 9.17° E) and Ringebu stave churches (i.e., longer than two years), will soon provide data to better describe the “historic climate” of other stave churches under different protocols for heating use [26].

The RAT works as follows: in Figure 6, the climate-induced risk is quantified by converting the corresponding measured values of T and RH into a level of risk that is evaluated in a predefined scale of 0 to 1. That is to say that this model displays the correlation between X and Y, where $Y = f(X)$. When T or RH x-axis values (input) enter the plots in a white area over the abscissa, the level of (risk*weight) is zero (output, y-axis); while, when T and RH x-axis values enter the plots within a grey area over the abscissa, the level of (risk*weight) is different from zero. The (risk*weight) value, read over the y-axis, is obtained moving vertically from the input T or RH value over the abscissa up to the parallel grey horizontal line limited by two grey dots in Figure 6.

The abscissa of the grey dots are T and RH target/threshold values which define unsafe conditions within which the (risk*weight) is different from zero.

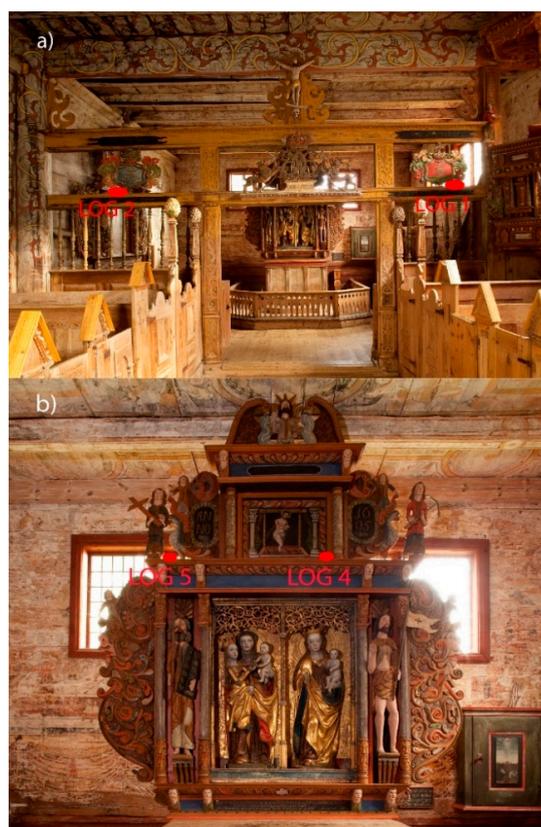
Figure 7. Images showing the location of the four data loggers in Kvernes stave church. (a) loggers 1 and 2; (b) loggers 4 and 5 (date: 3 March 2011) Photo: NIKU © 2011.

In Kvernes church, the T and RH values were recorded using four Tinytag data loggers (Gemini Data Loggers Ltd., Chichester, UK) deployed on the east side of the church (Figure 7). The positioning of these four loggers was slightly different; data loggers 1 and 2 were placed nominally 2 m above the floor, while data loggers 4 and 5 were placed about 3 m above the floor. Temperature and relative humidity data were recorded for a little over one year (20/06/2011–13/06/2012), after which, the data collected during this monitoring campaign were analyzed using the RAT.

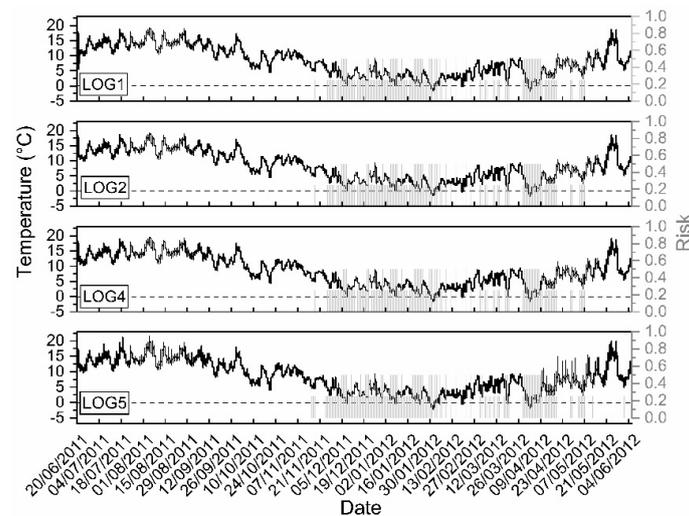
Figure 8. Indoor temperature data from the four data loggers collected between 20/6/2011 and 13/6/2012 every 2 h. Dotted lines indicate $T = 0$ °C. Grey vertical lines indicate the level of risk (right y-axis).

Temperature and relative humidity data collected during 20/6/2011–13/6/2012, from the interior of Kvernes church, are shown in Figures 8 and 9, respectively. The right y -axis reports the risk assessment results of T-induced risk (Figure 8) and RH-induced risk (Figure 9). For this study, the maximum risk value was pre-set to 1 for T-induced risk (right y -axis of Figure 8) and a value of 1.5 (over a scale of 2.0) for RH-induced risk as we counted both biological (max value = 1) and mechanical risk (max value = 1) (right y -axis of Figure 9). The grey lines in Figures 8 and 9 denote the level of risk, and Figure 8 clearly indicates that the riskiest period for temperature-driven decay is during the winter/spring period. Additionally, data acquired by Log5 indicate greater variations, especially in the spring/summer seasons in term of maxima registered temperatures, since this logger was exposed to direct sunlight. The positioning of Log5 was deliberate, in order to assess the effect of solar radiation on the sensors. Consequently, the relative humidity data recorded by Log5 showed the highest variations, and constantly registered lower values with respect to the three other devices. On the contrary, data collected from Log1 often indicated oversaturation of RH values (>100% RH) (Figure 9). The risk analysis carried out on the RH data (Figure 9) is more complex, as it displays intermitted climatic conditions during autumn, between mid-September and the beginning of December. However, most of this time period could be considered quite safe (risk = 0).

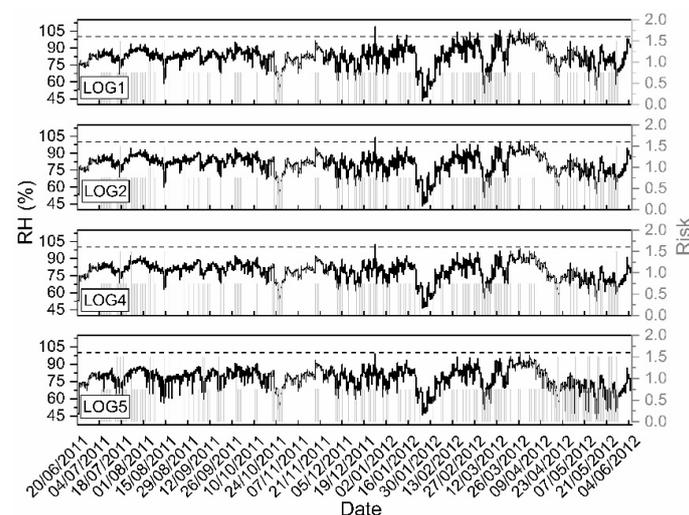
Figure 9. Indoor relative humidity (RH, %) data from the four data loggers collected between 20/6/2011 and 13/6/2012 every 2 h. Dotted lines indicate $RH = 100\%$. Grey vertical lines indicate the level of risk (right y-axis).

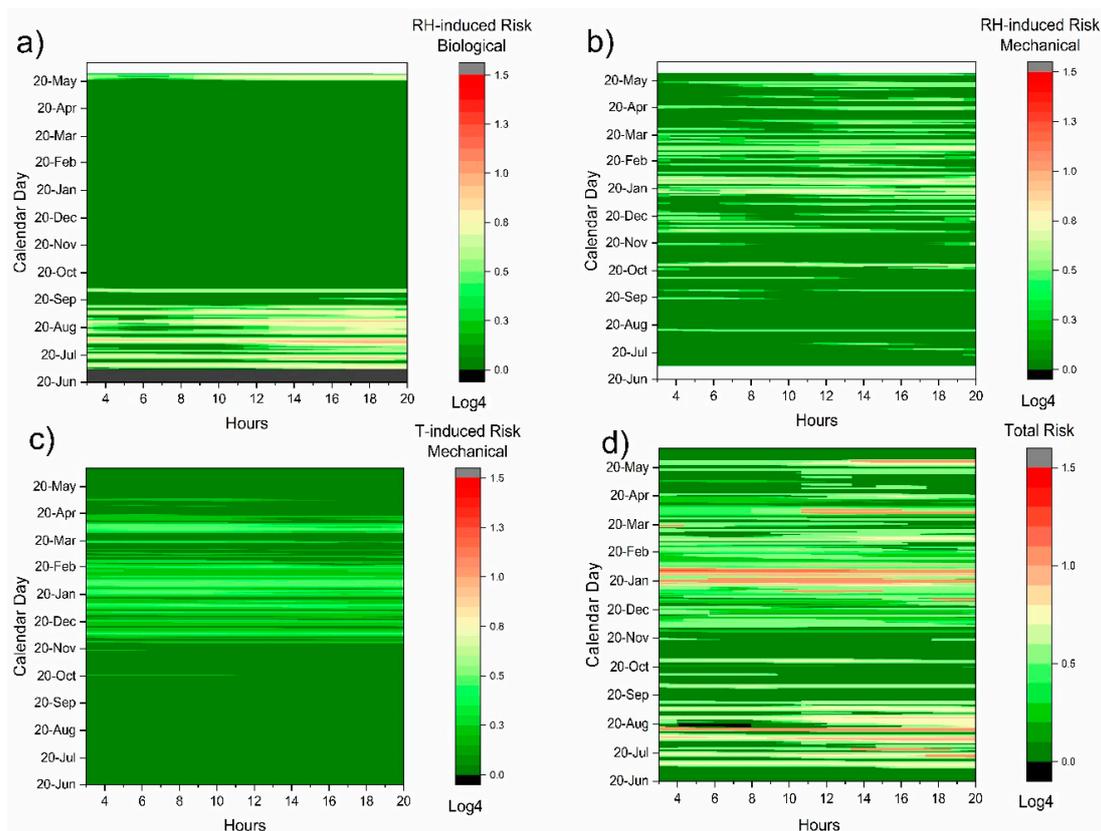
Figure 10. (a) RH-induced risk of biological decay on wood (i.e., woodworm and fungi infestation). (b) RH-induced risk of mechanical decay caused by wider RH fluctuation than the historic climate as stated in the EN15757:2010 standard; (c) T-induced risk of mechanical decay on wood (i.e., freezing–thawing cycles; (d) total risk (i.e., sum of the previous three types of calculated risk to show the synergistic effect. Colors associated to the maps are related to the index value reported on the scale: green from 0 to 0.5 indicates low risk conditions; yellow to orange, from 0.5 to 0.75 indicates moderate risk; red, approaching 1.5 indicates high risk.

When examining data collected from Log1, Log2, and Log4, we decided to use the data from Log4 as the representative of this group, as the data collected from these three loggers are directly comparable (Figures 8 and 9); consequently, as Log5 was constantly hit by sun radiation, it was considered separately. Data from Log4 and Log5 were elaborated using a RAT (Figures 10 and 11). Figure 10 highlights the combined effect (Figure 10d) of the indoor environmental conditions and the

risk threshold of the three most important agents of deterioration for distempered paint: biological decay (Figure 10a), mechanical decay due to the RH fluctuation (Figure 10b), and mechanical decay induced by low T values (Figure 10c). One might argue that the impact of RH fluctuations outside the frame of the historic climate should be placed as the primary deterioration agent. However, in cases like Kvernes, it is difficult to decide which agent of deterioration is the most important. During the monitored calendar year, starting in June of 2011, risk of biological decay was recorded in the summer months, with a maximum at the end of July (Figure 10a). Risk of mechanical decay caused by a RH variation, larger than that established by the historic climate, was recorded from January to March (Figure 10b). In addition, risk of mechanical decay caused by too low T ($<2\text{ }^{\circ}\text{C}$), was slightly higher from December to February (Figure 10c). Overall, the synergistic risk recorded in Kvernes highlights three periods of risk (Figure 10d). The first risk period occurs during July and August showing the optimum condition for biological decay due to high T and RH values; whereas, the second risk period starts at the beginning of January and for almost a whole month shows the optimum conditions for mechanical decay on the distemper paint due to a combination of large RH fluctuations and very low temperature (i.e., lower than $2\text{ }^{\circ}\text{C}$). The third and final risk period occurs in May, and this period highlights a risk of mechanical decay caused by RH fluctuations only. At the opposite, the period with natural environmental conditions most appropriate for the conservation of the distempered paint happens in the autumn, from September to November, and spring in mid-April. Other aspects, like the actual T of the wall surface, needs to be considered before deciding upon a conservation campaign in November.

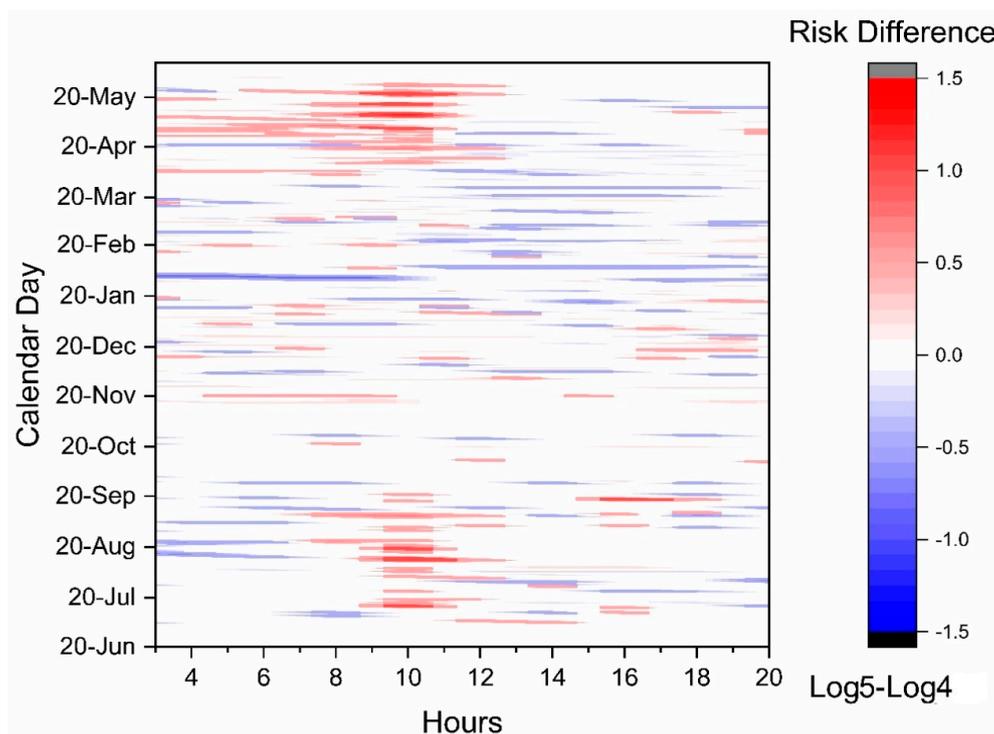
Figure 11. Risk difference caused by radiation disturbance as detected by the difference between Log5 and Log4. Red color, environmental conditions which trigger higher total risk; blue color, environmental conditions which trigger lower total risk.

The elaboration shown in Figure 11 was obtained by comparing the evaluated risks for Log5 and Log4, as discussed above. In this figure, the red areas denote an increase in risk, whereas the blue areas signify a decrease in risk. When examining only the red areas, it is possible to observe how the most sensitive periods occur during the summer months (mid-June to the beginning of September) and spring months (mid-March to mid-May). Additionally, Figure 11 also displays how the risky daily interval partially overlaps for both periods. During the summer the daily risk intervals are concentrated between 9:00 and 11:00 a.m., while in spring longer intervals are observed (from 2:00 to 11:00 a.m.). For just a short number of spring days (ca. 15) the whole morning period is considered risky. This risk assessment once stopped dangerous wavelength radiation, as UV and IR also provide interesting information on the beneficial effect of a daylight increase in temperature (risk decrease in blue areas).

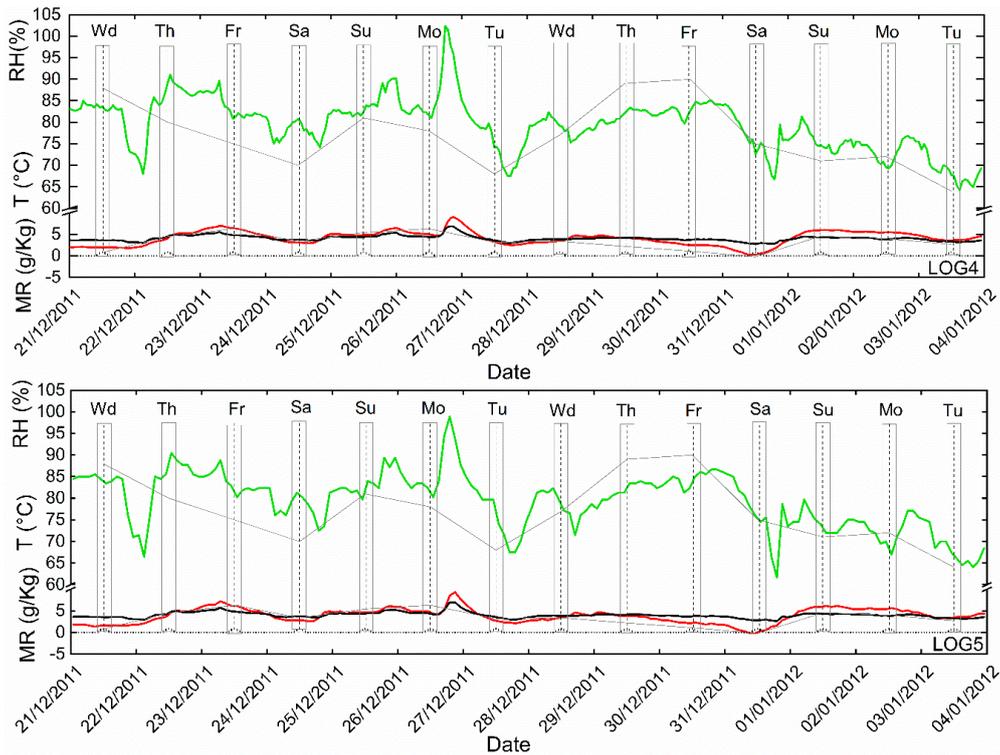
Figure 12. Indoor RH (%)—green line, T (°C)—red line, mixing ration (MR) (g/Kg)—black line values for Christmas week representative of microclimate conditions and churchgoers’ presence in winter as measured by Log4 (top plot) and Log5 (bottom plot). The grey line refers to outdoor RH values collected by the Kristiansund lufthavn weather station. Daylight duration is highlighted by rectangular areas.

Finally, in order to develop a broader understanding of the internal microclimate of Kvernes, a detailed analysis was performed for Log4 and Log5 on the weeks of Christmas and Easter when the Church hosts churchgoers. Elaborations proposed in Figures 12 and 13 show windows segmenting the daily light durations as indicated by data available at eKlima website of the Norwegian Meteorological Institute [31], superimposed to T, RH, and mixing ration (MR) trends (i.e., the trend of water vapor (gr) mixed into 1 kg of dry air which is a useful microclimate parameter used in historic structures to study the effects of infiltration).

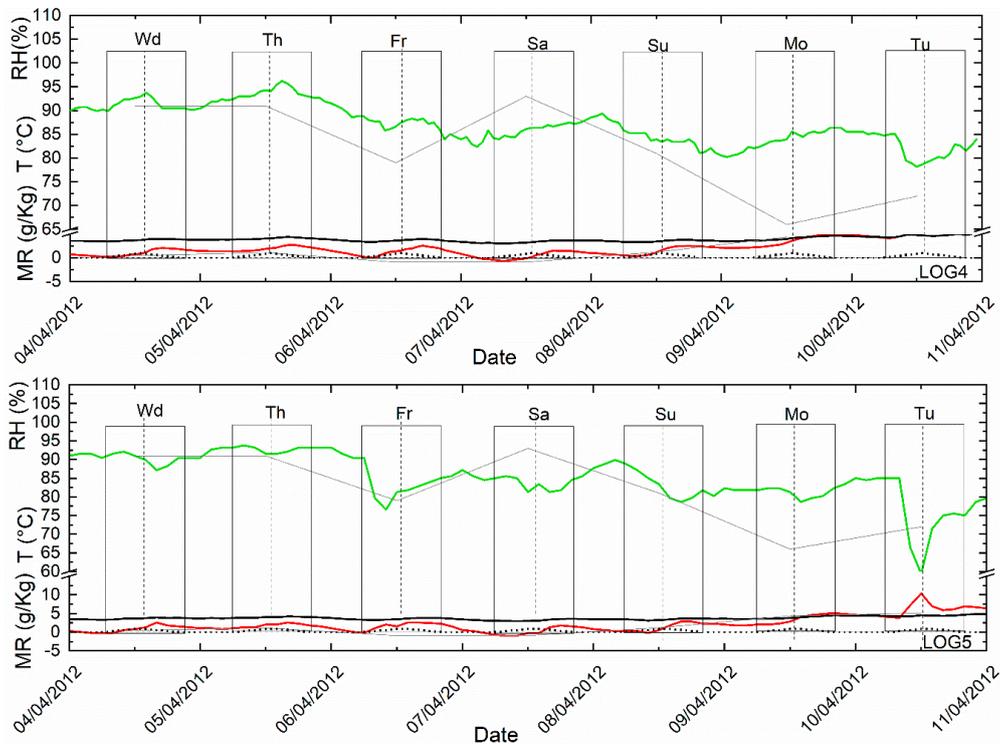
Figure 13. Indoor RH (%)—green line, T (°C)—red line, MR (g/Kg)—black line values for Easter week representative of microclimate conditions and churchgoers’ presence in spring as measured by Log4 (top plot) and Log5 (bottom plot). The grey line refers to outdoor RH values collected by the Kristiansund lufthavn weather station. Daylight duration is highlighted by rectangular areas.
