Fracture Resistance of Repaired 5Y-PSZ Zirconia Crowns after Endodontic Access

Abstract: This study analyzed the fracture load before and after a chewing simulation of zirconia crowns that were trepanned and repaired using composite resin. Overall, 3 groups with 15 5Y-PSZ crowns in each group were tested. For group A, the fracture load of the unmodified crowns was evaluated. For group B, the crowns were trepanned and repaired using composite resin, also followed by a fracture test. For group C, crowns were prepared like in group B but received thermomechanical cycling before the final fracture tests. Furthermore, scanning electron microscopy (SEM) and X-ray microscopy (XRM) analysis were performed for group C. The mean fracture loads and standard deviation were 2260 N ± 410 N (group A), 1720 N ± 380 N (group B), and 1540 N ± 280 N (group C). Tukey-Kramer multiple comparisons showed a significant difference between groups A and B ($p < 0.01$) and groups A and C ($p < 0.01$). After ageing, surface fissures were detected via SEM, but no cracks that reached from the occlusal to the inner side of the crown were detected via XRM. Within the limitations of this study, it can be stated th

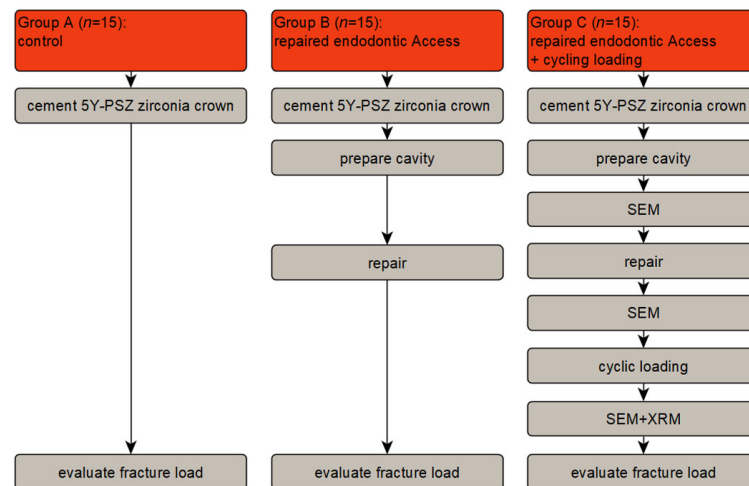
Figure 1. Schematic overview of the study design: Scanning Electron Microscopy (SEM) imaging was done for 5 specimens, whereas characteristic results are shown exemplarily; X-Ray Microscopy (XRM) analysis was performed for one specimen. 5Y-PSZ: Partially Stabilized Zirconia with 5 mol% Yttria.

SEM imaging was performed for 5 specimens of group C after the cavity was prepared, after it was repaired and after the chewing simulation (Figure 1). For clarity, the result section shows only a characteristic selection of those images. Before imaging, the specimens were vacuum dried at room temperature. Imaging was done with a Zeiss EVO MA 10 (Carl Zeiss, Oberkochen, Germany) without sputtering at pressures of roughly 5×10^{-4} Pa using a Secondary Electron Detector operating at variable pressure (VPSE).

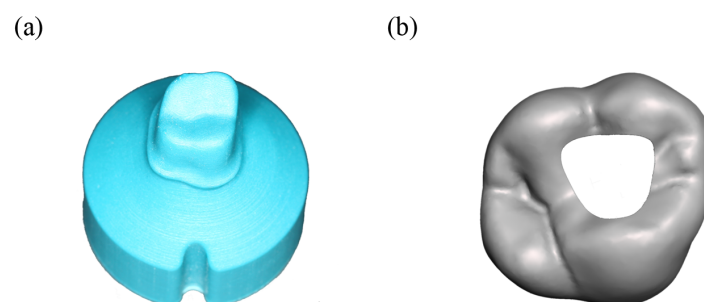
Figure 2. (a) abutment tooth used for crown support. (b) 3d-model of tooth 16 in occlusal view, with a cavity for endodontic access.

Based on the digital model described before a negative form was created via CAD and 3D-printed with a Form 2 printer (Formlabs, Berlin, Germany) and Dental SG (Formlabs, Berlin, Germany). Finally, this negative form was used to create polyurethane model abutment teeth, using AlphaDie MF (Schütz-Dental, Rosbach vor der Höhe, Germany). The finished abutment teeth (see Figure 2a) were blasted with Al₂O₃ particles (50 µm) at 1 bar.

In order to simulate a cavity suitable for endodontic access, a cavity was created in the crowns STL file mentioned earlier (see Figure 2b). This file was then used to create a drilling template. Using this template, an experimental setup using a milling unit (Ceramill, Amann Girrbach, Pforzheim, Germany) and a laboratory turbine (Presto Aqua, Amann Girrbach, Pforzheim, Germany) was constructed. This setup allowed for a cavity with a reproducible geometry. The crown was trepaned under water-cooling using a dental bur ZR6881.314.016 (Komet Dental, Lemgo, Germany) with manual pressure. After penetrating the crown, the grinding depth of the bur into the polyurethane was <0.5 mm.

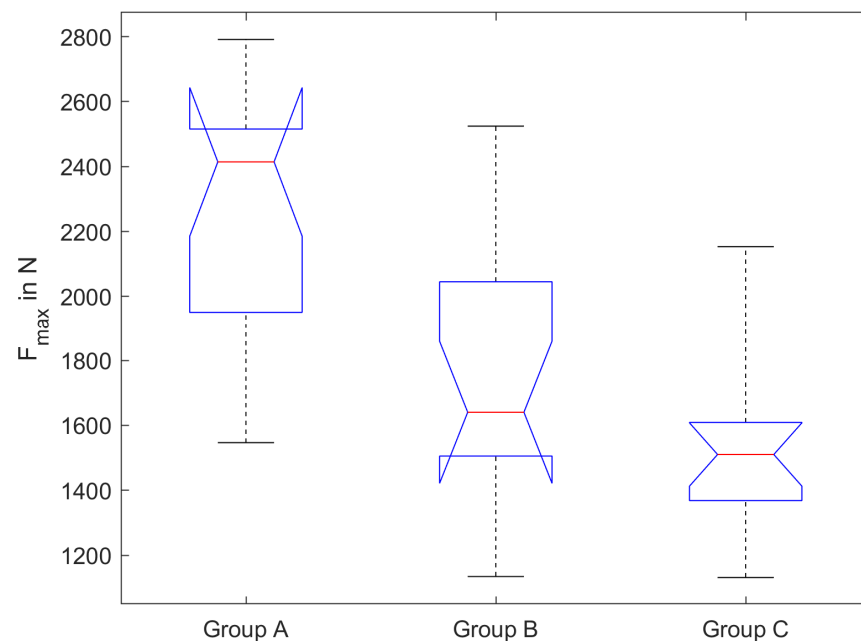
Figure 3. Fracture load for crowns from group A (control), group B (trepanned and repaired without ageing) and group C (trepanned and repaired with ageing), shown in a notched boxplot; the red lines mark the median and the notches mark the 95% confidence interval; $n = 15$ for each group.

The results of the fracture test are shown in Figure 3. The mean fracture loads and standard deviation are 2260 N \pm 410 N (group A), 1720 N \pm 380 N (group B) and 1540 N \pm 280 N (group C). A Kolmogorov-Smirnov test failed to reject the hypothesis that the results for groups A, B and C were drawn from a population with normal distribution. To put it simply, normal distribution of the underlying population is likely according to the performed test. A one-way anova showed a significant difference in the fracture load between the three groups ($p < 0.05$). Tukey-Kramer multiple comparisons show a significant difference between groups A and B ($p < 0.01$) and groups A and C ($p < 0.01$). Between groups B and C, no significant difference can be found ($p = 0.37$).

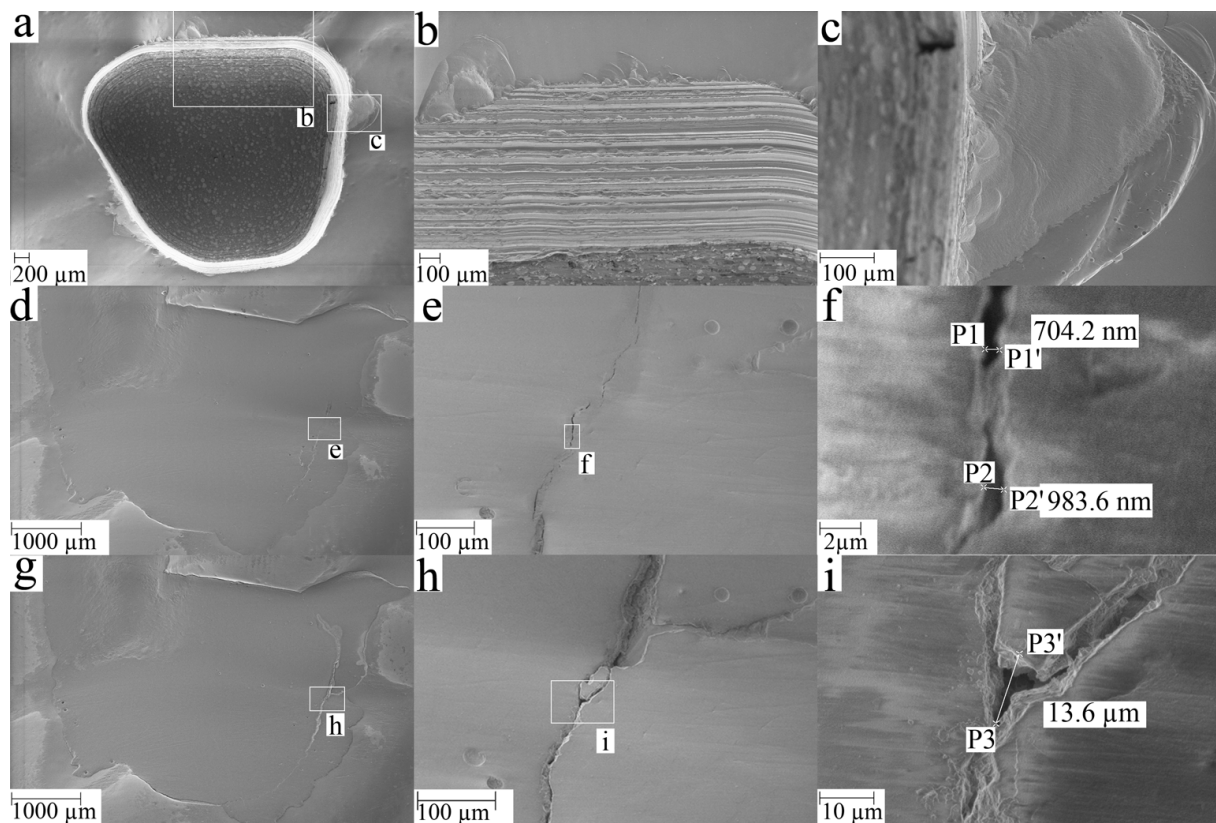
Figure 4. Exemplary SEM-image of a trepanned crown at various stages in the process (all images for the same specimen from group C: (a) overview of the trepanned crown without repair, (b) enlarged section on the oral side showing grinding grooves and chipping at the occlusal surface, (c) enlarged defect on occlusal surface, (d) overview of the repaired area (before CS), (e) enlarged section of the repaired area (before CS), (f) further enlarged section of the repaired area (before CS), (g) overview of the repaired area (after CS), (h) enlarged section of the repaired area (after CS), (i) further enlarged section of the repaired area (after CS). The points P1, P1' (same applies for P2, P2', P3, P3') are start and end point of the measured distance.

SEM images of one crown from group C are shown in Figure 4. After crown trepanation, some chipping can be observed on the occlusal surface next to the cavity (Figure 4a–c). The repairing composite overlaps the trepanned area and covers the chipped areas (Figure 4d). Before the chewing simulation, ditches are visible in Figure 4d–f, which in the case of f) had a width of $\approx 1 \mu\text{m}$. After the chewing simulation, some of the material at the margin of the trepanned area disappear and widening of the ditches can be observed ($>10 \mu\text{m}$ in some areas) (Figure 4g–i). These observations are typical and similar observations were made for other specimens.

The depth of the ditches could not be determined as the SEM only captures the near-surface region. In order to evaluate whether cracks propagated from the occlusal to the internal side of the crown an XRM scan was performed. Due to the specimen's chemical composition and dimensions, the transmission was only about 5%, which resulted in a rather low resolution (voxel edge length of $7.65 \mu\text{m}$). Figure 5a) exemplarily shows pores observable at the crown cement interface and pores at the interface of the repairing composite and the crown. However, these pores do not cover the full distance from the internal surface to the occlusal surface (Figure 5b). This observation is limited by the voxel size stated above.

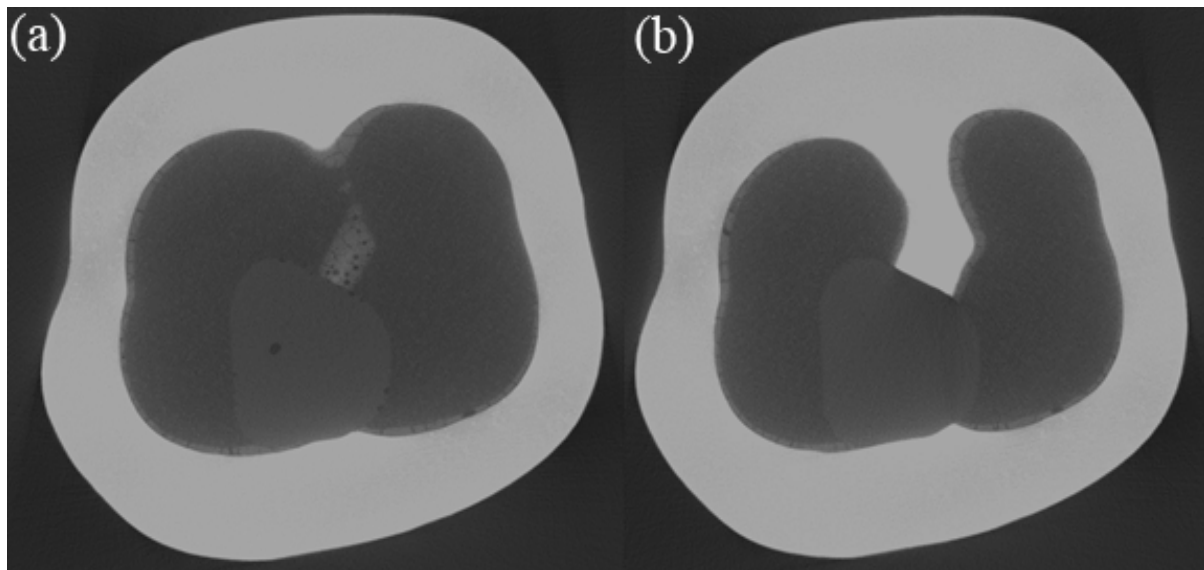
Figure 5. XRM-scans of a repaired crown (specimen C1): (a) slice taken close to the cement-crown interface, where pores in the cement, as well as pores in the repairing composite, are visible; (b) slice which is about 0.19 mm closer to the occlusal plane than (a); nearly no pores are visible at the crown-composite interface.

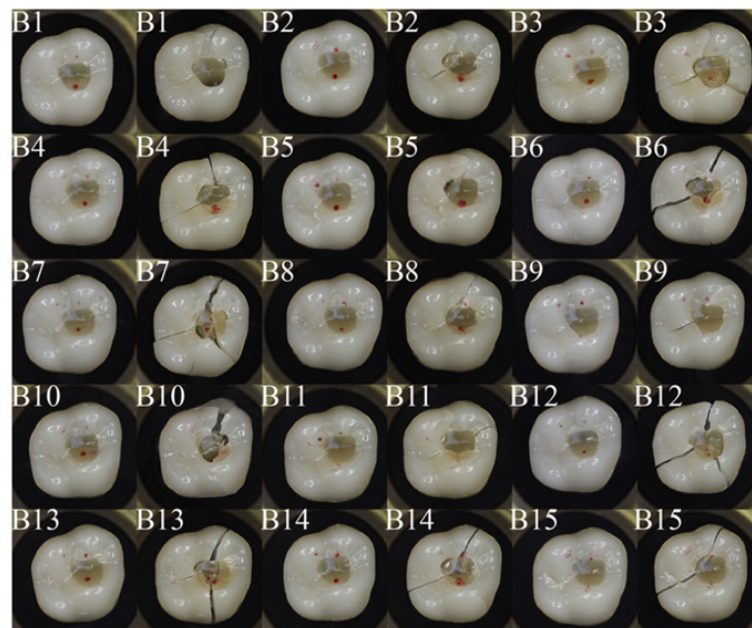
Figure 6. Crowns from group B, before and after the fracture test; the red features indicate the areas where contact with the steel ball occurred; post-fracture the remaining pieces were reconstructed.

Figures 6 and 7 show occlusal views of all crowns tested in group B and group C, with the contact areas between the crown and antagonist sphere marked in red. Variations in the contact situation can be observed. They originate from slight height differences in the manually repaired segments. In group B, 12 specimens had two contacts on the zirconia part of the crown and one contact on the repaired area. Three specimens had two contacts on the zirconia part of the crown and one contact close to the margin of the repaired area. In group C, 10 specimens had two contacts on the zirconia part of the crown and one contact on the repaired area. Five specimens had two contacts on the zirconia part of the crown and one contact close to the margin of the repaired area. If one contact was on the repaired area, the crowns often show a crack through this contact area, whereas the main cracks are oriented from the repair site in distal direction, in mesio-buccal direction, and in mesio-palatal direction. If no contact was on the repaired area, the crack path can be observed from disto-palatal to mesio-buccal. This behavior is similar for groups B and C.

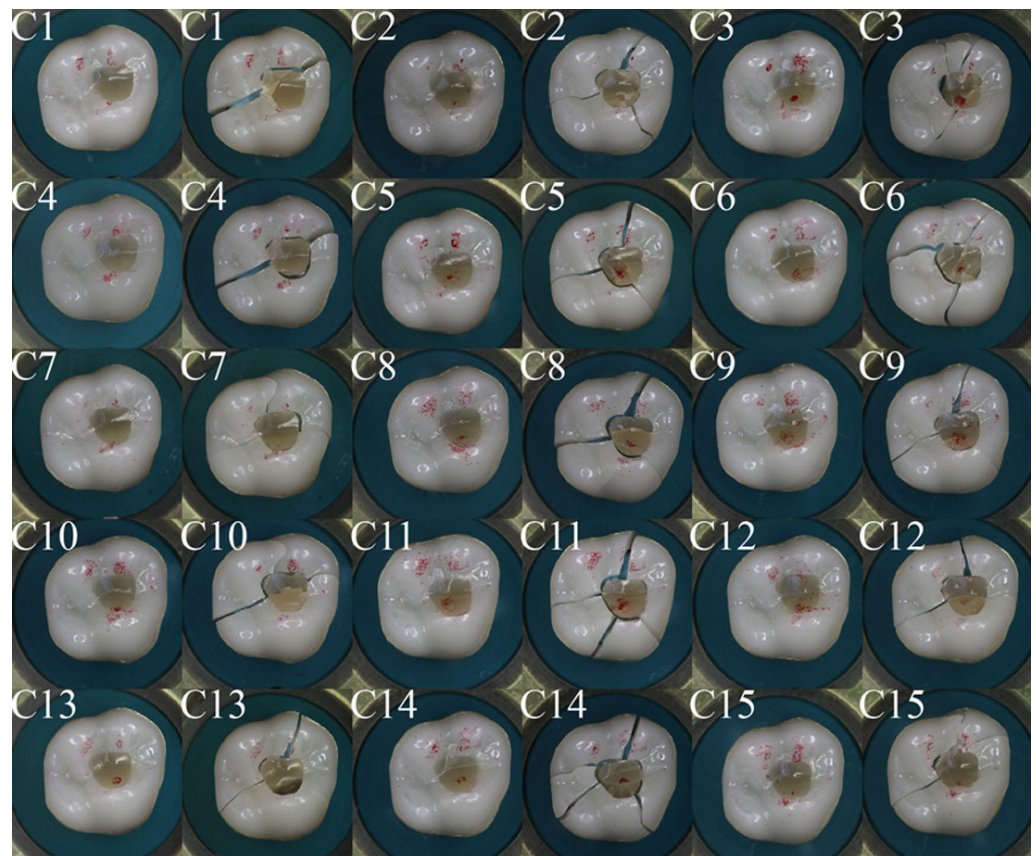
Figure 7. Crowns from group C, before and after the fracture test; the red features indicate the areas where contact with the steel ball occurred; post-fracture the remaining pieces were reconstructed.
