Impacts on Crash Cushions—Analysis of the Safety Performance of Passenger Cars with Improved Safety Equipment Compared with Test Vehicles Based on Assessment Criteria as Defined in EN 1317

Ernst Tomasch * and Gregor Gstrein

Vehicle Safety Institute, Graz University of Technology, Inffeldgasse 13/VI, 8010 Graz, Austria; gregor.gstrein@tugraz.at

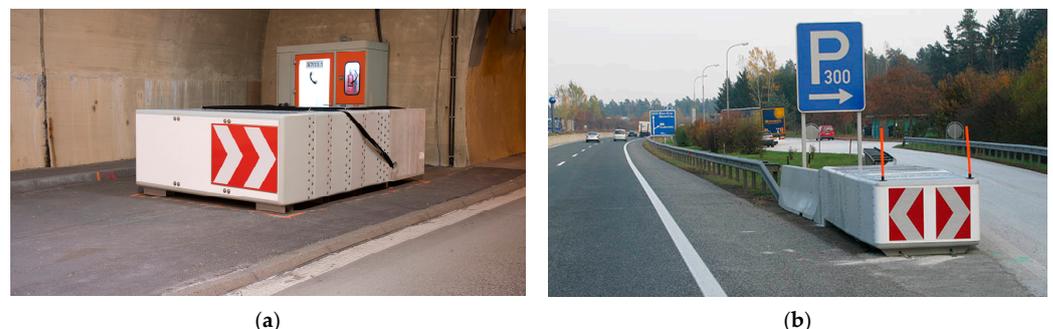
Figure 1. A crash cushion positioned in front of the end-wall of a lay-by (a) and a gore point (b) [1].

On high priority roads such as motorways, crash cushions are typically used to prevent errant vehicles from impacting hazardous obstacles on the side of the road (e.g., tunnel lay-bys, tunnel portals, and gore points; Figure 1).

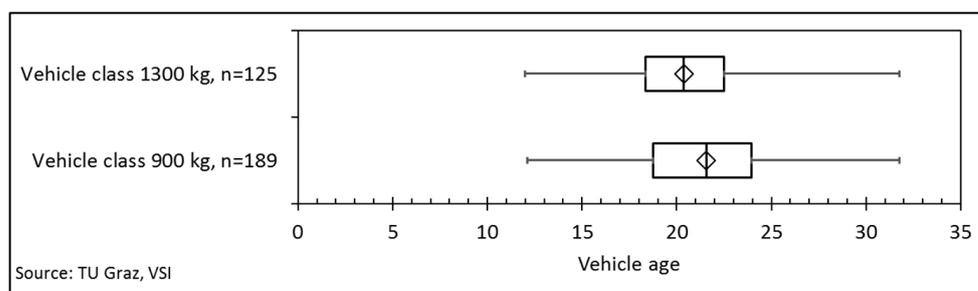
Figure 2. Average vehicle age of passenger cars used for impact tests according to EN 1317.

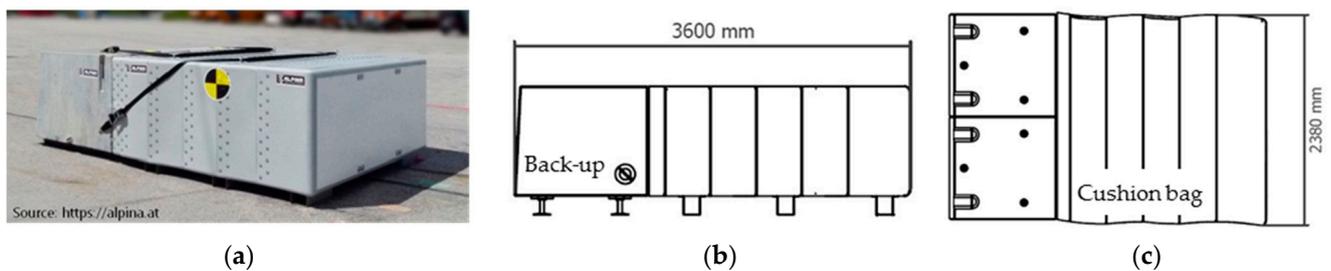
Figure 3. (a) A non-redirective crash cushion unmounted to the road surface, (b) side view, (c) top view [23].

In the tests, a non-redirective F1-80 crash cushion from the manufacturer ALPINA (Bavaria, Germany), which was not attached to the road surface, was used. The performance level of this crash cushion is 80. The maximum test speed in the approval test is 80 km/h. The length of the crash cushion is 3600 mm, and the width is 2380 mm (Figure 3). The back-up is separated into two concrete blocks. The weight of the cushion bag is approximately 300 kg, and the back-up has a weight of approximately 6640 kg.

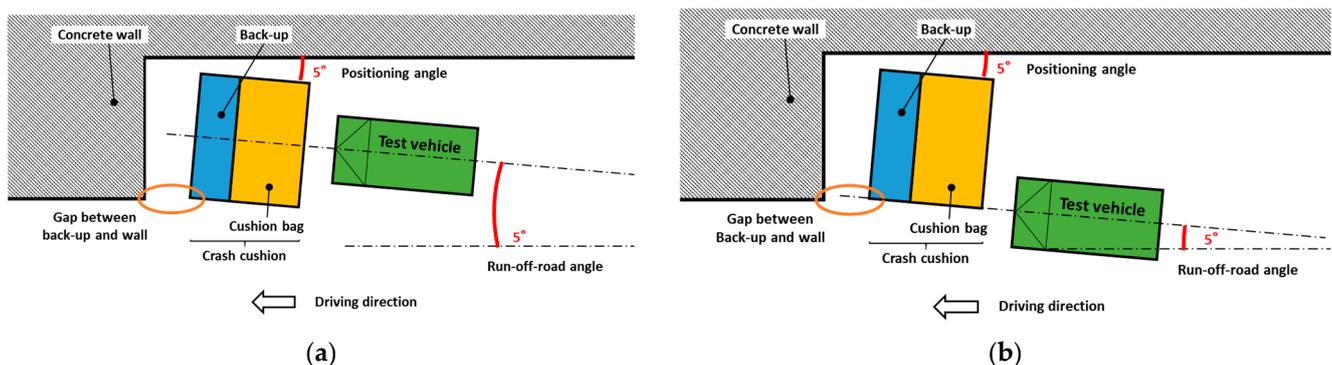
Figure 4. Test set-up: (a) vehicle position at the center line of the crash cushion at first contact and (b) vehicle offset with the vehicle's center line impacting the corner of the crash cushion.

The crash cushion was positioned according to the F1-80 installation manual (Figure 4). The gap between the crash cushion and the concrete wall was approximately one meter and was chosen in accordance with the tests performed by Tomasch et al. [24]. The angle of installation to the roadway was 5°. The run-off-road angle was calculated from the CEDATU (Central Database for In-Depth Accident Study) road accident database [25,26] and was set to 5° [24]. In combination with the installation angle, the impact angle calculates to zero degrees.

The vehicle position at the point of impact was defined at the center line of the crash cushion, i.e., the center line of the vehicle and the crash cushion were coincident. The vehicle had a full overlap of 100%. A vehicle offset of 50% was defined for the second impact configuration. The center line of the vehicle impacts the corner of the crash cushion.

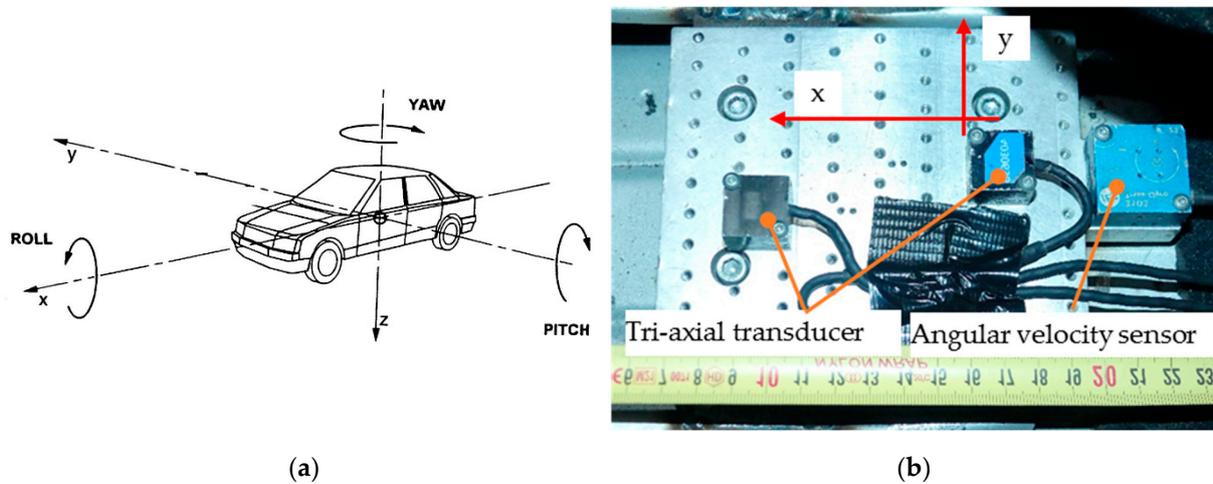
Figure 5. Vehicle coordinate system (a) and position of the acceleration transducers mounted at the center of gravity (b) c.f. [24].

Two acceleration sensors (manufacturer: ASC, Pfaffenhofen an der Ilm, Germany; type: 5411LN-100 and Measurement Specialties; type: 1203-0500-10-240X) and one angular velocity sensor (manufacturer: IES, Kirchheim bei München, Germany; model: 2103-2400) were used to record the acceleration and the angular velocity of the vehicle body. The measuring range of the acceleration sensors is 100 g and 500 g, respectively. The measurement range of the angular velocity sensor is 2400°/s. All sensors were mounted on a metal plate, which was attached to the vehicle (Figure 5) as near to its center of gravity

as possible. All sensors were calibrated. The sensors' positions and the coordinate system of the vehicle were defined according to EN 1317 [3].

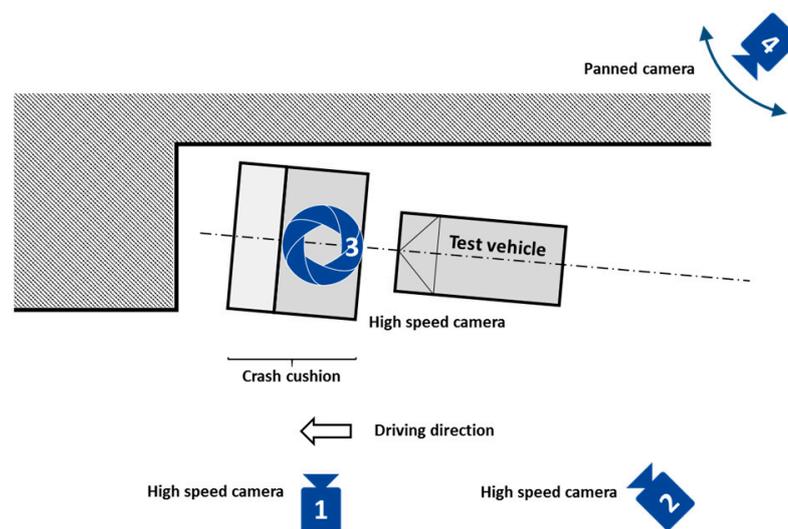
Figure 6. Sketch of the position of the video cameras. Positions 1 to 3: high speed cameras. Position 4: panned normal speed camera.

The tests were recorded with three high-speed cameras at 500 frames per second. The positions of the cameras are shown in Figure 6. One camera was positioned laterally (1). A second camera recorded the test from an oblique angle (2). An overhead camera (3) recorded the vehicle's motion, and the fourth camera (frame rate: 24 frames per second) also recorded the vehicle's approach prior to impact (4).

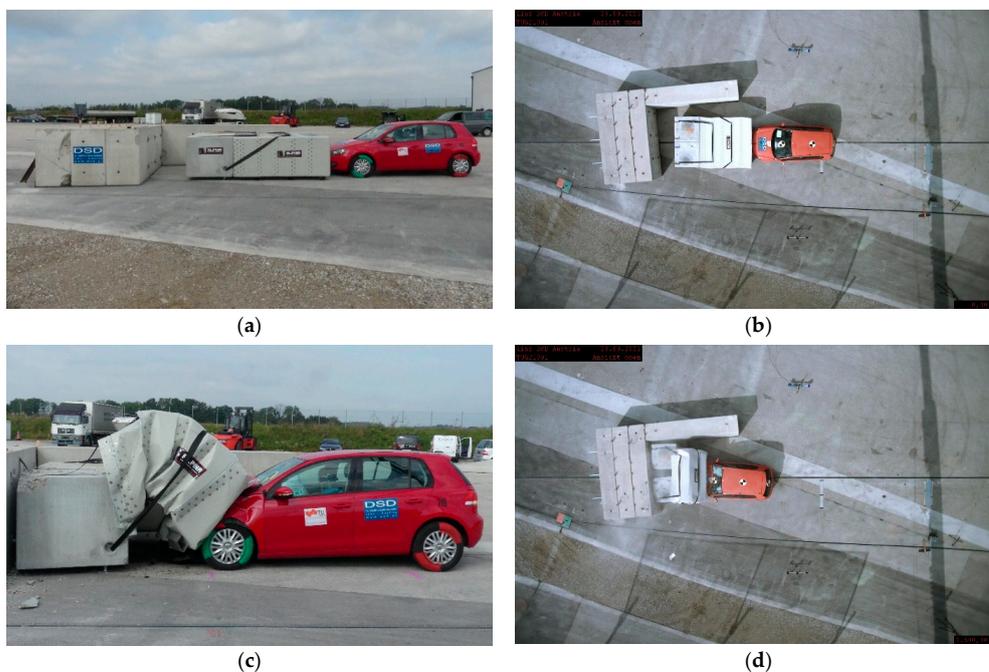
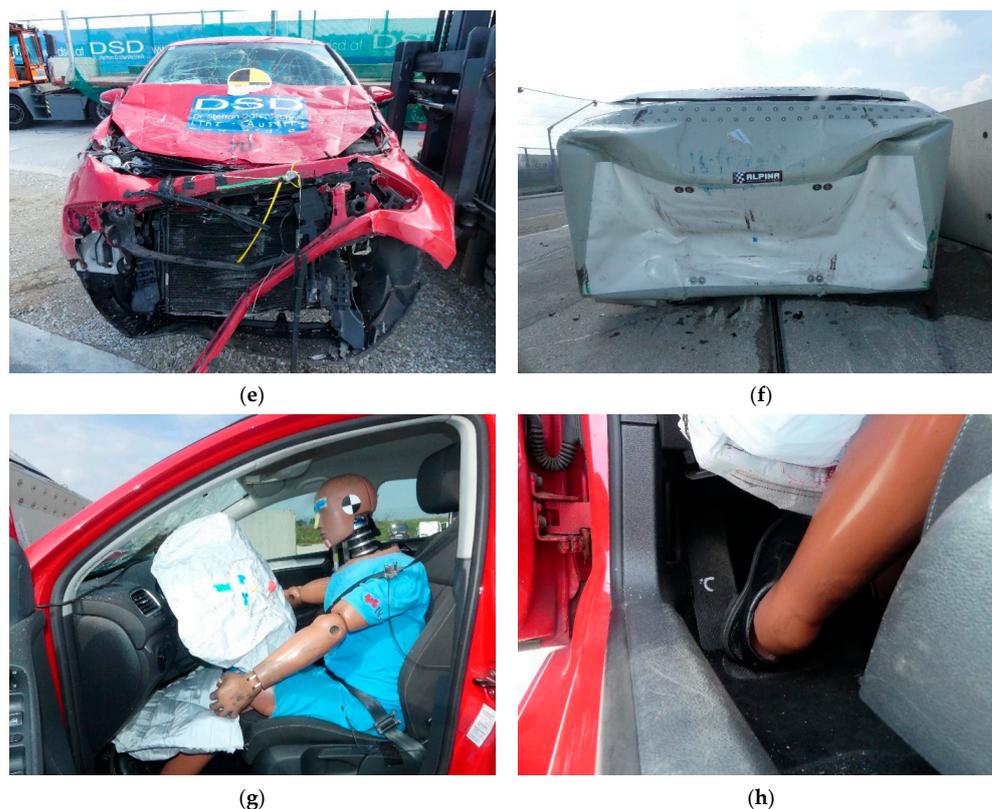
Figure 7. Test 1: Initial position of the vehicle (picture (a,b)). Final position of the vehicle after the impact (picture (c,d)). Damage to the vehicle and crash cushion (picture (e,f)). ATD position and lower legs (picture (g,h)).

The vehicle hit the center of the crash cushion with an overlap of 100%. The back-up of the crash cushion started to move after approx. 70 ms and hit the concrete wall with its rear edge after approx. 316 ms. The vehicle was fully decelerated and started to accelerate against the direction of impact at 450 ms. The final position was reached after 1.5 s. In its final position, the vehicle was rotated clockwise approximately 2° around its vertical axis.

During the impact, the vehicle moved beneath the crash cushion, and the crash cushion was lifted upwards. The bumpers were fully compressed, and the floor panel impacted the road. The vehicle hit the back-up of the crash cushion after approx. 150 ms, and the vehicle and the back-up continued to move at a constant speed against the concrete wall. At approx. 316 ms, the back-up collided with the concrete wall, and an increase in the acceleration signal was observed.

Approx. 20 ms after the impact, the front airbags (driver airbag, knee airbag, and passenger airbag) started to deploy (visible on the video). The side airbags (curtain and seat) did not deploy. The seat belt pretensioner and the seat belt load limiter were activated. Webbing marks on the seat belt were visible.

No intrusions into the passenger compartment were observed; the passenger compartment remained undamaged, and the wheelbase was not shortened. The damage occurred mainly in the area of the bonnet and was caused by the underrun of the vehicle. The impact on the back-up did not contribute significantly to the damage.

Pictures of the car's moment of impact, final position, and damage pattern are shown in Figure 7.

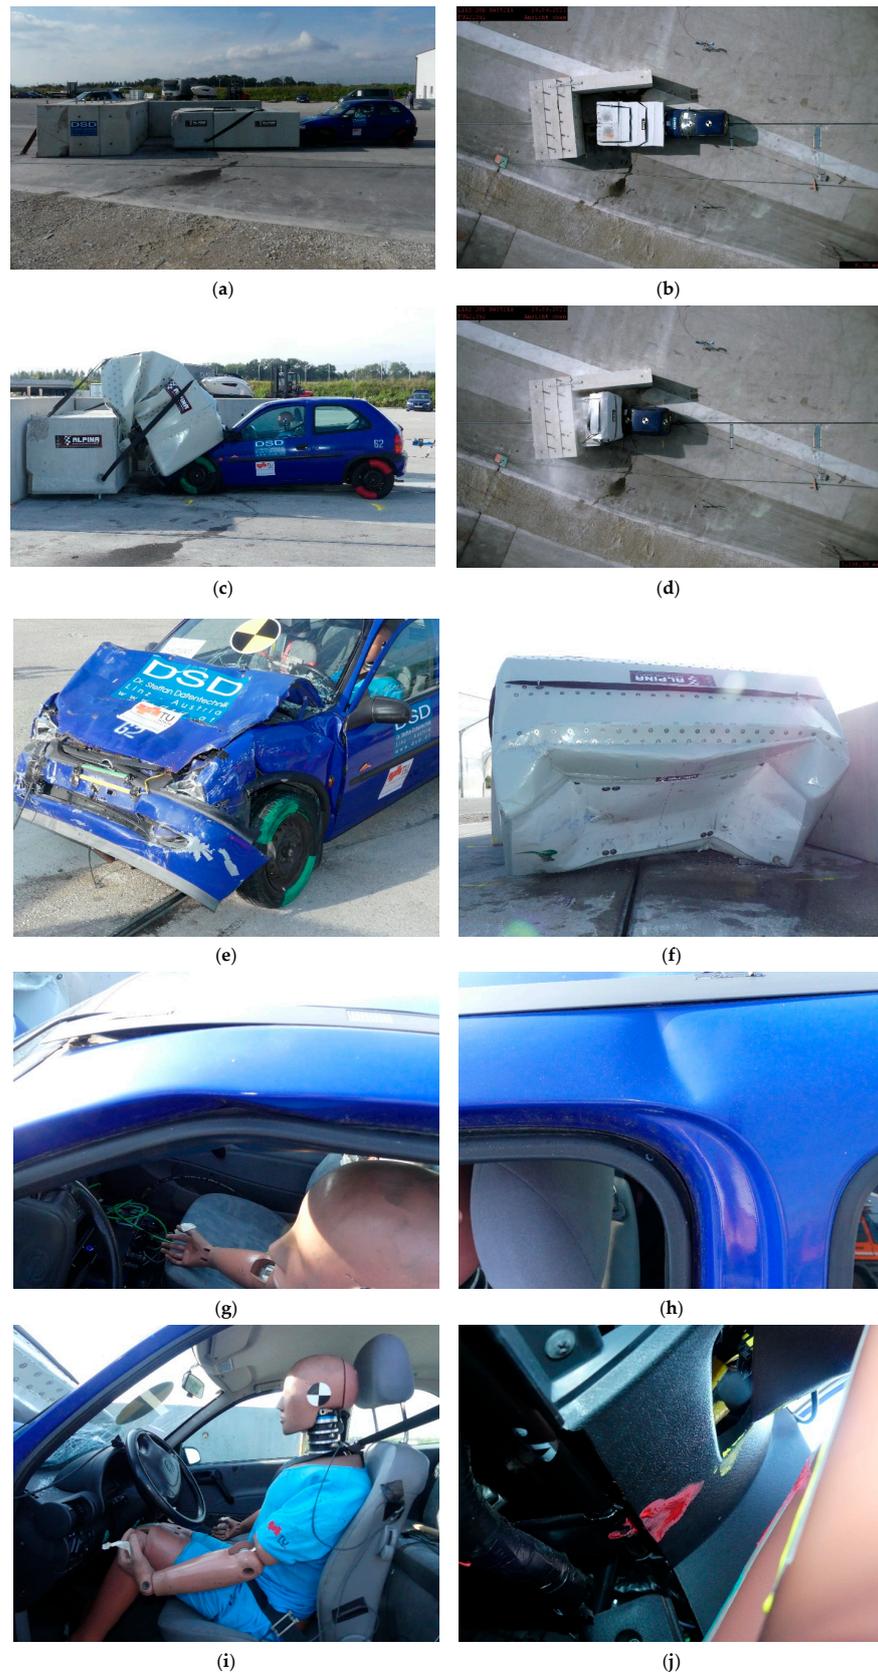
Figure 8. Test 2: Initial position of the vehicle (picture (a,b)). Final position of the vehicle after the impact (picture (c,d)). Damage to the vehicle and crash cushion (picture (e–h)). ATD position and lower leg contact against the dashboard (picture (i,j)).

The vehicle hit the center of the crash cushion with an overlap of 100%. The back-up of the crash cushion started to move after approx. 110 ms and hit the concrete wall with the rear edge after approx. 424 ms. The vehicle was fully decelerated and started to accelerate against the direction of impact at about 880 ms. The final position was reached after 1.1 s with a yaw angle of about 5° of clockwise rotation as compared to the impact position.

As in test 1, the vehicle was moved beneath the crash cushion during the impact, causing the crash cushion to be lifted slightly upwards. The bumpers of the vehicle were completely compressed, and the floor panel impacted the road surface. An impact of the vehicle against the back-up could not be determined, doubtlessly due to the dust generated during the test.

There were no intrusions into the passenger compartment, but the header rails were buckled on the driver’s side around the area of the B-pillar. As a result of the impact, the wheelbase was shortened by about 6 cm on both sides.

The seat belt pretensioner was activated, and webbing marks were visible on the seat belt. Knee contact between the ATD and the dashboard was observed.

Pictures of the car’s moment of impact, final position, and damage pattern are shown in Figure 8.

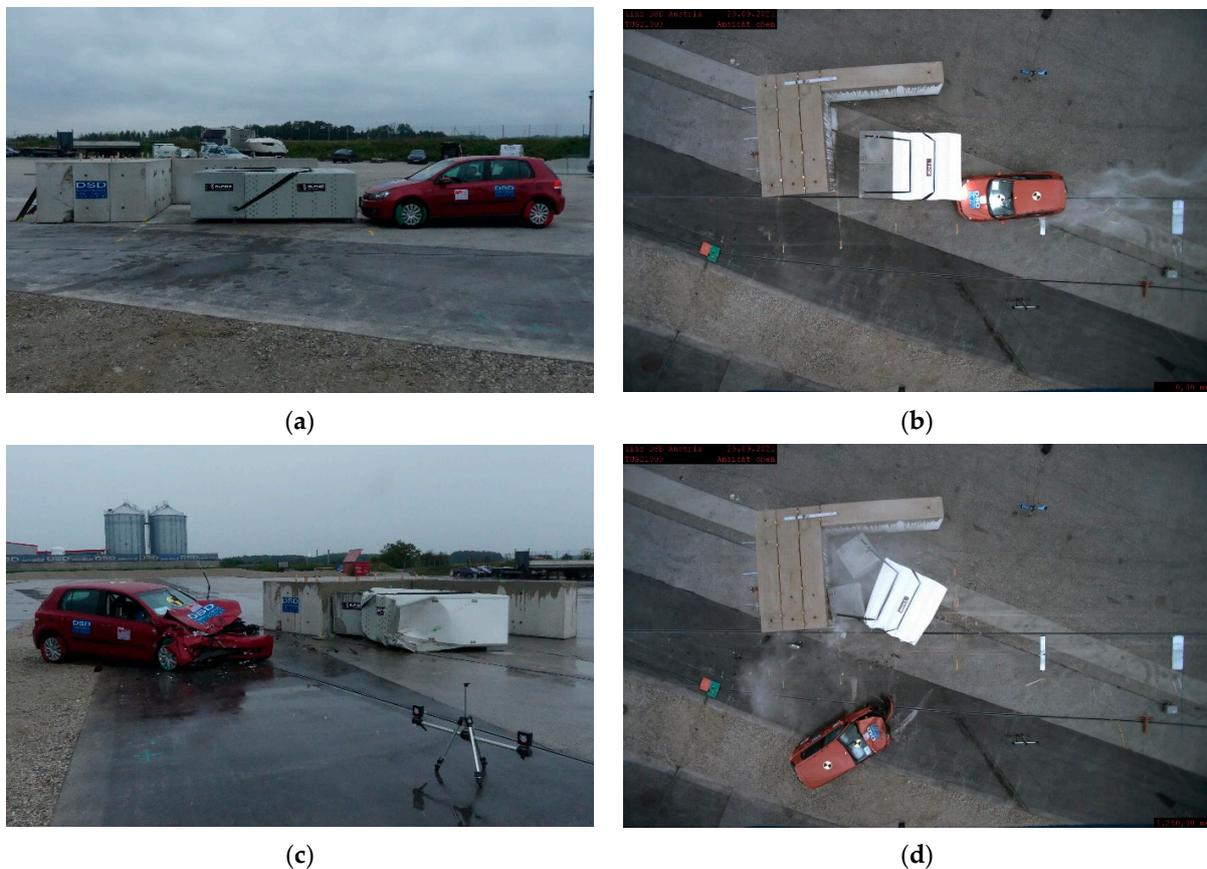
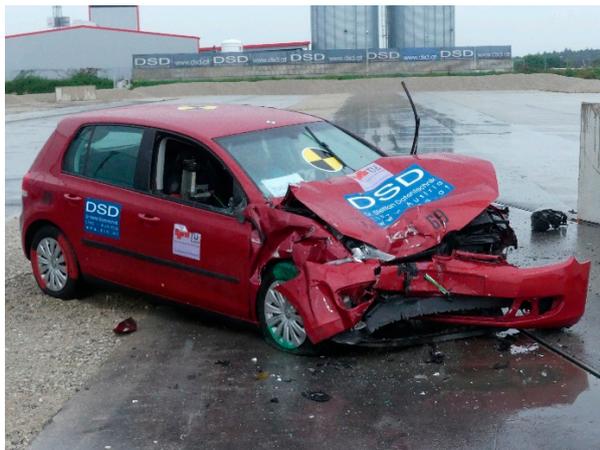
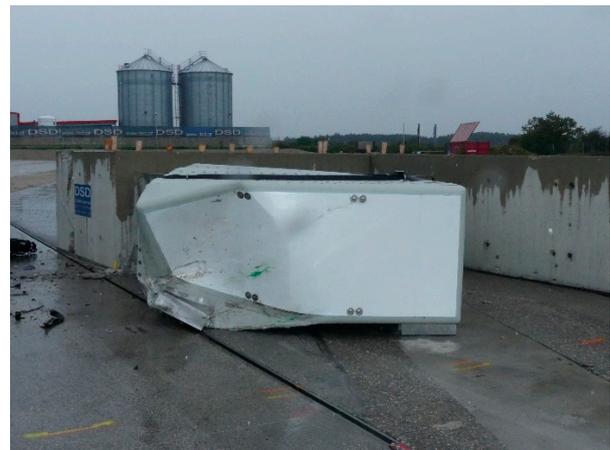
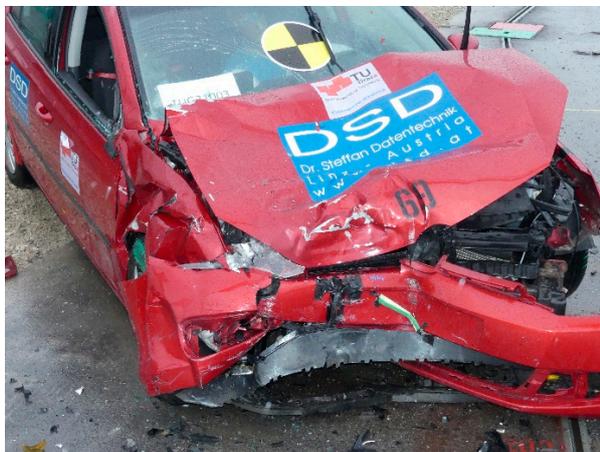
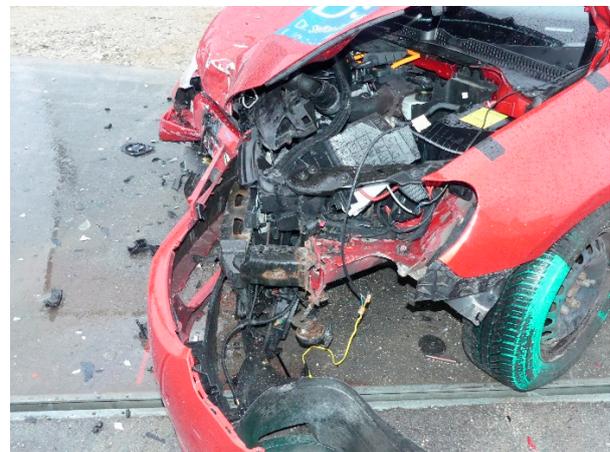
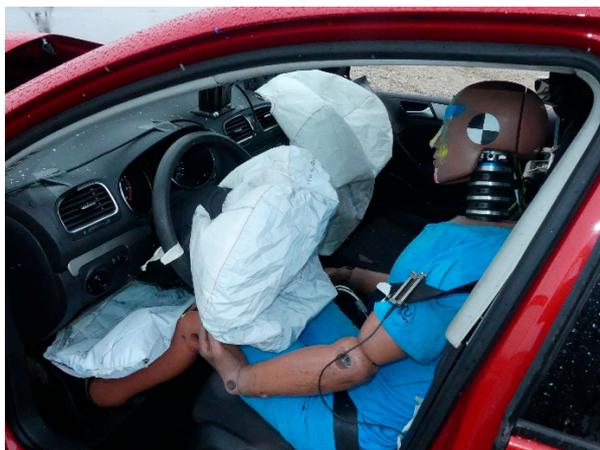
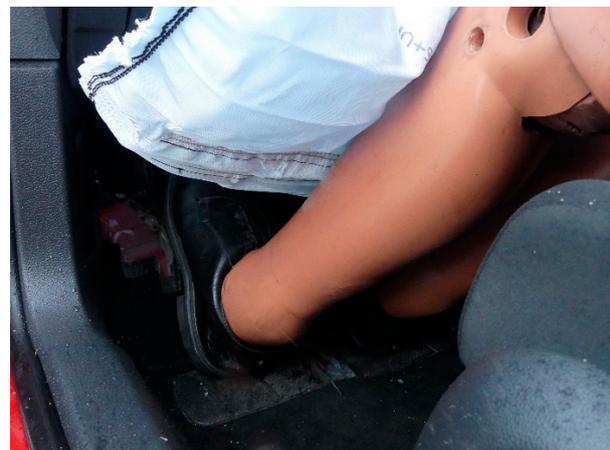
Figure 9. Test 3: Initial position of the vehicle (picture (a,b)). Final position of the vehicle after the impact (picture (c,d)). Damage to the vehicle and crash cushion (picture (e–h)). ATD position and lower leg position (picture (i,j)).

The vehicle hit the crash cushion with an overlap of 50%. Half of the right front of the vehicle was covered. The back-up of the crash cushion started to move after approx. 100 ms, and hit the concrete wall with its rear edge after approx. 270 ms. The vehicle rotated clockwise around its vertical axis into its final position, coming to a complete standstill after 1.25 s against the direction of travel prior to the impact. The yaw angle in the final position was approx. 145° relative to the impact position. The distance between the left front wheel and the corner of the concrete wall was approx. 3.2 m, and the distance between the left rear wheel and the corner of the concrete wall was approx. 4.6 m.

The vehicle penetrated the cushion bag and crashed against the back-up after approx. 100 ms. The main damage is on the front right half of the vehicle, according to the impact configuration. The right front wheel contacted the wheelhouse. The right wheelbase was shortened by approx. 9 cm. On the left side, the wheelbase remained unchanged by the impact. No intrusions into the passenger compartment could be detected.

Roughly 128 ms after the impact, deployment of the front airbags (driver airbag, knee airbag, and front passenger airbag) became visible in the video. The side airbags (curtain and seat) did not deploy. The seat belt pretensioner and load limiter were activated. Webbing marks on the seat belt were visible.

The head of the ATD hit the steering wheel or was hit by the deploying airbag close to the steering wheel at approx. 128 ms.

Pictures of the car’s moment of impact, final position, and damage pattern are shown in Figure 9.

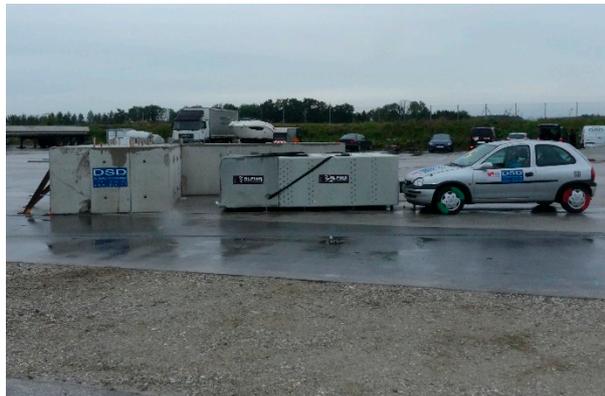
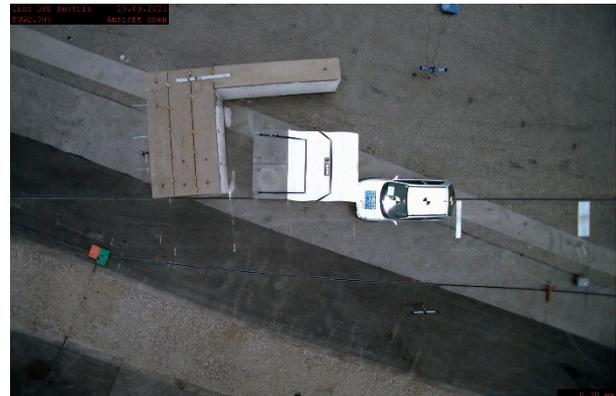
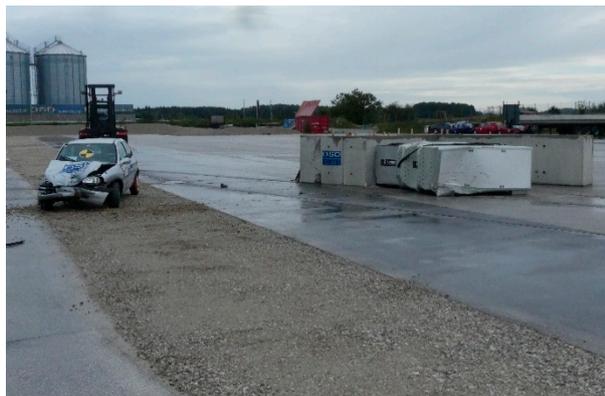
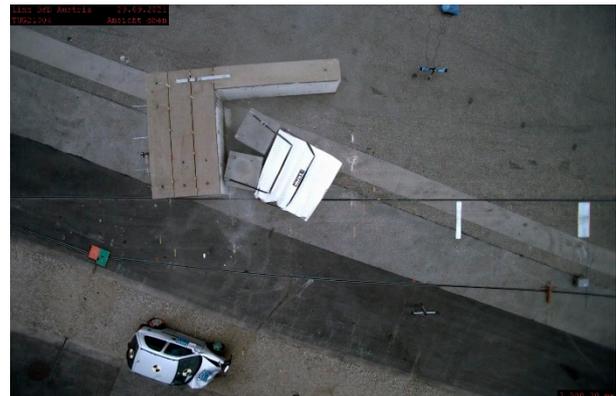
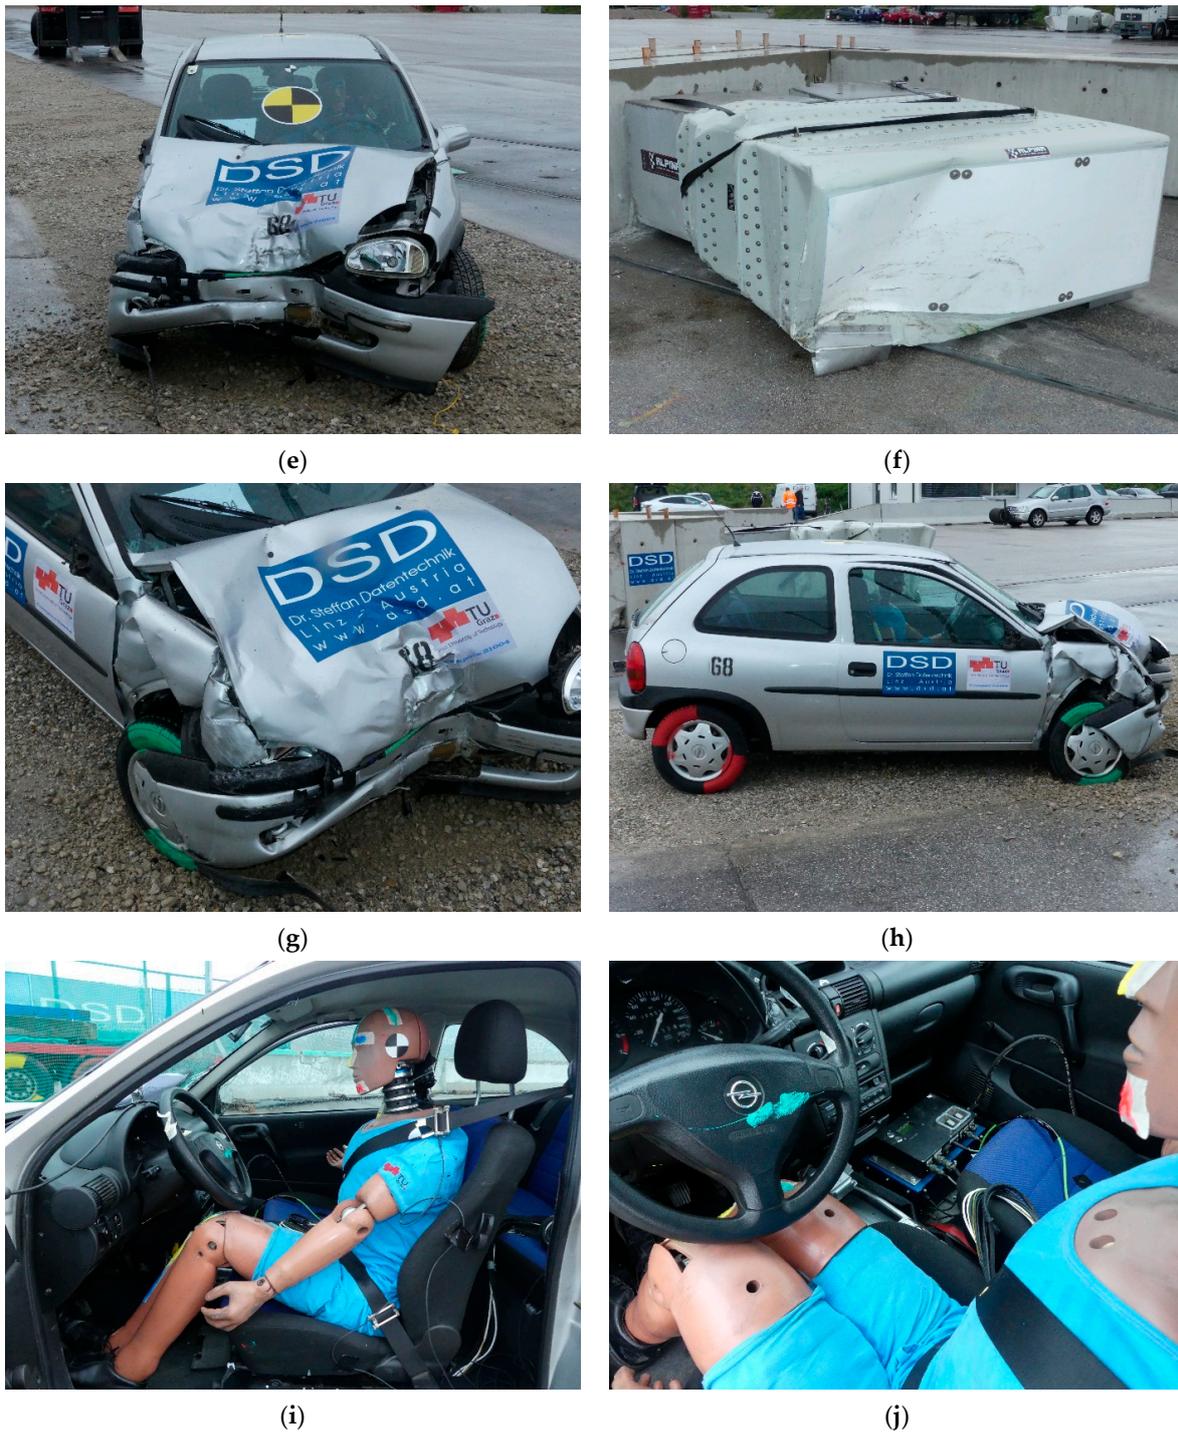
Figure 10. Test 4: Initial position of the vehicle (picture (a,b)). Final position of the vehicle after the impact (picture (c,d)). Damage to the vehicle and crash cushion (picture (e–h)). ATD position and head contact evidence on the steering wheel (picture (i,j)).

Similar to test 3, the vehicle hit the crash cushion with an overlap of 50% so that half of the right front of the vehicle was covered. The back-up of the crash cushion started to move after approx. 112 ms and hit the concrete wall with its rear edge after approx. 294 ms. The vehicle rotated clockwise around its vertical axis into the end position and came to a

complete standstill after 1.5 s against the direction of travel prior to the impact. The yaw angle in the end position was approx. 220° relative to the impact position. The distance between the left front wheel and the corner of the concrete wall was approx. 6.44 m and the distance between the left rear wheel and the corner of the concrete wall was approx. 5.66 m.

The vehicle penetrated the crash cushion and crashed into the back-up after approx. 108 ms. The damage was on the front right half of the vehicle, according to the impact configuration. The right front wheel contacted the wheelhouse. The right wheelbase was shortened by approx. 14 cm, and the left wheelbase was lengthened by approx. 6 cm. The right header rail at the B-pillar buckled slightly. Intrusions into the passenger compartment could not be detected.

The head of the ATD hit the steering wheel at approx. 143 ms. The impact could be clearly detected, with evidence (colored marks) appearing on the steering wheel.

Pictures of the car's moment of impact, final position, and damage pattern are shown in Figure 10.

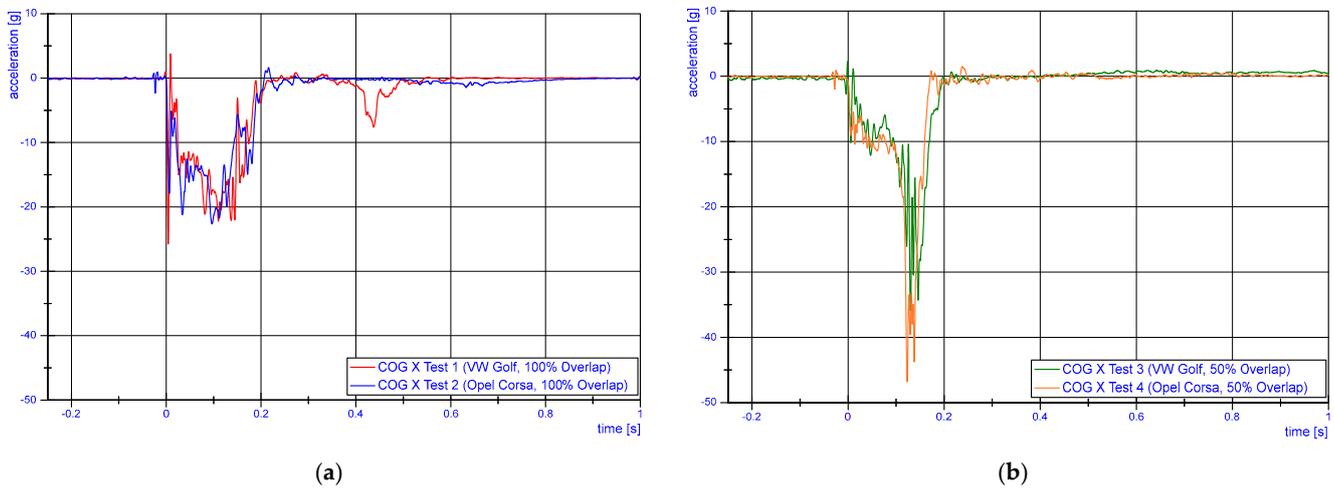
In the case of an impact with a full overlap, there is a clear peak in the acceleration signal at the beginning of the impact, which cannot be detected in the offset impacts (Figure 11). After the peak, the acceleration decreases and then increases again. If the first acceleration peak is ignored, then the acceleration signal has a more or less trapezoidal characteristic. In the case of an impact with an offset impact, an acceleration of approx. 8 to 10 g is reached until the vehicle strikes the back-up, which is clearly visible in the

acceleration signal. From this point on (approx. 100 ms), the acceleration increases to approx. 30 to 40 g. The Opel Corsa experiences a significantly higher maximum acceleration (approx. 40 g) than the VW Golf (approx. 30 g). The acceleration characteristic is initially comparable to the full overlap, except at the beginning peak. After the impact with the back-up, a triangular shaped curve appears.

Figure 11. Vehicle acceleration time history in x-direction: (a) full overlap impact; (b) offset impact.

In both impact configurations (full overlap and offset impact), the acceleration time is approx. 200 ms, whereas in the case of the Opel Corsa in the offset impact, the acceleration time is approx. 170 ms.

In the offset impact, the vehicle was crushed against the back-up after approx. 100 ms (VW Golf) and approx. 108 ms (Opel Corsa). From this point on, the vehicle’s acceleration started to increase significantly. At this point, a speed reduction of approx. 27 km/h and approx. 37 km/h is detected, respectively, for the VW Golf and Opel Corsa. Thus, the VW Golf collides with the back-up at a speed of approx. 73 km/h and the Opel Corsa collides with the back-up at a speed of approx. 63 km/h. In comparison, at the same time, a speed reduction of approx. 45 km/h and approx. 51 km/h is observed, respectively, for the VW Golf and the Opel Corsa during the full overlap tests.

The analyzed acceleration signals differ significantly between the full overlap impact and the offset impact. In the case of an impact with full overlap, immediately after the impact, a steep increase in the acceleration signal is detected and a local maximum of approx. 27 g (VW Golf) and approx. 18 g (Opel Corsa) is reached. The acceleration then

drops to 5 g and increases continuously to a maximum acceleration of approx. 22 g for both the VW Golf and the Opel Corsa. In the tests with an offset impact, an acceleration of approx. 10–12 g is observed for both vehicles in the first 100 ms. After this initial period, the vehicle hit the back-up, causing the acceleration to increase to the maximum values (VW Golf approx. 38 g and Opel Corsa approx. 48 g). In the full overlap test, the airbag began to deploy after approximately 20 ms, but in the offset impact, the airbag began to deploy after approx. 128 ms. Compared to the full overlap test, the acceleration level of the first time period is relatively low, and there is no significant gradient at the beginning that would initiate the deployment of the airbag. Thus, the airbags do not provide any safety protection for the occupant during the offset impact, as the airbag deployed directly before the head hit the steering wheel. This effect could actually be disadvantageous to the occupants.

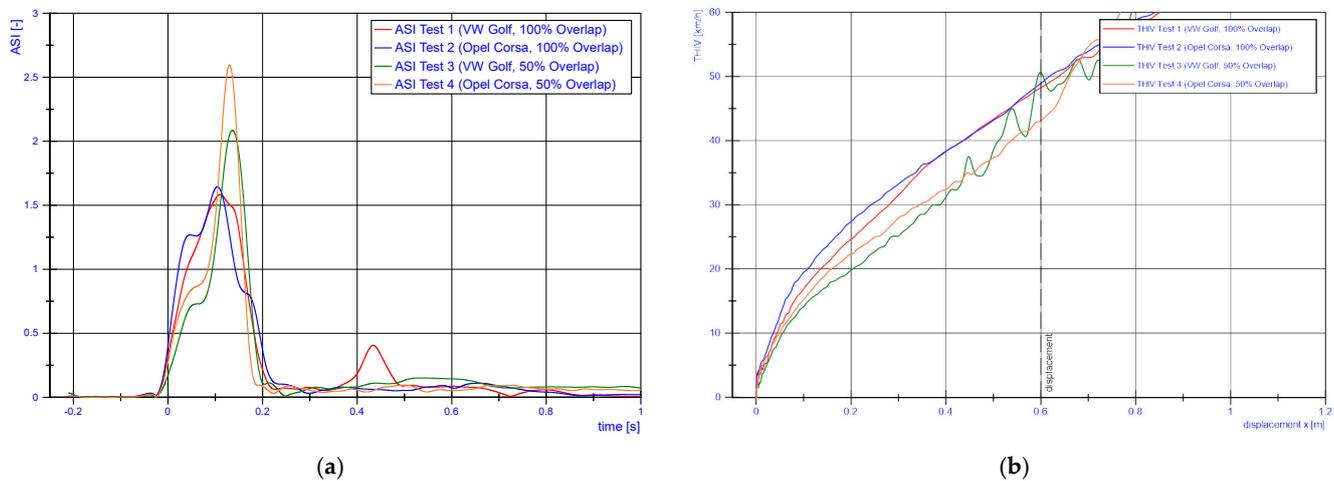
The acceleration characteristic also has an effect on the ASI curve (Figure 12a). The slopes of the ASI curves in the offset impact tests are flatter as compared to the tests with full overlap. When the vehicles hit the back-up, there is a clear discontinuity in the curve. There is no significant difference between the ASI of the two vehicles in the full overlap tests. An ASI of 1.6 was calculated for the VW Golf and an ASI of 1.66 for the Opel Corsa. In the case of an offset impact, however, the ASI of 2.11 for the VW Golf is significantly lower than the ASI of 2.63 for the Opel Corsa.

Figure 12. (a) ASI time history; (b) THIV displacement.

In any case, the ASI in the offset impact tests is significantly higher than in the full overlap tests, which results from the impact with the back-up after completely compressing the crash cushion.

The picture is somewhat different for the THIV (Figure 12b). In the tests with full overlap, the values do not differ significantly. For the VW Golf, a THIV of 48.53 km/h was recorded and, for the Opel Corsa, a THIV of 49.09 km/h was recorded. In the case of an offset impact, THIVs of 51.56 km/h and 43.37 km/h were recorded, respectively, for the VW Golf and the Opel Corsa. Similar results can be observed for the OIV.
