Article

Water Erosion Processes on the Geotouristic Trails of Serra da Bocaina National Park Coast, Rio de Janeiro State, Brazil

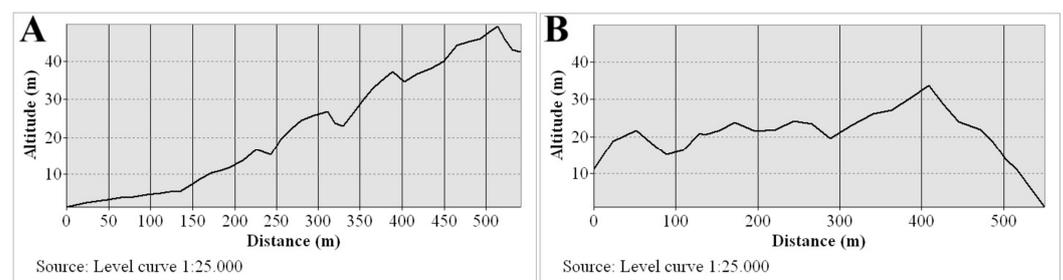
The Swallows trail has a length of ~600 m, with an average slope of approximately 12.4% and an altitude range between 0 and 46 m (Figure 3). It gives access to the WSS (Figure 4). The CDN Trail is also ~600 m long, with an average slope of around 14.3% and an altitude range of 0 to 63 m (Figure 3), and it provides access to the CDN (Figure 4).

Figure 3. Topographic profiles of the trail to the Waterfall of Stone that Swallows (A) and the Caixa D'Aço Natural Pool Trail (B) on the coast of the PNSB. Author: Lima.

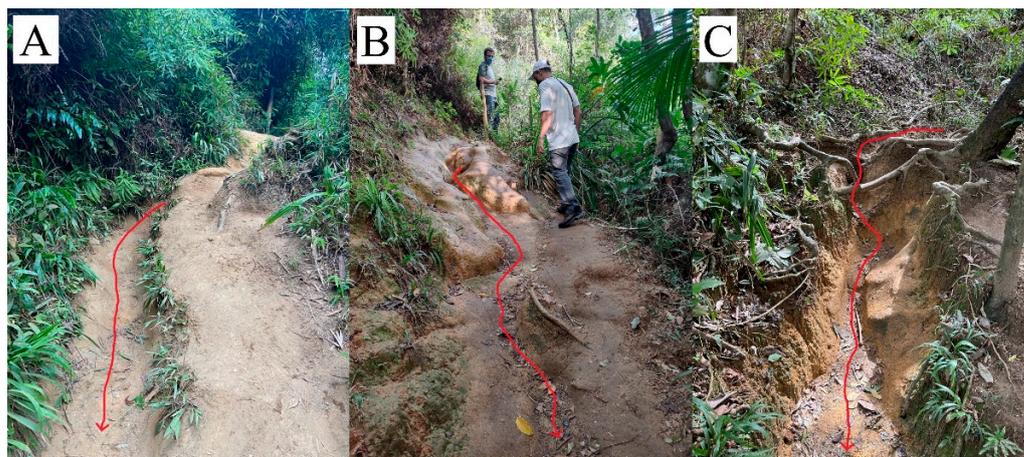
Figure 5. Soil collection sites (A–C) on the trail to the Waterfall of Stone that Swallows on the PNSB coast. The red arrow shows the direction of main flow during periods of intense rainfall. Photos: Lima.

The soil microtopography was determined through the installation of erosion bridges (PDE) with stakes from one edge to the other in the cross sections of sites and on the beds of the trails that presented water erosion processes, following the method developed by Shakesby [30] and adopted by Ferreira [31] in studies on water erosion in soils and subsequently applied to trails [9,22,32]. Thus, the evolution of erosion features was monitored between August 2021 and March 2022 and between August 2022 and March 2023. Therefore, we were able to obtain significant and contrasting variations in the temporal data on rainfall in the region. It is important to note that the monitored sites were the same sites from which the soil samples were collected to obtain the physical–chemical characteristics (Figures 5 and 6).

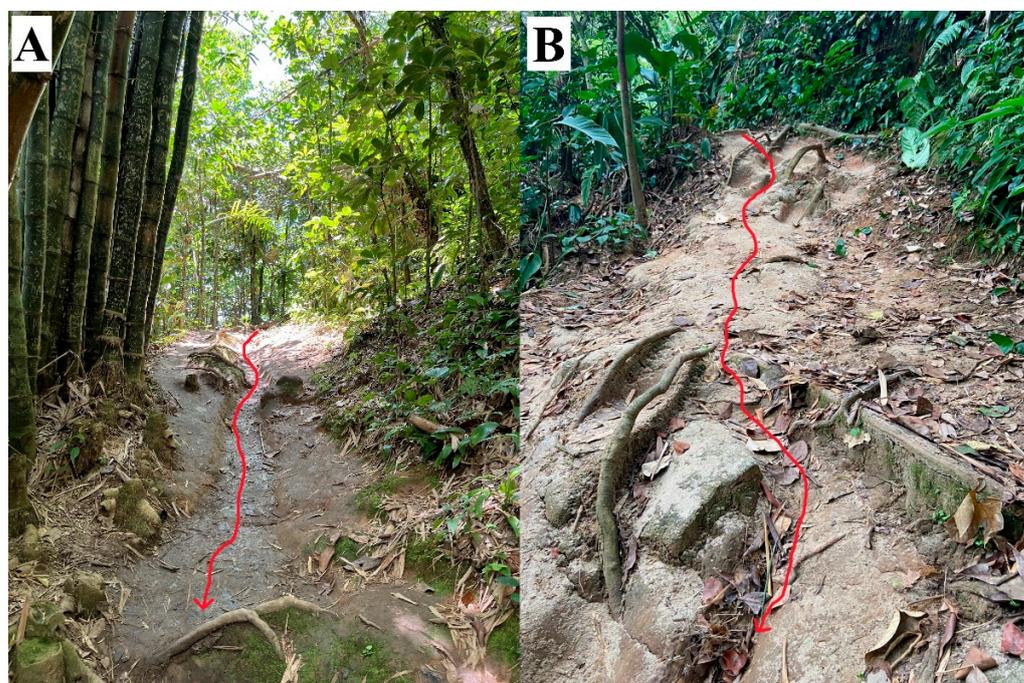
Figure 6. Soil collection sites (A,B) on Caixa D’Aço Natural Pool Trail on the PNSB coast. The red arrow shows the direction of main flow during periods of intense rainfall. Photos: Lima.

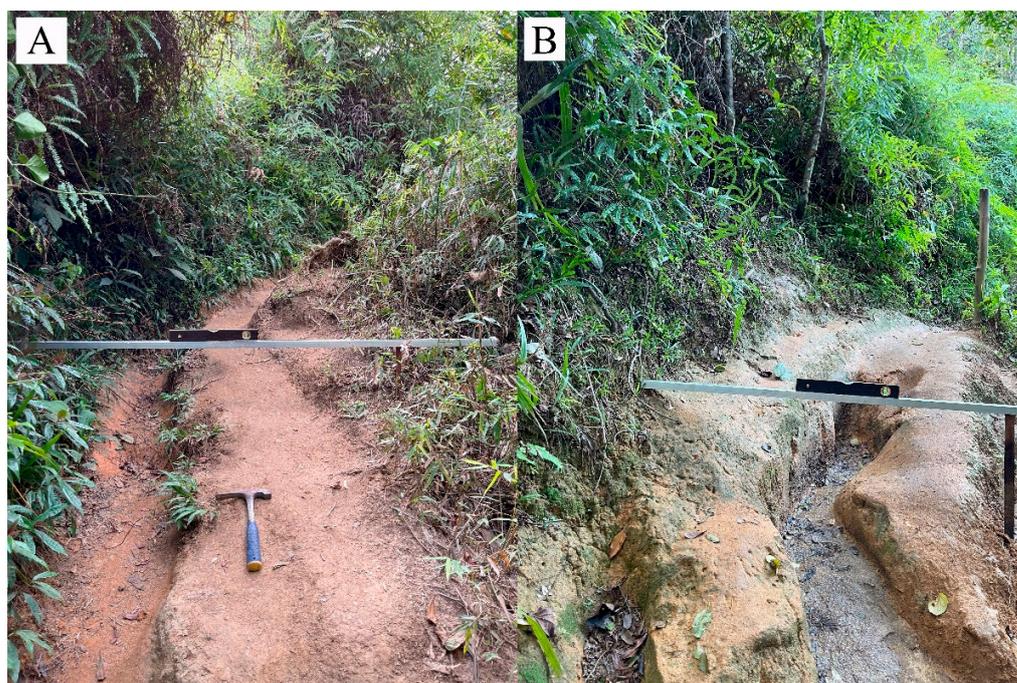
The model developed by Shakesby [30] and adapted for trails by Silva and Botelho [32] was used, whereby 50 cm wooden stakes/rods (useful for leveling), 2 m slats (erosion bridge), and a 1 m iron rod (measuring rod) were used with a measuring ruler offering 100 holes (analysis points) at 2 cm intervals. Two stakes were installed at the edges of the cross section (sites) so that they could be leveled between the edges of the trails and the values could be measured (Figure 7).

Figure 7. Example of the PDE leveling on sites (A,B) the trail to the Waterfall of Stone that Swallows on the PNSB coast. Photos: Lima.

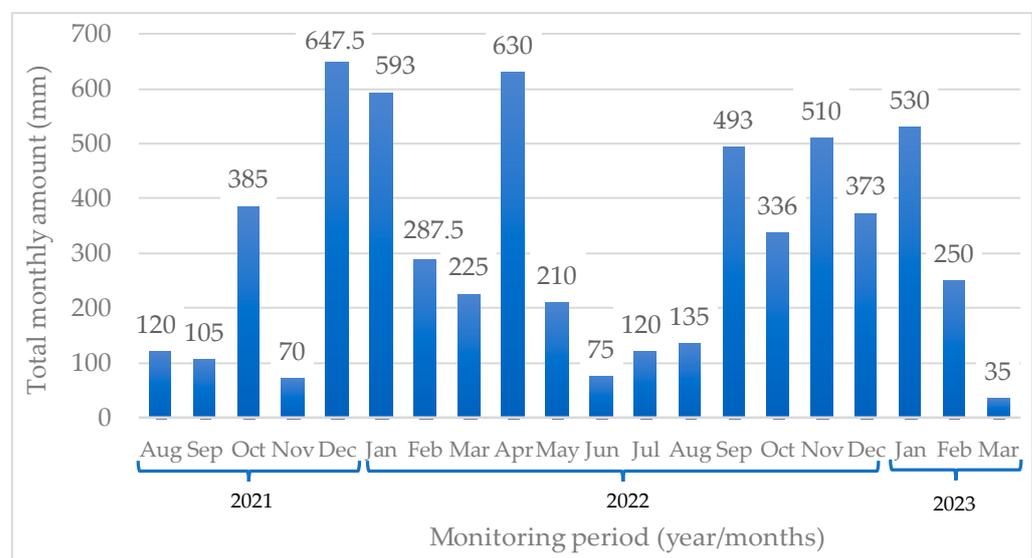
Daily rainfall data allowed total monthly volumes to be calculated (Figure 8). Moreover, rainfall occurred throughout less than half of the total monitoring period (219 days), with daily values higher than the total average, which was 11 mm, being recorded on more than half of these days (Figure 8). It was also possible to identify that this precipitation was concentrated in December (2021), January (2022), April (2022), November (2022), and January (2023), which in turn were the months with the highest averages of rainfall (21 mm, 19 mm, 21 mm, 17 mm, and 17.1 mm, respectively) (Figure 8). In addition, the highest monthly total volumes were also recorded in these months, that is, 647.5 mm in December 2021, 593 mm in January 2022, 630 mm in April 2022, 510 mm in November 2022, and 530 mm in January 2023 (Figure 8).

Figure 8. Total monthly values of precipitation on PNSB coast during the four monitoring periods.

When considering the intervals of days between each monitoring period, it was also possible to identify that, from the first monitoring (2021) to the second monitoring period (2022/1), the daily rainfall average was 11 mm, and these precipitations were concentrated within just 85 days. From the second monitoring period (2022/1) to the third (2022/2), despite the daily average rainfall being lower than the total average (11 mm), that is, equal to 8.3 mm, rainfall was concentrated within only 33 days. From the third monitoring period (2022/2) to the fourth (2023), the daily average rainfall was greater than 13 mm, that is, greater than the total average, with rainfall concentrated within 95 days (Figure 8). In this way, in addition to the rainfall concentration, in specific months, we noted that, between the intervals of the monitoring periods, with the exception of the second to the third, the daily average rainfall was equal to or greater than the total average precipitation during the entire monitoring period. This indicates an ideal scenario for the evolution of erosion features due to splash erosion and the increase in runoff amount on the beds of the trails.

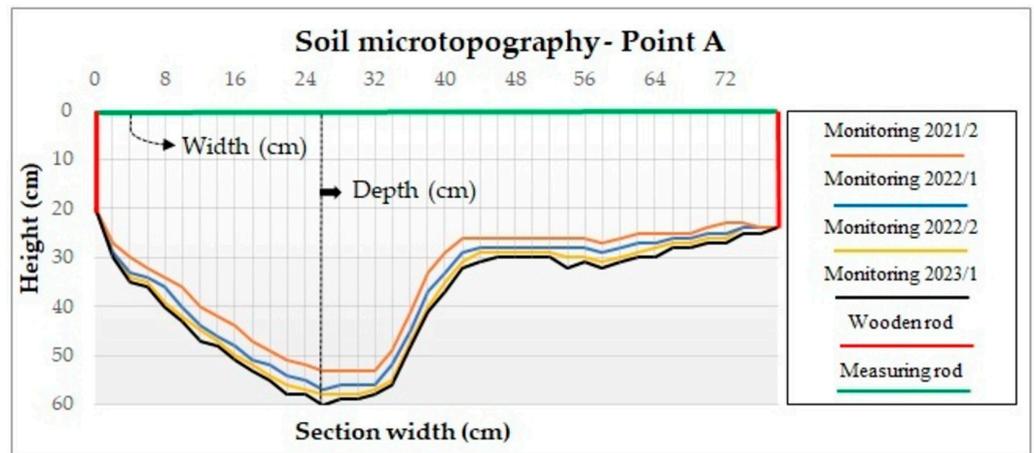
Figure 9. Soil microtopography at site A of the Waterfall of Stone that Swallows Trail on the PNSB coast.

Figure 9 shows that, during the first monitoring period of this site (2021), for example, the maximum depth of this rill was approximately 25 cm, while in the last monitoring period (2023), the depth increased by ~8 cm. Furthermore, it should be noted that the width of this rill also showed space–time evolution, since the value in the last monitoring period was ~4 cm greater than that in the first period (Figure 9). This space–time evolution corroborates the increase in the total cross-sectional area between the monitoring periods, since this area was 0.265 m² in the first monitoring period (2021), 0.284 m² in the second period (2022/1), 0.295 m² in the third period (2022/2), and 0.304 m² in the last period (2023). Therefore, this indicates an increase of approximately 0.039 m² in the cross-sectional area from the beginning of monitoring.

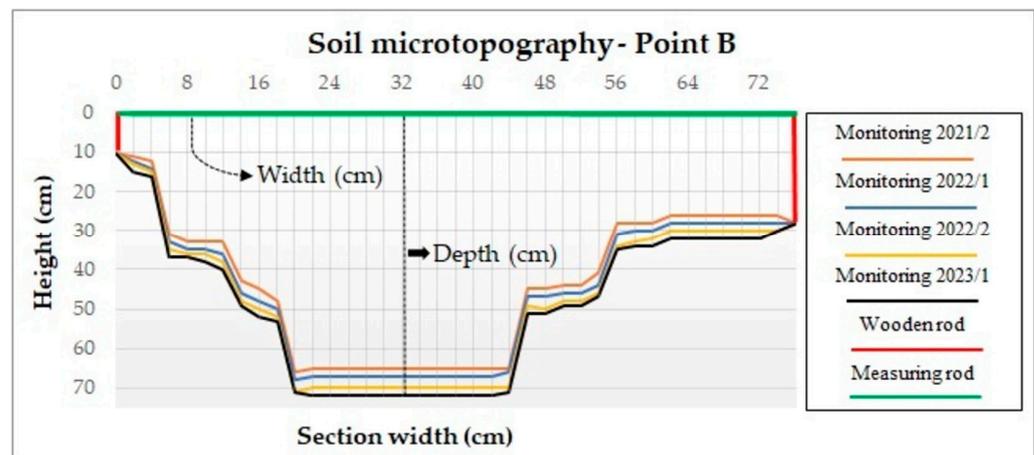
Figure 10. Soil microtopography at site B of the Waterfall of Stone that Swallows Trail, on the PNSB coast.

Figure 10, which shows the soil microtopography at site B of the WSS Trail, also indicates a space–time evolution of the monitoring period erosion feature. In the central portion of this rill, for example, it was possible to identify that in the first monitoring period (2021), the maximum soil depth surface was ~65 cm, while in the last monitoring period (2023), this depth was greater than 70 cm (Figure 10). This space–time evolution was reinforced by the increase in the total cross-sectional area between the monitoring periods, since the total area was 0.327 m² in the first monitoring period (2021), 0.336 m² in the second period (2022/1), 0.258 m² in the third period (2022/2), and 0.372 m² in the last one (2023), i.e., an increase of about 0.044 m² in the total cross-sectional area from the beginning of the monitoring period (Figure 10).

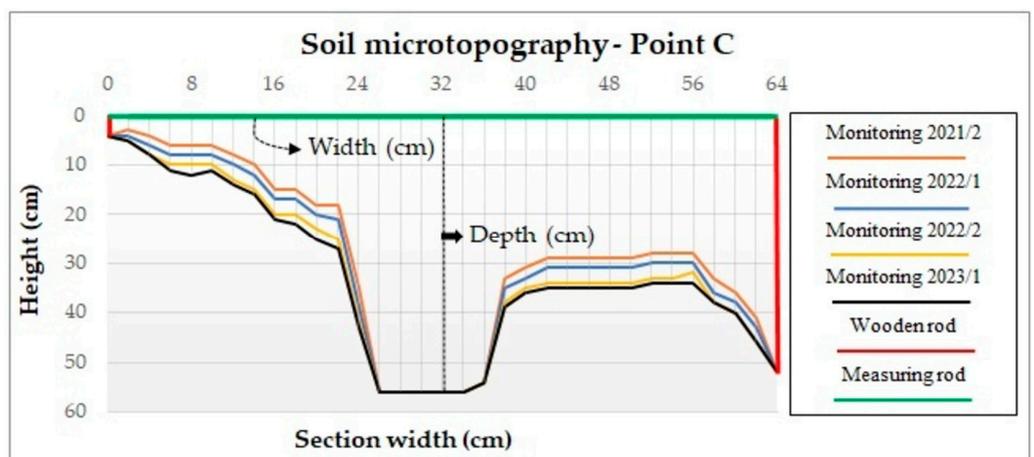
Figure 11. Soil microtopography at site C of the Waterfall of Stone that Swallows Trail on the PNSB coast.

Figure 11, which shows the microtopography of the soil at site C of the WSS Trail, also shows a space–time evolution of the monitored erosion feature, especially in the lateral portions of the cross section (Figure 11). The exception was found in the central portion of this erosive feature. This occurred because the soil loss was severe at this site, and, in turn, reached the rocky layer underlying the soil layer, as can be seen in Figure 7B. Although the central portion of this rill did not indicate a space–time evolution at this point due to the rock outcrop, which is more resistant to the erosion process, it was possible to identify lateral soil loss in the other portions of this cross section. We considered the total cross-sectional area at this site, which was 0.177 m² in the first monitoring period, 0.192 m² in the second, 0.205 m² in the third, and 0.210 m² in the last, that is, an increase of 0.032 m² from the beginning of the monitoring period (Figure 11).

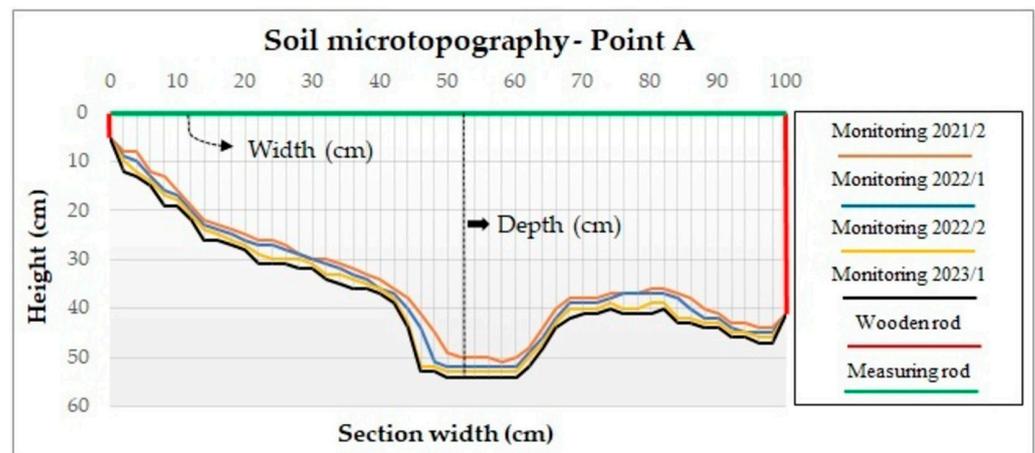
Figure 12. Soil microtopography at point A of the Caixa D’Aço Natural Pool Trail on the coast of the PNSB.

Figure 12 indicates the data associated with the monitoring of soil microtopography at site A of the CDN Trail. It is possible to identify that, in the central portion of this cross section, that is, inside the erosion feature, the maximum depth during the first monitoring period (2021) was approximately 14 cm. In the last period, this depth was approximately 4 cm greater in relation to the first. This space–time evolution is corroborated by data on the total area of the cross-section, which was 0.336 m² in the first monitoring period, 0.355 m² in the second, 0.37 m² in the third, and 0.381 m² in the fourth. This indicates an increase of approximately 0.045 m² in the total area from the beginning of the monitoring period.

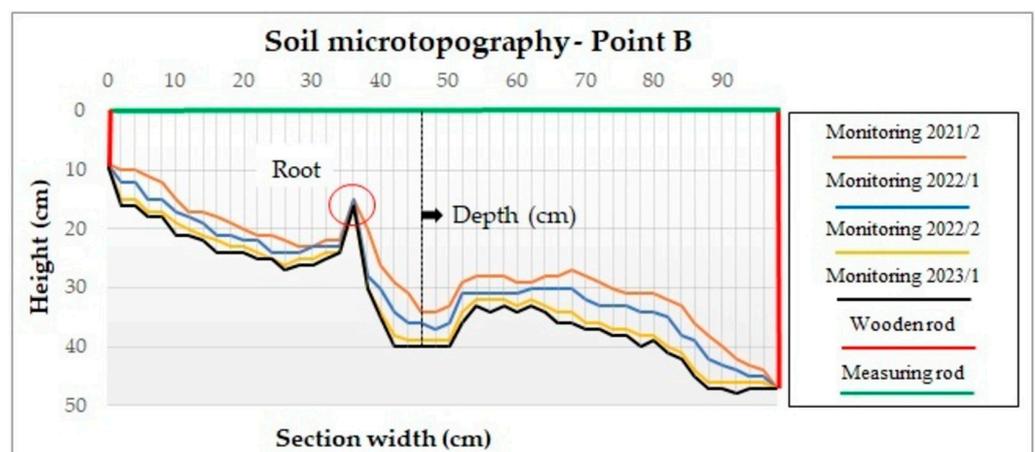
Figure 13. Soil microtopography at site B of the Caixa D’Aço Natural Pool Trail on the PNSB coast.

Figure 13, which presents the soil microtopography data from site B of the CDN Trail, also shows a space–time evolution of the monitored erosion feature that is similar to the behavior of the other monitoring sites. At this site, it was possible to identify a significant space–time evolution of soil loss by exposing the roots, the greater distance between the lines that indicate the soil surface, or the increase in the total value of the cross-sectional area (Figure 13). In the first monitoring period, for example, the total cross-sectional area was approximately 0.259 m², while in the second monitoring period, it was 0.284 m². In the third monitoring period, the total value of this area was 0.307 m², and in the last monitored period, 0.318 m². This indicates an increase of about 0.059 m² from the beginning of the first monitoring period.
