Article

Corrosion of Aluminium and Zinc in Concrete at Simulated Conditions of the Repository of Low Active Waste in Sweden

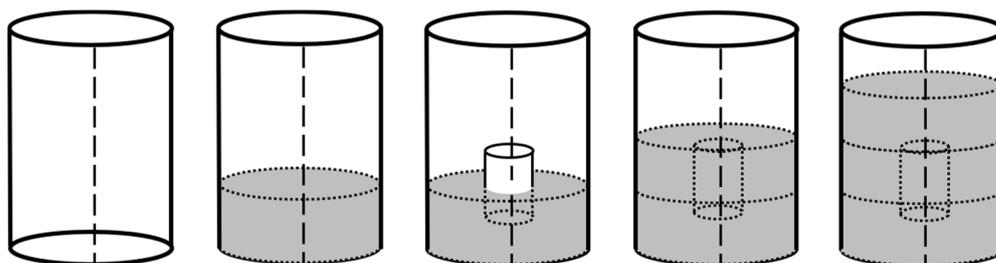
Figure 1. Schematic of the concrete cylinder casting procedure.

Al and Zn samples were embedded in individual concrete cylinders with a height of 80 ± 10 mm and a diameter of 63 ± 0.1 mm. Concrete was poured into cylindrical moulds made of PVC to a height of 40 mm. The metal samples were inserted approximately 15 mm into the concrete layer in the middle of the cylinder. A second layer of concrete was poured and the two layers were stitched together using a thin plastic rod to ensure a solid coherent cylinder, Figure 1. After stitching, a third layer was poured and stitched accordingly. The cylinders were covered with a plastic sheet to prevent evaporation and left to cure for 20 h.

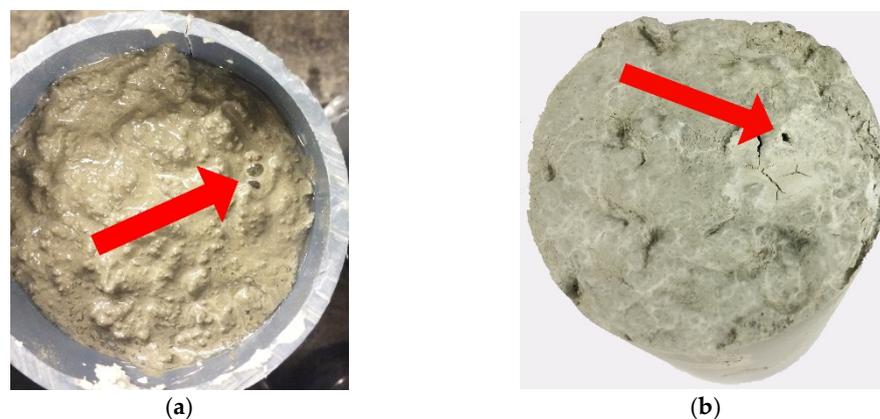
Figure 2. (a) Gas bubbles on the surface of wet concrete containing Al samples minutes after finished pouring the concrete into moulds; (b) Gas vent outlet on the upper surface of concrete cured for 20 h.

Bubbles were observed on the surface of the Al containing concrete cylinders within minutes after casting the last layer of concrete, Figure 2a. The effect was also evident after curing for 20 h, Figure 2b.

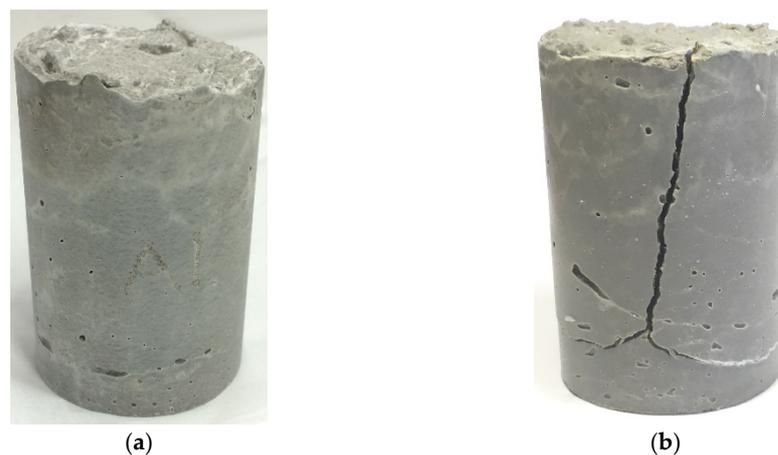
Figure 3. (a) Concrete cylinder representative for all samples and time periods except two Al containing cylinders (out of five) exposed for two years and (b) Concrete cylinder containing Al that cracked after two years of exposure.

corrosion process or by expanding volumes of evolved corrosion products. Independent on the material embedded inside the concrete, no cracks were observed in any of the cylinders exposed for either 2, 4, 12, 24 or 52 weeks, as seen in Figure 3a. However, two of the five cylinders with embedded Al revealed after 104 weeks of exposure evident cracks originating from the embedded Al sample surfaces all the way to the outside of the cement cylinder, Figure 3b. The width of the cracks, up to 3 mm, indicates that the underlying mechanism is internal pressure caused by gas evolution from the corrosion process and/or expanding corrosion product volumes as naturally formed cracks due to shrinkage or expansion during curing of the concrete would be hairline thick [19]. It is also unlikely that the concrete cylinders would crack from the shrinking process during drying as the cylinders were kept moist during the first 24 h of settling and curing before immediately immersed in AGW. One gas vent leading from the embedded Al samples to the top of the concrete surface was observed for each of the Al-containing cylinders. These vents, marked by the red arrow in Figure 2b, were formed during the curing step. Their presence, which allows the removal of gas formed during the corrosion process, indicates that gas pressure did not have any significant impact on the cracking of the concrete. Rather, these failures were effects of the expanding volume of formed corrosion products. No cracking of the Zn containing cylinders was observed during exposure in AGW and no gas vents were observed either during casting, curing or exposure.

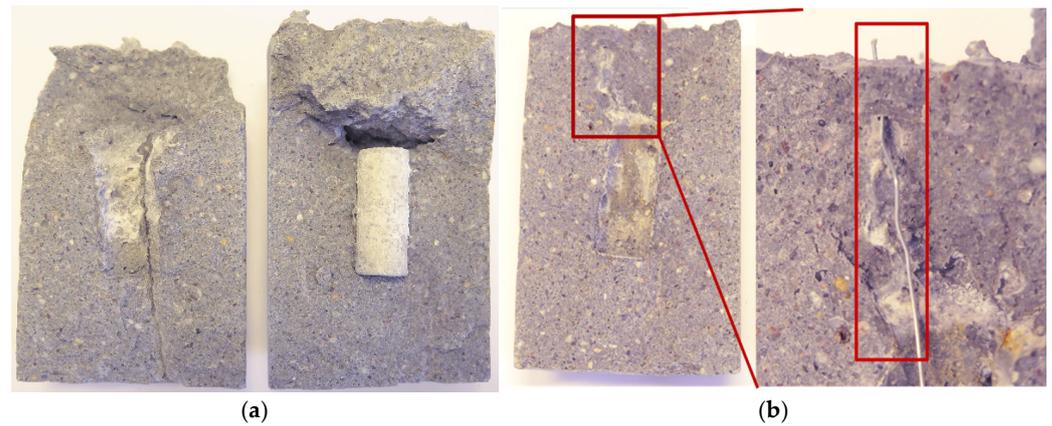
Figure 4. (a) Voids formed at the top end of the Al sample embedded in concrete and (b) Gas vent leading from the top of the void to the outer upper surface of the concrete cylinder.

When dismantling the metal samples from the concrete cylinders after the different exposure periods, a majority of the Al-containing cylinders cracked into multiple pieces revealing voids of varying size directly above the exposed metal sample, Figure 4a. These voids had formed by the evolution of hydrogen gas as the Al samples immediately started to corrode in contact with the strongly alkaline (pH 12.5) concrete environment. The rapid initial corrosion also resulted in a large amount of corrosion products causing poor adhesion between the Al samples and the concrete. Consequently, the Al samples were very easy to remove after exposure from the concrete as they essentially were loose and spontaneously detached. Cracking of the cement cylinders also revealed cross sections of the gas vents as the cylinders tended to crack along the vents where the mechanical strength of the concrete was diminished. It was clear that the vents reached all the way through the concrete from the Al sample inside the cylinder to the upper outer surface, as seen in Figure 4b.

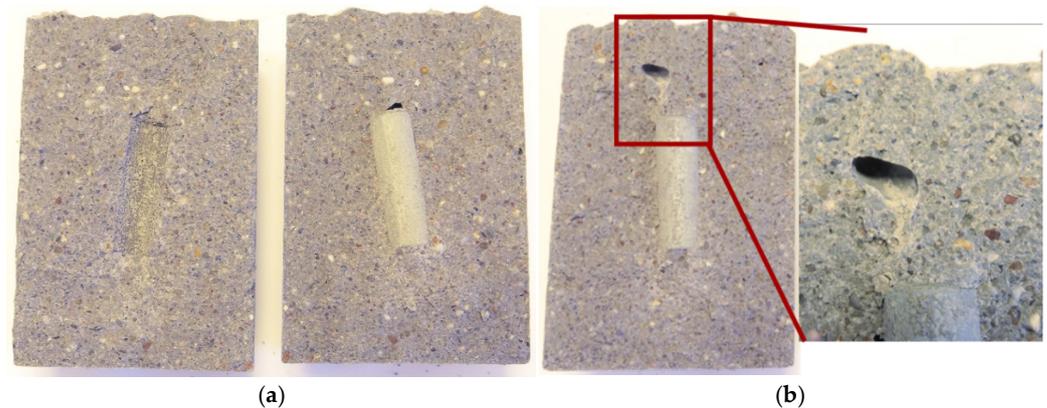
Figure 5. (a) Small voids formed at the top end of some of the embedded Zn samples and (b) Some voids penetrated deeper into the concrete without puncturing the outer concrete cylinder surface.

The Zn containing concrete cylinders generally broke into two halves when cracked indicating a higher structural integrity of the concrete compared with the Al containing cylinders. Most cylinders contained small voids in connection with the samples. This indicates that some gas evolution occurred initially but was not sufficient to create gas vents to the surface of the concrete, as seen in Figure 5a,b, as no gas vents to the surface were observed. The majority of the exposed Zn samples was firmly attached to the concrete without any significant visually observed formation of corrosion products. The samples had to be carefully chiselled out as not to damage their surfaces.

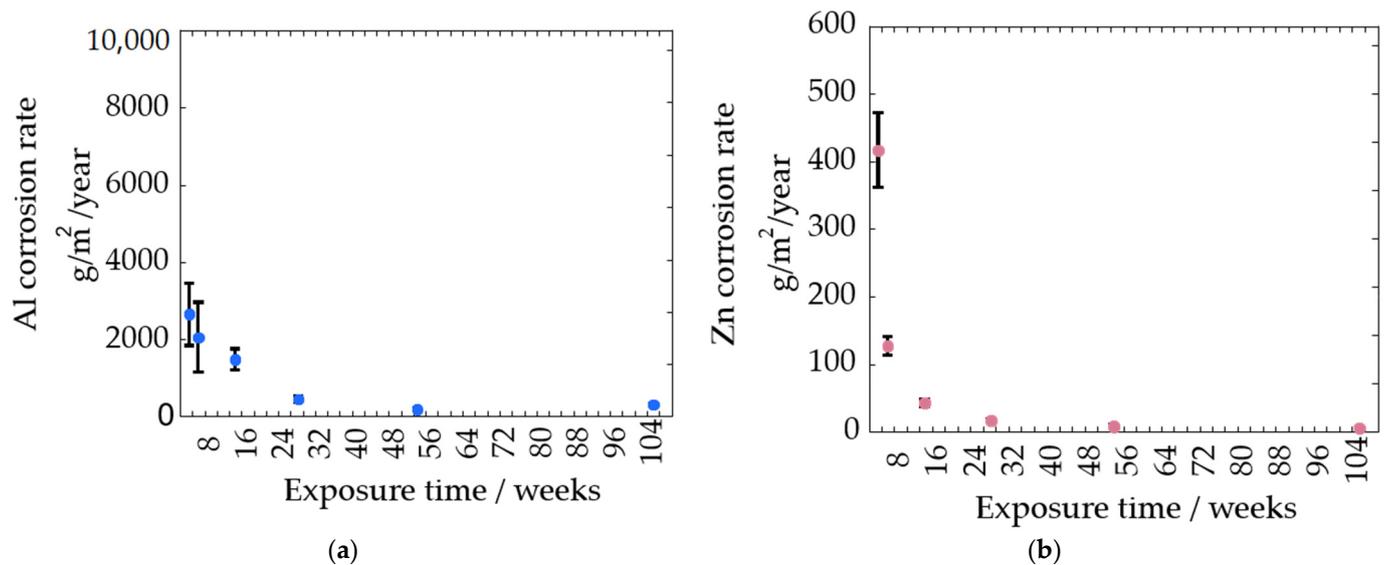
Figure 6. Corrosion rates of Al (a) and Zn (b) embedded in concrete immersed in artificial ground water (AGW) at anaerobic conditions for 2, 4, 12, 24, 52 and 104 weeks.

It is well known that Al rapidly corrodes at pH values exceeding 9 [7]. Reported corrosion rates in alkaline aqueous solutions ranges between 22 and 670 g m⁻² year⁻¹ (8.1–248 μm year⁻¹) [6]. As a result, high corrosion rates of Al were expected when exposed in concrete (pH 12.5 ± 0.2). Corrosion rates of 20 μm year⁻¹ have been reported for Zn–Al alloys (12 wt.% Al) exposed at aerobic conditions in concrete [2]. These rates were by far exceeded by the rates measured in concrete in this study (Figure 6 and Table 2). The initial corrosion rate was equal to 2700 g m⁻² year⁻¹ after 2 weeks (based on triplicate samples), as seen in Figure 6a, assuming a constant corrosion rate extrapolated to 1 year. The variation in corrosion rates between the triplicate samples was large for the two initial exposure time periods, 2 and 4 weeks, and no significant reduction in corrosion rates was observed until after 12 weeks. After 26 weeks, the corrosion rate was substantially reduced and the variation between the triplicate samples was significantly smaller, 443 g m⁻² year⁻¹. A reduction in corrosion rate was expected due to the gradual formation of corrosion products formed on the Al surfaces able to act as a physical barrier slowing down the passage of ions and corrosive species. Interestingly enough, the Al samples exposed within the cracked concrete cylinders exposed for 2 years did not show any different corrosion rates compared with uncracked cylinders (all in the range 309 ± 20 g m⁻² year⁻¹). As the test was terminated after this exposure time, and no inspection of the cylinders was performed in-between 1 and 2 years of exposure, the exact time for the fracture is unknown. How long the crack in the concrete had been open for transport of AGW into the embedded poorly adherent Al samples is, hence, unknown. It could be that it fractured shortly before the test was terminated and that an increased transport of AGW into the Al surface was not sufficient to influence the corrosion rate. It could also be that the barrier properties of the corrosion products were sufficient to slow down any effect of corrosive species. It should, thus, be kept in mind that cracking of the cylinders may have an influence on the corrosion rates. However, measured corrosion rates are of the same order of magnitude indicating minor implications of such a scenario.

down the corrosion process. Observed differences in initial corrosion rates, for both Al and Zn, are also a consequence of the porosity of the AGW saturated concrete adjacent to the embedded metal forming local corrosion cells, which influence the electrochemical dissolution process [21]. After 12 weeks of exposure in concrete there were only small variations (13%) between triplicate samples, and even smaller for the samples exposed for 26, 52 and 104 weeks ($\approx 2\%$). The observation of uniformly corroded samples without any observation of locally corroded areas supports the conclusion that the initial large variation between triplicate samples predominantly was caused by variations in surface characteristics of the freshly prepared unexposed surfaces.

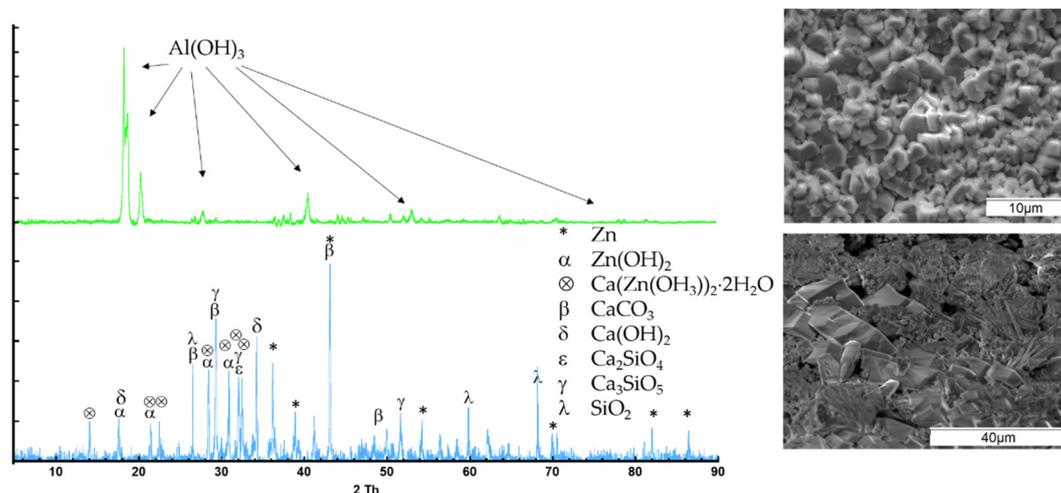
Figure 7. Corrosion product morphology by means of XRD diffractograms and SEM images for Al (top) and Zn (bottom) embedded in concrete immersed in AGW at anaerobic conditions for 1 year.

The morphology of the corrosion products on the concrete-embedded Al and Zn surfaces after 1 year of exposure is illustrated in Figure 7. Elemental analysis by means of EDS revealed the predominance of Al and O for the Al sample, and of Zn and O for the Zn sample. Both metals revealed the presence of C and Ca. These results are in accordance with findings with XRD that resulted in diffractograms that revealed significant peak overlap, especially for Zn, which complicated a detailed identification of corrosion products, Figure 7.

$\text{Al}(\text{OH})_3$ was the predominant corrosion product on the Al samples. No crystalline phases that directly could be related to the concrete constituents were observed. This was most probably a result of the rapid corrosion process and gas evolution taking place when the Al samples were inserted into the wet concrete. The gas created a narrow space between the concrete and the Al samples preventing incorporation of concrete into the corrosion products. The formation of thick corrosion products and continued evolution of gas further caused porous and partially non-adherent corrosion products that were left at the concrete interface when cracked open. FTIR analysis performed after the shorter exposure periods supported the findings of $\text{Al}(\text{OH})_3$ and implied the presence of both amorphous Al_2O_3 and CaCO_3 (Figure 8a).

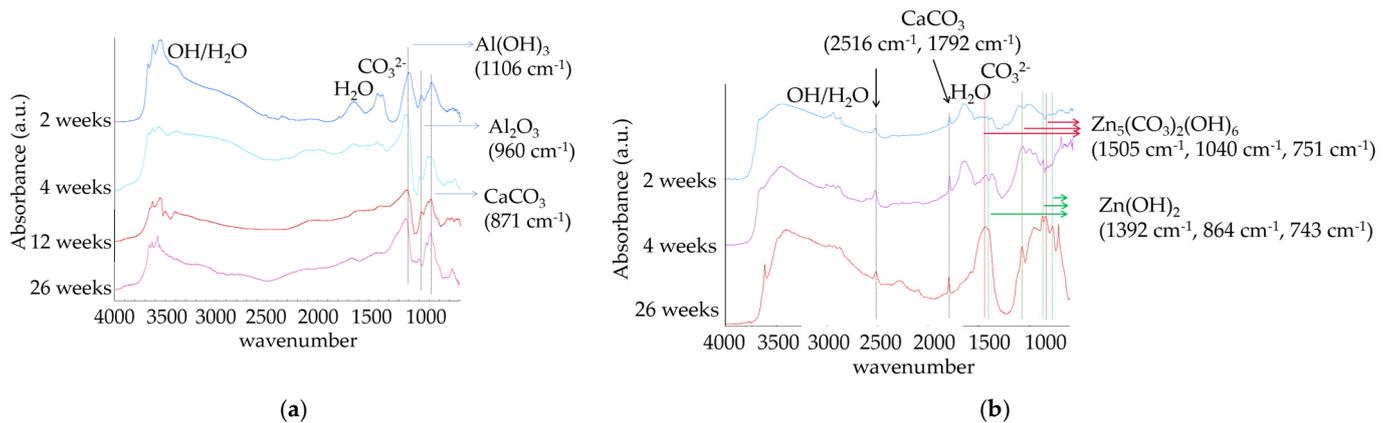
Figure 8. FTIR spectra generated for (a) Al and (b) Zn embedded in concrete immersed in AGW at anaerobic conditions for 2, 4, 12 and 26 weeks.

Since the investigations were performed on samples after exposure without any treatment or attempt to remove any residues from the concrete on the surface, concrete was still present on the surfaces of the samples. The incorporation of concrete constituents into the corrosion products on the Zn samples was therefore impossible to avoid without risking removing, changing or destroying the corrosion products. Both XRD and FTIR findings revealed spectra with overlapping peaks, which hampered their interpretation. The incorporation of concrete constituents into the corrosion products was evident. XRD revealed the presence of two crystalline compounds that could be related to the corrosion process, i.e., $\text{Zn}(\text{OH})_2$ and $\text{Ca}(\text{Zn}(\text{OH})_3)_2 \cdot 2\text{H}_2\text{O}$. The FTIR results (Figure 8b) supported the presence of both $\text{Zn}(\text{OH})_2$ as well as CaCO_3 and indicated the presence of amorphous $\text{Zn}_5(\text{CO}_3)_2(\text{OH})_6$.

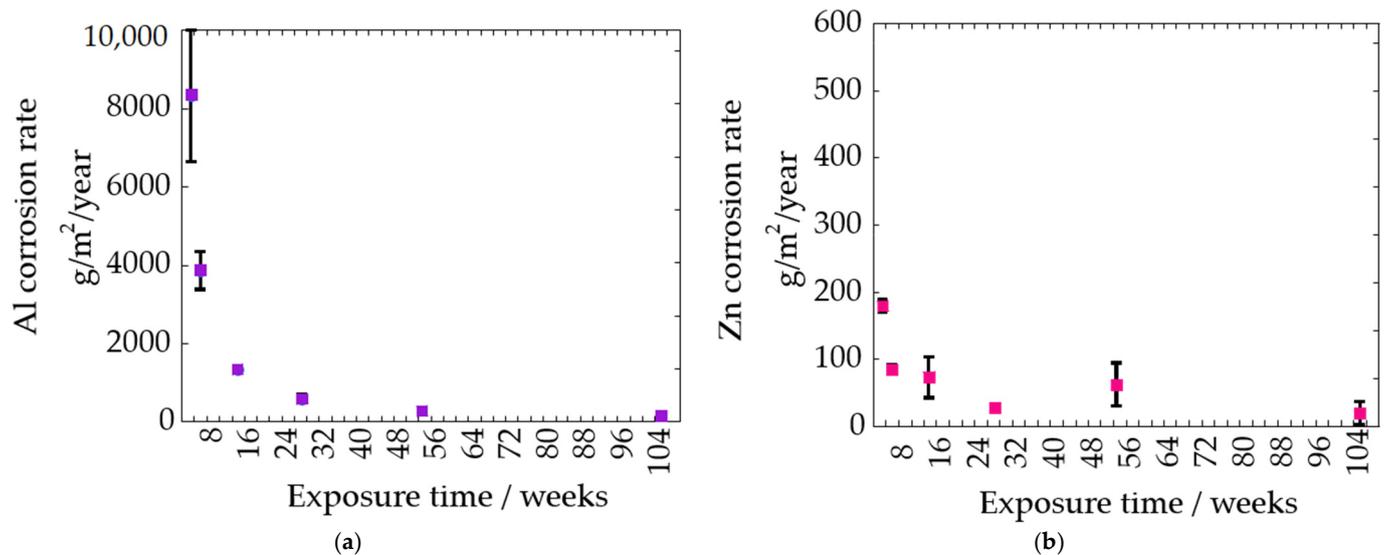
Figure 9. Corrosion rates of Al (a) and Zn (b) exposed in artificial ground water (AGW) at anaerobic conditions for 2, 4, 12, 24, 52 and 104 weeks.

With the fracturing of the concrete cylinders and the subsequent possibility of free transport of AGW, ions and corrosive species to and from the embedded metal surfaces, it was considered important to investigate differences between the corrosion of the Al and Zn metals in concrete and in AGW only. As discussed in the previous section, no significant difference in corrosion rates between the intact and cracked cylinders could be distinguished after 2 years of exposure of the Al samples. In addition, it was not possible to determine when the cylinders cracked and for how long the cracks allowed for free transport of AGW into the metal surfaces. However, these results suggest that the corrosion rate determining step was the barrier effect of formed corrosion products rather than direct surface contact with AGW. This hypothesis was supported by the corrosion rates determined for Al exposed in AGW only (Figure 9a and Table 3).

The initial corrosion rates of the Al samples in AGW were after 2 weeks ($8326 \text{ g m}^{-2} \text{ year}^{-1}$) and 4 weeks ($3856 \text{ g m}^{-2} \text{ year}^{-1}$), substantially higher (≈ 68 and 47% , respectively) compared with corresponding rates when exposed embedded in concrete, Figure 5a,b and Table 3. However, after 12 weeks of exposure, the corrosion rates were very similar and remained almost the same as in concrete after 24, 52 and 104 weeks of exposure ($146 \text{ g m}^{-2} \text{ year}^{-1}$ after 2 years) (Figures 5a and 9a and Tables 2 and 3). The similarity between the two different exposure conditions (concrete immersed in AGW and AGW only) strongly implies that the formation and barrier properties of corrosion products formed on the surface of the Al samples govern the rate limiting steps. It can also be concluded that exposures in AGW could, at least for the longer exposure times, be used to predict corrosion rates of Al in concrete at given conditions, and that cracks forming in the concrete should not speed up the corrosion process.

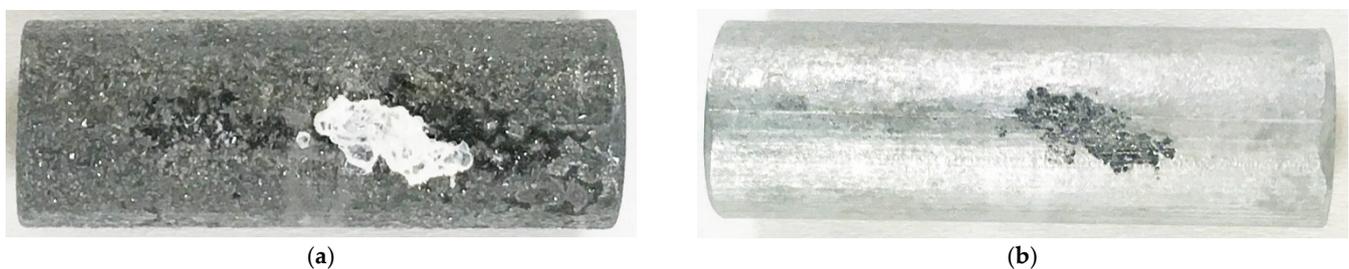
Figure 10. Zn sample exposed in oxygen free AGW for 12 weeks (a) before and (b) after pickling.

The Zn samples exposed in AGW were initially (2–4 weeks) visually very similarly corroded to the samples exposed in concrete with no signs of localised corrosion. For the longer exposure times, the area of the Zn samples in contact with the bottom of the vessel was partly covered by white corrosion products (Figure 10a). After the pickling procedure it was evident that local corrosion processes had been progressing in these areas (Figure 10b). These results explain the slightly higher corrosion rates in AGW compared with concrete. The surfaces only in contact with AGW did not show any signs of localised corrosion.
