Conservation of the Beira Railway Station in Mozambique: Lessons from a 20th-Century Heritage Case Study in Africa

Keywords: 20th-century built heritage; concrete; inspection and diagnosis; non-destructive evaluation; climatic analysis; comfort

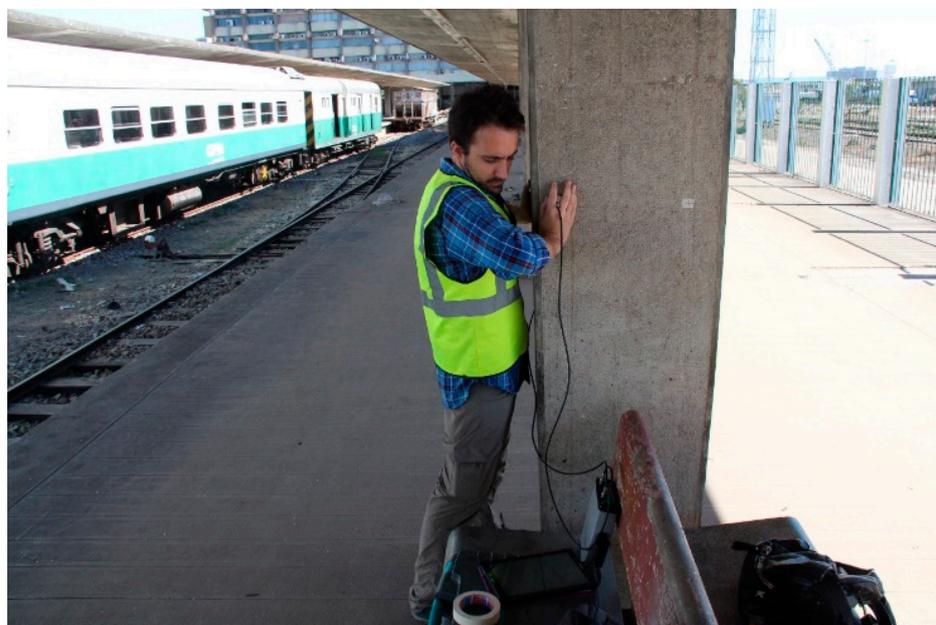
Figure 12. UPV test performed in one column in the platform area.

The UPV tests were performed in eight representative locations throughout the building. All tests were performed on concrete primary structural elements of the building, namely columns and beams. Exposed concrete structural elements, not covered by tiles, such as the columns in the platforms area, were preferred (Figure 12), as the columns in the administration body were all rendered with ceramic tiles. One of the concrete parabolic arches that define the atrium volume was also investigated. Two types of tests were used. The direct transmission arrangement, consisting of placing the transducers on opposite faces of the element, was used in all locations except one, where the indirect transmission arrangement was used. The tests were conducted with Pundit Lab equipment (manufactured by Proceq) with 0.1 μ s precision and two 54 kHz frequency transmission transducers. A coupling agent was used to give acoustical coupling between the concrete and the face of each transducer. The equipment measures the wave travel time (T). Once the distance between the centers of transducer faces (L) is known, the ultrasonic pulse velocity (V) can be calculated from Equation (1):

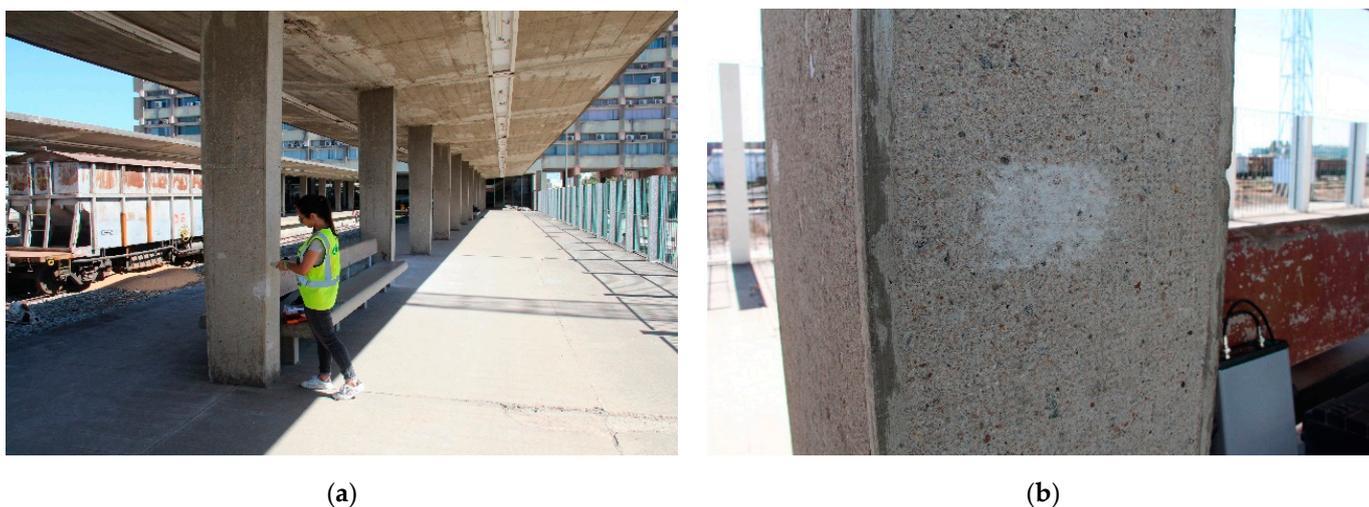
Figure 13. Rebound hammer test performed on a column on the platforms area: (a) test execution; (b) surface preparation.

The highest values of rebound numbers were obtained for the columns on the platforms, which range between 46 and 49. Nevertheless, all the remaining values of rebound numbers are within a similar range, varying between 44 and 45. The test performed in the exterior part of the arch showed a notably lower value, which can be because the surface tested seems not to be concrete but a rendering. The average value of the rebound number obtained from the six locations tested, disregarding the value from the arch, is 46. The variation among the locations is low, as well as the variations within each location. The sample is limited but, overall, shows a uniform concrete used throughout the building. Moreover, all values are above 40 and most of them are close to 50, which is typically indicative of good, hard concrete. Note that the scale ranges between 20 and 55.

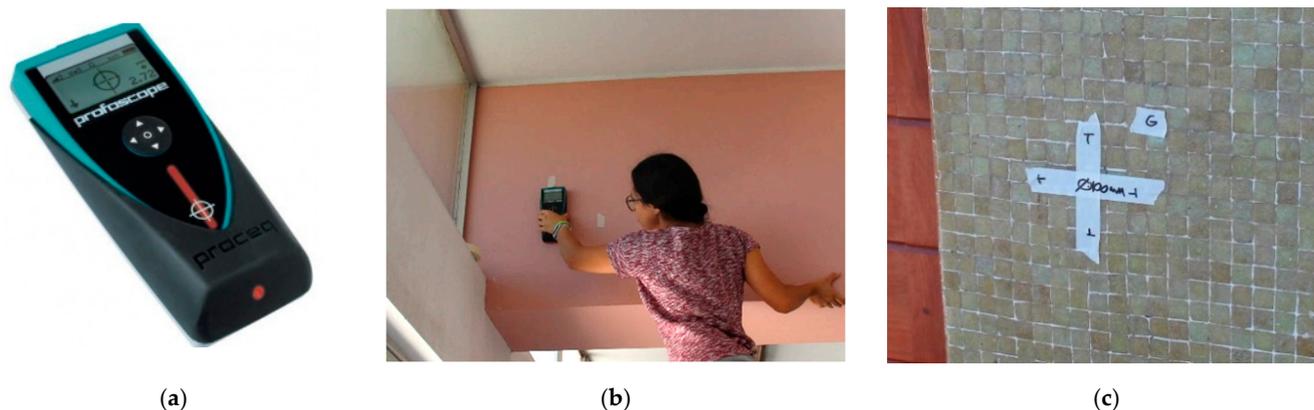
Figure 14. (a) PROCEQ Profoscope apparatus, (b) use of detector to find and mark suitable location for coring, (c) mark of location for coring.

In order to determine the appropriate location for the extraction of cores, a PROCEQ Profoscope rebar detector (Figure 14) was used. The compressive test specifications require concrete cores without reinforcing bars. The detector allowed us to locate the reinforcement bars and avoid them, so that intact concrete cores without reinforcement elements could be extracted.

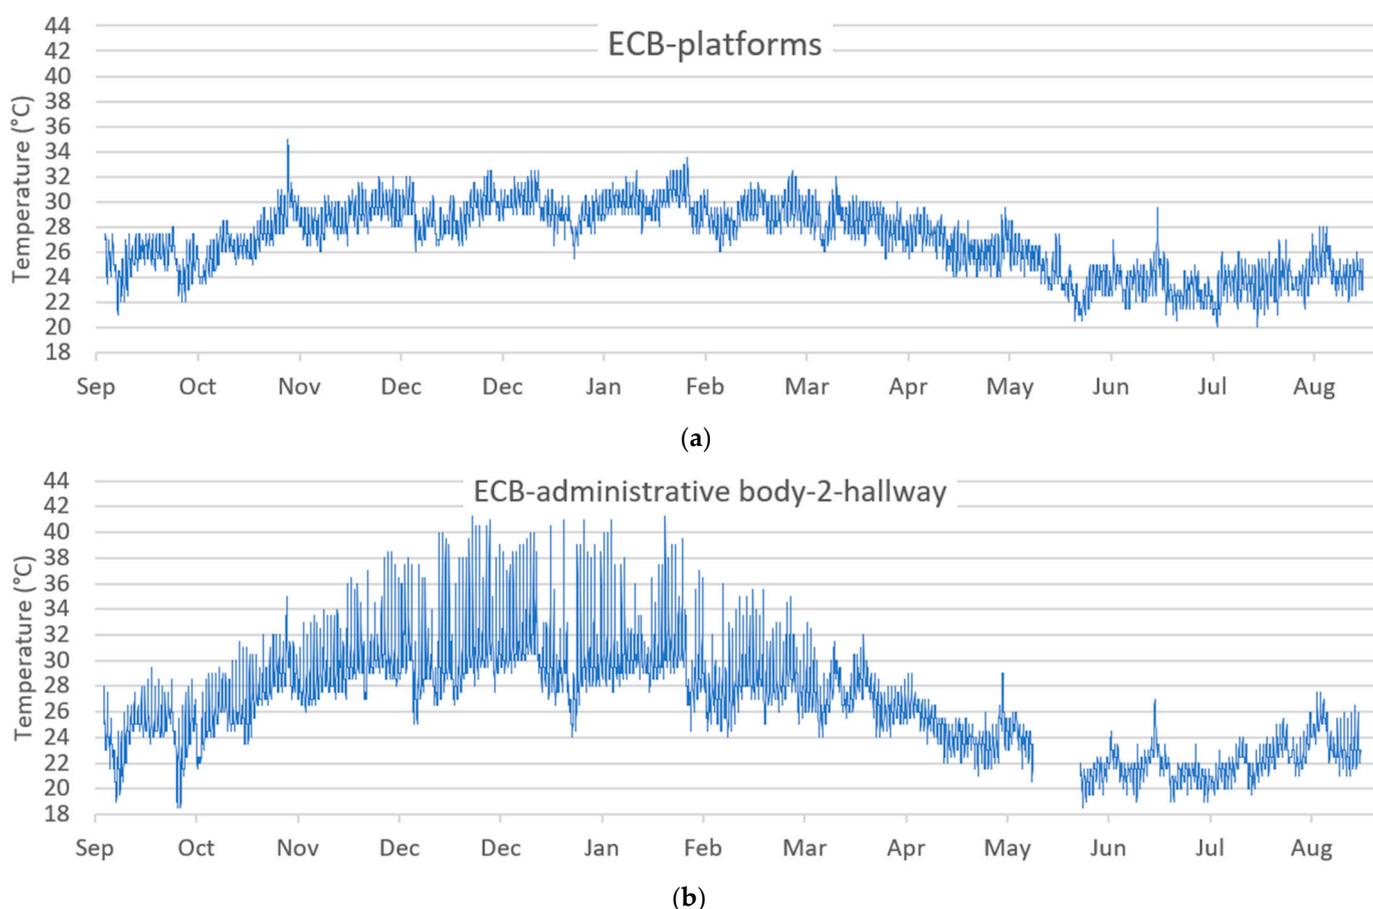
The results recorded from 4 September 2019 to 10 September 2020 show overall agreement with the general climate and weather information of Beira. The period that records the highest temperatures goes from November to March. From March to June, the temperatures decrease regularly, reaching minimum values in June and July. The overall trend can be observed clearly for the sensor located at the platforms, which provides a continuous reading of the temperature throughout the year (Figure 17). For sensors 1 (Figure 17a), 2, and 5 (located at the atrium, the platforms, and the interior of the administrative body, respectively), the daily variation of temperature throughout the year is regular, having a greater amplitude in the case of the platforms, which can be justified since this sensor is located in the exterior and is more subjected to the daily variations, while the other sensors are in interior spaces. The differences between maximum and minimum temperatures registered during the year are similar to the average ones. The average temperature varies from 18 °C in June to 32 °C in February, as registered by the sensor located on the exterior, in the platforms area. For the sensors located in the hallways of the administrative body, the daily variation of temperature is greater than 10 °C within a single day (Figure 17b). However, the daily variation of temperature is not regular throughout the year, as it is for the other sensors. The results show that the greatest amplitudes occur during the months of highest temperatures, from December to February. Possibly, the location of the sensors adjacent to the glazed façade is responsible for the higher variations. Indeed, the months when the highest daily variations of temperature and humidity are recorded by the sensors of the hallway correspond to the months when that façade (southwest) is exposed to direct solar radiation for a longer time during the day. This is further explored in the solar study performed and explains why, for the other sensors, the daily amplitude of temperature is lower and more regular during the year.

Figure 17. Temperature values per hour recorded by: (a) sensor 1 (at the platforms on the exterior); (b) sensor 3 (in the hallway of the administration body, second floor).

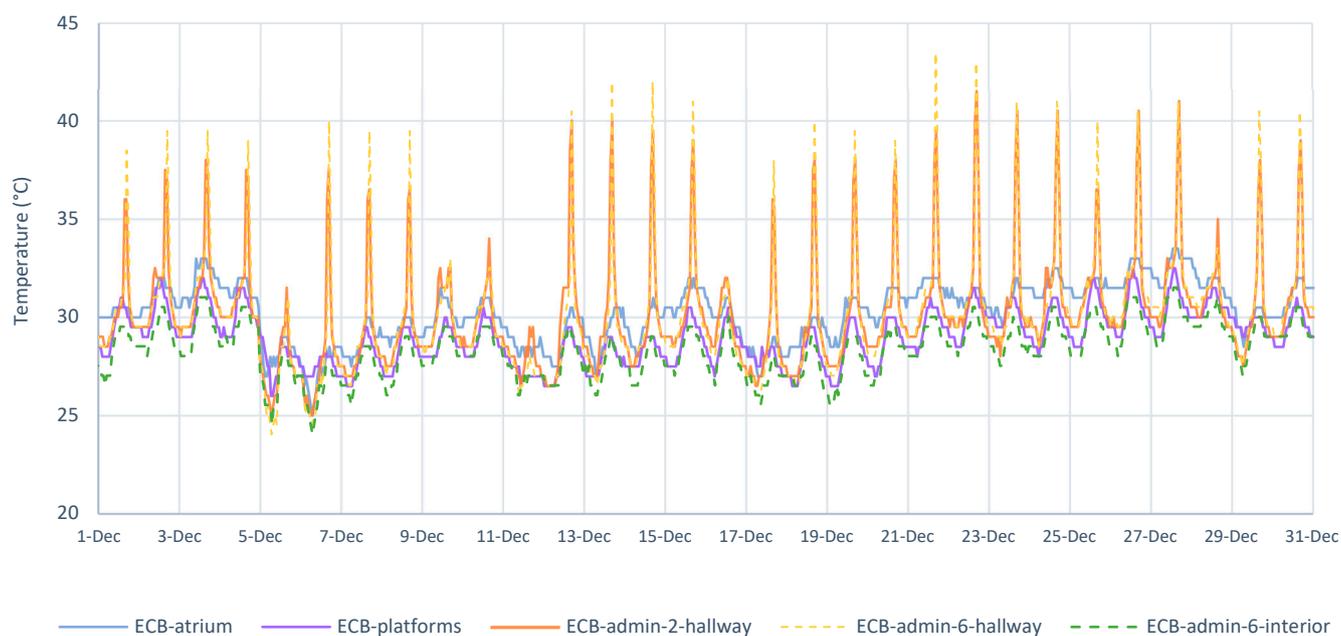
Figure 18. Temperature values per hour in December 2019.

To better understand the thermal behavior in each area, a closer look at the temperature profile is shown in Figure 18. December was analyzed since it presents the highest values of temperature and the highest differences between sensors. The two sensors close to the glazed façade reach maximum peaks of temperature 10 °C greater than the remaining ones. It is noted that these sensors are located in the shade. Thus, temperature variations can be greater in areas directly exposed to solar radiation. This is the case with the exterior masonry walls of the administration body, which show severe cracks in a random pattern. They are directly subjected to solar radiation and thus subjected to significant variations in temperature within a single day, likely over 20 °C. The thermal variations on the walls can, very likely, justify the widespread cracking observed, possibly combined with thermal shock in case of sudden intense rain.

The remaining three sensor locations show a more uniform temperature with maximum values typically exceeding 30 °C and daily variations of less than 5 °C. Thus, the temperature is generally too warm to guarantee thermal comfort conditions. The office on the sixth floor shows the lowest temperature values and the comfort conditions could be, possibly, improved by increasing ventilation (to reduce the possible greenhouse effect in the hallway) and air velocity.
