Identification and Mitigation of Subsidence in Karstic Areas with Sustainable Geotechnical Structures: A Case Study in Gallur (Spain)

Abstract: In various areas of the Ebro valley in Spain, including the region discussed here, the risk of sinkholes is becoming particularly severe, particularly impacting urban areas and roadways where land subsidence from karstic processes is common. However, knowledge of the area, its geological–geotechnical configuration, and the carrying out of specific research studies are allowing solutions to be tested in an attempt to resolve these situations. A case in point is the examination of settlement issues along a stretch of the access road leading to the city of Gallur from the east (known as Camino Real) in the Zaragoza province, Spain. Numerous surface manifestations of recent subsidence and/or collapse activities have been observed, manifesting as craters and ground undercuts, some several meters in diameter. The prevalence of highly karstifiable materials in the area, evident from the existence of subsidence pockets and collapse dolines, poses significant safety concerns, particularly for traffic and town access, prompting the closure of Camino

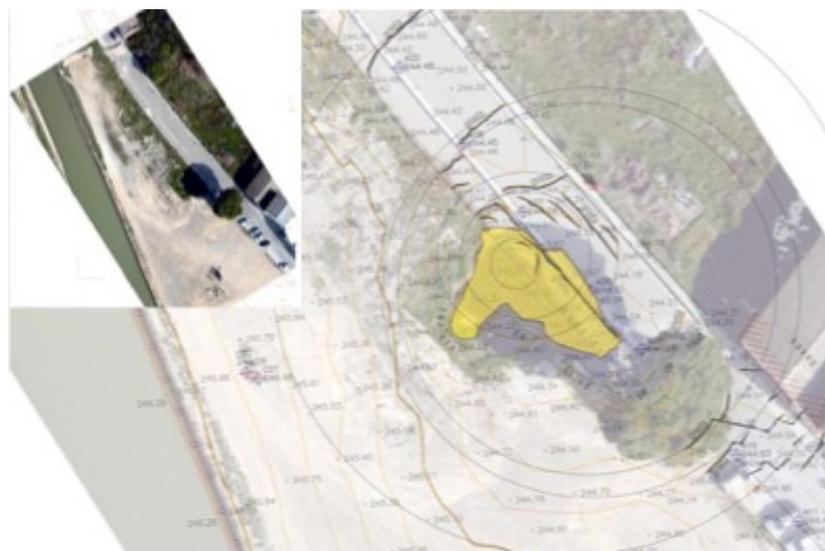
Sinkhole hazards exert a significant economic impact in Spain, as indicated by recent studies focused on identifying and investigating sinkholes in the Iberian Peninsula [9,14–16]. Specifically, the city of Zaragoza in northeastern Spain and its surrounding areas are identified as the highest sinkhole risk area in Europe [17]. The abundance of gypsum serves as the primary origin of these sinkholes, although the interstratal dissolution of halite and glauberite beds also contributes to their development [9,17,18]. In this context, this paper presents a case study in Gallur, a town situated in a high-risk area in Spain (Figure 1). Over the course of several years, the access road to Gallur from the east (Camino Real) experienced disruptions due to the emergence of a sinkhole, impeding access to the town. A preliminary examination of the area uncovered a sinking sinkhole, with its most depressed sector located immediately to the southwest. In this region, a cluster of discharge edges was identified, undermining the mentioned road surface (Figure 2).

Figure 2. Topography via aerial photography (year 2015). The area affected by land subsidence is marked in colour (yellow). The layout of the contour lines shows the subsidence edges and defined.

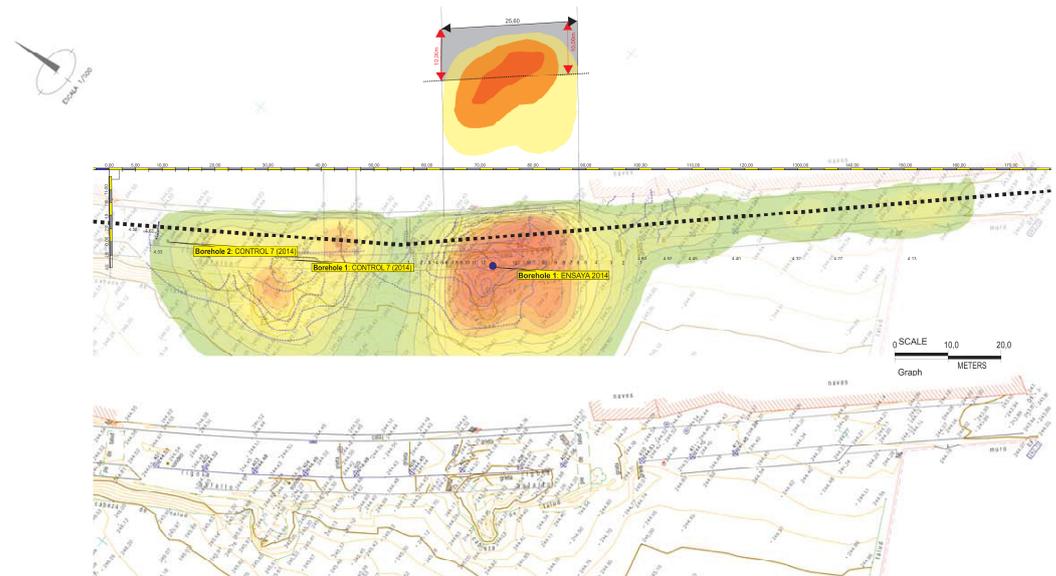
Figure 4. Situation plan with positioning of the subsidence model defined, based on the existing data.

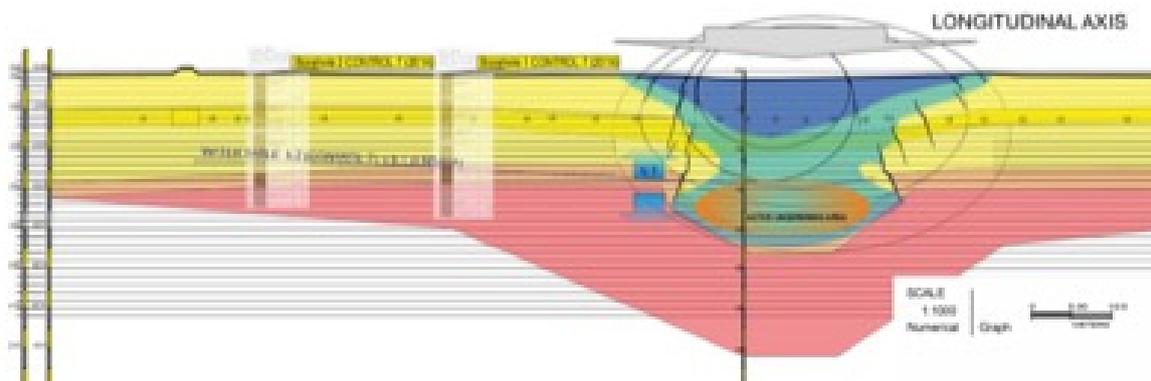
In the correlation conducted (Figure 5), two reference (guide) levels were obtained, serving to establish the relative decreases recorded in the subsidence zone affected by the sinkholes in this particular case. Level two (2), made up of coarse gravel with sand, showed a relative drop of around 3–4 m in the sounding. Reference level 4 also showed a relative drop of another 4–5 m, so that the accumulated result would be in the order of 7 to 9 m. The thickness of level 3 reached more than 10 m in the area that registers a subsidence process, while in the part where apparently that did not occur, the thickness was between 5 and 6.5 m. One can interpret that the gravel with sand that forms this defined level is very dense and compact ($N_{SPT} > 50$ /Rejection) in boreholes 1 and 2 and much looser, not very compact, in the borehole performed in the sinkhole, where the resistance to penetration ($N_{SPT} = 5$ –14) is significantly lower. The model considered the ground following the geotechnical profile obtained in this work (see Table 1 for the corresponding properties).

Figure 5. Longitudinal geological–geotechnical profile established based on the existing data.

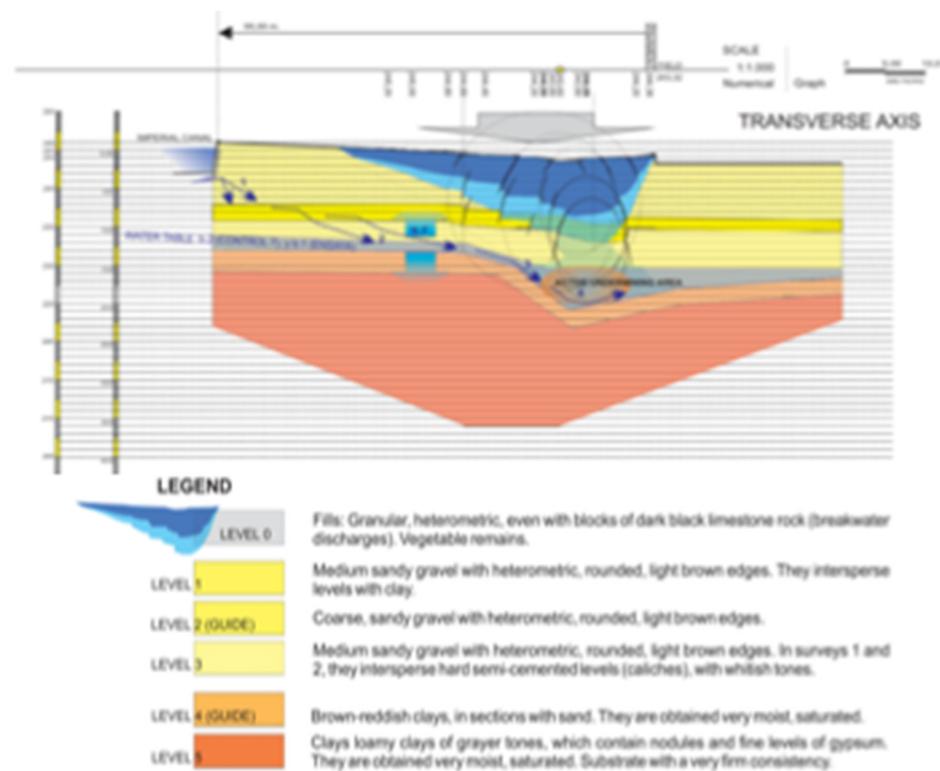
1. In the area of the oscillation of the water table and in the contact between the deposit of granular material (gravel and sand) and the clay–marl substratum (with gypsum), there is an anomalous differential concentration of a sub-valve flow in the direction of the river Ebro.
2. A higher velocity flow is generated in this area and, consequently, a greater dragging capacity (scour) of both the fines in the granular deposit and those displaced due to the alteration of the substratum.
3. For this reason, the gravel of level 3, in the zone of contact with the clayey substrate, has a low fines content, which results in a higher relative permeability and abnormally low strength.
4. Hence, the process can be likened to a large hourglass with lateral expansion, favoring the preferential flow line toward the base level of the entire aquifer system, situated in the direction of the Ebro river.

Figure 6. Geological–geotechnical cross-sectional profile established based on previous existing data (source: [21]).

From a perspective taken from a transversal axis of the road (Figure 6) and based on the surface morphology of the terrain, an interpretation of the situation can be made that leads to a model in which the following aspects can be assessed:

- There is no nearby catchment basin that could justify a process of this magnitude. The unusual influx of water into the system might be attributed to the nearby Canal Imperial de Aragón. In recent history, it is widely known that repairs were necessary on a section located immediately to the west, merely 30–40 m away. The same issue that prompted the aforementioned repair could have influenced the emergence of the new subsidence observed in this access area to Gallur.

- These inputs have been infiltrating for a long time through the gravel deposit that makes up the soil in the area. The infiltrated flow was incorporated into a system of high relative porosity (levels 1 and 2), taking advantage of levels where the proportion of fines is lower (level 3), incorporating itself into the phreatic. The natural, preferential direction of this flow is in the direction of the river Ebro, towards the west.

- Taking into account the correlation among the boreholes surveyed, it is conceivable that there was a reduction in the relief corresponding to the Tertiary substratum. In this relative difference in elevation, there is a shift in the speed of the phreatic flow, which also integrates infiltrated contributions from the nearby channel, likely accumulating over the years. This contact gives rise to a flow with higher velocity and, consequently, an enhanced capacity for dragging (scour) of both fines from the granular deposit itself and those displaced due to the alteration of the substratum.

- Even though the issue of seepages from the canal was addressed at the time, the process retains a certain inertia that promotes the emergence of sinkholes long after the required repairs to the canal were completed. It is crucial to ensure that the canal does not persist in leaking within this environment.

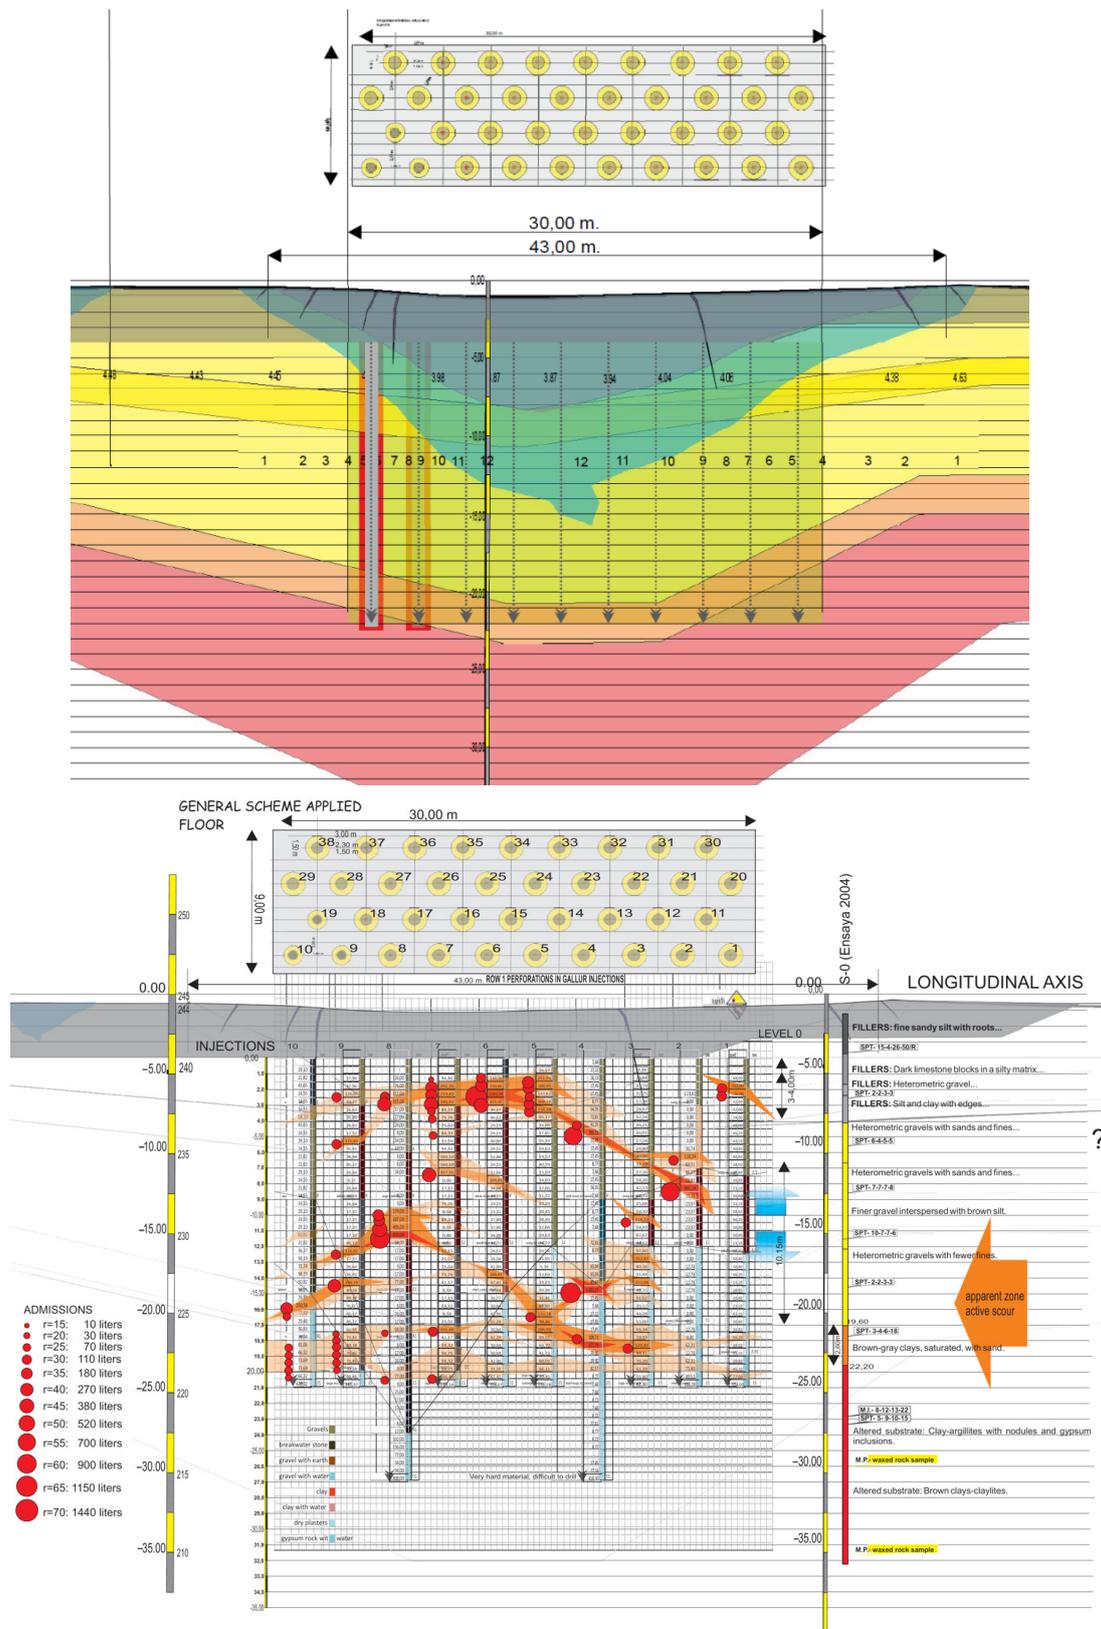
Figure 11. Profile showing the arrangement of the injections in the section with the highest apparent subsidence at the surface, where the correlation model showed the largest deformations.

The work was carried out in the arrangement shown in Figure 11 and to previously determined depths at each injection point, initially assessed to be -21.00 m deep from the excavation grade, at -3.00 m from the current street.
