Influence of the Manufacturing Process on Defects in the Galvanized Coating of High Carbon Steel Wires

Abstract: This study is a detailed failure analysis of galvanized high carbon steel wires, which developed coating cracks during the torsion test performed as a quality control at the end of the manufacturing process. Careful visual inspections showed that the cracks are already present in the coating before the torsion test. In order to explain the origin of these cracks, systematic metallographic investigations were performed by means of optical and scanning electron microscope on both the wires and the rods that have been cold drawn to produce the wire. The chemical composition of the galvanized coatings was evaluated by means of energy dispersive spectroscopy. Micro bidimensional X-ray diffraction experiments were also performed to measure the residual stresses in the galvanized coating. The results showed that the failure is related to two main factors: the relatively high content of silicon in the steel and the unsuitable cooling rate of the rods at the exit from the galvanizing bath. The mechanism proposed to explain the origin of the defects was supported by Finite Elemen

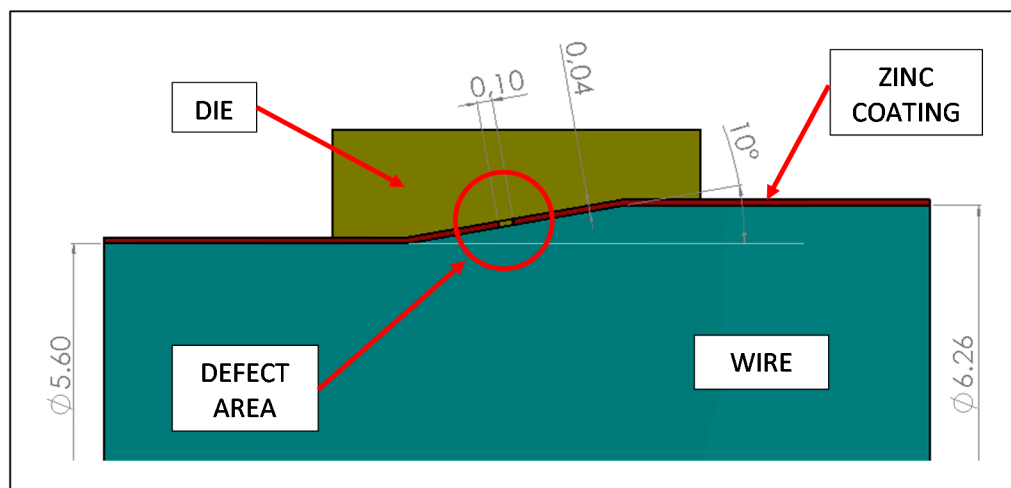
Figure 3. Model geometry for FEM analysis.

The model geometry defined for the simulation is shown in Figure 3. On the basis of metallographic analysis, the Zn coating thickness was fixed at $40\text{ }\mu\text{m}$, while the defect was considered to be a coating delamination with the length of $100\text{ }\mu\text{m}$. The approach angle of the die is 10° and the area reduction per drawing pass is 20%. The interface between the wire and the zinc coating was bounded, while the zinc coating and the die surfaces are in contact. The friction coefficient between the galvanized rod and the die wall was reasonably fixed at 0.1 [17].
