Building Damage and Business Continuity Management in the Event of Natural Hazards: Case Study of the 2004 Tsunami in Sri Lanka

Chandana Dinesh Parape ^{1,*}, Chinthaka Premachandra ², Masayuki Tamura ¹, Abdul Bari ³,
Ranjith Disanayake ³, Duminda Welikanna ¹, Shengye Jin ¹ and Masami Sugiura ⁴

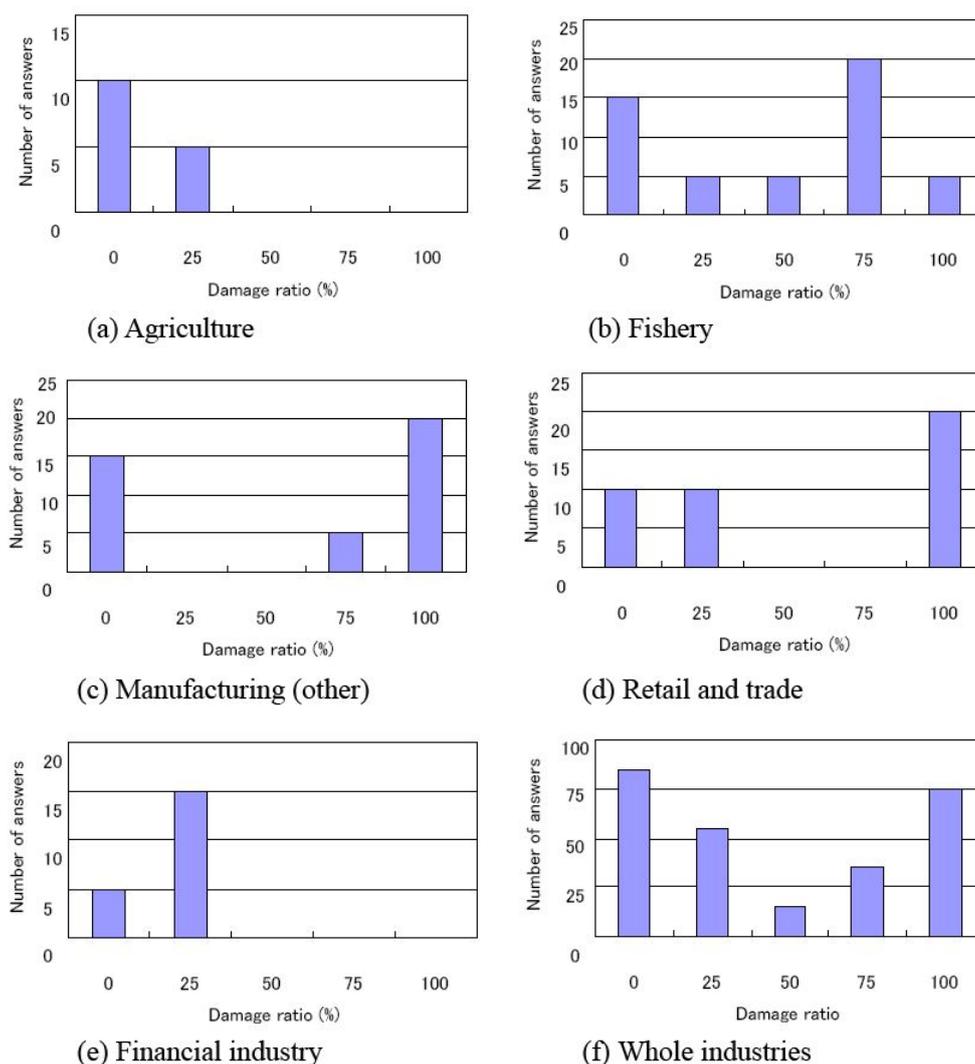
Figure 3. Damage to building facilities.

Figure 3 shows the total building damage percentage of each industry. Most of the buildings in this local area were made of bricks or reinforced concrete. However, in case of buildings located near the coastal area, not only infill walls but also concrete frames were washed away by the tsunami severely.

As regards the fact that most of the concrete frames were damaged and or washed away, it is difficult to recognize the places of reinforcing rods. In addition, most of the buildings in manufacturing industries and retail trade had 100% damage. On the other hand, the finance business and lifeline companies had little damage.

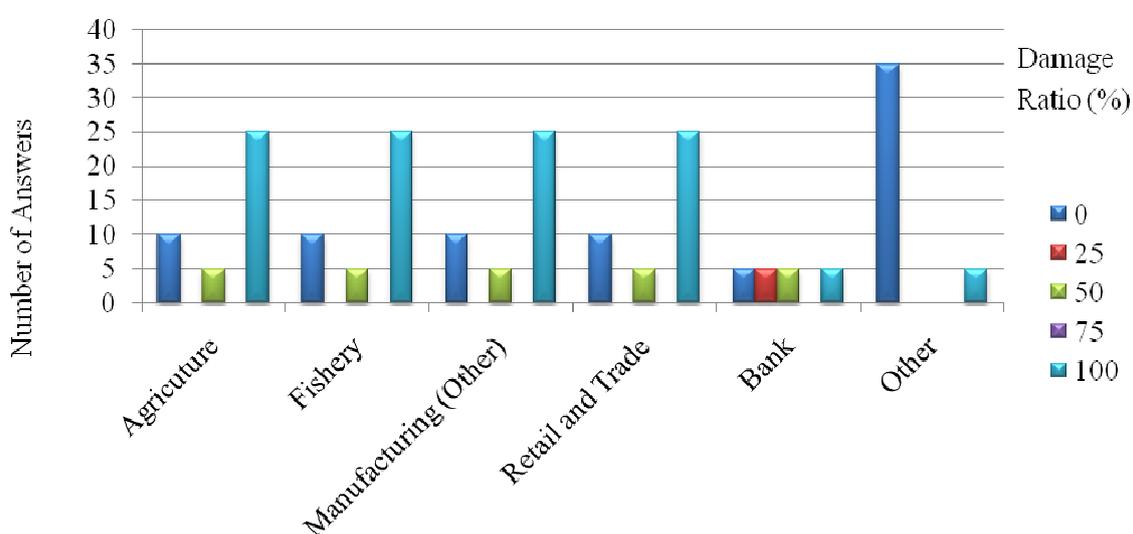
Figure 4. Damage to industrial facilities.

The damage to the industrial facilities is shown in Figure 4. The types of facilities are different in each company, except financial (banks) and lifeline companies, in which the percentage of damage concentrates from 0% to 100% and becomes a concave distribution. From the individual answers of the investigation, the facilities inside the buildings were buoyed with the flood current, including debris. In many places, electric facilities soaked in seawater did not report massive damage to the outside of facilities, but their internal electricity systems tended to break down. The facilities of an ice making company were heavily damaged including equipment such as electric generators and other ice plant devices.

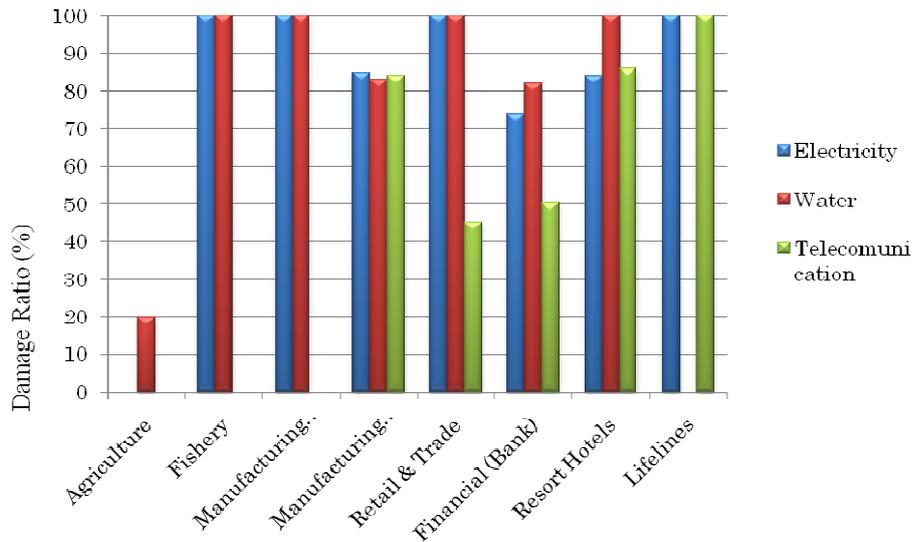
Figure 5. Damage condition of lifeline.

Moreover, the three lifelines of electricity, water supply and telecommunication have been investigated. Because the study area had not a gas pipeline but LP (Liquid Petroleum) gas cylinders, the gas lifeline was removed from this analysis. In terms of water supply, most of the families in the countryside usually use well water. However, in this study, we were concerned with the damage related to piped water. Figure 5 shows the supply situation of lifelines according to each type of industry. In case of agriculture, they were located far from the coastline, thus protecting them from the tsunami damage in Galle. Comparing three lifeline systems, on average 84% of the electricity system and 75% of the water supply system were out of service after the tsunami. However, the telecommunication system had less damage compared with other lifelines. The people already use mobile telephones, and therefore the influence of blackout was small for fixed lines.
