# Development of a GIS Tool for High Precision PV Degradation Monitoring and Supervision: Feasibility Analysis in Large and Small PV Plants

This study aims to evaluate the potential of a specifically designed GIS tool in the location of PV faults and analysis of the degradation effects on PV power plants working in real operating conditions. As a case study, the proposed tool was applied to two representative PV plants: a 108 kW peak power (kWp) grid connected power plant and a 9 kWp self-consumption power plant.

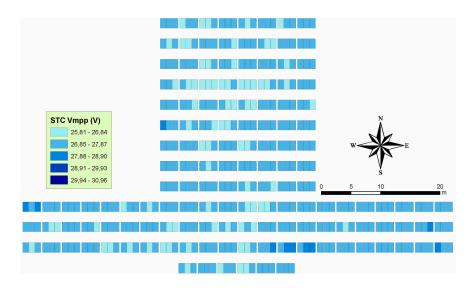
Figure 13. STC maximum power voltage distribution analysis (108 kWp PV plant).

Figure 13 shows the STC maximum power voltage distribution. In this case, the distribution seems to be less homogeneous than the one seen for the maximum power current. Lowest maximum power voltage modules, in the range 25.81–26.84 are located in the northern and center parts of the PV plant, while certain modules located in the second row from the south show a higher voltage value. The histogram for this parameter, which can be seen in Figure 18f shows a distribution close to the normal, with less than 4% of the voltage values higher than 27.68 V and less than 3% of the values lower than 26.40 V.

In Figure 12 the STC maximum power current can be easily distinguished between the groups of PV modules with high values. Distribution on the PV field of this electrical value is not uniform and low values can be correlated with low values of the STC maximum power voltage in Figure 13. Undoubtedly, those PV panels must be inspected with special caution. It can be noticed that higher differences in this value between close located PV modules can be found than when analyzing the maximum power voltage distribution.

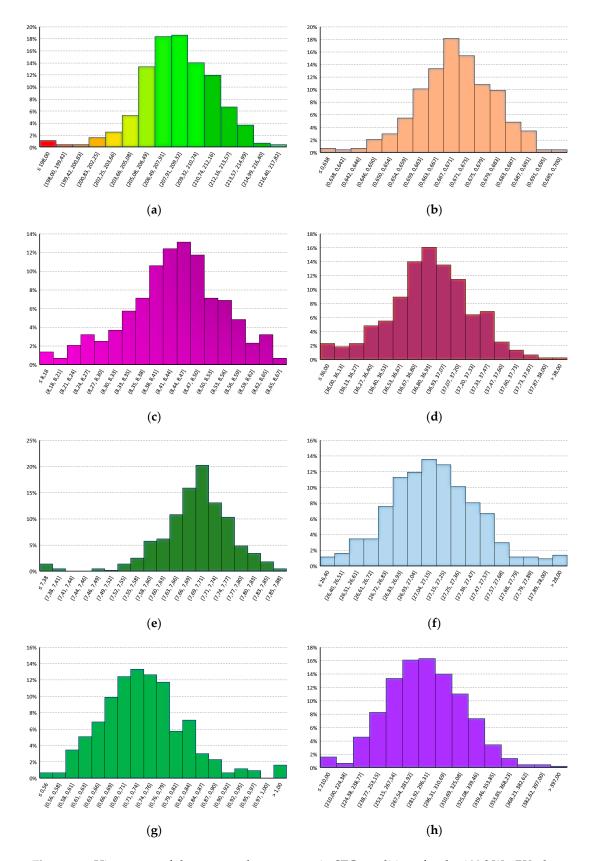
**Figure 18.** Histograms of the measured parameters in STC conditions for the 108 kWp PV plant: (a) peak power; (b) fill factor; (c) short circuit current; (d) open circuit voltage; (e) maximum power current; (f) maximum power voltage; (g) series resistance and (h) parallel resistance.

Figure 8 shows lower peak power values for STC conditions in the center of the lower part of the installation, whereas the extremes show significantly higher values. This effect may be caused by the temperature distribution through the PV modules and the refrigeration by air convection conditions. The lowest STC peak power was 184.46 W, where the highest value was 217.82 W (18.09% difference). Figure 18a shows the distribution of the peak power values, where it can be noticed that more than 70% of the modules are in the 205–211 Wp range.

In a similar way, Figure 9 shows the fill factor of the PV modules transformed to the reference STC. Figure 18b shows the histogram for these values. It can be noticed that the PV modules are affected by a significant rate of degradation where 80% of the modules are in the range 0.66–0.68, when the nominal fill factor (FF) given by the manufacturer achieves 0.8018 (see Table 3). Less than 1% of the PV modules present a FF > 0.695. Moreover, it can be observed that those modules with lower values for peak power in Figure 8 show also lower values of FF in Figure 9. However, higher variations of the FF can be noticed in this late figure rather than on the peak power analysis. The fill factor distribution shows not to be homogeneous in the installation and, thus, modules with high values of FF are linked to modules with very low values for FF. Some cases show differences up to 10.53%. This may affect significantly the overall performance of the string series.

Figures 10 and 11 show the STC short circuit current and STC open circuit voltage distributions respectively. Moreover, Figure 18c,d shows their histograms. From these figures it can be observed that there exist very slight variations on the short circuit distribution (0.6 A max), but significant variations (up to 3.28 V) in the open circuit voltages. Both distributions in the spatial field are absolutely not homogeneous.

Figure 12 shows a uniform distribution of the STC maximum power current distribution apart from few PV modules which show current values in the range 6.52–6.79 A, while the average, according to Figure 18e is 7.67 A, which is 3.56% lower than the nominal  $I_{mpp}$ .

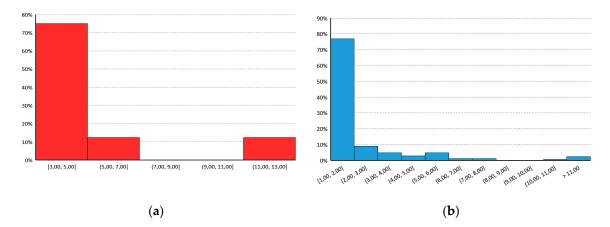
**Figure 19.** Histograms of the main PV faults found at the 108 kWp PV plant: (a) hot spots and burn marks and (b) snail tracks.

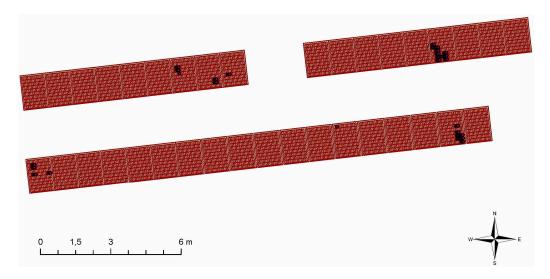
**Figure 21.** Cells discoloration distribution (9 kWp PV plant).

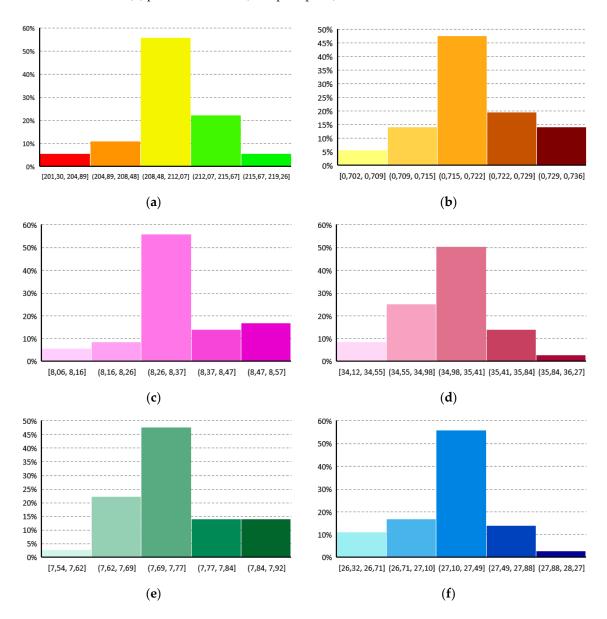
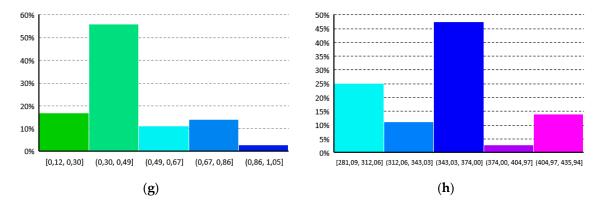
**Figure 23.** Histograms of the measured parameters in STC conditions for the 9 kWp PV plant: (a) peak power; (b) fill factor; (c) short circuit current; (d) open circuit voltage; (e) maximum power current; (f) maximum power voltage; (g) series resistance and (h) parallel resistance.

Figure 23c–f shows the histograms for  $I_{sc}$ ,  $V_{oc}$ ,  $I_{mpp}$ , and  $V_{mpp}$ , respectively. Dispersion of these parameters is too low and no high differences with the nominal values are observed.
