# Detection of Porosity in Impregnated Die-Cast Aluminum Alloy Piece by Metallography and Computer Tomography

**Abstract:** The porosity of die-cast aluminum alloys is a determining factor for the quality of the product. In this paper, we studied the porosity of a selected part of a die-cast AlSi9Cu3(Fe) compressor part by computer tomography and metallography. In the case of this part, the achievable resolution by CT, a non-destructive testing method, was 30  $\mu\text{m}$ —this method could not detect smaller cavities. Based on metallographic analysis, the percentage of defects larger than 30  $\mu\text{m}$  ranges from 10 to 30% of the total number of defects, which represents 75–95% of the defective area (area ratio). Impregnation with methacrylate resin (used to seal cavities to prevent leakage) can be detected with UV-illuminated optical microscopic examination on metallographically prepared specimens. As confirmed by scanning electron microscopy, partial filling and partial impregnation can occur in a system of shrinkage cavities.

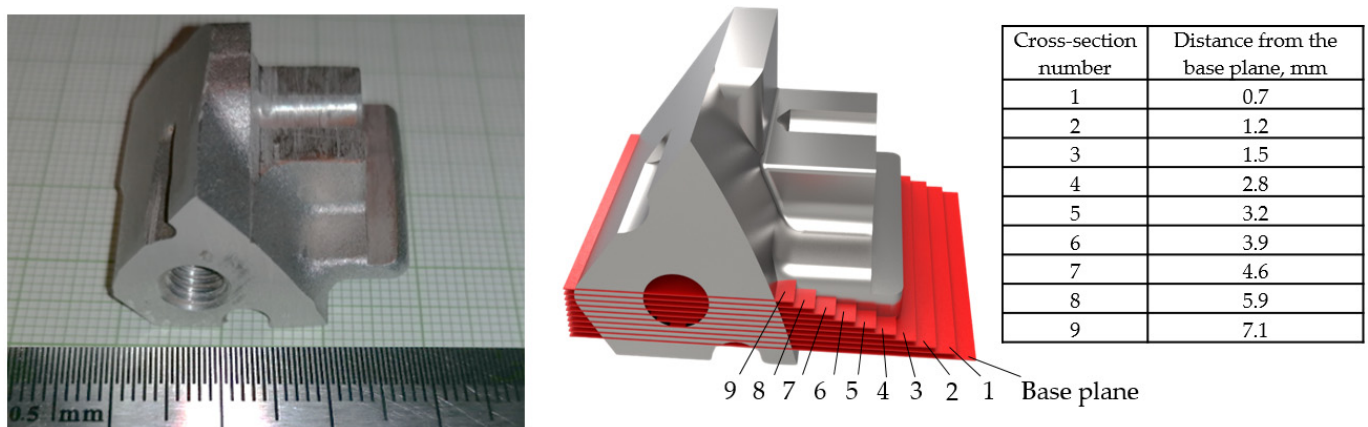
A detailed structural analysis was conducted on the cast piece (Figure 1). The machined specimen contains a volumetric size of about 4.5 cm<sup>3</sup>, including the threaded bore. Therefore, it can be assumed that there are discontinuities associated with leakage in this region. The defect distribution characteristics were determined by computed tomography (micro-CT) and metallographic analysis, for which the sample was embedded in metallographic resin. The tests were carried out within the planes presented in Figure 1. The examined planes were parallel to the base plane. The sample was studied by light optical microscopy (LOM), without etching, after metallographic preparation (grinding and polishing). Lower magnification metallographic images, showing the complete cross-section of the sample, were produced with an OLYMPUS DSX1000 (Olympus Scientific Solutions Americas Corp., Waltham, MA, USA) opto-digital microscope with a resolution of 3.4  $\mu\text{m}$ . Higher-resolution images of the elements of the revealed structure were produced with the opto-digital microscope (LOM) and a JEOL JSM 5310 LA scanning electron microscope (SEM).

**Figure 1.** The sample from the leakage region and positions of the cross-sections examined by metallography.

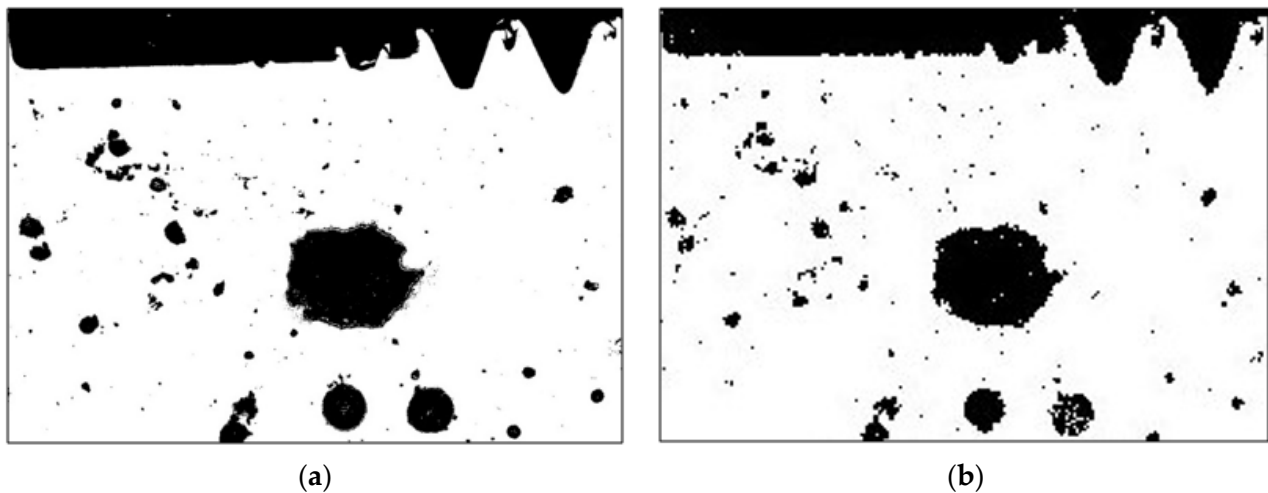
in size increased during binarization. We did not modify the binarized image in any way. Figure 5 shows the optical and CT images of Figure 4d after binarization. The binarized CT image on the right shows several continuity gaps of 1 pixel in size, which are not found in the optical image (left), which we consider the reference. In order to reliably evaluate the area of larger cavities, we did not apply erosion and dilation to the image. Optical microscopy images can have similar defects, but to a lesser extent, due to the significantly better image quality.

**Figure 5.** Images of cross-section 6 after binarization; (a) optical microscopy; (b) micro-CT.

In the full cross-section of the sample (Figure 5), 3901 defects can be detected in the optical microscopy image and 849 defects in the CT image.

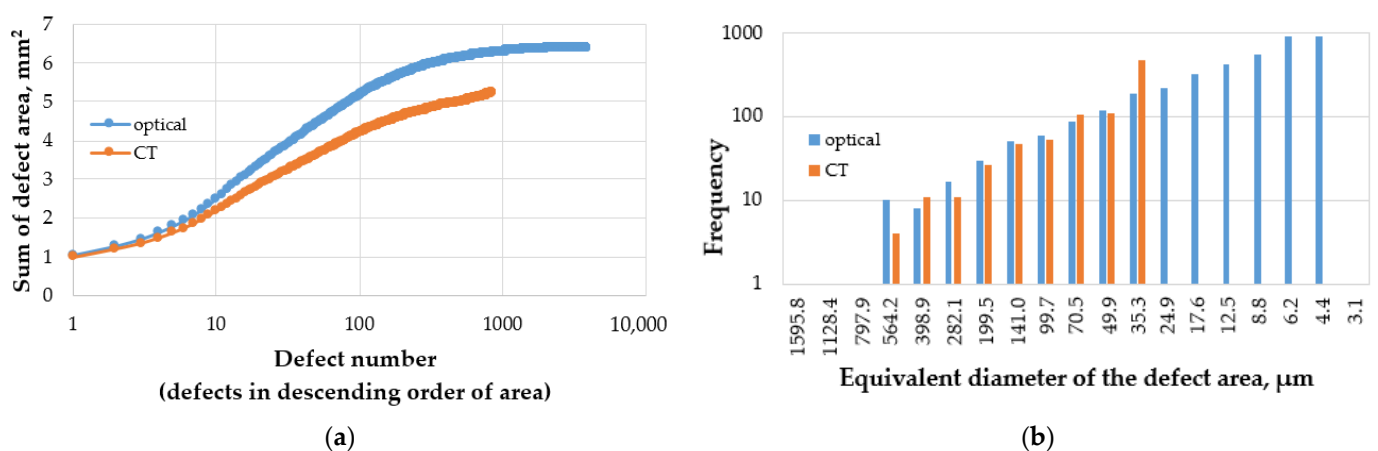
The diagram in Figure 6a shows the size distribution of the identified defects. In this diagram, the diameter of a circle with the same area as the defect area, the so-called equivalent circle diameter, is used to characterize the size of the defect. The frequency of defects increases sharply with decreasing size, based on both the metallographic and CT examination results. The higher value identified in the CT image in the 35  $\mu\text{m}$  equivalent defect size category is caused by the binarization of the gray image, as explained above. The 35  $\mu\text{m}$  equivalent defect size category is representative of the presence of continuity defects of a few pixels in the CT image.

**Figure 6.** Assessment of the discontinuities identified in cross-section 6. (a) Frequency distribution of defect size (equivalent circular diameter); (b) sum of defect areas in descending order.

More than 3,000 defects, or about 78% of the total number of defects, cannot be detected by CT because their size falls below the resolution of CT, in the equivalent diameter range

of 4–30  $\mu\text{m}$ . However, this amount of defects account for about 19% of the area of defects, i.e., more than 80% of the defect area in the examined section was detectable by CT. We sorted the detected defects in decreasing order as a function of their area measured in the plane and then plotted the sum of the defect areas 1 to  $n$  ( $n \leq$  number of defects) (Figure 6b). The value of the points representing the sum function provides the sum of the area of the detected defects, with a maximum value of 6.4 mm for optical microscopy and 5.3 mm for CT.

The area sum function for CT is continuously below the area sum function determined by optical microscopy. The area of the first defect, i.e., the largest defect (the largest defect in the images in Figure 2), is 1.03 mm<sup>2</sup> in the optical microscopy image and 0.98 mm<sup>2</sup> in the CT image. The summed areas of the first ten largest defects show a similar difference, with 2.48 and 2.17 mm<sup>2</sup>, respectively. The cumulative defect area up to the first 849 defects (all the defects detected by CT) is 6.259 mm<sup>2</sup>, determined by optical microscopy, and 5.222 mm<sup>2</sup>, determined by CT. The cumulative area of the 3901 defects detected by optical microscopy is 6.340 mm<sup>2</sup>. The 3901 – 849 = 3052 defects identified on the metallographic section account for 6.340 – 6.259 = 0.081 mm<sup>2</sup> of the cumulative defect area, proportionally 1.3% of the total value.
