# Failure Analysis of High Strength Galvanized Bolts Used in Steel Towers

**Abstract:** This paper analyses the failure of three bolts used in the structural connections of a number of steel towers located in northern Europe. The analysis comprises optical and scanning electron microscopy, microstructural and hardness analysis, mechanical testing and structural integrity assessments. The three bolts present very similar failure processes, with a circumferential external crack that led to the final failure. The morphology of the crack propagation is typical of Hydrogen-Induced Stress Corrosion Cracking (HISCC), with mixed intergranular-transgranular micromechanisms, tearing processes and secondary cracking. The cracks then grew subcritically until they reached their critical size. Quench cracking or fatigue processes have been ruled out.

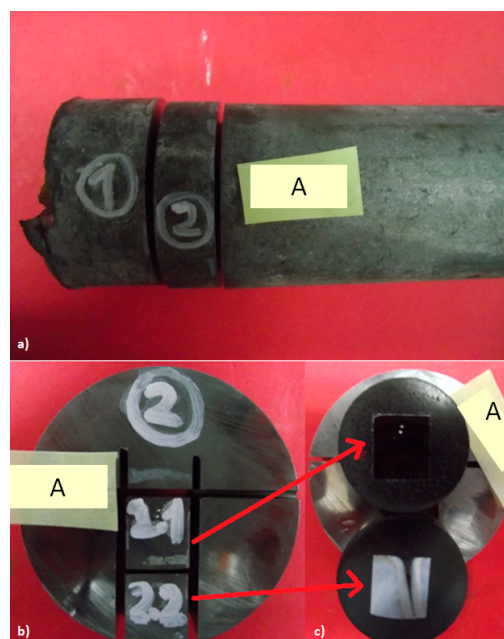
The bolts were sectioned as shown in Figure 3. Two sections (identified as 1 and 2) were obtained from each shank: the first piece contained the fracture section, while the second section was used to analyse the material microstructure in two different locations (samples 2.1 and 2.2, as shown in Figure 3).

**Figure 3.** Sectioning of the shaft (bolt A). (a) Sections 1 and 2; (b) samples 2.1 and 2.2 taken from Section 2; (c) samples 2.1 and 2.2 mounted.

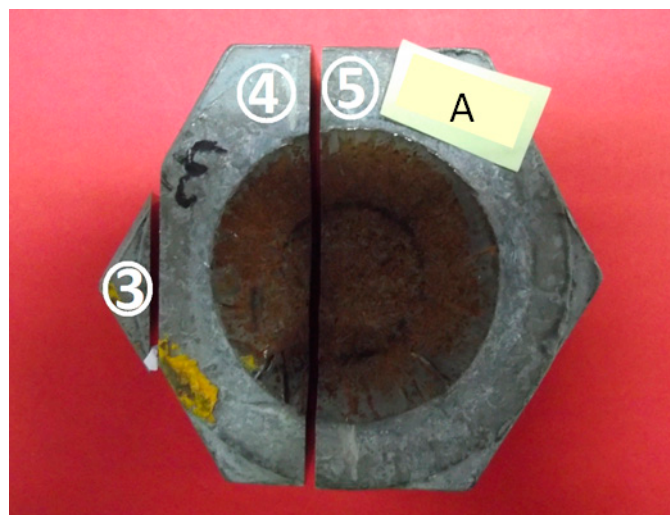
The heads of the three bolts were also cut (see Figure 5) into three sections (named 3, 4 and 5). Different samples were obtained from Section 4 in order to analyse the corresponding microstructure. This was analysed at different points (A to D, as shown in Figure 6). In all cases, tempered martensite was found to be the dominant microstructure, with bainite in the centre of the section (point D, see Figure 7).

**Figure 5.** Quartering of the head (bolt A).

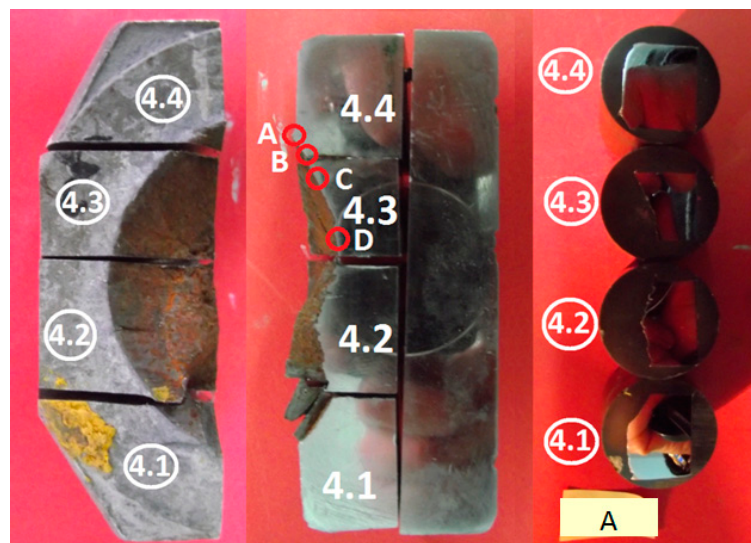
**Figure 6.** Quartering of Section 4 (bolt A) with the identification of the different samples and the location of the points where the microstructure was analysed.

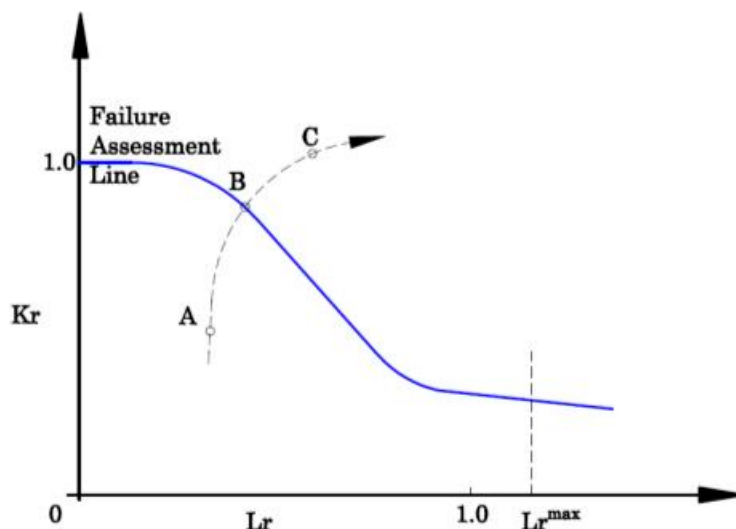
**Figure 14.** FAD analysis (initiation) showing three possible situations: A, safe conditions; B, critical condition; C, unsafe conditions.

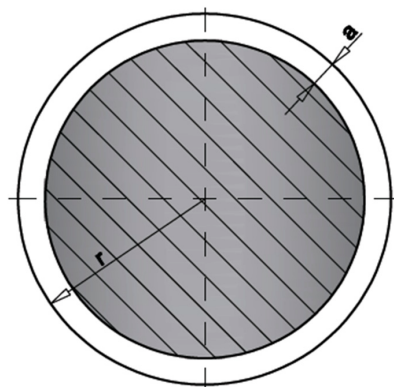
- Circumferential flaw in the round bar (Figure 15), the crack size ( $a$ ) being 11.5 mm (as a lower value of the size of the external smooth area). The corresponding critical load is determined.

Figure 15. Idealisation of the bolt section and the crack geometry.
