# Assessment of the Residual Life of Steam Pipeline Material beyond the Computational Working Time

**Abstract:** This paper presents the evaluation of durability for the material of repair welded joints made from (13HMF) 14MoV6-3 steel after long-term service, and from material in the as-received condition and after long-term service. Microstructure examinations using a scanning electron microscope, hardness measurements and creep tests of the basic material and welded joints of these steels were carried out. These tests enabled the time of further safe service of the examined repair welded joints to be determined in relation to the residual life of the materials. The evaluation of residual life and disposable life, and thus the estimation and determination of the time of safe service, is of great importance for the operation of components beyond the design service life. The obtained test results are part of the materials' characteristics developed by the Institute for Ferrous Metallurgy for steels and welded joints made from these steels to work under creep conditions.

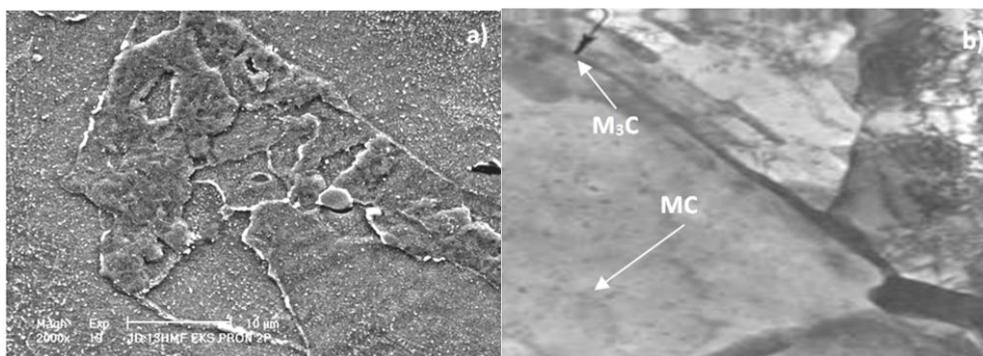
The microstructure of 14MoV6-3 steel in the as-received condition is a mixture of bainite and ferrite, sometimes with a slight amount of pearlite. Moreover, very fine MC carbide precipitates that occur inside the ferrite grains are observed within the structure. In the bainite areas, there are small spheroidal cementite precipitates, while in the pearlite colonies, cementite lamellas exist. An example of the characteristic microstructure of 14MoV6-3 steel in the as-received condition is shown in Figure 2.

**Figure 2.** Structure image of 14MoV6-3 ferritic-bainitic steel in the as-received condition (a) SEM; (b) TEM.
