Fatigue Behavior of Non-Optimized Laser-Cut Medical Grade Ti-6Al-4V-ELI Sheets and the Effects of Mechanical Post-Processing

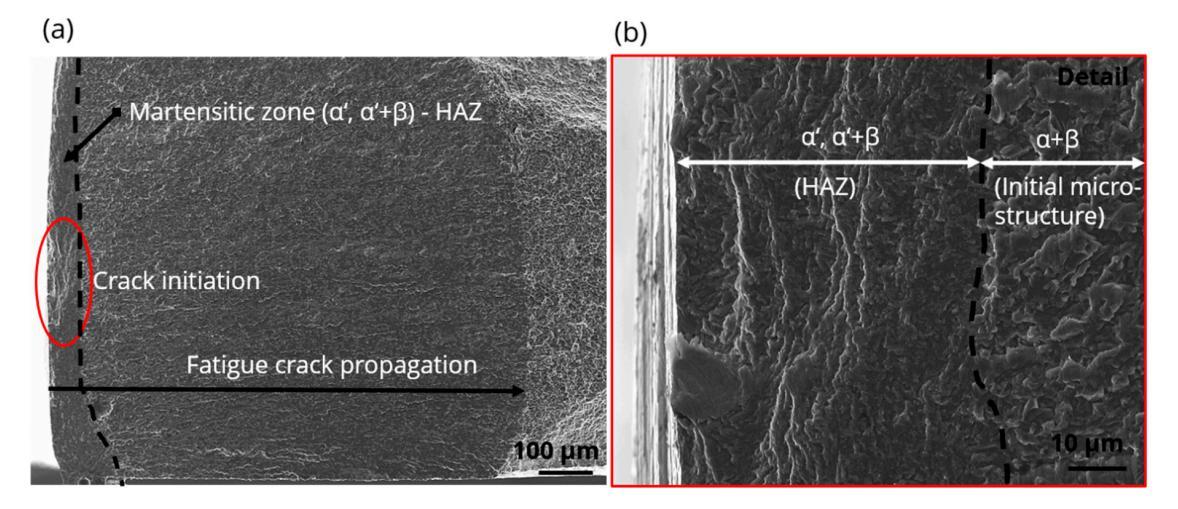
Figure 8. Fractography of a Ti-6Al_BG sample with barrel-grinded surface condition failed at 375 MPa and 5.1×10^4 cycles: (a) SEM (SE) analysis of the laser-cut edge with detectable notches; (b) The corresponding fracture surface with detailed view on fatigue crack initiation.

The sample series with the barrel-grinded surface condition (Ti-6Al_BG) showed, on the contrary, fatigue crack initiation always on the laser-cut edges, which is exemplarily depicted in Figure 8. Furthermore, the crack initiation sites are not always located at the smallest loaded cross-section but rather in the radius section. The cause for this behavior can be assigned to the remaining and detected surface notches after the barrel-grinding process in the middle of the laser-cut edges (Figures 3 and 8a). The irregular size and distribution of these remaining notches leads consequently to stress concentration, crack initiation, and failure at the biggest notches, and these can be located outside the smallest loaded cross-section. Associated with the effective lower overall surface roughness of

the laser-cut edges and the observed, particularly rounded, sample corners (Figure 8b—lower stress concentration sites), all Ti-6Al_BG samples are expected to fail at one of the remaining notches.
