Fatigue-Prone Details in Steel Bridges

Reza Haghani *, Mohammad Al-Emrani and Mohsen Heshmati

Civil and Environmental Engineering Department, Division of Structural Engineering,
Chalmers University of Technology, Sven Hultins Gata 8, 41296 Gothenburg, Sweden;
E-Mails: Mohammad.Al-Emrani@chalmers.se (M.A.-E.); mohsen.heshmati@chalmers.se (M.H.)

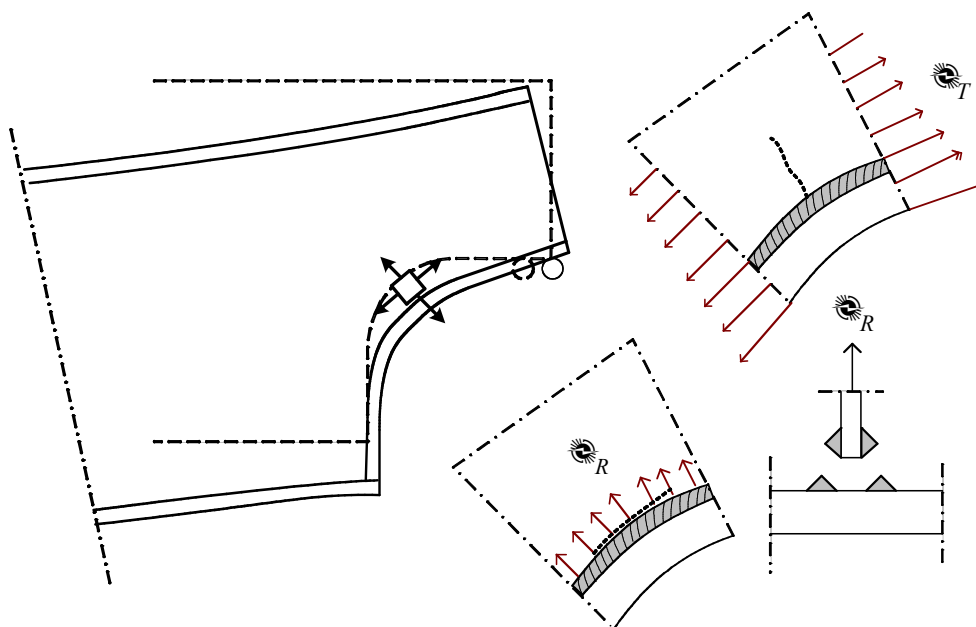
A detail in which numerous fatigue problems have been found in the United States and Japan [5,6] can be found in Gerber bridges and in bridge girders with reduced depth at the supports, Figure 3. According to beam theory, bending stresses in the girder near the support are negligible and the beam is designed at these locations with respect to shear force. Owing to the reduction in girder depth and the resulting change in cross-section, the deformation of the girder will induce additional tangential and radial stresses in the girder web and in the flange-to-web welds along the curvature of the out-cut, see Figure 4.

Damage cases involving fatigue cracking in the web of the girder, as well as in the flange-to-web welds, have been reported. In the latter case, the connection between the flange and web was made by means of fillet welds. The cracks in the girder web can grow either in a direction tangential to the flange curvature (caused by the radial stress component) or in a radial direction (generated by the tangential stress component), see Figure 5.

Figure 4. Tangential and radial stresses in beams with reduced depth and the three cracking modes that can occur in this detail.

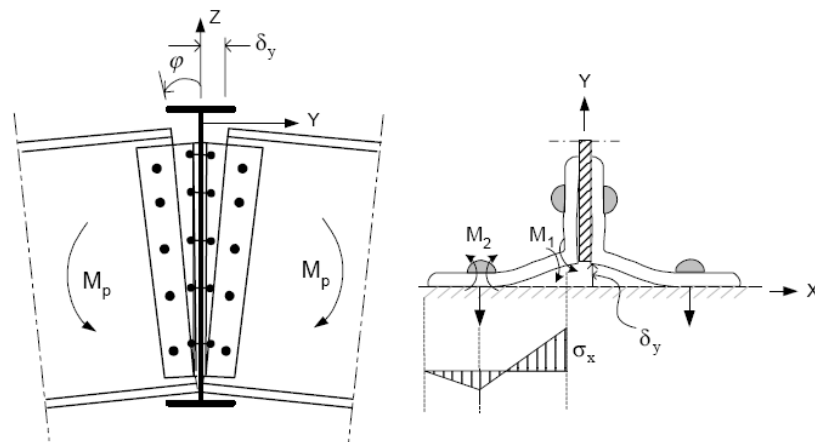
The rotation of stringer ends associated with bending. Even though double-angle connections were designed as simple shear connections, it is generally inevitable that these connections also acquire some rotational stiffness, thus partially restraining the rotation of stringer ends. Consequently, negative bending moment will develop at the ends of the stringers, subjecting the fasteners and the angles of the connections to load effects which are not taken into account during design, see Figure 15. This kind of action has a relatively short influence line, giving rise to a large number of loading cycles during the service life of the bridge.

Figure 15. Secondary bending at stringer ends due to restrained end rotation. Bending and axial stresses at the top of the stringer-to-floor-beam connection might be high enough eventually to result in fatigue cracking.

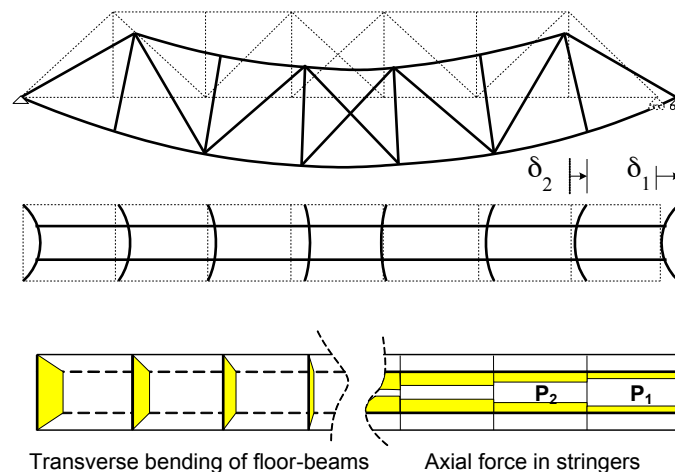
An overlooked interaction between the floor system (stringers and floor beams) and the main load-carrying structure (main girders or main trusses, for example). Bending deformation of the main truss bridge, for instance, involves the longitudinal displacement of the truss joints to which the floor beams are connected. The floor beams are, however, partially restrained from following this deformation due to the axial stiffness of the stringers and their connections to the floor beams. As a result, secondary axial forces will develop in the stringers and their connections to the floor beams, while the latter will be subjected to secondary bending (in the weak axis), see Figure 16. This kind of interaction has an influence line, which is equal to the span of the bridge and, in the case of railway bridges, there is essentially one loading cycle every time a train passes.

Figure 16. The interaction between the floor system (stringers and floor beams) and the main bridge trusses results in secondary axial forces and bending moment in the stringers and the floor beams, respectively.

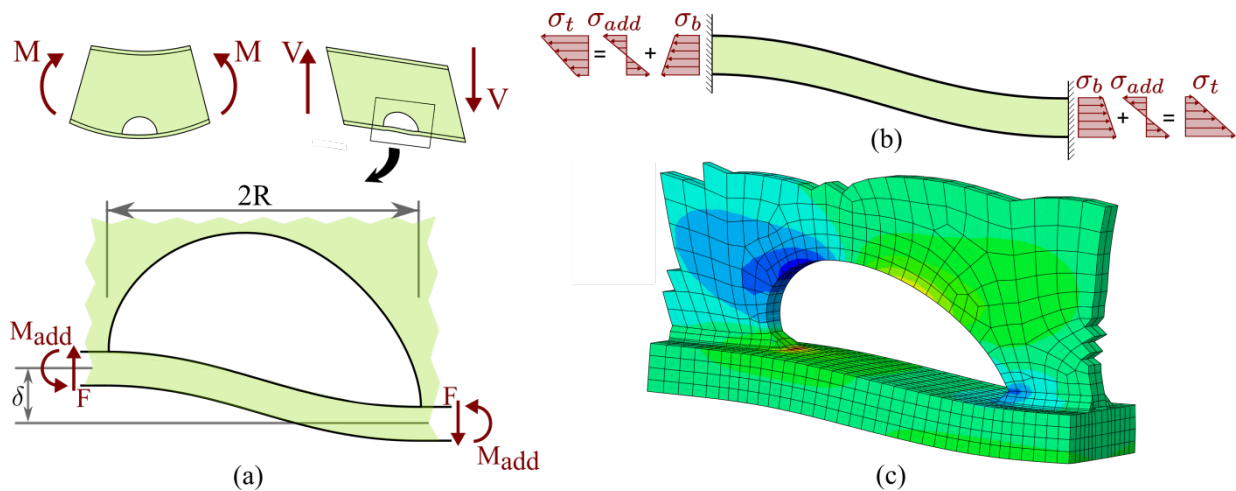
2. *Secondary stresses due to shear deformation of the girder.* Although the shear deformation of stiff long-span girders is generally neglected in design, the local effects of such deformations may be significant. As can be seen in Figure 23, as a result of existing shear, a relatively small displacement (δ) is induced between the sections before and after a cope-hole. However, as the lateral support of the flange provided by the web is no longer available in this section, the flange undergoes an additional deformation. In this instance, the flange is analogous to a beam with both ends fixed sustaining an additional moment (M_{add}). This deformation gives rise to the stresses acting on the weld toe at one end and decreases them at the other end.

Figure 23. (a) Bending and shear deformation of a section with cope-hole; (b) Stress distribution through flange thickness at weld toe; (c) 3D finite element model.
