Analysis of Cylindrical Masonry Shell in St. Jacob's Church in Dolenja Trebuša, Slovenia—Case Study

Keywords: masonry shell; cracks in shells; static analysis; strengthening

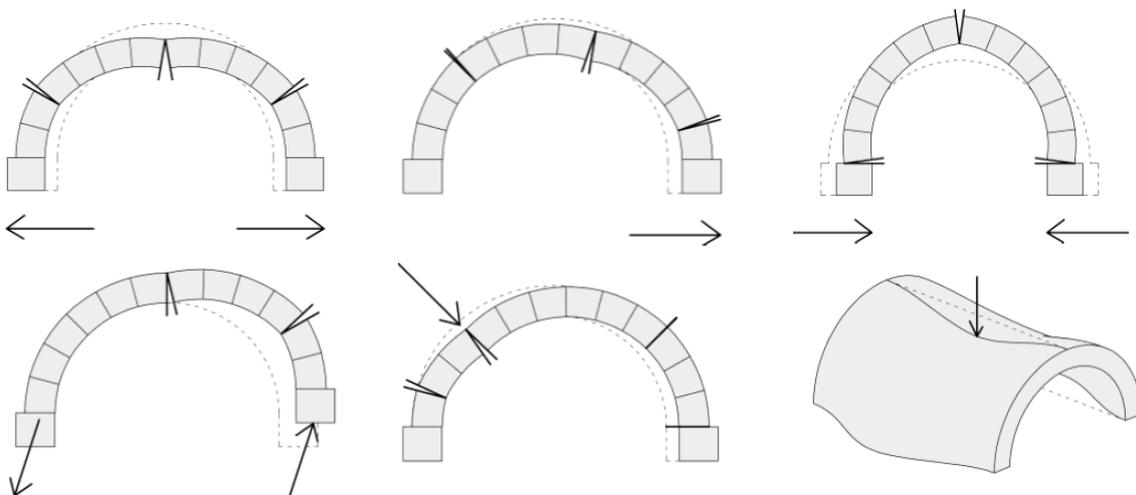
Figure 2. Some typical crack configurations for barrel vault [4].

Damage of shells, often in the form of cracks, occurs due to various reasons: Foundation settlement, horizontal displacements of supporting walls, material deficiencies and degradation or local overloading as well as their combinations. Some typical crack configurations due to various reasons in the case of barrel vault are shown in Figure 2.

When the registered crack pattern is compared with possible crack configurations shown in Figure 2, several actions can be identified as the potential cause of such damage. The longitudinal crack at the bottom middle part of the shell may thus be caused either by simultaneous horizontal divergent displacement of supporting walls (Figure 2 top left), differential settlement of foundations (Figure 2 bottom left) or point load in the central part of the shell (Figure 2 bottom right).

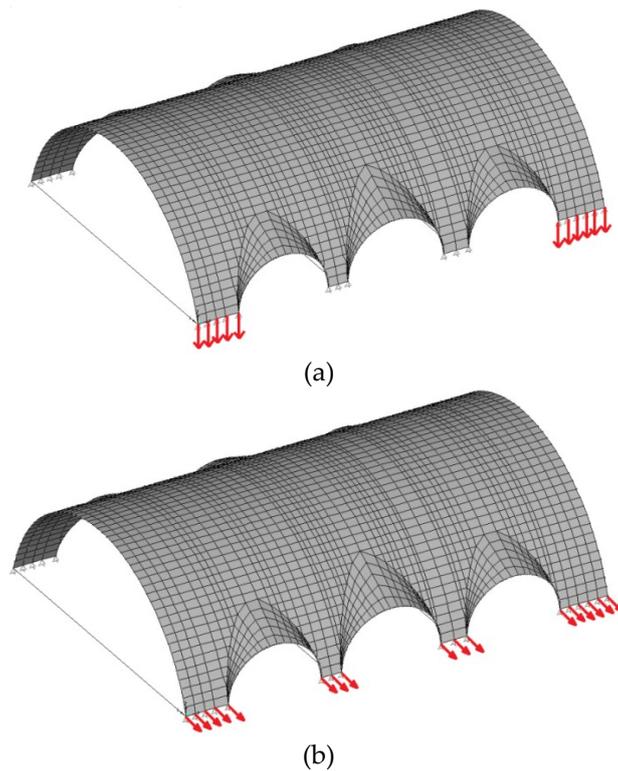
Figure 7. Load case simulating vertical displacement of outer supports on one side (a) and horizontal displacement of all supports on one side (b).

In load case »2« vertical displacement ($\Delta_z = -0.5$ cm) of outer supports on one side was considered which simulates differential settlement of foundations. In this case, high tensile stresses occur in the top area of the shell (Figure 11), which may cause the recorded longitudinal crack. Differential settlement of foundations can thus be one of possible causes for the registered crack pattern. However, the results of this load case otherwise show high stress levels also in other parts where no damage of the actual shell has been recorded.

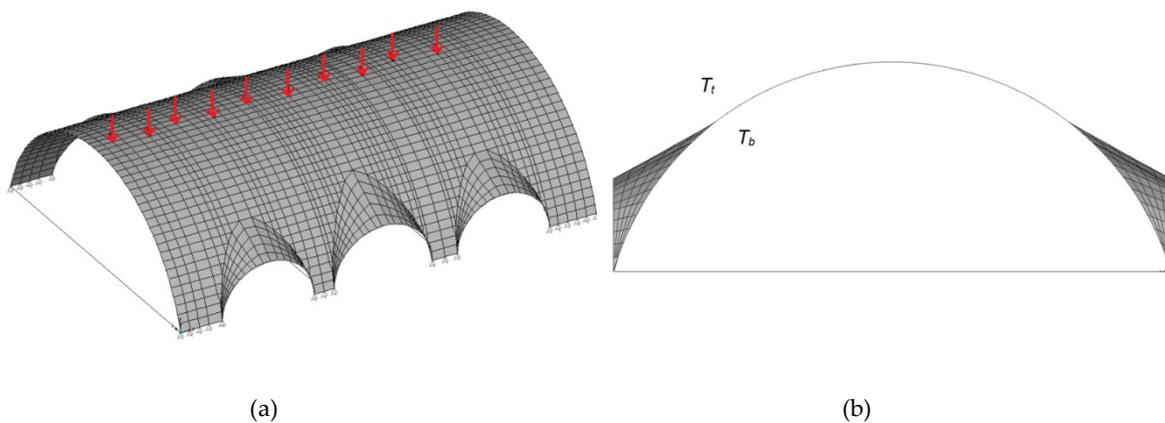
Figure 8. Load case simulating maintenance team (a) and temperature difference (b).

Load case “3” took into account the self weight of the structure, weight of the rubble layer and weight of the maintenance team. In this case, compressive stresses in the upper middle part (Figure 13) as well as tensile stresses in the lower middle part (Figure 12) of the analysed shell are exceeded, which coincides with the registered crack pattern. This loading combination can therefore be considered as the most possible cause for the formation of a longitudinal crack [8].

Results of load case “5” which took into account self weight of the structure, rubble layer and temperature change ($\Delta_T = 15$ °C) show that such loading combination is critical for collateral vaults but cannot be responsible for the registered longitudinal crack.

Based on the results of the analysis of the considered shell, it can be concluded that the cracks formed mainly due to direct loading of the middle upper part of the shell (simulation of maintenance works in load case “3”). Considering the fact that cracks reappeared in the same areas after repair works in 2013, it is recommended that monitoring of the shell be carried out with an emphasis on the longitudinal crack in the middle part of the shell. In the case that the widening of that crack continues, strengthening of the shell will be required. Strengthening could be done by applying reinforced concrete layer either using FRP (fiber reinforced polymer) or FRM (fiber reinforced mortar) on the critical area. However, if the monitoring does not confirm any propagation (widening and/or length extension) of cracks, strengthening considering unchanged loading condition is not necessary. Nevertheless, the problem in the case of loading of the shell during maintenance works should be solved for any potential future works as the numerical simulations show that the shell is locally overloaded even by weight of a single maintenance worker. A possible simple solution for this problem is a working platform not only for access of the maintenance team but generally also for any secure access to the area above the shell [8]. The weight of the platform could be partially carried by the existing wooden roof structure and mainly by the stronger stone-masonry walls of the church structure.
