# Article Case Study—An Extreme Example of Soil–Structure Interaction and the Damage Caused by Works on Foundation Strengthening

Abstract: This paper describes the works on foundation strengthening of the towers of the Cathedral of St. Theresa of Avila in Subotica and the damages caused by these works. Strengthening was performed by means of jacked-in piles and deep soil injection. The construction of the Cathedral began in 1773 and it lasted for several decades with frequent interruptions and changes to the project. The present appearance of the facade was created in 1912. According to historic data, several years after construction, the cracks appeared on the front facade. With time, these cracks became more pronounced, and in 2015, when the remediation project started, the total width of major cracks reached about 15 cm. The first contemporary attempt to repair the towers was made in 2017 by inserting piles beneath the foundations. These works were interrupted due to increased settlements and the appearance of new cracks. In the second attempt, the strengthening was performed by deep injection of soil with expansive resins. During these works, settlements and damages intensifie

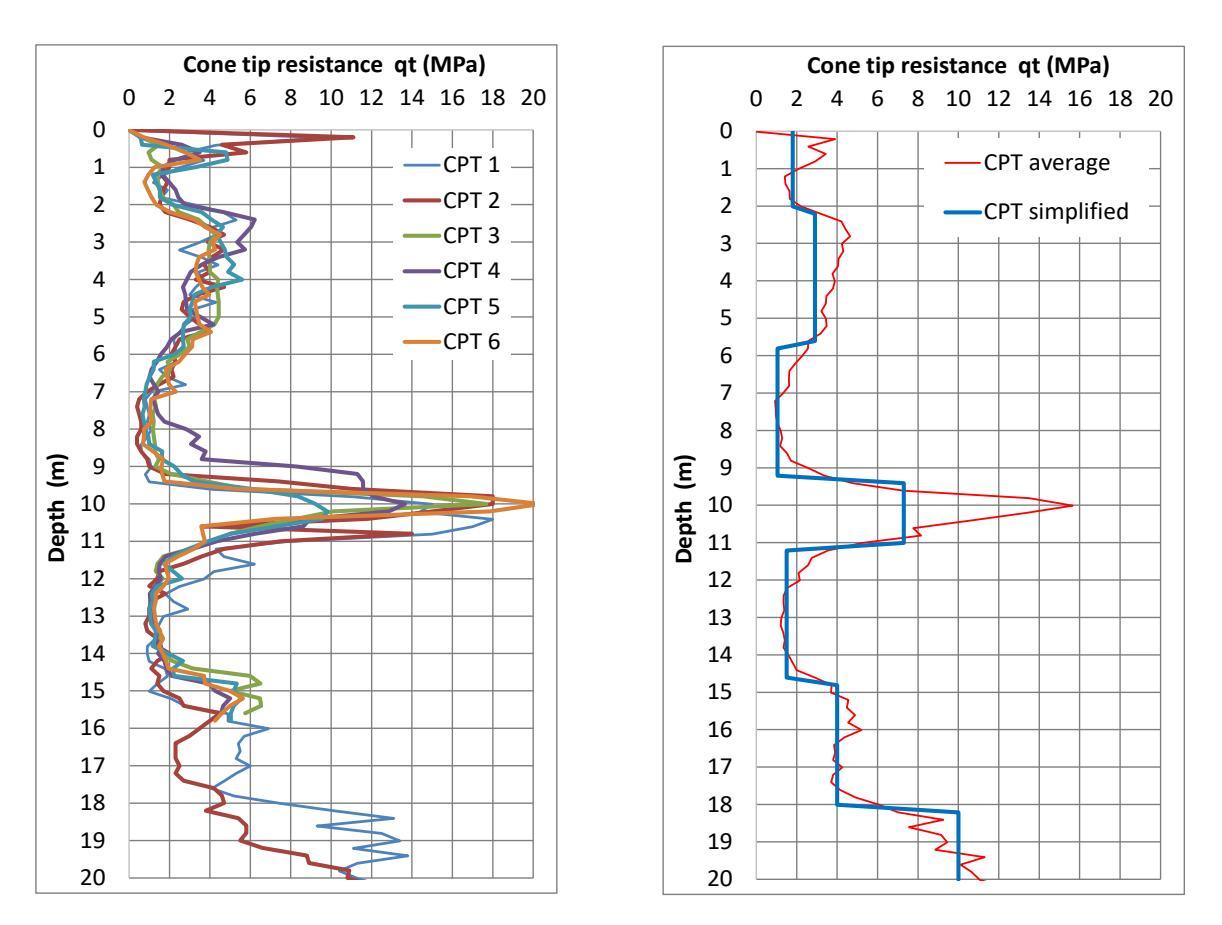
Figure 5. All penetration tests next to the towers (left) and average of all tests (right) [5].

Installation of crack meters, inclinometers, geodetic markers and measurements, and complete recording of the geometry and condition of the structure and materials of the building were made. As part of soil-mechanic tests, six static penetrations 16 to 21 m deep, and four boreholes of 15 m were made, from which samples were taken. Laboratory tests have shown that the soil profile, up to a depth of 9 m, consists of low/medium plastic soft clay (CL-CI), below which is a layer of sand (SF) 1.8 to 2 m thick (Figure 5).

After that, clays reappear, ending above a layer of compacted sand at a depth of 18 to 20 m. According to historic data, this location in the past was bordered by swampy troughs and canals, which is indicated by the presence of muddy and marshy impurities in the upper parts of the terrain. According to limited piezometric measurements (Figure 6), the groundwater depth is at 3.2 to 4.2 m from the ground level around the Cathedral (112.6 m MASL).

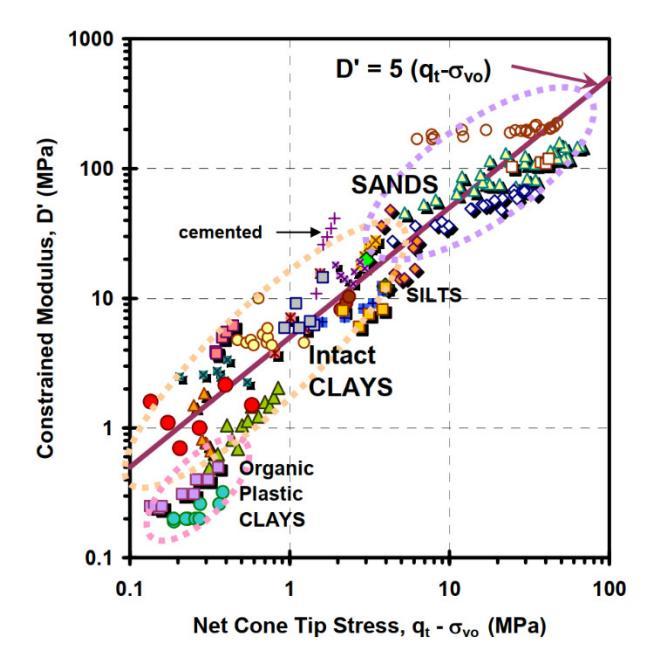
Figure 10. Correlation of soil compressibility modulus and cone resistance [11].

The soil compressibility modules were adopted by the correlation with one penetration resistance, using a simplified diagram of mean values on Figure 10. The calculated settlement is about s = 25 cm.

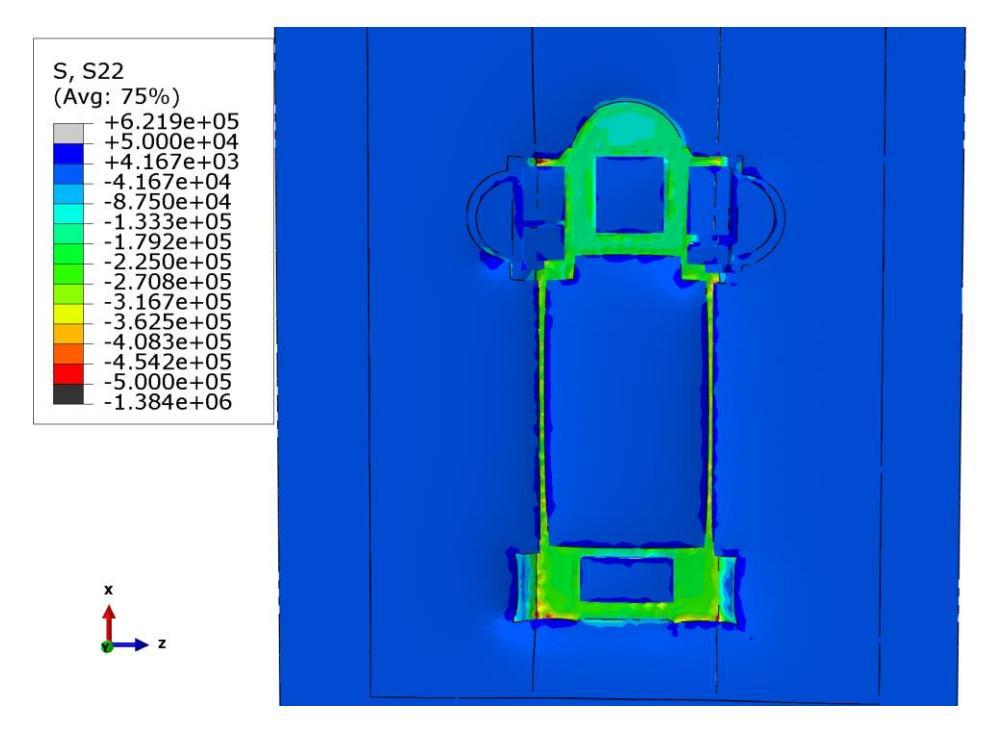
Figure 13. Vertical contact stresses in the soil at the idealized (flat) bottom surface  $(N/m^2)$ .

Calculations have shown (Figures 13 and 14) that the maximum edge pressure is below the southeast and northeast corners of the tower, and is about 816 kPa, which is much greater than the centric stress. The divergence of the towers is about 6.0 mm/m. Although the 3D model is a rough approximation of the actual condition in the structure and soil, the results of static calculation agree well with the results of visual observation of what happens to the object and measurement results, which is a good starting point for determining the methodology of structural rehabilitation.

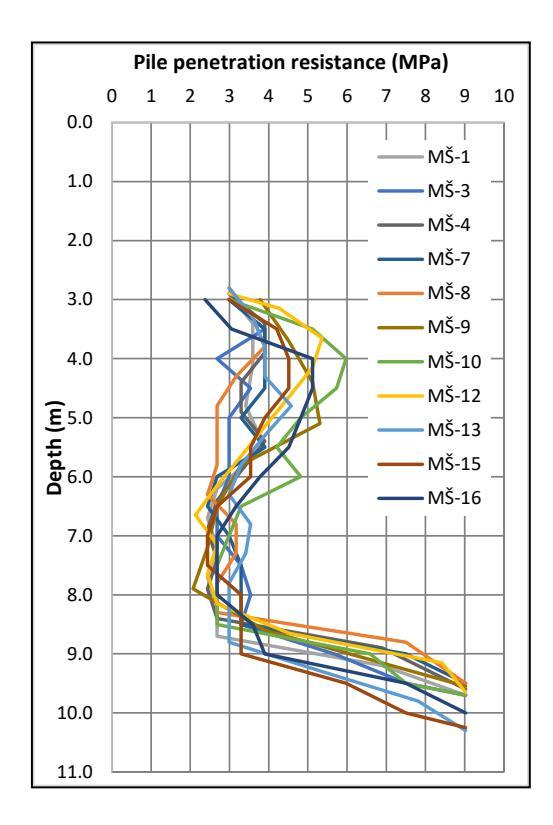
Figure 21. Measured resistances on the hydraulic jacks when pressing piles.

Each pile consists of several steel segments–cylinders with a diameter of 323 mm and a height of 500 mm. In order to install the piles, a narrow trench was excavated next to the foundation. From this trench, the working space ("a gallery") within the foundation was excavated, 1.3 m high, 1.0 m wide and 0.8 m deep. The galleries were excavated in succession—the work on the new pile did not start before the previous one was activated. Relative to the total foundation area of 128 m<sup>3</sup>, one such gallery represented less than 1%. Inside the gallery, a steel frame and a hydraulic jack were placed. The hydraulic jack was used to press steel cylinders, one by one, into the ground beneath. The initial steel cylinder of each pile was formed with a conical tip. All segments were welded to each other continuously along the circumference. The piles were pressed all the way down to the layer of sand, where the pressing force was limited to 0.74 MN, so as not to cause a shear fracture in the lime concrete foundation footing above the pile. The resistance diagram of piles being pressed into the ground is shown in Figure 21, and it is very similar to the tip resistance (CPT) in Figure 5.

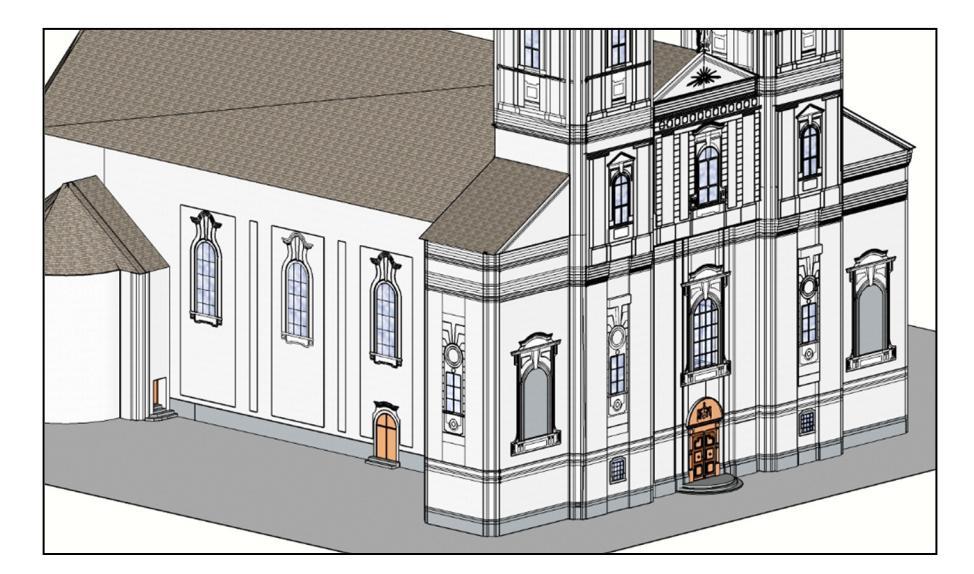
Figure 22. Remediation proposal with additional massive apses.

The negative experience with the jacked-in piles ruled out solutions that would include interventions/strengthening on the foundations themselves and reaffirmed the idea of reducing the weight of the towers, as well as the idea of adding massive side apses with pile foundations to stabilize the towers. Figure 1a depicts the present appearance of the front facade, and Figure 22 depicts the remediation proposal with additional massive apses.

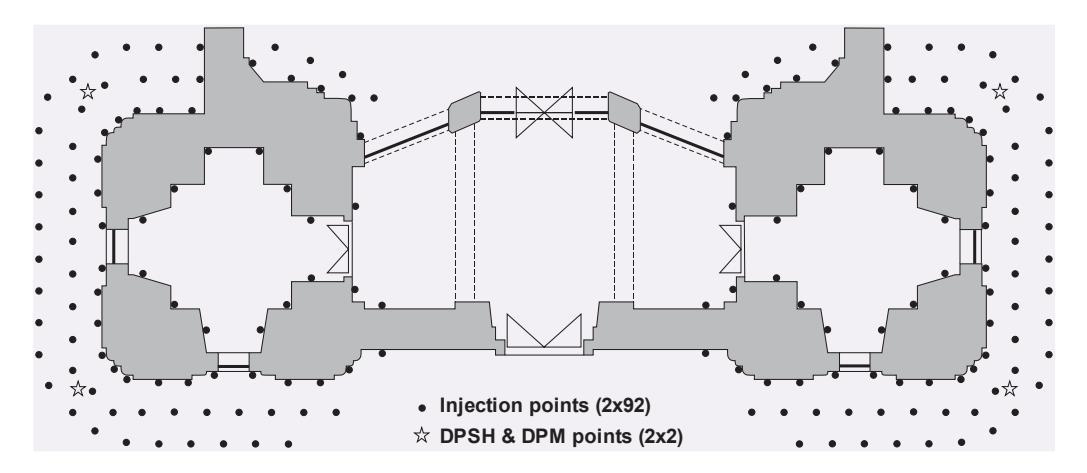
Figure 23. Position of injection points around the foundations of the towers.

However, such solutions were not in accordance with the existing restoration guidelines for cultural monuments protection and therefore were not accepted. At the investors request, an expert team from Budapest proposed, in October 2017, the stabilization of the towers by means of deep grouting of soil with polyurethane expanding resin. During penetration and expansion, the resin exerts pressure on surrounding soil, and creates and penetrates cracks in the form of a branched root. This method was originally developed by the oil industry to increase the yield of wells, while in geotechnics it has been adapted for the purpose of precise remediation of settlement under structures. Based on their experiences on similar objects that were also damaged by excessive settlement, the expert team guaranteed the cessation of the settlement with local uplift of the structure and/or surrounding terrain in the order of magnitude up to 0.5 mm. The injection was performed through long steel pipes with a 12 mm diameter. During the injection procedure, upward movement of the geodetic wall markers is considered to be a proof of successful soil stabilization. The project envisaged the stabilization of the ground beneath the northern and then beneath the southern tower, at  $2 \times 92$  injection points at a depth of 2, 3, 4, 5, 6, 7, 8, 9 and 10 m, measured from the ground surface. The external injection points were placed in three rows, the first row along the wall, the second and third row at a distance of 1 m and 2 m from the wall, respectively. The internal injection points were placed only in one row along the inner walls—see Figure 23. First, the outer row was injected at a distance of 2 m, then the row at a distance of 1 m, and finally, the rows directly next to the tower wall on the outside and on the inside. The downward direction of injection along the wall is sloping at an  $8^{\circ}$  angle towards the wall, while the other directions are vertical. The works lasted from February to August 2018. According to an approximate calculation, the volume of injection mass per injection point, after expansion, is about 0.17 m<sup>3</sup>, or a total of 15.5 m<sup>3</sup> for each tower. If the average injection radius is about 0.3 m, then in relation to the affected soil volume around the injection pipe, the initial soil porosity of about 0.45 should have been reduced by about 15%.

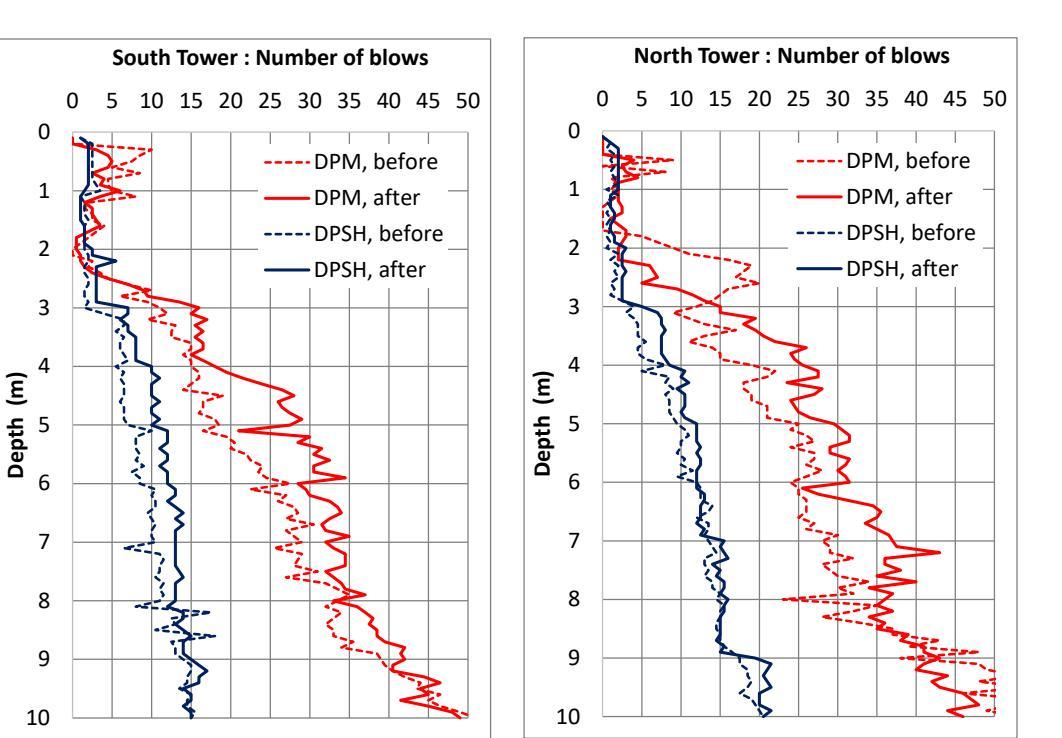
Figure 24. Results of penetration tests before and after soil injection.

Based on comparative diagrams, at depths below 3 m, a certain increase in soil resistance is observed beneath both towers as a result of injection. Increasing the penetration resistance means that in a certain region of the soil around the foundation, the strength and stiffness of the soil are increased, which should have favourable consequences on the foundation bearing capacity. However, contrary to expectations, very soon after the beginning of the soil injection, next to north tower, an increase in settlement and the appearance of new cracks in the walls and arches of the Cathedral nave was observed. These effects were significantly less favourable than the ones observed during jacked-in piling. Based on the assumption that the settlement was the result of a large increase in pore pressure and a decrease in effective stresses in the clay, the contractor reduced the injection speed, which prolonged the works. Despite this, the settlement continued at a lower intensity. In order to gain an insight into settlement dynamics, geodetic measurements were performed during and after the injection for 12 h straight, with final measurement conducted 24 h after the injection. The geodetic markers were measured on the south tower,
