# Field Reconnaissance and Earthquake Vulnerability of the RC Buildings in Adıyaman during 2023 Türkiye Earthquakes

**Abstract:** The 6th February 2023 Pazarcık and Elbistan earthquakes ( $M_w = 7.7$  and  $M_w = 7.6$ ) caused great destruction in many cities and were the disaster of the century for Türkiye. The greatest destruction was caused in the provinces of Hatay, Kahramanmaraş, and Adıyaman during these earthquakes, which were independent of each other and occurred on the same day. Information about earthquakes and strong ground motion records is given within the scope of this study. Reinforced concrete (RC) structures which constitute a large part of the urban building stock in the earthquake region were exposed to structural damage at different levels. The structural damage in the RC structures in the city center, Gölbaşı, and Kahta districts of the province of Adıyaman was evaluated within the scope of earthquake and civil engineering after field investigations. Insufficient RC, low-strength concrete reinforcement problems, RC frame failure, heavy overhang, short columns, soft story, and pounding effect are the main causes of the earthquake damage. The presence of these

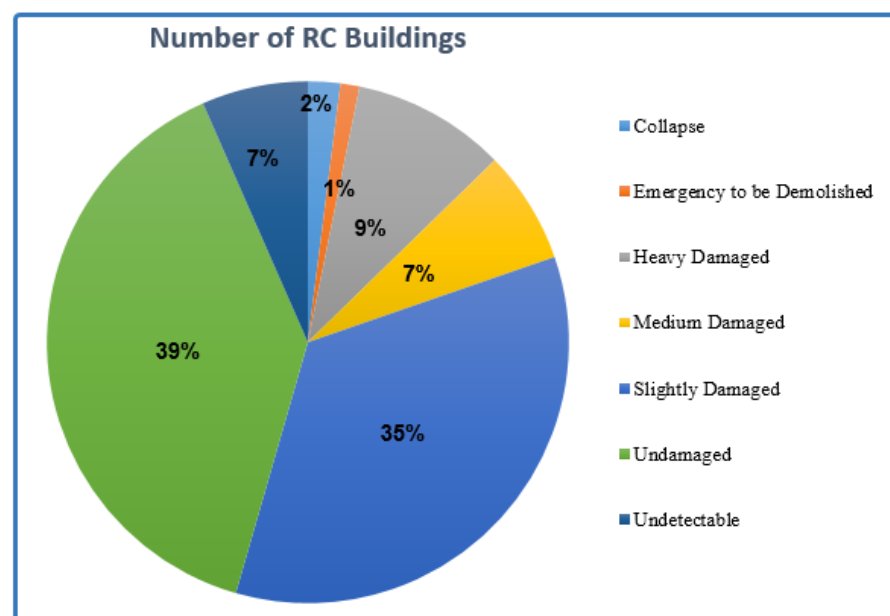
RC structures are commonly preferred in settlements with a city center of approximately 632,000. This earthquake caused great destruction for Adıyaman since the building stock in the rural areas did not receive engineering service and most of them were old and simple structures [40–42]. Over time, the buildings that completed their service life and were demolished in rural areas were replaced by mixed and reinforced concrete structures. Reinforced concrete structures constitute approximately 58% of the total building stock of Adıyaman cities and districts. Buildings are considered as collapsed, to be demolished, heavily damaged, moderately damaged, slightly damaged, undamaged, and having no detectable damage. This study is based on the data before 2 April 2023. No detectable damage refers to buildings whose damage cannot be determined due to different reasons. Building distributions according to damage levels are shown in Figure 8. Approximately 13% of the RC building stock in Adıyaman city center and its districts has become unusable. This shows the scale of the destruction in Adıyaman. About 74% of the RC building stock survived the earthquakes with slight or no damage.

**Figure 8.** Damage distribution of reinforced concrete buildings in Adıyaman (by Adıyaman Provincial Directorate of Environment, Urbanization and Climate Change, 2023).
