A Case Study on the Rehabilitation of a Fire-Damaged Structure

Abstract: This paper presents a case study on the rehabilitation of a fire-damaged structure and describes the results of a site investigation and tests, leading to a plan for the rehabilitation of the structure. The fire took place in the main control room of a thermal power plant and lasted about three hours until it was finally extinguished. To set up a rehabilitation plan for the damaged structure, a visual inspection of the damaged condition was first carried out, which was followed by analysis and on-site material tests indicating the degree of neutralization progress in the remaining structure. Specimens of damaged concrete and reinforcing bars were sampled and tested for their residual strengths. As a conclusion, two methods of rehabilitation were suggested considering the current condition of the structure and the sequence of construction.

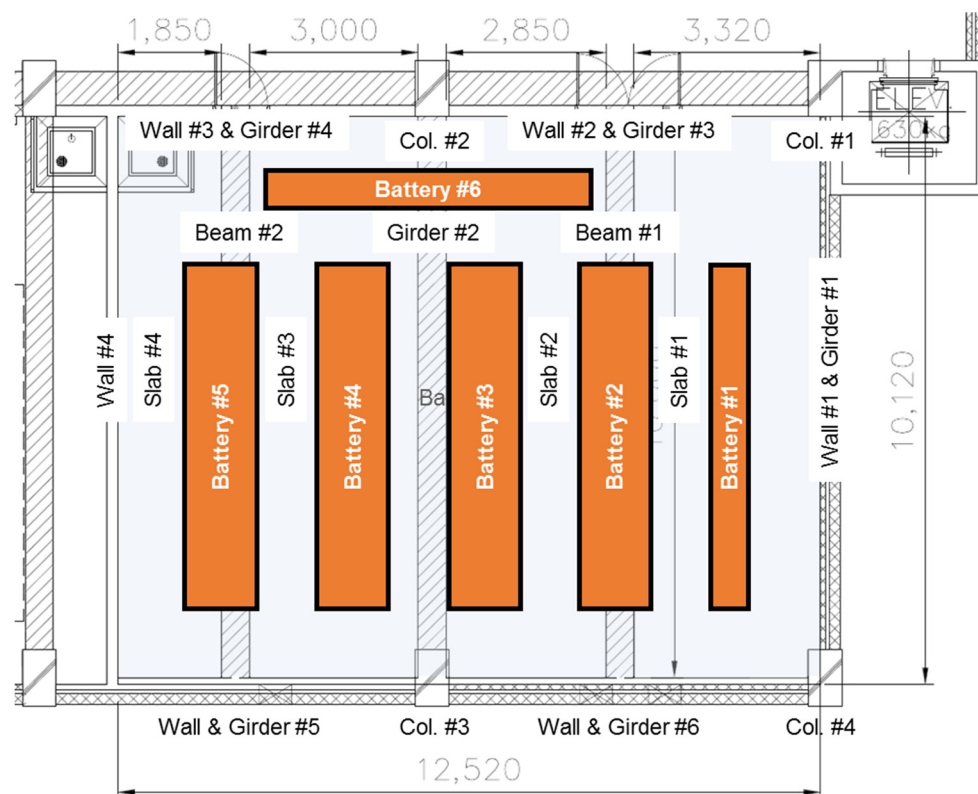
Figure 1. Locations of structural elements and batteries in the battery room.

The site investigation was carried out two days after the fire occurrence. The condition of all the main structural components damaged by the fire such as slabs, girders, beams, columns and walls were visually examined. Among them, severely damaged components were categorized. The location and identification number of each structural member are indicated in Figure 1. Additionally, of interest at first was whether the structural damage involved the possible explosion of batteries. However, no sign of explosion or blast was identified during the investigation.

The visual inspection revealed that most of the batteries in the room were burned down, especially the Batteries #1, #4, #5 and #6. For Batteries #2 and #3, part of the battery structures still remained as

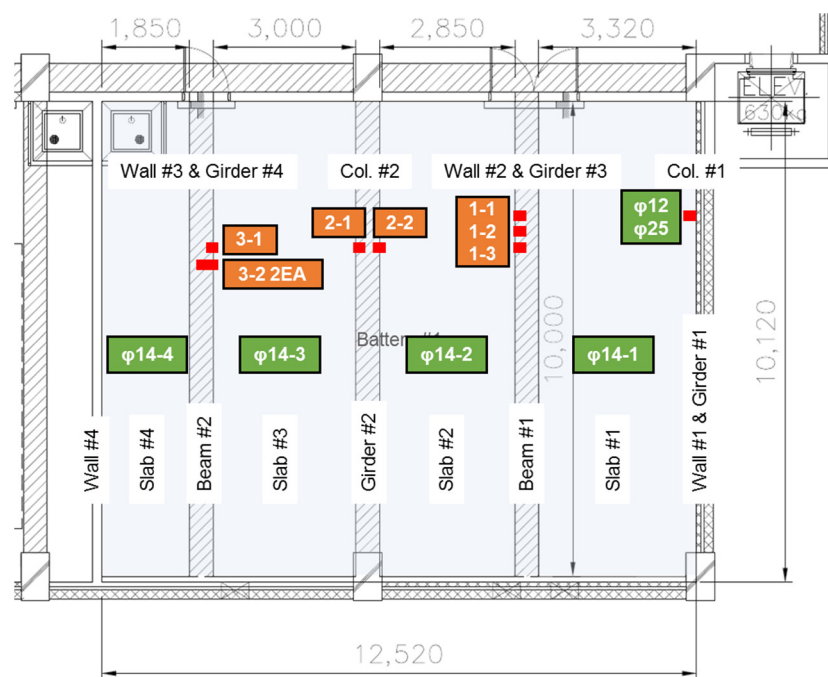
Figure 12. Locations of sampled concrete core and rebar coupons.

For the strength test of the concrete cylinders, two or three cylinders with diameters of 100 mm were sampled from Beams #1 and #2, and Girder #2 indicated in Figure 12, respectively. Examples of the cored specimens are shown in Figure 13. The compressive strength tests of these specimens were conducted per ASTM (American Society for Testing and Materials) C42 [11]. The results are summarized in Table 1. Excluding the test results from three non-confirmative specimens represented by the shaded region, which are 1-1, 3-2 and 3-3, the average compressive strength was 30.7 MPa. This is equivalent to the design compressive strength (f'_c), 30 MPa. According to BS EN 13791 [12–14], the strength of cored specimens is lower than that of molded specimens due to the micro-cracks developed by the impact from drilling during the sampling process. The minimum characteristic *in-situ* compressive strength required by BS EN 13791 is calculated by multiplying a factor of 0.85 and the design strength.

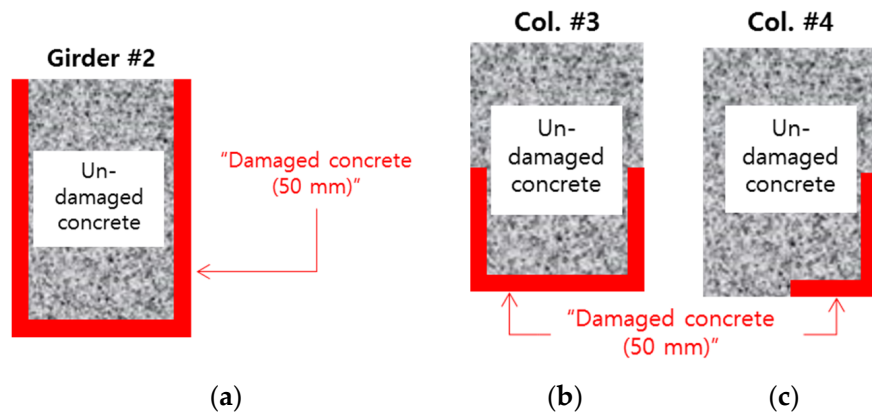
Figure 14. Assumed depth of damaged concrete for target elements: (a) Girder #2, (b) Column #3 and (c) Column #4.

- (i) Rebar is undamaged;
- (ii) The depth of damaged concrete is about 50 mm as shown in Figure 14;
- (iii) The residual strength of the damaged concrete is approximately 60% compared with the original capacity.

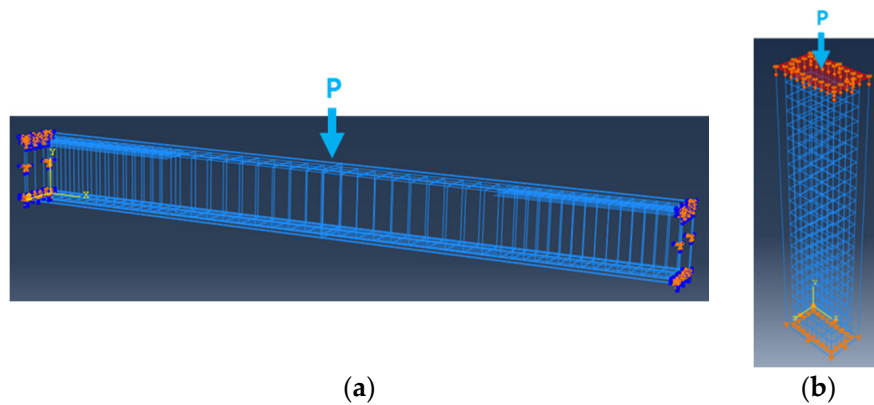
Figure 15. Boundary and loading conditions of girder model (a) and column model (b).

Figure 15 shows the numerical models of the target structural components including rebar arrangement. The target concrete girders and columns were modeled using 8-node solid elements with reduced integration (C3D8R). The rebar was modeled using truss elements (T3D2) with the embedded option in ABAQUS. Both edges of the target components were restrained to simulate axial and rotational restraint effects provided by the adjacent structural components, which reflects the actual condition of girder and column connections. A displacement-control analysis was conducted by imposing a vertical displacement in the middle of the beam and on the top surface of the column, respectively, as illustrated in the figure. The numerical modeling adopted in this study is also utilized in [20,21], thus confirming its validity.

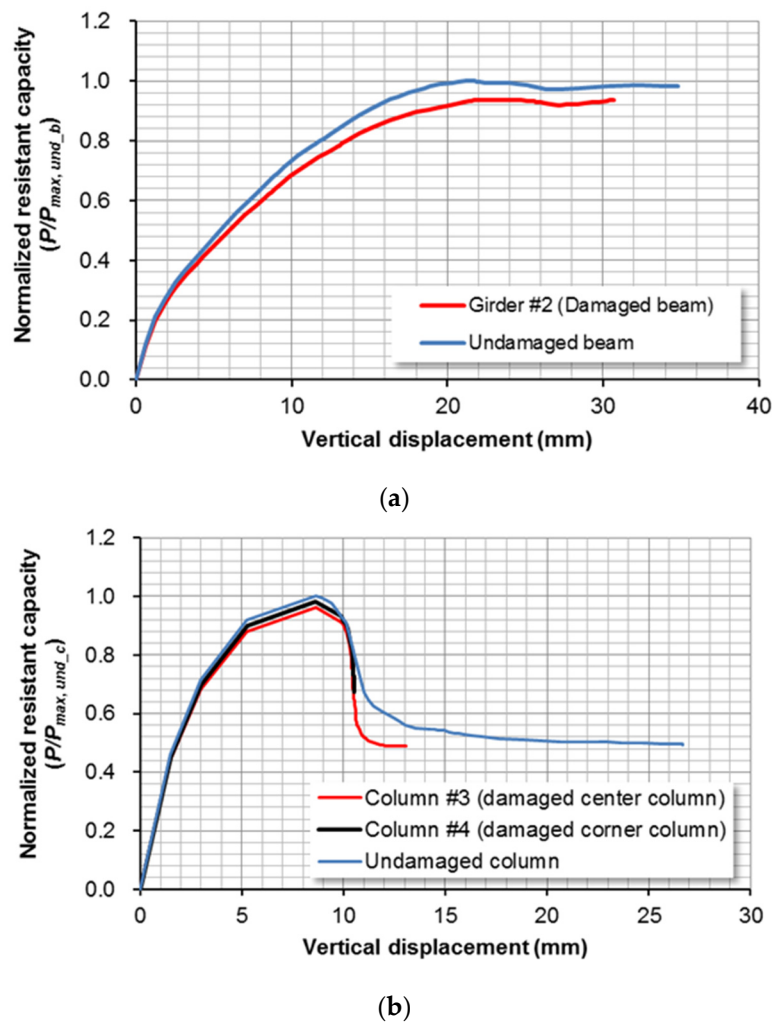
Figure 16. Comparison between load-displacement relations of damaged and undamaged structural elements. (a) Girder #2. (b) Column #3 (exterior column) and #4 (corner column).

Figure 16a,b shows the load-displacement curves obtained from the numerical analysis for Girder #2 and Columns #3 and #4, respectively. The load-displacement curves of undamaged (*i.e.*, original) components are also provided in the figures. In these figures, the ordinate axis indicates the vertical load normalized by the peak load value of the undamaged structural component. Table 3 summarizes the results of the numerical analysis. In the table, P_{\max, und_b} and P_{\max, und_c} indicate the vertical resistant capacities of the undamaged beam and column, respectively.

Similar to the case of Girder #2, P_{\max} 's of Columns #3 and #4 are approximately 96% and 98% of the corresponding value of the undamaged column, respectively. The vertical displacements corresponding to P_{\max} are the same in all of the damaged and undamaged cases. As a consequence, it can be also judged that Columns #3 and #4 still have enough resistant capacity.

From this discussion, overall it can be observed that the behavior pattern and the maximum vertical load are hardly affected by the components that are assumed to be damaged. In other words, in spite of the loss of the sectional area and material strength of the target structural components, since the core concrete surrounded by stirrups, ties and rebar survived the fire hazard, it can be concluded that all of the target damaged girder and columns retain enough strength.
