# Failure Analysis of Topside Facilities on Oil/Gas Platforms in the Bohai Sea

**Keywords:** jacket platform; ice-induced vibration; failure mechanism; ice-resistant cone

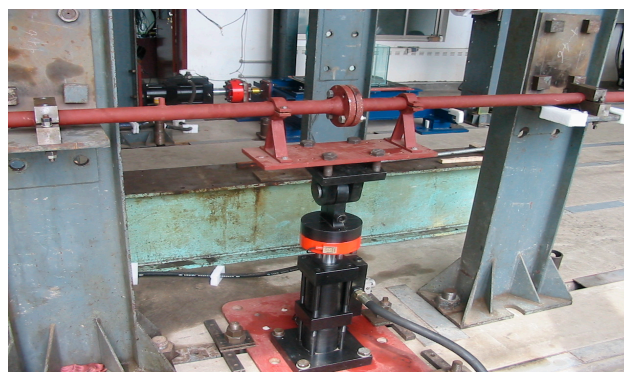
Figure 7 shows the arrangement of the laboratory test: It comprised racks, a test pipeline flange, loading system actuator, and data acquisition system. The racks and flange form a beam structure that has concentrated forces at both fixed ends; the middle flange is stressed by bending. The amplitude and frequency of lateral alternating loads are controlled by actuators. Brackets and clamps are symmetrically applied to the pipeline on both sides of the flange, and the ends of the pipeline are fixed by a bolt and "v block" to the I-beam. This experiment simulated the accident's platform pipeline system under vibration using Class600 (11.0 MPa), 2-inch (DN50) nominal diameter, standard convexity welding neck flange, and 8 M16, high-strength bolts made of CrMoA. The metal-graphite, spiral-wound gasket consisted of a locating ring and an inner ring, and was made of 0Cr13.

**Figure 7.** Arrangement of the laboratory test, which simulated the characteristics of the actual accident.

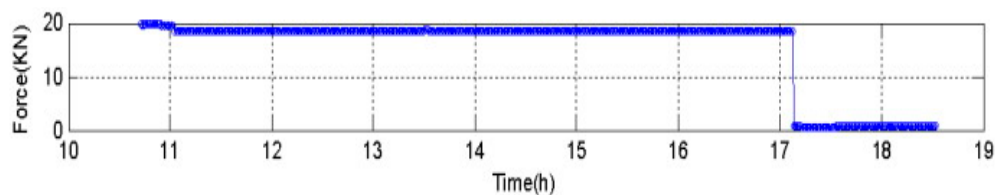
The first set of pretightening force is kept at 15% of the yield strength (18 KN), wherein the lower pretightening force can ensure that the graphite gasket is not crushed. Experimental data has found that when the excitation vibration acceleration is small (2 Hz), the pretightening force of the bolt hardly changes. In contrast, when the excitation frequency and acceleration are large, the bolt may loosen. When it occurs suddenly, the pretightening force is directly reduced from the initial value to almost zero (Figure 8).

**Figure 8.** The pretightening force of the bolt when the initial pretightening force is 15% of the yield strength and excitation frequency is 6 Hz.

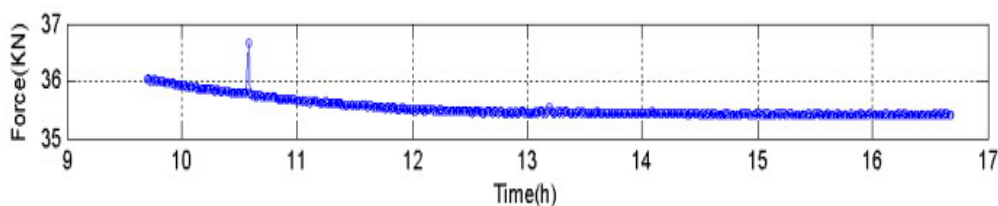
Figures 9 and 10 show the increase of the bolt's pretightening force to 30% and 45% of the yield strength, respectively. The analysis reveals that this force has a small decrease, even at a large vibration frequency. It is far from being loose, although the downward trend is obvious.

**Figure 9.** The pretightening force of the bolt when the initial force is 30% of the yield strength and the excitation frequency is 6 Hz.

Further tests on the flange in a vibrating environment show that a smaller initial pretightening force of the bolt can ensure a great sealing performance of the gaskets; however, the flange bolts will loosen under strong ice-induced vibration. Larger initial pretightening forces can delay or even prevent loosening, but excessive initial pretightening force may cause the gasket to yield prematurely, affecting its sealing performance.

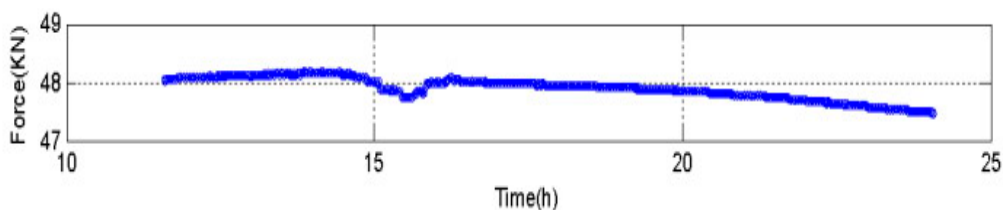
**Figure 10.** The pretightening force of the bolt when the initial force is 45% of the yield strength and the excitation frequency is 6 Hz.

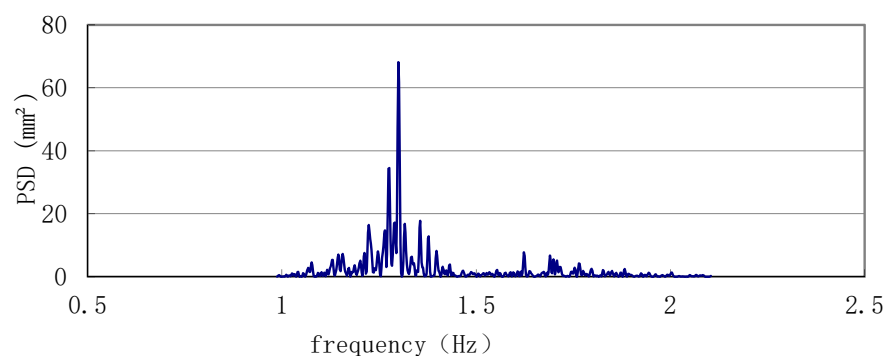
Field monitoring has found that the periodic load generated by sea ice can evoke large acceleration responses in the platform. We performed spectral analysis of the above-mentioned offshore platform (Figure 11) using monitored response data. The results show that the vibration of the platform was focused on the first mode.

**Figure 11.** The studied offshore platform's main deck X-directional displacement spectrum.

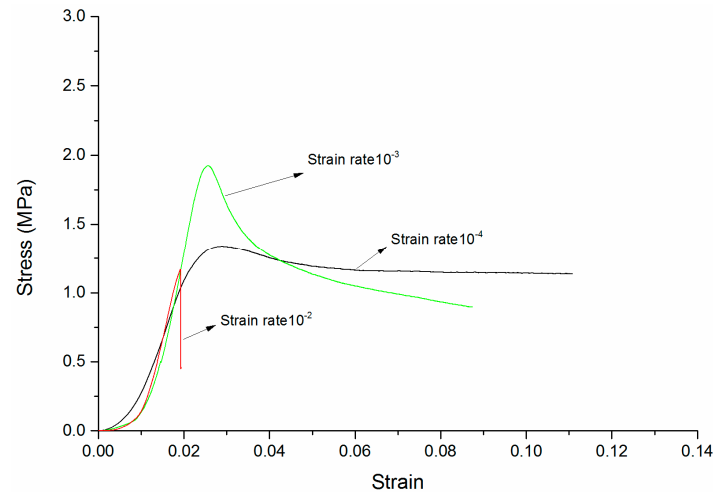
As a material, ice is very sensitive to the loading rate. Figure 12 shows that the uniaxial compressive strength of ice varies significantly with the strain rate, and the mechanical behavior of ice changes greatly when subjected to compressive loads. According to the different macroscopic mechanical behaviors of ice, the strain rate is divided into ductile region, ductile–brittle transitional

**Figure 12.** Sea ice load curves under different strain rates.

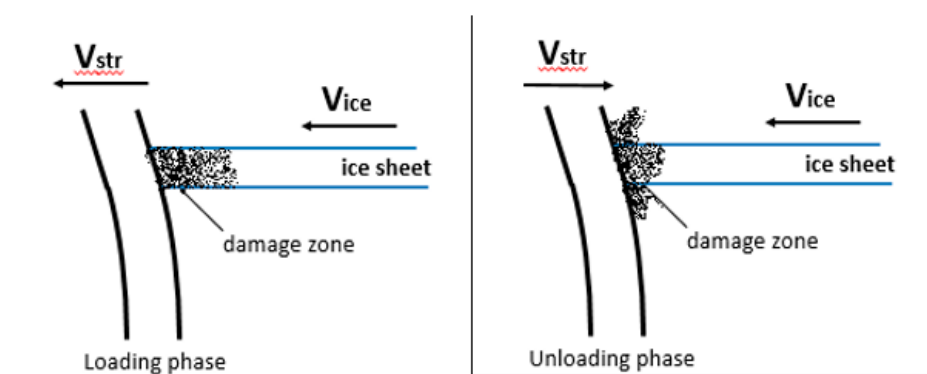
As shown in Figure 13, the cycle of self-excited vibration is divided into the loading phase, transition phase, and unloading phase. In the loading phase, the platform structure moves in the same direction as the sea ice at a similar speed. The loading speed of the ice sheet is slow, in the range of the ductile–brittle transition region. With loading of the ice force, new microcracks continue to be generated inside the ice, although they do not expand rapidly. As the loading rate continues to increase, the force is large enough to allow airfoil cracks to interpenetrate, and the ice sheet undergoes brittle failure. In the unloading stage, the direction of the structure’s motion is opposite to that of the ice. The structure smashes the ice sheet, which was already damaged during the loading phase. It breaks down simultaneously, and the ice’s force starts to unload. The structure swings back to the starting point of the loading phase, marking the end of a vibration cycle.

**Figure 13.** Ice-induced self-excited vibration physical mechanism.

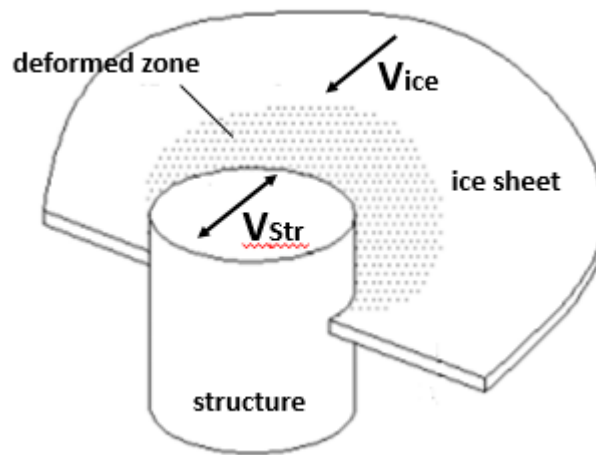
Figure 14. Outline of the ice sheet crushing the cylindrical structure.

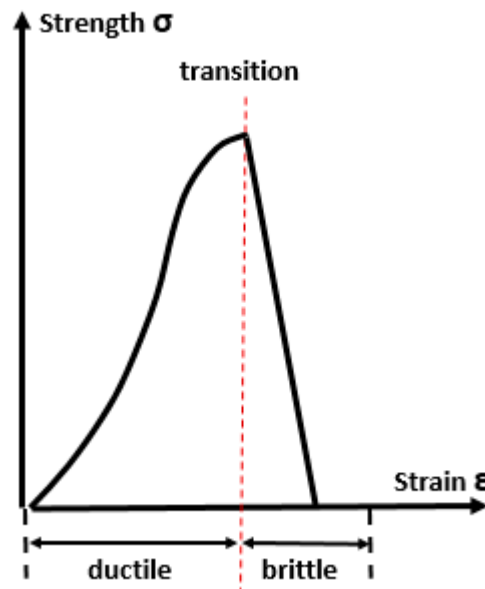
Figure 15. Loading curve of the ice sheet during strain rate increase.
