Case Report

Combination of Diagnostic Tools for the Proper Identification of Moisture Pathologies in Modern Residential Buildings

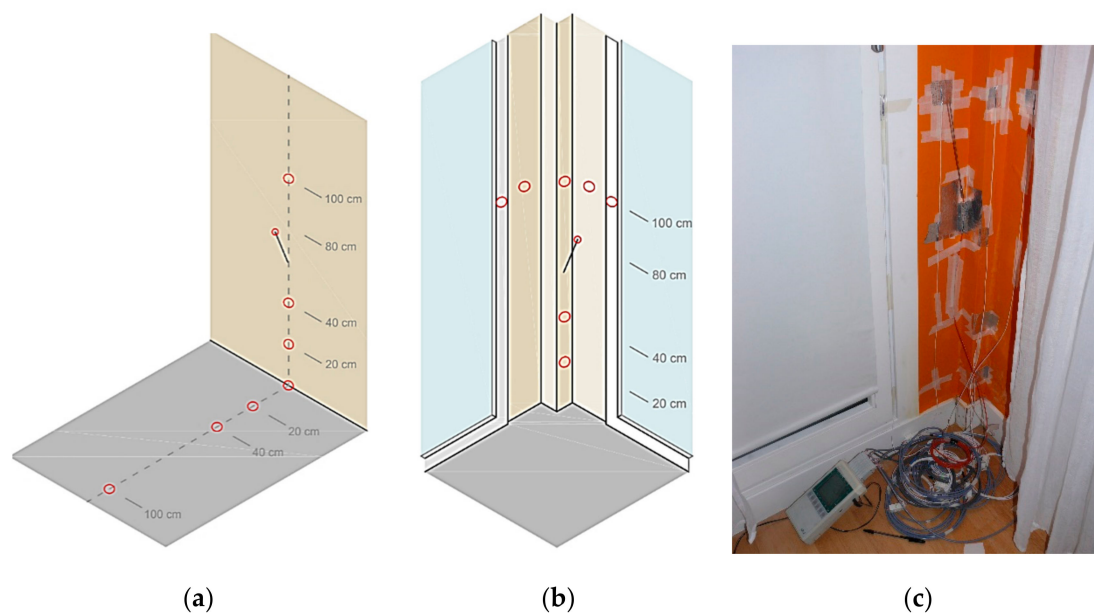
Figure 3. (a) Schematic of sensor installation in a façade and slab thermal bridge; (b) schematic of sensor installation in a façade corner pillar; (c) sensors and data logger installed in a façade pillar.

To measure the thermal performance of the opaque elements and the thermal bridging effect, a number of surface temperature meters were placed on the envelope, as shown in Figure 3. By using those sensors, detailed temperature profiles were obtained, and temperatures in the coldest point in contrast to the adjacent elements were evaluated. Data acquisition was done using two small data loggers.

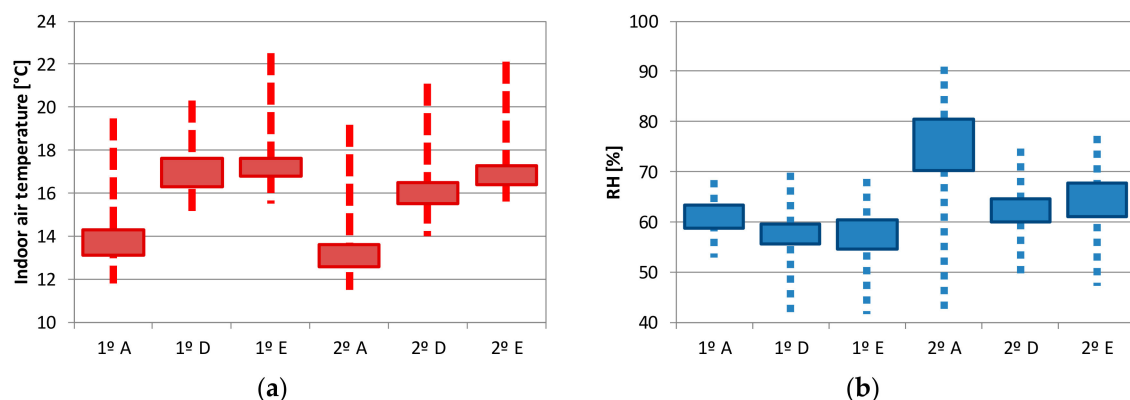
Figure 14. (a) Box-plot of monitored indoor temperatures; (b) box-plot of monitored indoor RH.

First, the assessment of the condensation risk in the studied façade, based on the D1 climate zone typical winter conditions and the measured indoor air conditions, is summarized in the box-plots in Figure 14, with the most frequent indoor air conditions of each dwelling. This assessment provides some evidence that there are three dwellings where the RH was over 70% for many hours. This high level of humidity is related to low heating use and insufficient ventilation. Additionally, it is worse in this case because of the small stack ventilation effect and inadequate window-opening habits for natural ventilation. The condensation risk for the building façade indicated that when the indoor air RH is over 70%, there is a clear interstitial condensation risk in all six dwellings, according to the annual method of the UNE-EN ISO 13788:2016. Table 2 gathers the main results of this verification, and in Figure 15 a comparison of condensing and non-condensing façade examples is presented. The situation in each dwelling is singular on a daily basis; on a monthly calculated basis, only one dwelling presented a measurable risk of interstitial condensation. The other dwellings presented only occasional surface condensation risks. For this reason, taking into account only this tool, it wasn't possible to determine the origin of the humidity problems of the other five dwellings.
