Structural Behavior of the General Archive of the Nation (AGN) Building, Mexico

Marcos M. Chávez, Fernando Peña *, Claudia Cruz and Gustavo Monroy

Instituto de Ingeniería, Universidad Nacional Autónoma de México, México City 04510, Mexico; MChavezC@iingen.unam.mx (M.M.C.); CCruzC@iingen.unam.mx (C.C.); GMonroyG@iingen.unam.mx (G.M.)
* Correspondence: fpem@pumas.iingen.unam.mx; Tel.: +52-555-623-3600

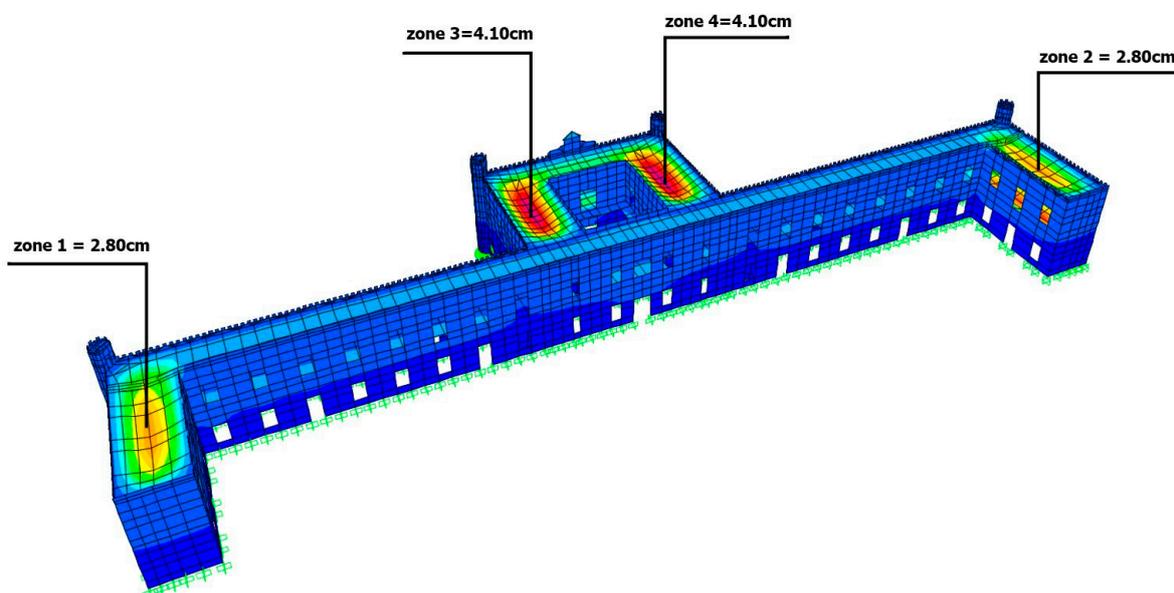
Figure 9. Displacements by own weight and maximum live load in vertical direction (cm) [12].

Table 5 shows the summary of the results for the review of permissible displacements while Figure 9 shows the displacements present on the numeric model structure. According to the results, the present displacements fall within the Building Code.

Zone	Own Weight			Review
	$\Delta_{elastic}$ (cm)	Δ_{slab} (cm)	$\Delta_{m\acute{a}x}$ (cm)	$\Delta_{m\acute{a}x} > \Delta_{Iosa}$
1	1.40	2.80	4.08	Ok
2	1.40	2.80	4.08	Ok
3	2.05	4.10	4.46	Ok
4	2.05	4.10	4.46	Ok

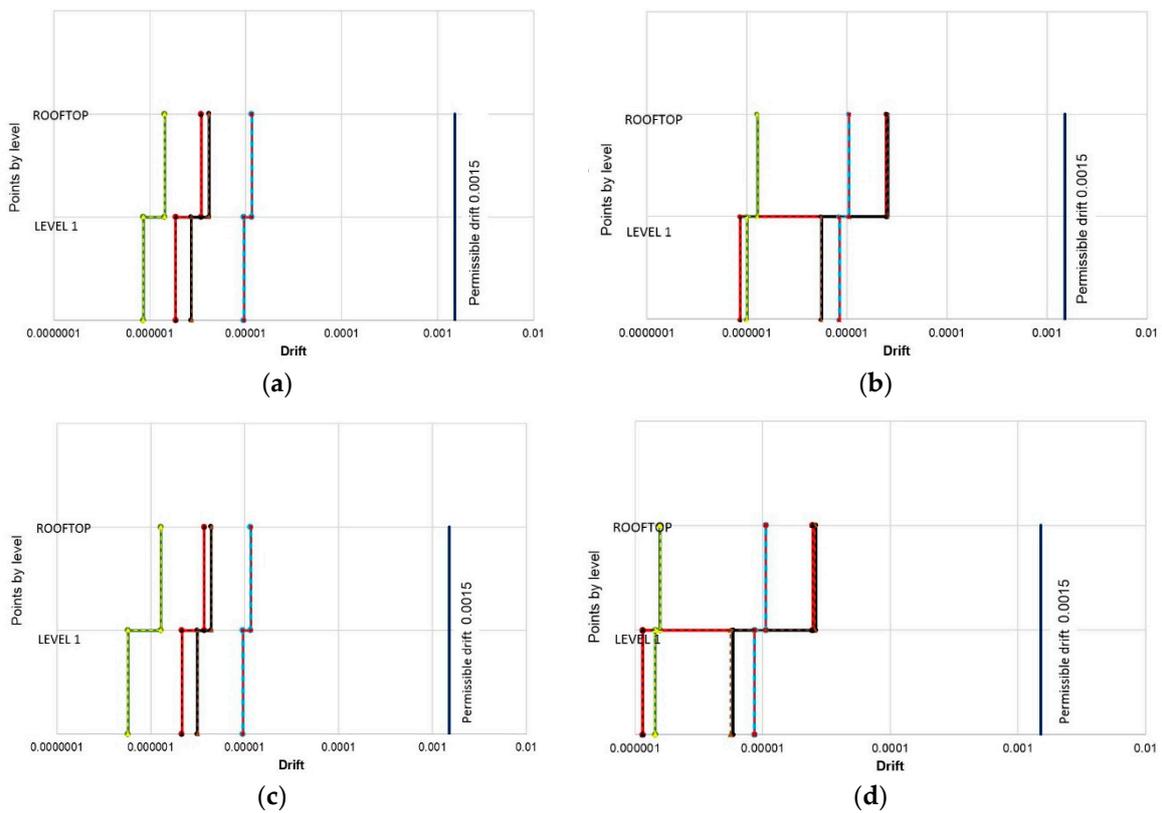
Figure 12. Seismic combination 100% S_x + 30% S_y : (a) direction x, (b) direction y; seismic combination 30% S_x + 100% S_y : (c) direction x, (d) direction y.

Figure 12 shows the drift results for different combinations by level. It should be noted that because the drifts are small, the abscissa axis is logarithmic. The building is very stiff in both directions so earthquake forces barely deform it. This means that drifts fall within the limits. The drift profiles are typical of two story buildings where the upper level has a bigger drift. Table 8 shows the basal shear obtained for each seismic load combination. Figure 13 shows the maps of vertical and horizontal axial stresses.

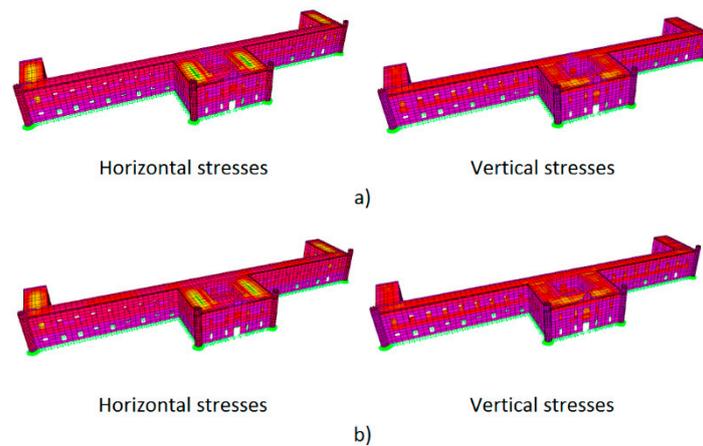
Figure 13. Map of vertical and horizontal axial stresses (MPa): (a) earthquake combination 100% S_x + 30% S_y ; (b) earthquake combination 30% S_x + 100% S_y .

The stress maps show that the building’s behavior is similar independent of the direction of the earthquake, although the solicitations for an earthquake in a transversal direction increase. Even

These results show that the structure does not have difficulties resisting seismic actions according to the Mexican Building Code. This can be mainly attributed to the building's stiffness, which causes the structure's period to be far from the soil's period that is located in the ascending branch of the design spectrum.

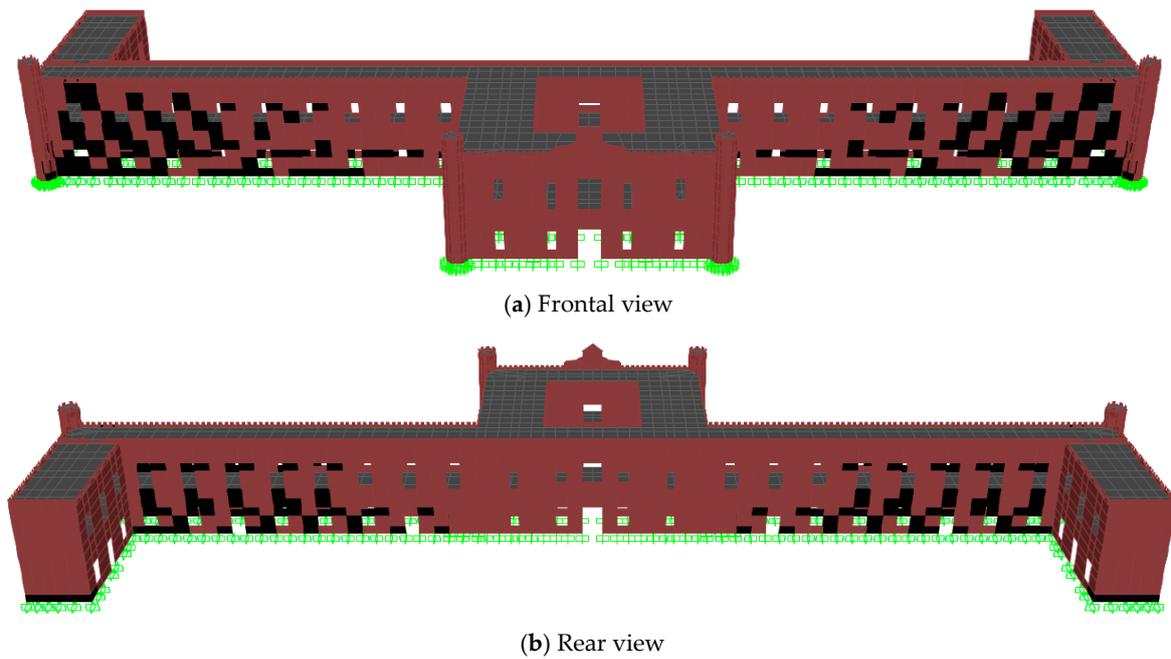
Figure 17. Elements with reduced elastic modulus.

When analyzing the results of the elastic model, it was observed that a large portion of the walls present high tensile stresses values which is interpreted as damaged area; however, because the analysis is linear, a redistribution of stresses cannot be generated, so they will increase proportionally without limit. As a result, in order to generate a stress redistribution, it was decided to perform an analysis in which the elements' elasticity modules whose major principal stresses exceed the diagonal tensile resistance are reduced, so that these zones reduce their tensile stresses. This idea has already been implemented in the geometric correction analysis of the Metropolitan Cathedral [19]. Details on the implementation of linear sequential analysis can be found in [20,21]. Figure 17 shows the elements with reduced elastic modulus.

Figure 18 shows the maps of horizontal axial stresses that resulted from this analysis. These maps display tensile stress concentrations between 0.2 and 0.4 MPa at both ends of the model, at the front mainly; this contrasts with Figures 15 and 16 in which the stresses in the same areas are over 0.4 MPa.
