# Load Testing of Cultural Heritage Structures and Sculptures: Unconventional Methods for Assessing Safety

Miloš Drdácý \*

**Abstract:** The paper presents the results of static and dynamic experimental tests conducted on historical heritage structures and sculptures. In recent years, there was an increasing need to address the behaviour of these types of structures due to several reasons. Diagnosing the actual condition of a historical structure involves not only identifying the cause of a detected defect, but also determining its impact and assessing whether the structure can continue to perform safely. This article utilises unconventional loading methods to generate measurable mechanical responses. In one case, a lifting procedure is employed to study strains in a composite structure, while in another example, the mass and movement of people are used as a form of loading. Proof load tests conducted on a monumental sculpture allowed for the determination of load distribution among its heterogeneous structural components, namely a bronze shell and an iron reinforcing frame. Furthermore, the static and dynamic loading of a ceiling supported by a masonry vault demonstrated its abi

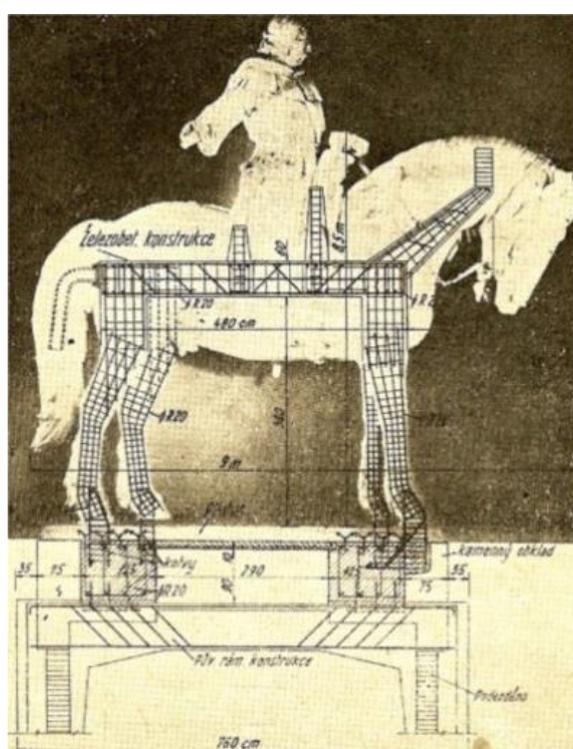
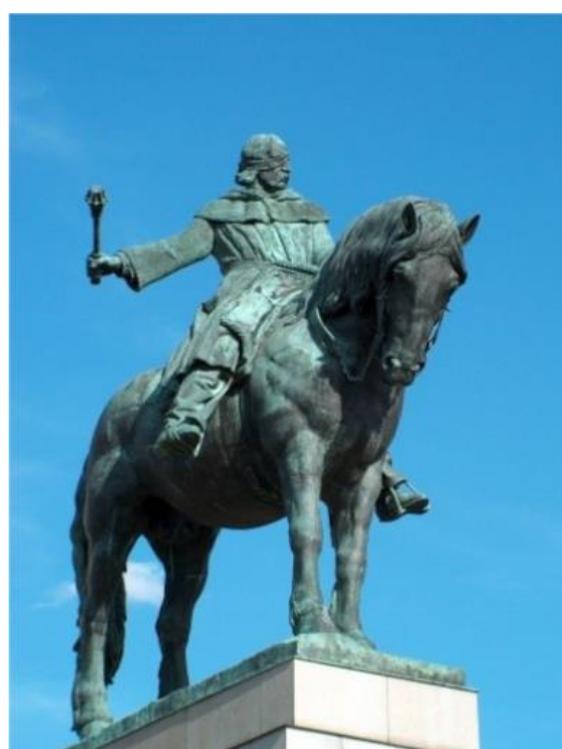
**Figure 1.** Bronze equestrian statue depicting the Hussite hetman Jan Žižka in Prague (right) and its reinforced concrete supporting frame (left).

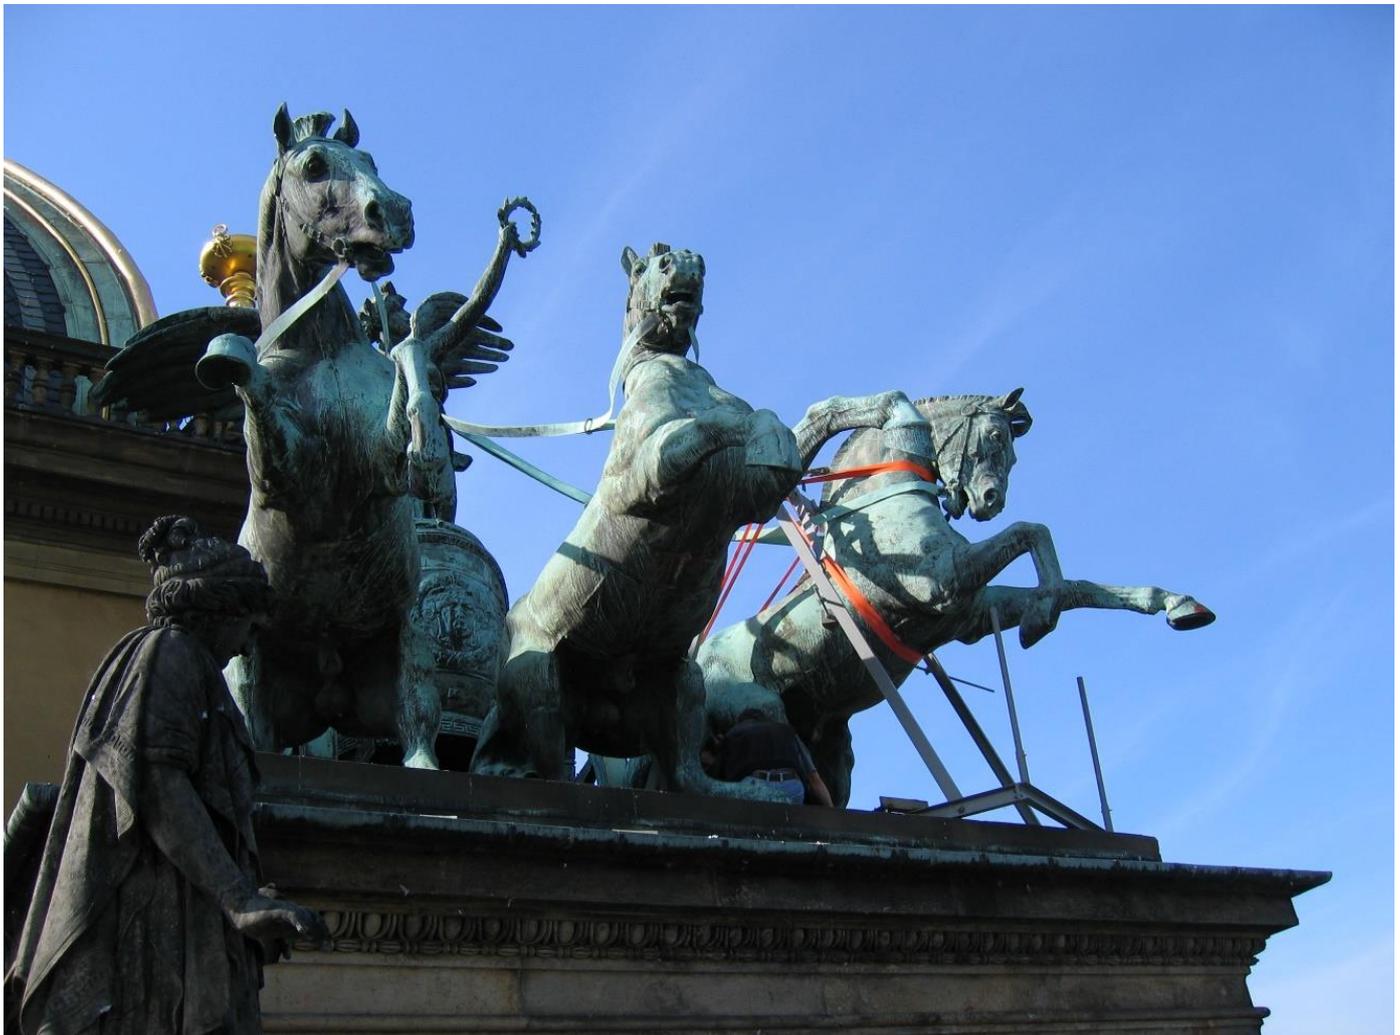
The triga sculptures designed by Czech Sculptor Bohuslav Schnirch were placed on the pylons of the roof of the National Theatre in Prague in 1911 (Figure 2) and were restored three times since then. In 1940, when the statues were opened, they were found to be in surprisingly poor condition. According to the restoration report, the lower parts of the horses' legs were filled in with concrete in order to "increase stability, due to the possible bombing of the city and thus the shocks or onslaught of blast waves". It is not known by what methods the deformation response and possible stresses in the structure were verified under these dynamic effects. The statues of the horses have relatively little rigidity in the horizontal direction and perpendicular to the median plane of the horses' bodies, which may have raised concerns about their stability. During further restoration in 1966 and 1981, the construction of the horses was not interfered with. Several approximate static calculations were made—most recently, during the survey described in this paper. It was found that the stress of the inner reinforcing steel frame assuming the full load of the weight of the statue is so high in some cross-sections that this structure would not be able to safely transfer the load of the statues without the cooperation of the bronze shell. It was expected that the bronze shell itself is sufficiently rigid and strong to accommodate a substantial part of its own weight and external loads.

**Figure 2.** Western bronze triga horses with carriage on the pylons of the roof of the National Theatre in Prague.

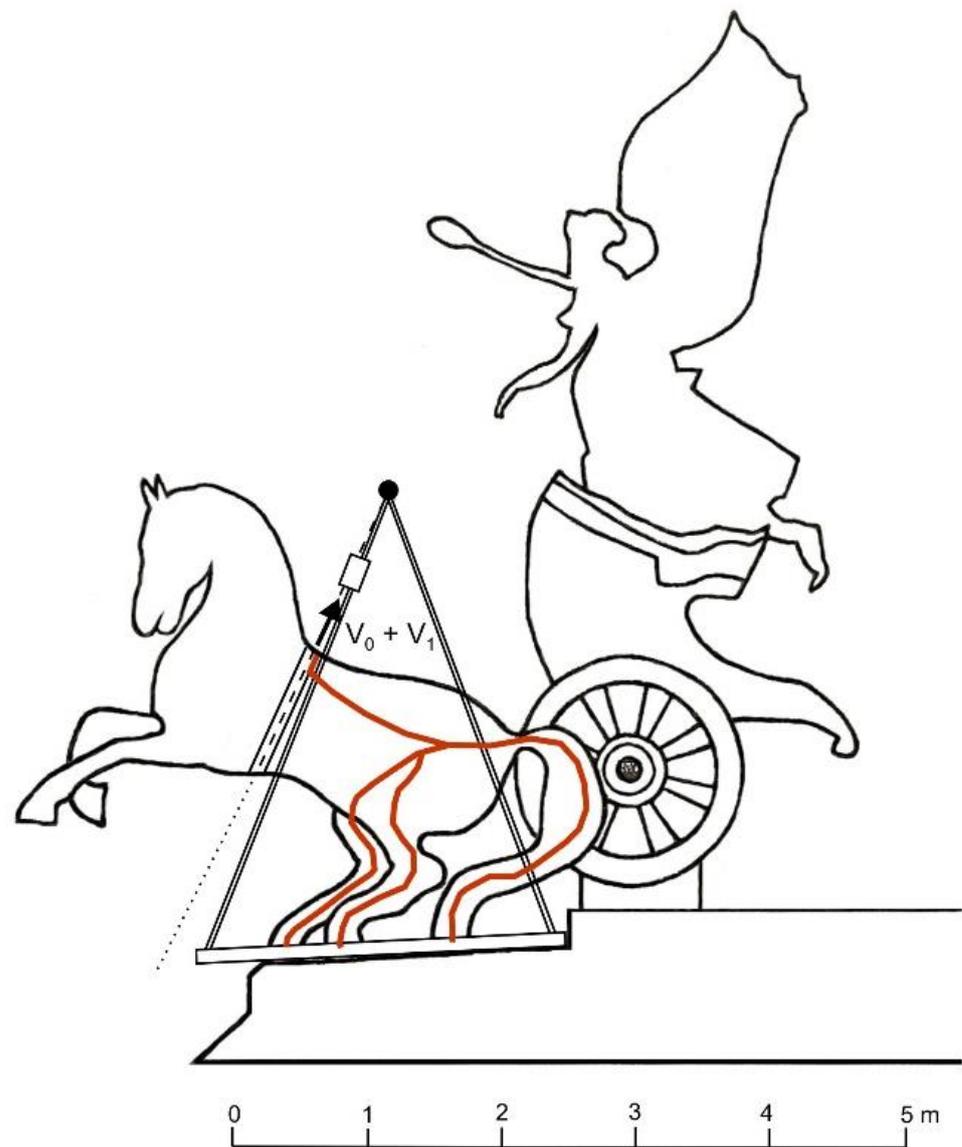
The statue of the horse is supported by a steel skeleton of complex shape, made of solid profiles of square cross-sections of 50 mm × 50 mm that are forge-shaped according to the needs of the geometry of the statue. This steel frame is firmly connected to the steel structure of the base grid built into the pylon roof slab. The bronze legs and tail are attached to the steel skeleton, sometimes in very close contact. A diagram of the skeleton is shown in Figure 3, where the interior steel skeleton is marked in red.

**Figure 3.** The figure shows a schematic view of the inner steel skeleton (red) with a temporary triangular supporting frame and the position of load cells.

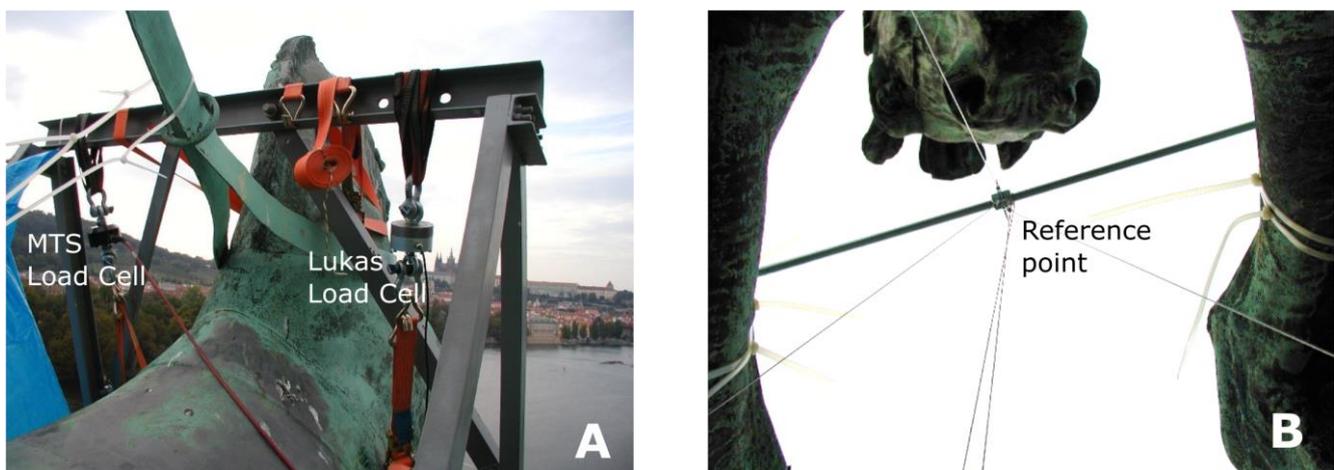
Load cells for measuring the applied force were inserted between the suspension straps and the existing steel suspension structure (frame). Due to the small working height between the statue and the frame, two load cells (marked V0 and V1 in the pictures) were used to measure the force in the straps on both sides of the horse, Figure 4A. The load cells were suspended in the system after completely loosening the straps applied for the restoration process and removing them in the parts where the force was not measured (neck and tail). Deformation and proportional deformation were monitored on the statue during the release of the straps and later during loading. The straps were tensioned by a tooth mechanism, which did not allow for equalisation of the forces on both sides of the horse and made the measurement more difficult. Therefore, it was not possible to achieve a completely symmetrical stress in both straps, nor a continuous increase in force. One material test systems (“MTS”) load cell with a capacity of 25 kN and one “LUKAS” load cell with a capacity of 50 kN were used for the measurement. The structure was loaded continuously, and the force and other monitored values (displacement and proportional strain) were continuously measured.

**Figure 4.** Load cells for measuring the applied force (A); the centre of the connection between the front legs was the reference point for the displacement measurements (B).

The displacement of the statue complex cantilever end required the creation of a reference point. This point was considered the centre of the connection between the front legs, fixed by means of a threaded rod attached to the statue (Figure 4B). The spatial record of the displacement characterises the horse's deformation under load and was determined by measurements using three rotary potentiometric path sensors. The individual pickups were marked PP (on the right when facing North), PL (left), and PZ (to the rear below the horse's chest).

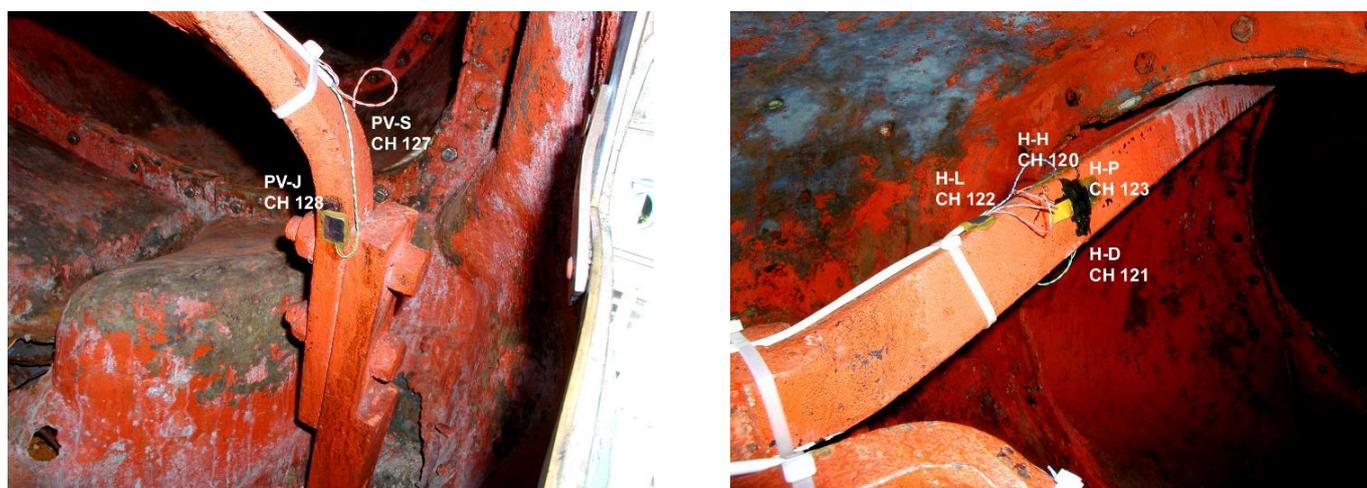
The relative strain was measured by means of electrical resistance strain gauges glued to the examined statue, its bronze shell, and to the reinforcing steel structure. An example of the location and marking of strain gauges on the steel structure is illustrated in Figure 5. Here, H denotes the dorsal profile and PV right leg reinforcing bar with sides facing north (S) or south (J) sides. The measurements were performed on the dorsal profile (strain gauges CH 120, 121, 122, and 123) and on the right (strain gauges 127, 128) and left (strain gauges 125, 126) sides of the back leg (CH denotes measuring and recording channel). On the bronze coat, proportional deformation was measured on both hind legs in two profiles (above the hoof and on the thigh) and on the tail, as shown in Figure 6. Strain gauges were placed in the vertical plane on the upper and lower surface of the hollow profile of the foot, in the horizontal plane in the assumed level of the neutral axis. This arrangement enables calculation of the bending moments and axial forces in the measured element. Strain gauges on the right (and left) leg were marked PN (and LN), H, and D for the upper and lower surfaces; in the neutral axis PN (and LN), P, and L according to the right and left sides; the numbers of the corresponding measuring channels are shown in the figures. Strain gauges on the tail are marked O-H (and D, P, and L) according to the same scheme. The overall arrangement of strain gauges can be seen in Figure 7.

Figure 5. Strain gauges on the right hind leg upright (left) and dorsal profiles (right).

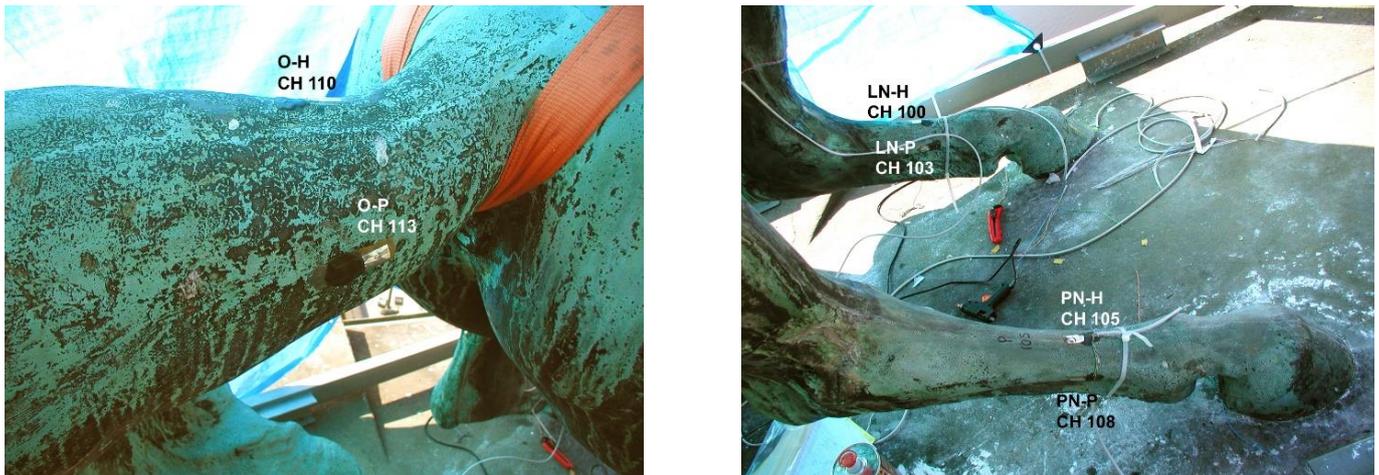
**Figure 6.** Strain gauges on the bronze shell; on the tail (left) and on the hind legs (right).

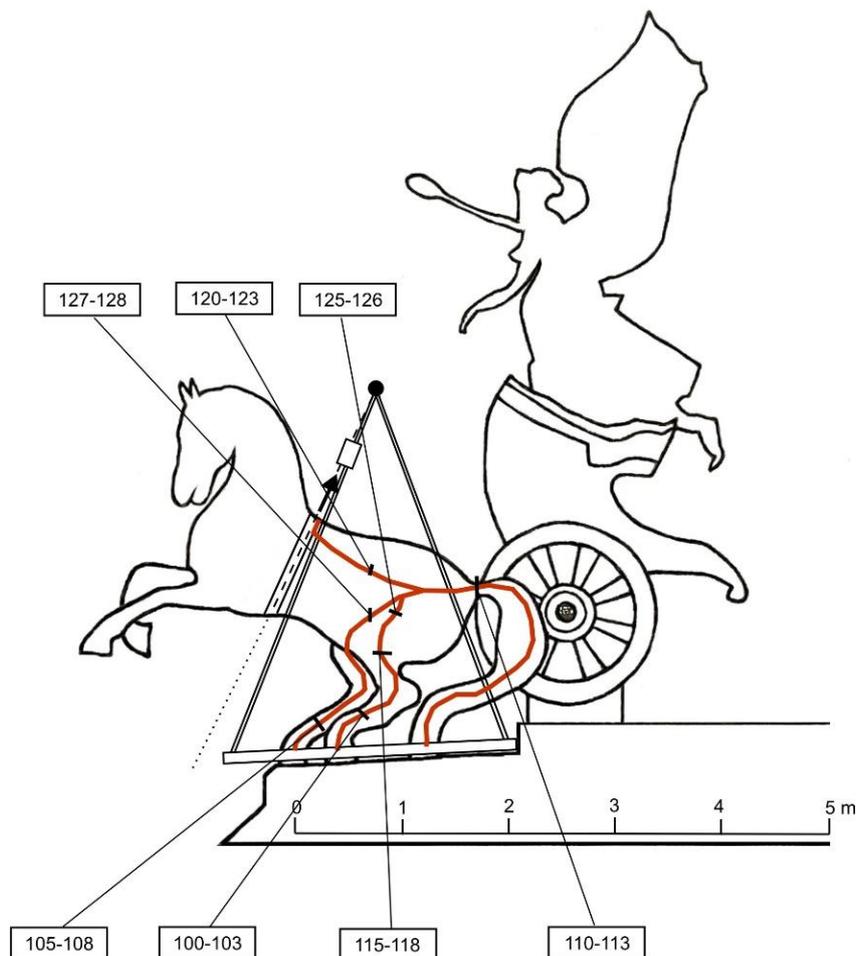
**Figure 7.** Overall arrangement of the groups of strain gauges on the sculpture.

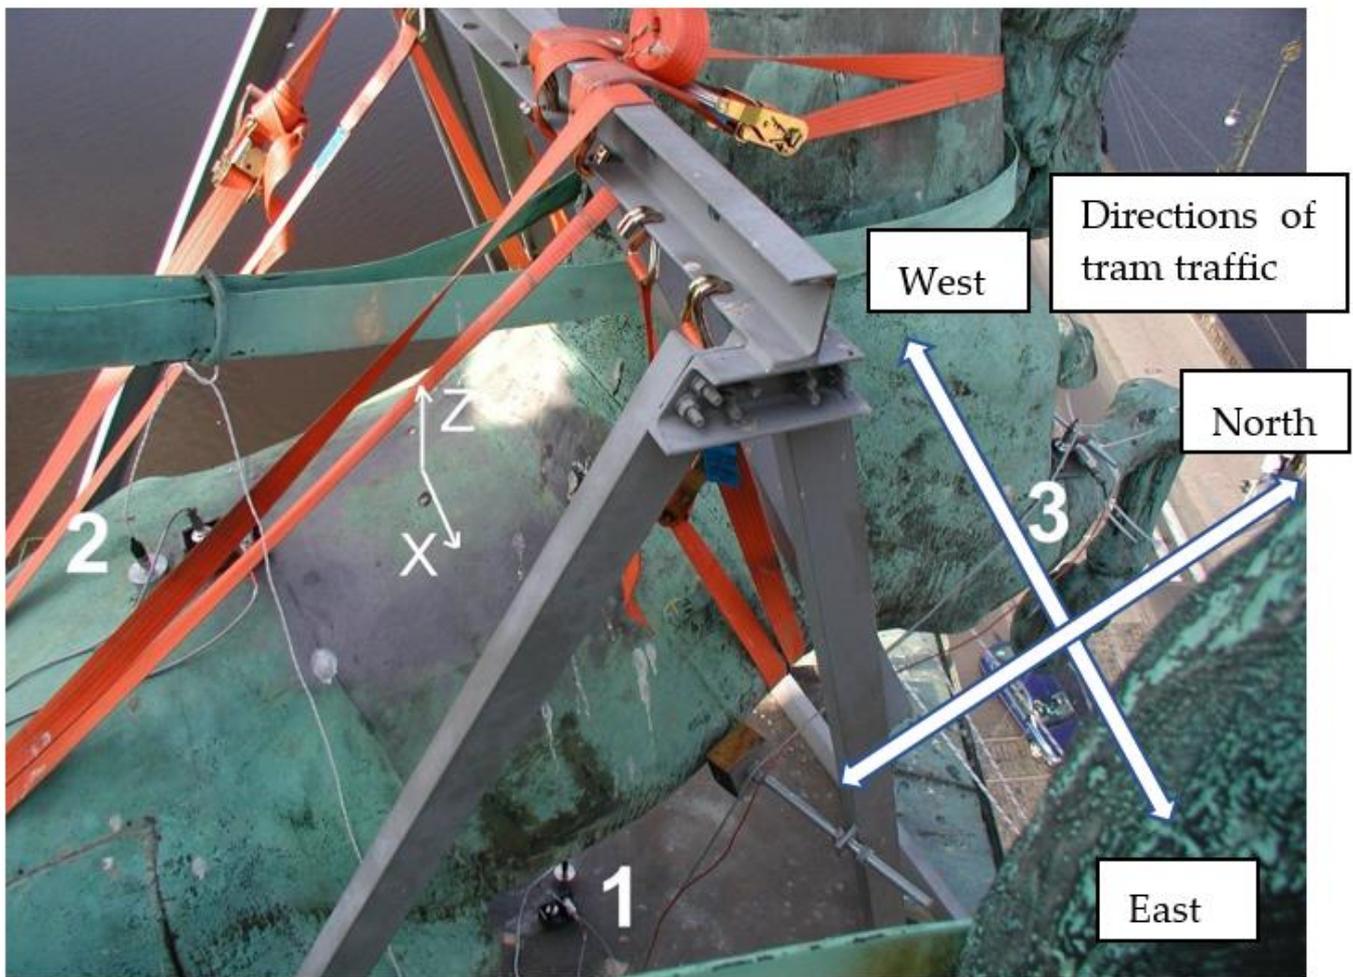
In order to capture the oscillation on the pylon of the roof of the National Theatre and on the statue at the same time, three measuring points were selected. An overall view of the locations of all the sensors is shown in Figure 8. The dynamic response was measured both during standard road traffic and when the statue vibrated due to an impulse in the horizontal or vertical direction.

**Figure 8.** Locations of vibration sensors (1, 2, 3) and the directions of tram movement.

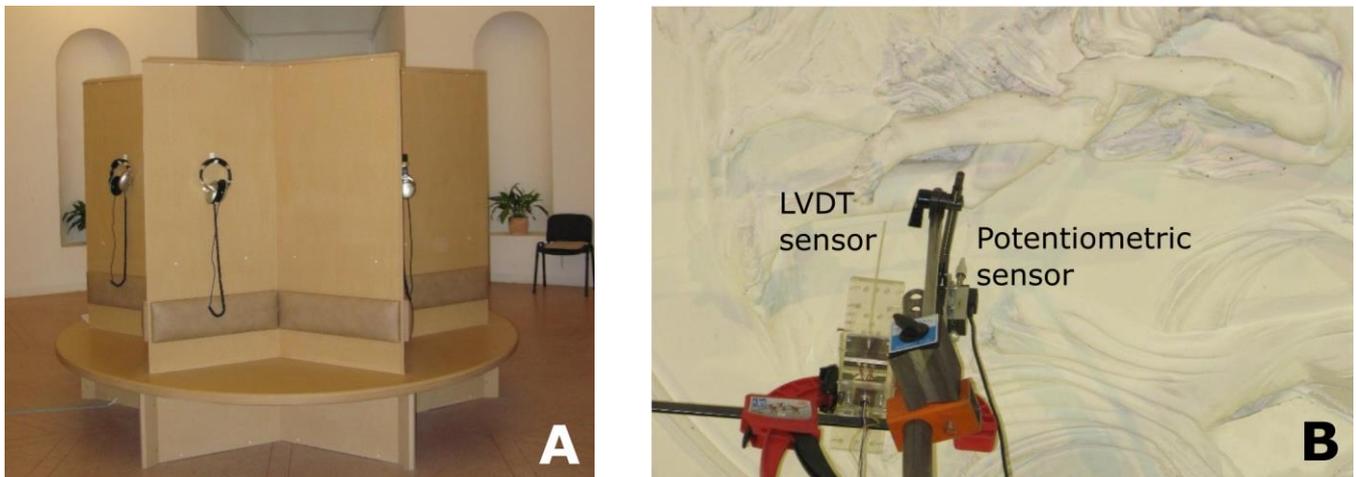
During the study load test, the vault was loaded by a group of people of known weight in order to model a load typical of exhibition visits. In the middle of the central space, there is a chipboard construction (Figure 13), adapted for visitors to sit and listen to the recordings accompanying the bands projected onto screens in radially spreading corridors. Therefore, the live load during the exhibition is well localised on the vault.

**Figure 13.** Seating structure for listening to recordings accompanying the exhibition (A). During the test, the loading persons with a total weight of 552 kg (first series) and 867 kg (second series) sat in the seats. Measurement of deflections using an LVDT sensor and a potentiometric sensor (B).

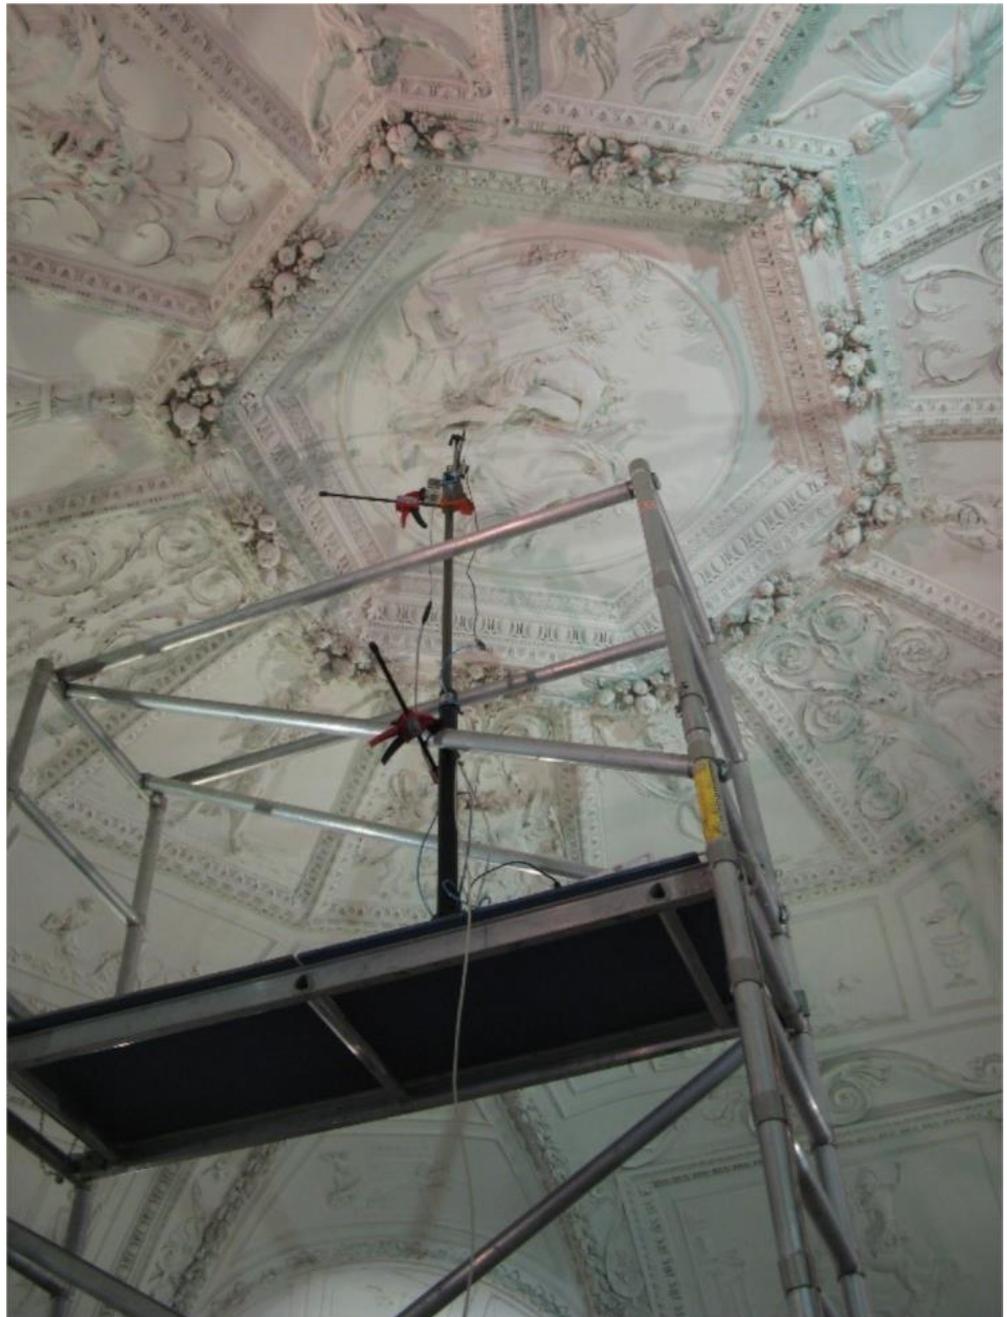
Measurements on the vault with its valuable stucco decoration did not allow for the attachment of sensors that would be needed to monitor movement in the crack. Therefore, only the deflection was measured using sensors that touch the surface of the vault. A very sensitive linear variable differential transformer (LVDT) sensor with a range of 1 mm and a linear potentiometric displacement sensor were used for inspection (Figure 13). The stands with sensors were placed on a light portable duralumin scaffolding (Figure 14). Before the test, vault defects were identified, manifested by a system of cracks, and their behaviour was visually monitored during the test with photographic recording. The basic system of cracks is indicated in Figure 12 and partly corresponds to the findings recorded during an inspection in the year 1991. At that time, no detailed documentation was made, but the historical report does not mention the oblique cracks in the barrel vaults of some corridors, which therefore possibly developed later. Without a more detailed analysis or probes or monitoring, it is difficult to evaluate their origin and development. On the surface of the vaults, additional cracks are noticeable that are related to the technology of stucco decoration and the peeling of thin layers of paint, which can be observed even by visitors.

**Figure 14.** Placement of the deflection sensors on a light scaffolding. The stucco decoration influenced the choice of location for the point of contact of the sensors with the vault, and therefore the measurement could not be carried out exactly in the middle of the vault.
