Compatibility Assessment in the Replacement of Damaged Sandstone Used in the Cathedral of Huesca (Spain)

1.1. Ebro Valley Natural Stone: Miocene Sandstone in the Cathedral of Huesca

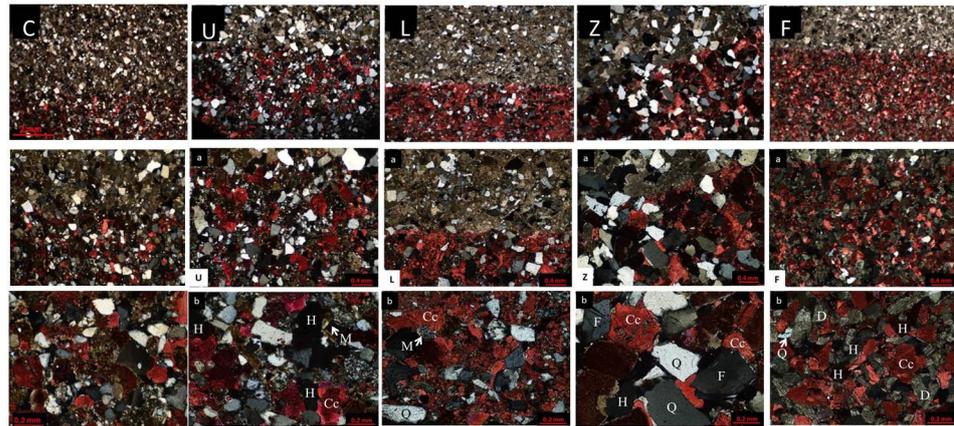
Petrographic features of the potential replacement sandstones (U), (L), (Z), and (F) are displayed in Figure 5 and also summarized in Table 1. Their compositional comparison clearly shows the greatest differences in both Oligocene stones (F and Z) related to the

original (C). While sandstone (F) shows higher proportions of carbonate components and especially the presence of dolomite, sandstone (Z) displays a higher content of siliciclastic components, compared to carbonate fragments, and greater amount of sparry cement. In addition, its particle size is notably different with an average of more than 0.5 mm diameter. On the other hand, and in comparison with the sandstone of the cathedral (C), the so-called (L) is very compact and fine grained detritic rock with much reduced interparticle porosity due to the high amount of sparry cement. As expected, sandstones (U) and (C) of the same age (Lower Miocene), although of different geological formations (Uncastillo and Sariñena), share great similarity in composition and particle size.

Figure 5. Petrographic images under polarized and analyzed light of the evaluated sandstones: C (Cathedral), U (Uncastillo), F (Floresta), L (Alastuey) and Z (Alcañiz). Red stained calcite by Alizarine. Noteworthy is the similarity in composition, texture, granulometry and porosity of the Lower Miocene sandstones (C) and (U). Legend: H (voids); Cc (calcite); M (marls); Q (quartz); F (feldspar); D (dolomite). For comparison, all photomicrographs in each row are at the same scale.

As is well known, the best criterion for selecting replacement sandstone is to ensure that the proposal stone has as many intrinsic characteristics in common with the original as possible [36]. The ratio of binding material to constituent fragments and the porosity must be alike. If the mineralogy of the replacement stone is similar to the original, the geochemistry of the stones will effectively be the same. Therefore, comparing the constituent grains, type, size, and proportions, the cement material and porosity, we should conclude that Uncastillo (U) sandstone is the most similar to the original (C).

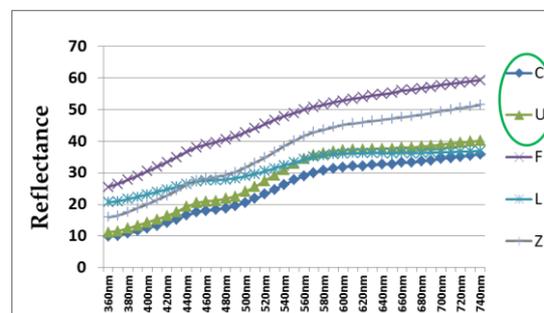
This match is also manifest in the similarity of both stones in colour, as can be seen in the representation of their comparative spectral curves (Figure 6).

Figure 6. Spectral curves obtained from the sandstones under evaluation: C (Cathedral), U (Uncastillo), F (Floresta), L (Alastuey), and Z (Alcañiz). Note the remarkable similarity in the reflectance line of C and U samples, circled in green to facilitate comparison.

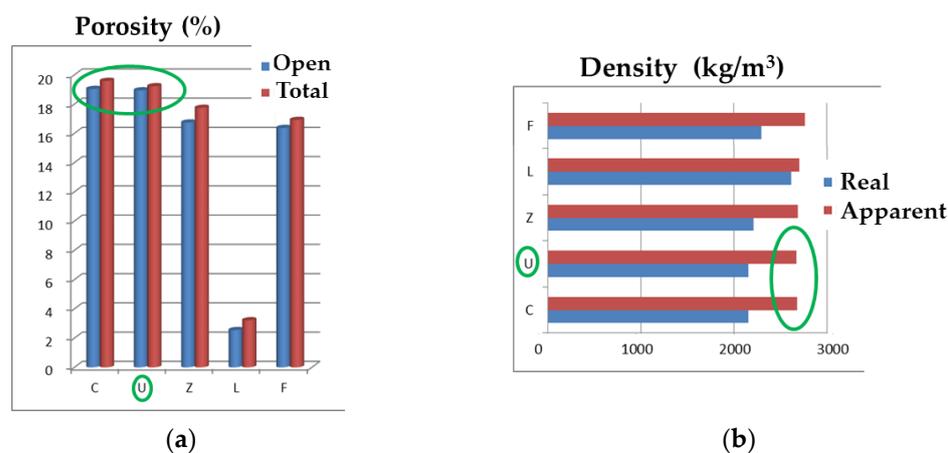
Table 2 summarizes the values obtained for the assays performed to evaluate the hydric and related parameters. The first five rows are the sandstones evaluated in this first step, while the remaining rows of Table 2 will be explained below (see Section 3.5.2). Comparative graphic representations of the sandstones under study are shown in Figure 7, illustrating the open and total porosity (%) in Figure 7a and the real and apparent density (kg/m^3) in Figure 7b. In agreement with the petrographic examination, in both graphics, sandstone (U) bears a close similarity to sandstone (C).

Figure 7. Comparative graphic representations of the sandstones under evaluation. In (a,b): Sandstone (U) from Uncastillo has the closest values to the original (C), in terms of Porosity and Density, respectively. They are circled in green to facilitate comparison.

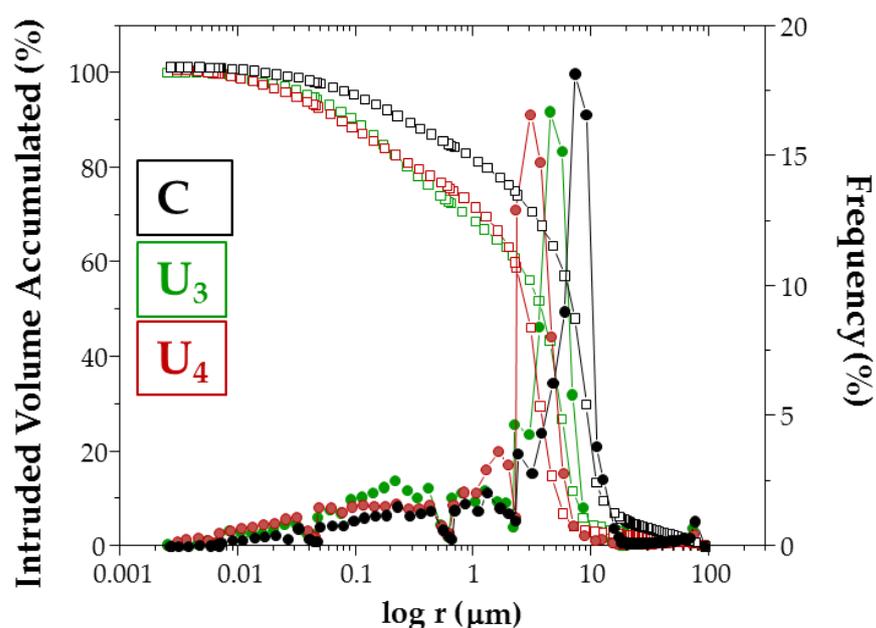
The overall value of porosity and the pore size distribution of both sandstones (original and the potential (U) for replacement) must also be alike to prevent any subsequent degradation. Though, in general, this critical feature is quite similar in both sandstones (C) and (U), this is also directly affected by the presence of that heterogeneous distribution of clay matrix. In Figure 8, the pore size distribution by MIP data of the original (C) sandstone and those of two (U) varieties (named U₃ and U₄) are shown, in which very subtle changes are detected with higher values of microporosity in the latter (U₄), in relation to (U₃) and (C). Their porosity data are summarized in Table 3, where it is evident that the median and average pore radius of sandstone U can vary from one sample to another in different blocks of the same quarry (e.g., in U₃ and U₄). Both varieties were also tested in accelerated ageing cycles to show the importance of selecting properly the potential replacement sandstone as their clay matrix distribution was also different in both specimens.

Figure 8. Examples of the pore size distributions determined by Mercury Intrusion Porosimetry (MIP). Comparison of the original sandstone (C) and two different samples of the same Uncastillo sandstone (U₃ and U₄).

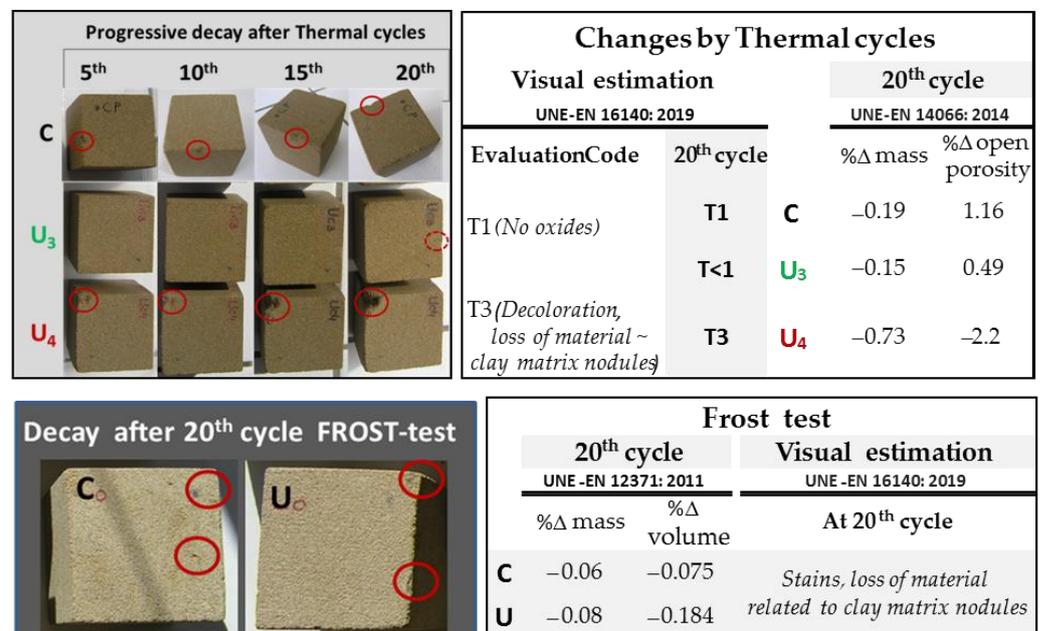
Figure 9. Accelerated ageing Frost (freeze-thaw) and Thermal (wetting/drying) cycle tests in (C) and (U) sandstones. Above: Images of the progressive decay at different Thermal cycles, their visual estimation and changes measured after 20th cycle. Note the different visual estimation and measured decay experienced by (U₃) and (U₄) samples related to the presence of clay matrix nodules (encircled in red). Below: Images, visual estimation with damage encircled in red, and changes measured after 20th frost cycle.

Thermal cycling (wetting/drying), as simulation of the weathering mechanisms of hydration, oxidation and dissolution related to the control exerted by temperature and moisture regimes, seems to be important in assessing the durability of sandstone [37]. In particular, certain researchers have highlighted the significance of surface moisture retention in accelerating weathering from matrix dissolution, attributing the frequency and dimension of tafoni in the Miocene Ebro Valley sandstone to the high insolation-induced afternoon warming in this semiarid environment [38]. During the accelerating ageing tests carried out in the current study, the negative effect of the existence of clay matrix nodules was observed, comparing the progressive decay after thermal cycles in specimens with apparently no visual clay nodules (U_3) and with them (U_4), as Figure 9 illustrates. After the 20th cycle, the codes assigned were $T < 1$ in (U_3), but T3 in (U_4), due to the evident loss of material related to the presence of clay matrix aggregates.

Concerning the freeze-thaw cycles, however, both sandstones (C) and (U) varieties (U_3) and (U_4) were estimated as durable stones, since after 20 cycles the loss of mass and volume were minimal, with slight stains around the clay matrix nodules (Figure 9).

It can be concluded that (U) sandstone is suitable for the replacement but requires selecting the material appropriately to avoid benches containing clay matrix nodules.

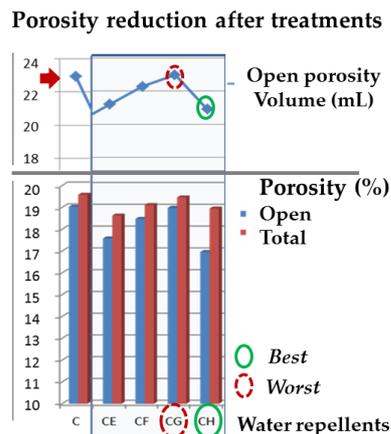
The last eight rows of Table 2 summarize the obtained values for all performed assays on the Cathedral and Uncastillo sandstones. Concerning the effective reduction of porosity after the water-repellent applications on (C) specimens, Figure 11 shows the worst and best products, being G and H respectively, with least closed and most sealed porosity.

Figure 11. Porosity reduction is illustrated (in volume and in %) after the water-repellent treatments (E, F, G, and H) in the original (C) sandstone. The best and the worst effect are encircled in green and red, respectively.

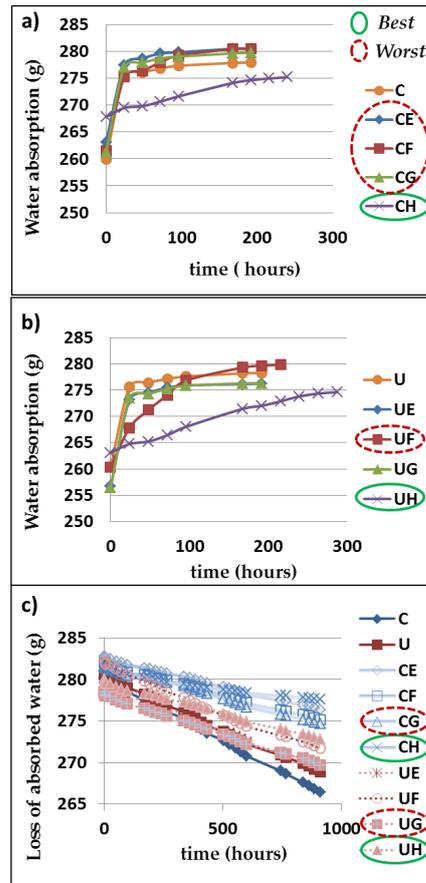
In Figure 12a,b, the results of the water absorption test registered in sandstones (C) and (U) and their behaviour after each water-repellent treatment is displayed. In both cases, H treatment behaves far better than the others, even maintaining the same pattern in both specimens, slowly increasing water absorption and lengthening the time until saturation. Figure 12c shows contrary behaviour, a progressive pattern in the loss of absorbed water during 912 h of testing of the same untreated and treated (C) and (U) samples, confirming G and H as the worst and best products, respectively, in both sandstones.

Figure 12. (a,b) Examples of the water absorption behaviour in the untreated and treated water-repellent tests in the original sandstone of the Cathedral (C) and in Uncastillo (U) sandstone. In both, the best and the worst effect is encircled in green and red, respectively. (c) Comparative graphic behaviour of the loss of absorbed water after 912 h, in the same specimens.

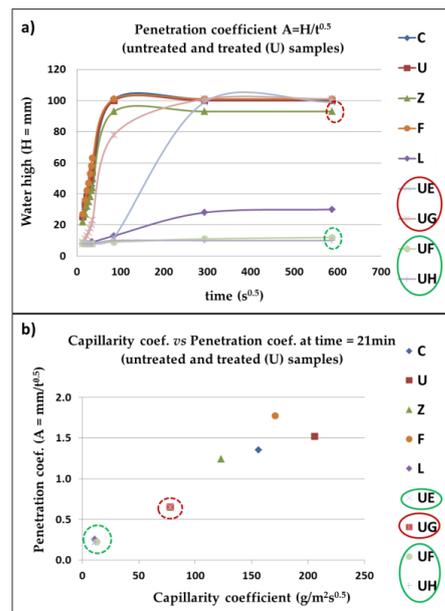
The capillary coefficients ($\text{g}/\text{m}^2 \text{s}^{0.5}$) obtained in the untreated samples varied widely among them, with values over $200 \text{ g}/\text{m}^2 \text{s}^{0.5}$ measured at 21 min in sandstone U (Table 2). However, after the water-repellent treatments, this value was considerably reduced in all (U) samples. A different and complementary way to evaluate the effect of capillary action, the penetration coefficient ($\text{mm}/\text{s}^{0.5}$), was also measured and is shown in Figure 13a,b, where the treated (U) samples are also illustrated. In both figures, treatment G is confirmed as the worst, while F and H significantly reduce both coefficients.

Figure 13. (a,b) Examples of capillary water behaviour in the untreated sandstones and treated water-repellent tests in Uncastillo (U) sandstone. In both, the best and the worst effect is encircled in green and red, respectively.
