A Practical Example of GaN-LED Failure Cause Analysis by Application of Combined Electron Microscopy Techniques

Elke Meissner ^{1,*}, Maral Haeckel ² and Jochen Friedrich ¹

¹ Fraunhofer Institute for Integrated Systems and Device Technology, Schottkystr. 10, 91058 Erlangen, Germany; jochen.friedrich@iisb.fraunhofer.de

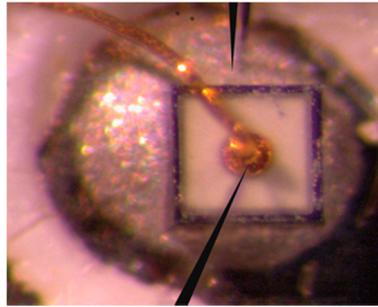
Figure 2. The blue LED chip prepared for the EBIC analysis. One can see the chip with the bond foot and wire. The chip is contacted by the EBIC tips (arrows). The side length of the chip is approximately 0.3 mm. The coverings were removed by chemical means.

One can see the LED chip and the bond, as well as the two EBIC tips in contact with the device. In summary, the above-mentioned route of investigation through combined analytical techniques was capable of clarifying the failure cause of the LEDs, as will be further discussed in the results section, below.
