# Comparative Analysis of Ultrasonic NDT Techniques for the Detection and Characterisation of Hydrogen-Induced Cracking

**Abstract:** The article is devoted to the investigation of ultrasonic inspection techniques suitable for detecting hydrogen-induced cracking (HIC) and a high-temperature hydrogen attack (HTHA), which are of great importance in petrochemical and refinery industries. Four techniques were investigated: total focusing method (TFM), advanced velocity ratio (AVR) measurement, advanced ultrasonic backscatter technique (AUBT) and time of flight diffraction method using ultra low angle ultrasonic transducers (TULA). The experimental investigation has been carried out on two carbon steel samples cut off from a heat exchanger of an oil refinery and potentially affected by HIC. It was shown that the AVR technique did not reveal any damage and was not effective in the case of the investigated samples due to a thin damage zone with respect to the total thickness of the samples. The AUBT method enabled us to indicate and classify the presence of the hydrogen-induced damage; however, it is complicated to use in practise due to the need perform measurements exactly at the same

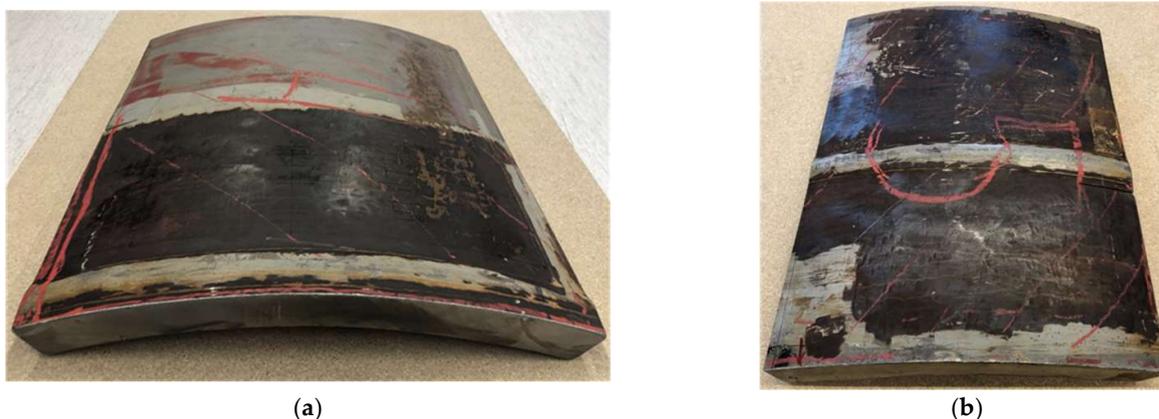
Both samples contained a circumferential weld, as can be seen from Figure 1. Among the abovementioned samples, Sample No. 4 was used for the comparison of HIC inspection techniques—AVR, AUBT, TULA and TFM—while Sample No. 5 was analysed with TULA and TFM only; the results obtained on this sample were, however, supported with a metallographic analysis.

**Figure 1.** Segments of heat exchanger pipe used for comparison of HTHA detection algorithms: (a) sample no. 4 and (b) sample no. 5.

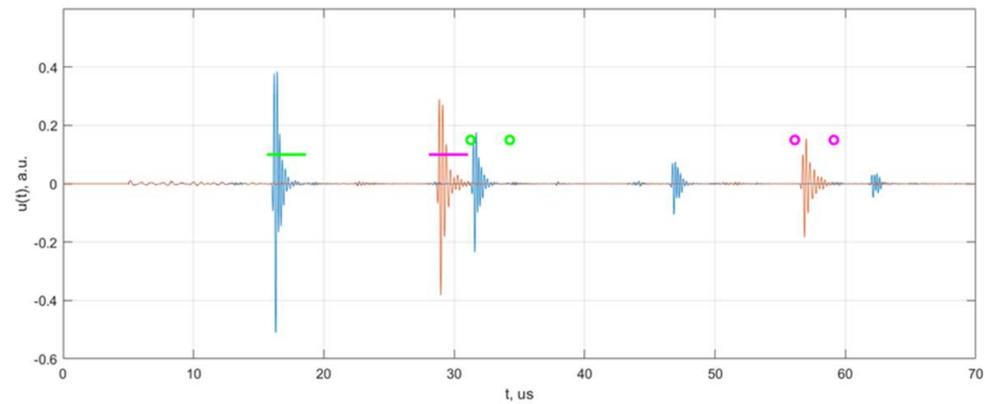
**Figure 6.** The measured signals of longitudinal (blue) and shear (red) waves. Horizontal lines indicate the time windows for the first backwall reflection, the circle markers show time gates for the second backwall reflection.

The obtained velocity ratio is equal  $0.548 \pm 0.01$  and does not depend on the measurement position, what is illustrated by TFM data at Figure 7. According to this method it is less than 0.55, thus it does not indicate the presence of HIC at these positions in the sample. However, at the second, fourth and fifth positions, some reflectors can be observed in the TFM image, likely due to HIC damage (see Figure 7). It can be stated also that indications are observed at 8mm above the back wall, so it can be assumed that the damage is present at only 18% of total thickness, so it is completely understandable that the influence of

the damage on the propagation time will be minor. So, it can be concluded that the AVR method possess poor sensitivity for the detection of HIC at a depth close to the bottom, at least in the case of thick samples.

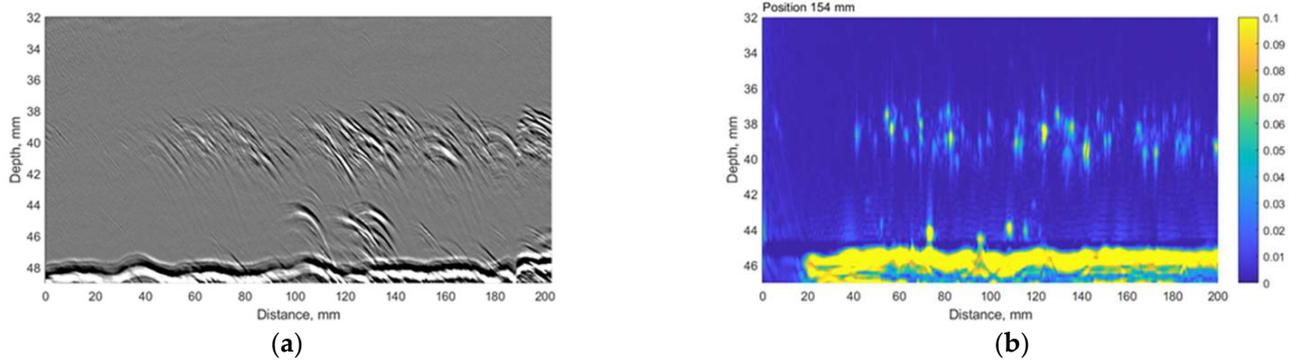
**Figure 13.** The comparison between (a) TULA and (b) TFM measurements at 154 mm circumferential scan position. Vertical colour bar represents the peak-to-peak amplitude in arbitrary units.

A good correlation can be observed between results obtained using the TFM and TULA method. Of course, there are some differences because it is impossible to scan exactly along the same line, especially considering the relatively small dimensions of the defect. The essentially higher resolution of TFM images can be noticed and it can be stated that the TULA technique, in general, enables the detection of HIC damage and is faster and simpler compared to the application of TFM with scanning. It is necessary to notice also that the frequency of TULA transducers (10MHz) is slightly higher than the frequency of the phased array (7.5 MHz) used by the TFM technique.

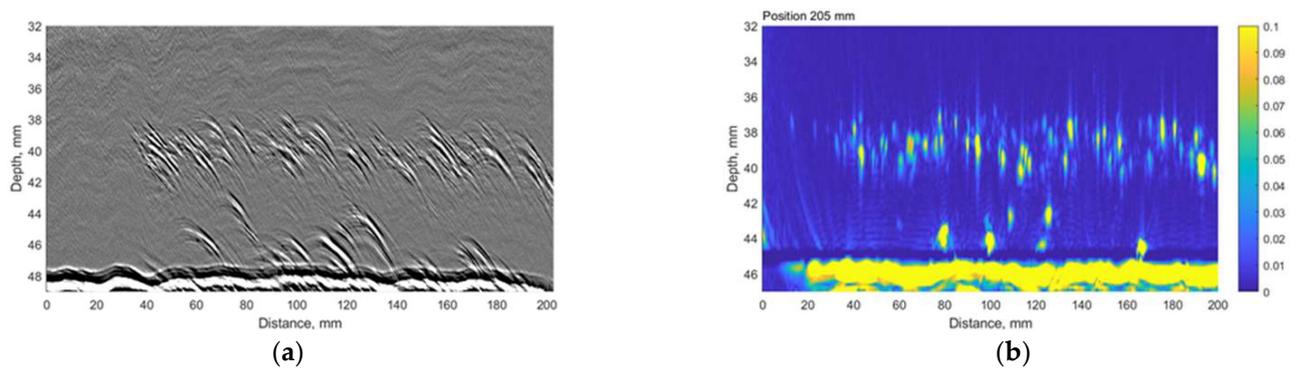
**Figure 14.** The comparison between (a) TULA and (b) TFM measurements at 205 mm circumferential scan position. Vertical colour bar represents the peak-to-peak amplitude in arbitrary units.

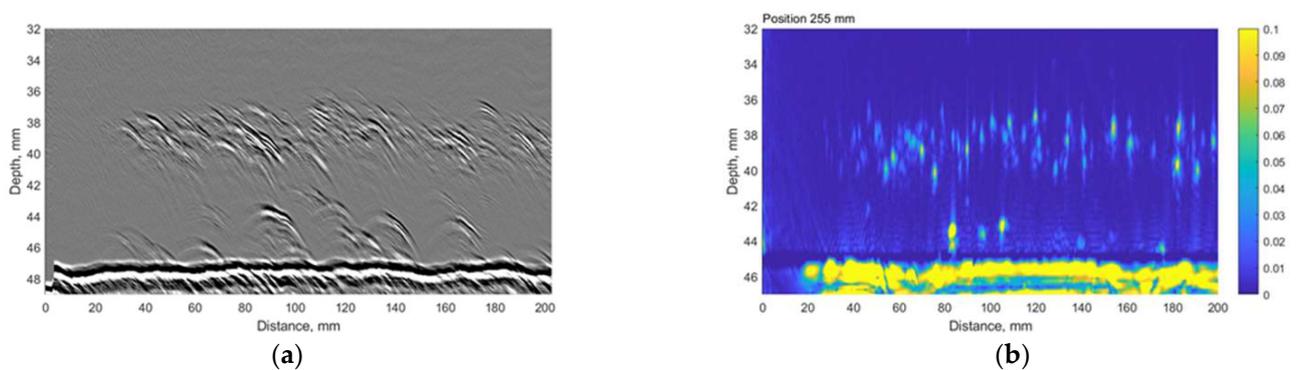
**Figure 15.** The comparison between (a) TULA and (b) TFM measurements at 255 mm circumferential scan position. Vertical colour bar represents the peak-to-peak amplitude in arbitrary units.

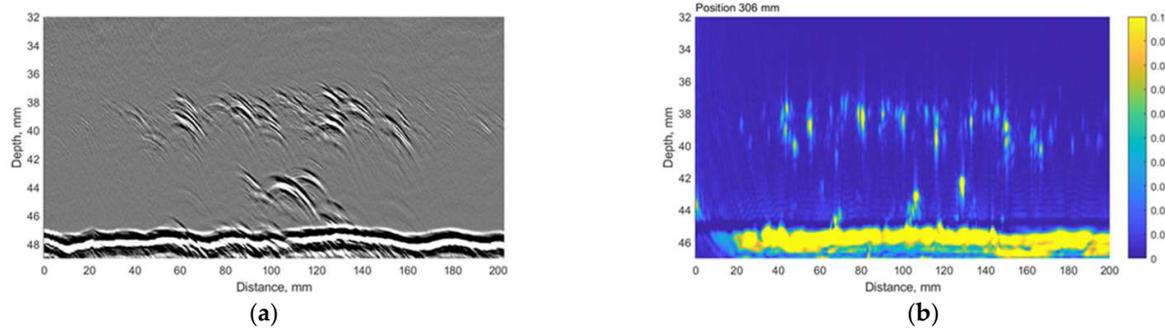
**Figure 16.** The comparison between (a) TULA and (b) TFM measurements at 306 mm circumferential scan position. Vertical colour bar represents the peak-to-peak amplitude in arbitrary units.

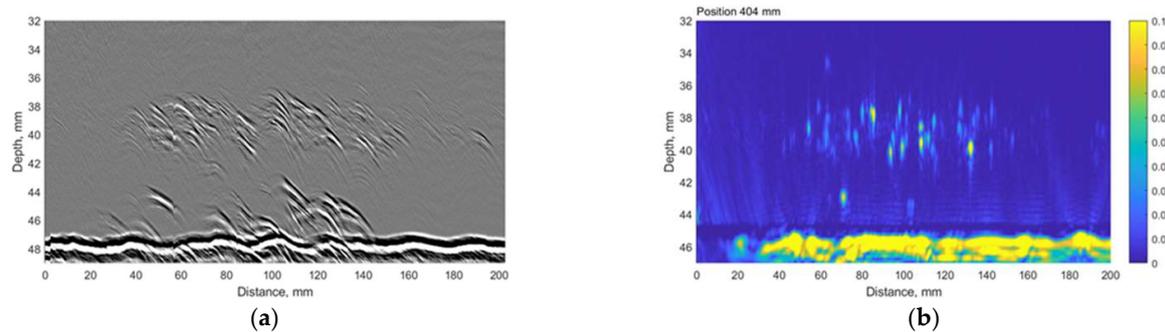
**Figure 17.** The comparison between (a) TULA and (b) TFM measurements at 404 mm circumferential scan position. Vertical colour bar represents the peak-to-peak amplitude in arbitrary units.

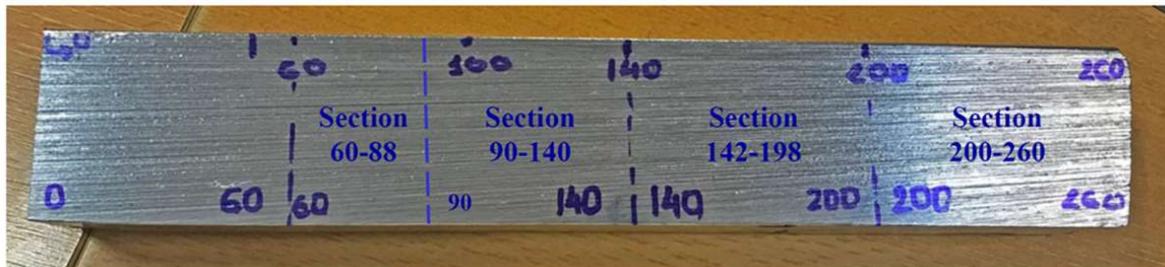
Figure 20. Examined section's general view.

Metallographic examination of a microstructure was performed in the DEKRA laboratory to verify the ultrasonic testing results. The slice was divided in four sections (60–80 mm, 90–140 mm, 142–198 mm and 200–260 mm) as presented in Figure 20. In the following paragraphs, metallographic images of each section are presented.
