Article Measuring Displacement before and after Repair on Korean Wooden Built Heritage: Records for Authenticity and Sustainability

In this study, the displacement of the Sungryeoljeon Shrine in Namhansanseong, the object of this study, was measured before and after its repair from 2017 to 2019. Subsequently, the displacements were measured again in 2023 to determine what changes had occurred since the repair. Accordingly, Section 2 examined the value of the Sungryeoljeon Shrine in Namhansanseong, a site inscribed on the UNESCO World Heritage List, and described how the displacement could be measured using a 3D scanner. Section 3 considered the Shrine Dismantling and Repair Report as a record of the repair of the Sungryeoljeon Shrine. Section 4 analyzed and interpreted the displacement measurement data using 3D scanning from 2017 to 2023.

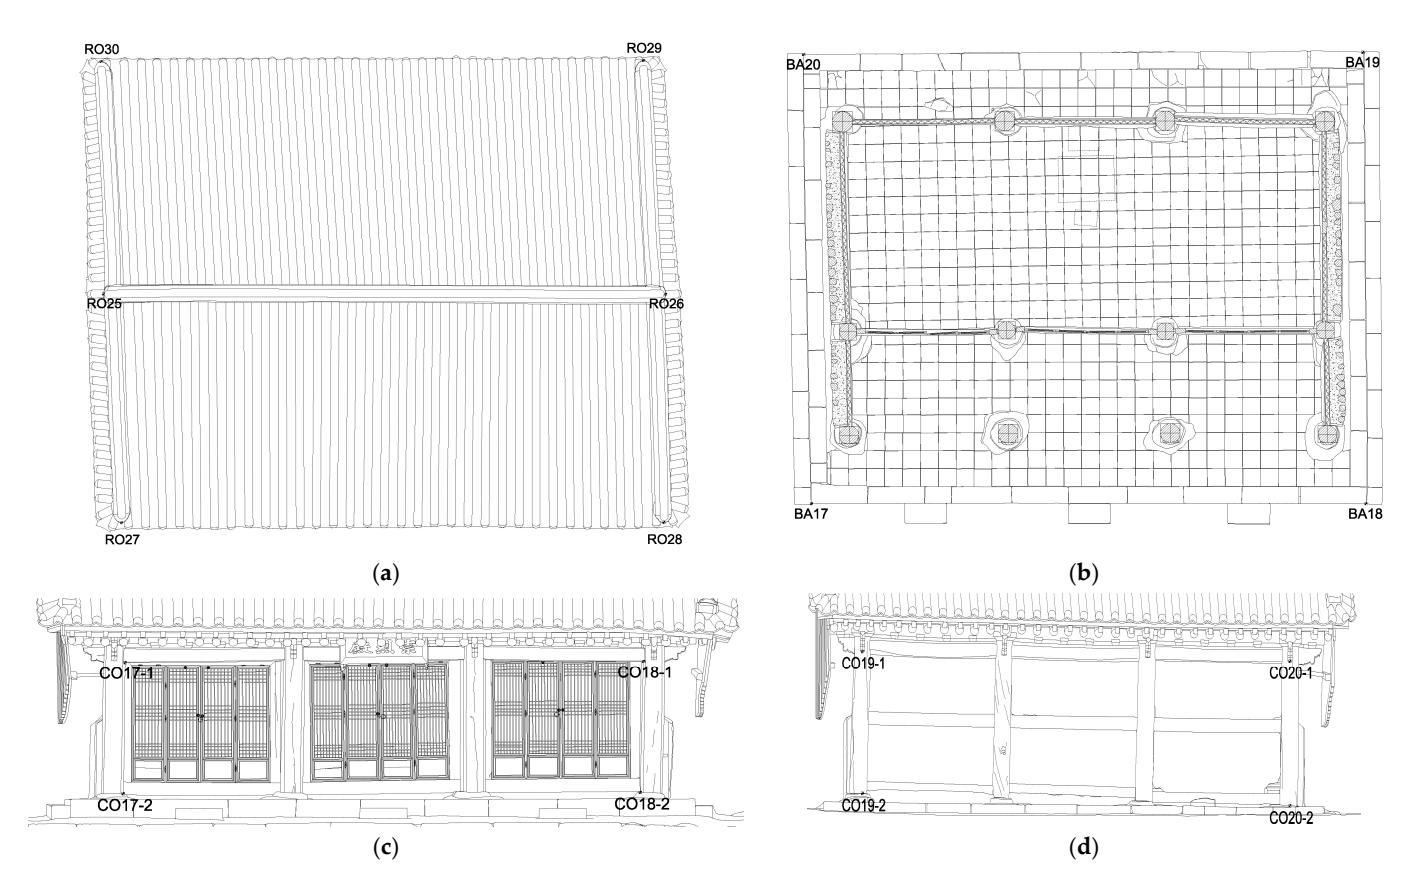
Figure 3. Measurement points for displacement in Sungryeoljeon (before repair): (**a**) the ridge and rafters; (**b**) the top of the stylobate; (**c**) the top and bottom of the corner columns as seen from the front; (**d**) the top and bottom of the corner columns as seen from the back. Because the same location of Sungryeoljeon was 3D scanned three times, code numbers were clearly displayed to eliminate confusion. And it was made to match the code numbers in the tables that follow. Source: the authors.

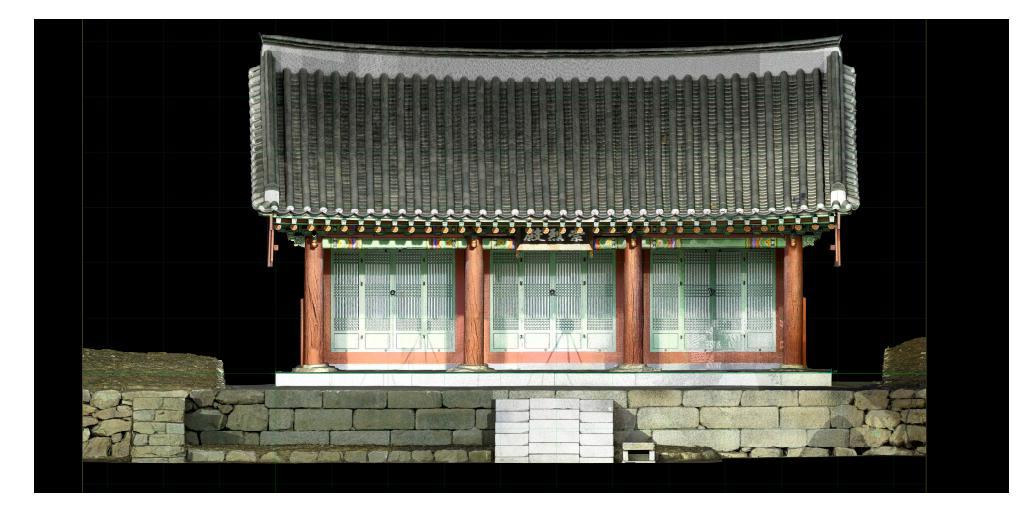
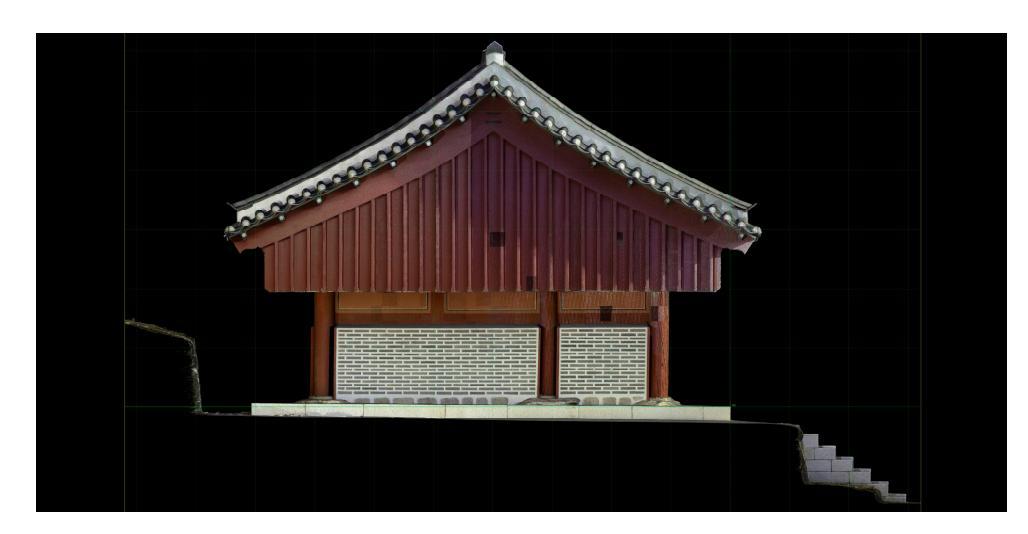
By examining the tilt of each column, corner column A was tilted 12 mm on the X-axis, corner column B was tilted 12 mm on the X-axis, corner column C was tilted 13 mm on the Y-axis, and corner column D was tilted 26 mm on the Y-axis. The individual columns showed a similarity to their conditions directly after the repair (Figures 8 and 9).

Figure 8. Sungryeoljeon 3D scan data (current front). Source: authors.

Figure 9. Sungryeoljeon 3D scan data (current side). Source: authors.
