Numerical Analysis of Dynamic Response in Large Caissons during Wet-towing after Cable Breakage

Abstract: Variable and complex marine environmental loads combined with wave resistance and the insufficient controllability of large caisson structures pose serious challenges during maritime towing. Cable breakage events are common, and improper behaviors could give rise to a variety of accidents. This work explored the dynamic responses of large caisson structures following towing cable breakage under irregular waves combined with harsh currents. Two types of cable breakage, i.e., main bridle and towing bridle breakage, were taken into account. Four potential wave–current combinations were assumed for each situation according to direction. The obtained results show that drag rope breakage could give rise to lateral shifts in the structure, which can become a serious condition when exposed to angled waves. Additionally, following breakage, significant force fluctuations took place in the remaining intact cables. For main cable breakage, both lateral and backward displacements were observed in the structure, which gradually entered a ‘flowing with the wave’ state. Furthermore, under th

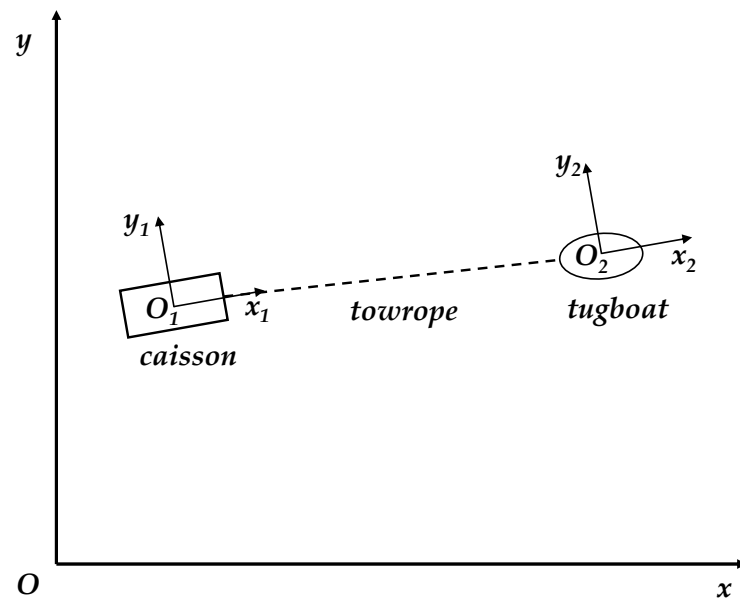
Figure 3. The coordinate systems applied in the research.

The coordinate systems used in the research are listed in Figure 3. Also, Figure 4 illustrates the towing system investigated in the current work. The towing rope was made of a mix of steel wire with a large diameter, and its cross-section is shown in Figure 5. One end of the bridle cable was attached to the caisson with the main parameters presented in Table 1, while the other end was connected to the main cable through a triangular plate. Surface elements were applied to model all studied structures. The surface element size was set to be 1 m based on the findings of the grid sensitivity analysis presented in [20].

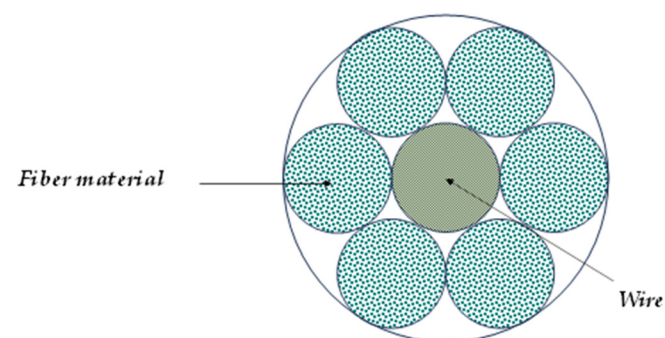
Figure 5. A schematic diagram of the cross section of the cable.

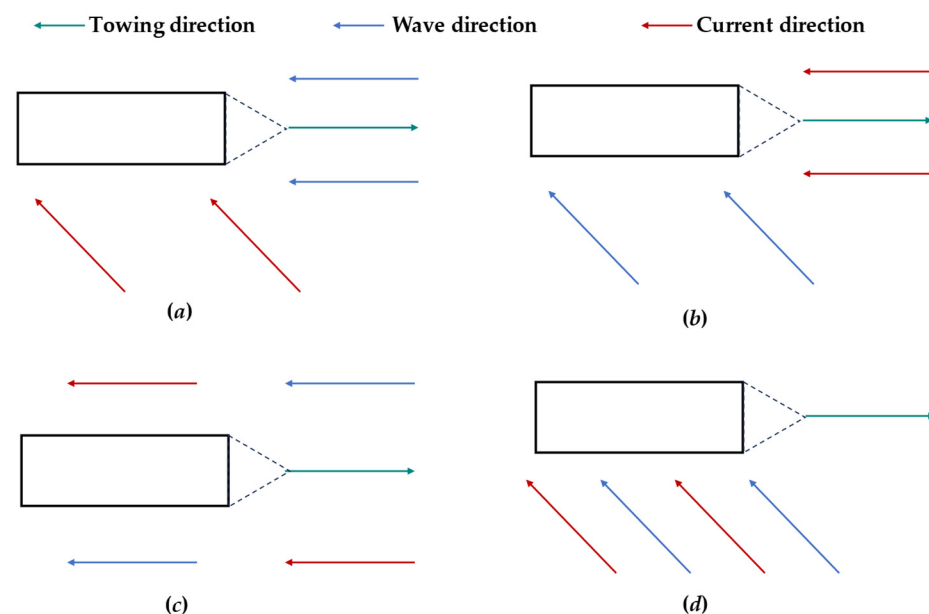
Figure 6. Wave and current direction distribution diagram. Note: (a) TWD_180; (b) TWD_135; (c) TWS_180; (d) TWS_135.

During towing at high water flow speeds, both the towing system cable tension and structure drag resistance were correspondingly increased, resulting in a higher possibility of a cable breakage phenomenon. In this research, variations in structural motion responses under the two conditions [24] of main cable breakage and towing bridle breakage were investigated. It was supposed that the cable breakage moment occurred 1.5 h after the beginning of stable towing. When investigating towing bridle breakage, the broken cable was the one which was exposed to greater force at the breakage moment. All of the towing plans are presented in Figure 6.

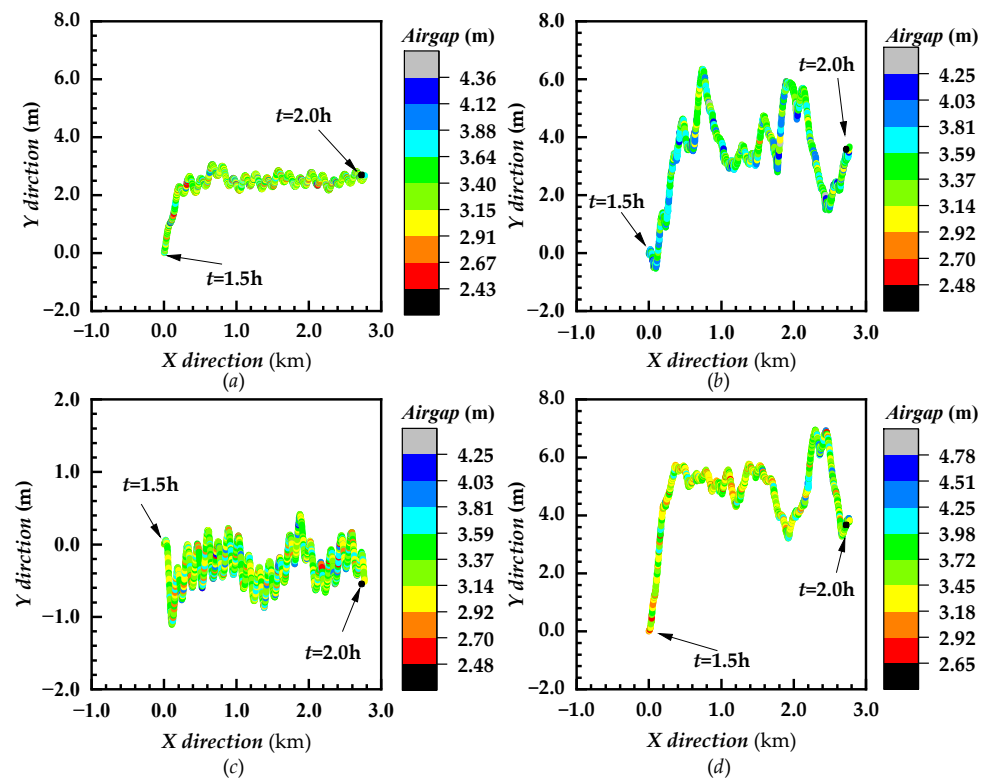
Figure 8. The trajectory of a caisson after the breaking of one towing bridle. Note: (a) TWD_180; (b) TWD_135; (c) TWS_180; (d) TWS_135.

Figure 8 illustrates changes in the plane motion trajectory of a caisson structure within half an hour after the breakage of one towing bridle. As seen in Figure 8, under the effect of complex floating environments, after the breakage of one towing bridle, a change occurred in cable tension throughout the towing system. This change caused the structure to migrate along the Y direction due to asymmetric external forces. The migration trajectory presented a gradually reducing fluctuation pattern, finally reaching a novel steady state. Along the surge direction, the structure continued to move forward under tug drag, and the movement distance was basically consistent with tug displacement, hardly affected by towing bridle breakage.

The dynamics of lateral movements were changed under different wave and flow directions. During head sea towing under different wave and flow directions, the main reason for structure lateral movement following towing bridle breakage was the action of oblique fluid force, with the wave impact playing a weaker role. In this regard, structure lateral displacement measured approximately 2.6 m (Figure 6a). However, under oblique wave towing and different wave and flow directions, the structure's lateral swaying motion was strongly affected by the waves. At this time, the structure's lateral displacement was notably increased to around 6.4 m (Figure 6b). Compared to the maximum lateral displacement illustrated in Figure 6a, the one in Figure 6b was increased by about 2.5 times. For head sea towing under similar flow and wave directions, following towing bridle breakage, a certain lateral displacement was witnessed in the structure because of uneven lateral forces (Figure 8c), and the maximum lateral deviation was slightly greater than that illustrated in Figure 8a. For oblique wave towing and similar flow and wave directions (Figure 8d), the structure's lateral swaying motion is strongly affected by waves.

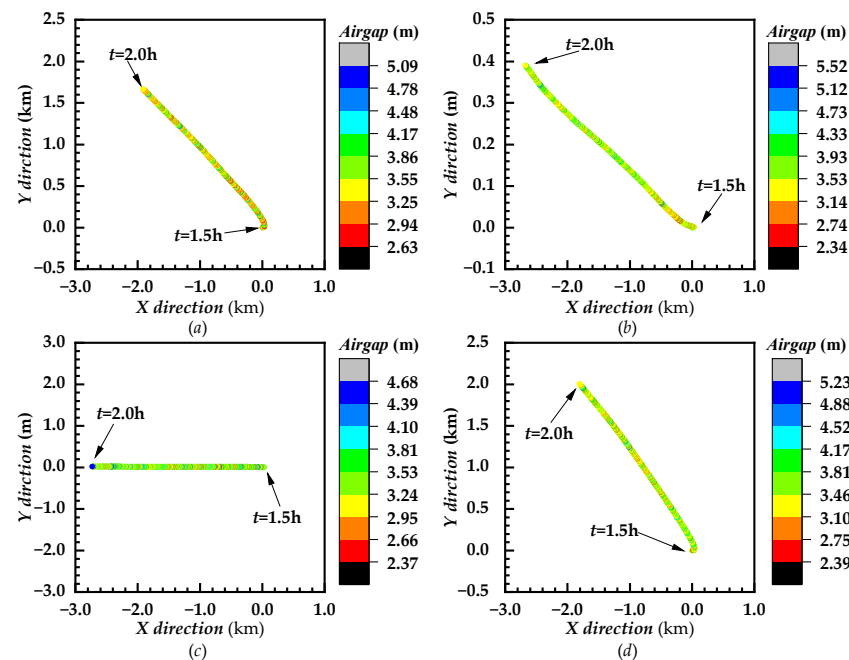
Figure 11. Tracks of caisson after main cable breakage. Note: (a) TWD_180; (b) TWD_135; (c) TWS_180; (d) TWS_135.

Figure 11 illustrates the trajectory of structure motion within half an hour following main cable breakage under the abovementioned four operating conditions. As seen in the figure, for a water flow direction of 135° and the existence of a lateral component of the water flow force (Figure 11a,d), the structure presented large displacements along the lateral direction, and the lateral offset within half an hour was over 1500 m. For a water flow direction of 180° , similar to the wave direction (shown in Figure 11c), the structure was basically symmetrically loaded from left to right, and then structure displacement along

the lateral direction was small, and lateral displacement within half an hour was about zero. For different directions of wave and water flow (shown in Figure 11b), following cable breakage, the structure first moved along the positive direction of the Y axis due to oblique water flow force, and then a certain degree of deflection was observed in the structure because of the combined action of water flow and wave forces. The shape of the oncoming flow area of the structure changed, and the caisson came to reach the ‘flowing with the wave’ state, with a 400 m lateral offset within half an hour.
