# Slate–Cork Laminate Enhanced with Silicone for Habitat Industry Application

**Abstract:** This study investigates the feasibility of using a composite material comprising slate reinforced with cork sheets for architectural purposes like facades and wall coverings. The research involves the comprehensive characterisation of both slate and cork materials along with the evaluation of the silicone adhesive used in their bonding process, specifically Sikasil<sup>®</sup> HT from SIKA<sup>®</sup>. It was found that both slate and cork exhibited low wettability, which was enhanced through cold plasma treatment. Subsequently, a composite sandwich structure was fabricated and subjected to impact testing in a drop tower, along with fire resistance evaluations. The fire tests revealed that when subjected to a flame of 900 °C for 15 min, the slate alone heated rapidly, reaching 500 °C within 3 min on the side opposite to the flame. However, the sandwich structure reached 260 °C on the cork side (opposite to the flame) at 7.5 min, maintaining this temperature until the deterioration or detachment of the cork between 11 and 12 min. This provided insulation and delayed ignition. The sandwich st

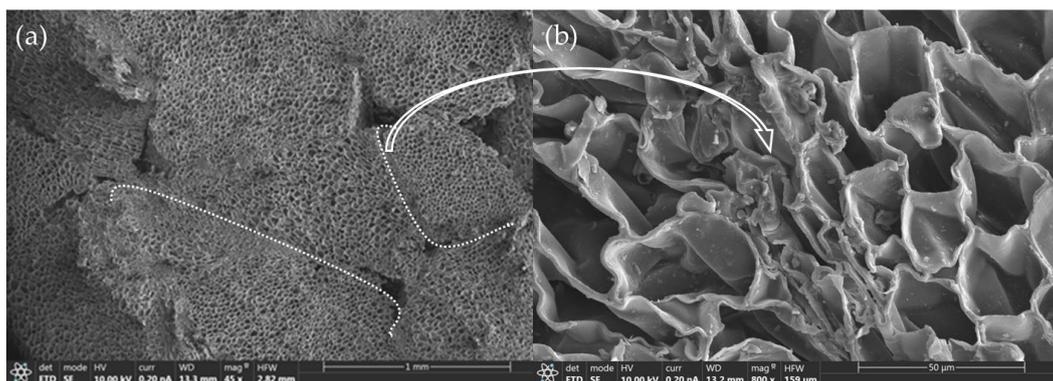
**Figure 1.** (a) A micrograph of the cork agglomerate (45×); the white dotted lines mark the joints between two cork particles. (b) Details of the union between two particles (800×).

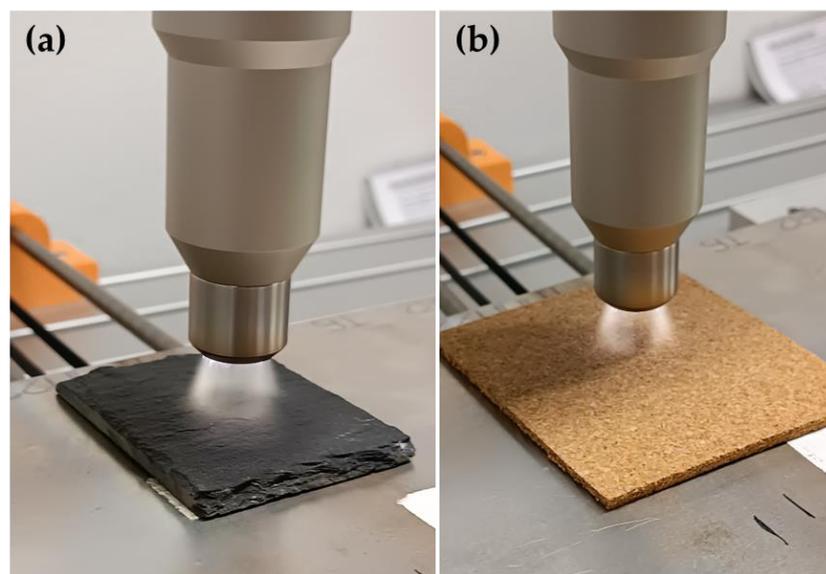
**Figure 2.** (a) APPT on slate. (b) APPT on cork.

An APPT device from Plasmatreat GmbH (Steinhagen, Germany) was utilised for treating the slate (Figure 2a) and cork laminate (Figure 2b). Employing potential-free ther-

modynamic equilibrium plasma treatments, also referred to as cold treatments, effectively cleansed and activated the predominantly polymer surface [59]. This equipment works at a frequency of 17 kHz and operates with a high-voltage discharge of 20 kV. It features a rotating torch with a ratio of 12.5 mm, culminating in a nozzle (1900 rpm) through which the plasma is discharged. The system includes a platform equipped with electronic speed control for accommodating the material being treated. Air plasma was generated within the rotating nozzle at a working pressure of 2 bar, utilising an off-balance discharge mechanism, and then expelled through a circular opening onto the samples. The distance between the sample and the plasma torch nozzle was maintained at 10 mm, while the speed of the platform was optimised at 20 mm/s. These parameters were optimised by checking the various conditions of the rate from 10 mm/s to 40 mm/s and the distance from 6 mm to 15 mm. The aim was to achieve the lowest contact angle with deionised water without causing damage to the surface.

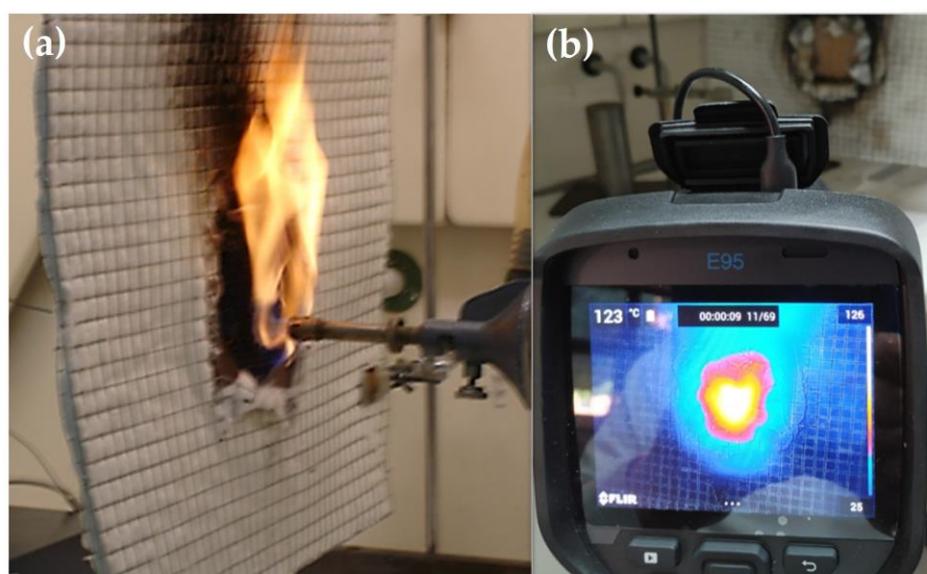
**Figure 3.** (a) Flame front of sample at 920 °C, and (b) FLIR infrared camera behind sample, with temperature depending on time.

The setup (Figure 3) aimed to replicate the conditions of a cubic furnace, which are specifically designed and produced to assess the durability, functionality, and stability of construction materials over time. These furnaces play a crucial role in applying safety standards to ensure effective evacuation during fire incidents and serve as invaluable tools for researching various products such as dampers, fire-resistant materials, electrical conduits, intumescent paints, and extractors. Depending on the material being tested, the specimen can be positioned either horizontally or vertically.

Three samples of slates and laminates measuring 80 mm × 80 mm with a thickness of  $13 \pm 1$  mm were produced for conducting fire experiments. The experiments involved exposing the samples to a 900 °C flame, generated by a Bunsen burner fuelled by propane gas, which was positioned directly in front of the sample. Throughout the test, the reducing section of the flame remained in contact with the material (as shown in Figure 3a). Temperature readings were taken on the side opposite to the fire test using an FLIR infrared camera model E95 (from FLIR Networked Systems S.L., Madrid, Spain), as illustrated in Figure 3b. Thermographic images were captured every 20 s, allowing for real-time monitoring of the fire test through 3D imaging. Temperature data were extracted from the images to plot the temperature evolution over time.

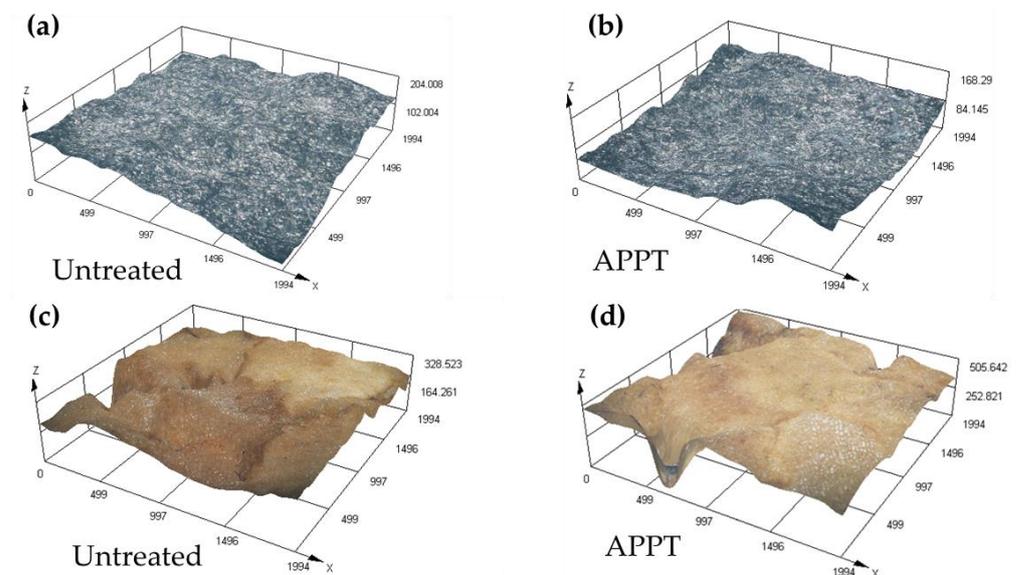
**Figure 4.** Three-dimensional digital microscope images of (a) untreated slate surface and (b) slate surface treated with APPT. (c) Untreated cork structures and (d) cork structures treated with APPT. All axes are in  $\mu\text{m}$ .

Plasma treatment also affects the surface roughness, particularly in terms of homogeneity. The treatment tends to make the roughness more uniform and enhances it at the nanometer scale [70,71]. In this case, although the roughness slightly decreases, it still provides sufficient bonding capability for silicone (Figure 4 and Table 2). Additionally, since silicone is highly viscous, it requires a smoother surface without large peaks to ensure optimal contact with the material.

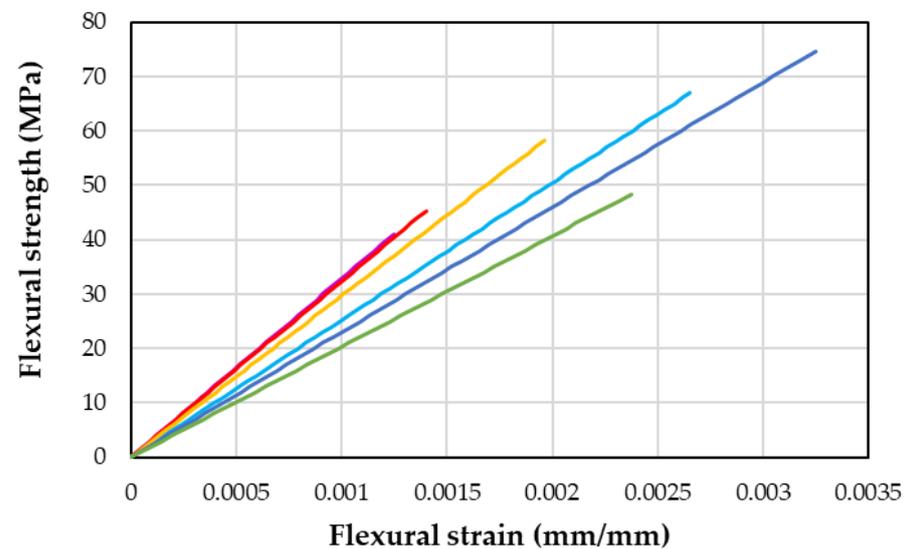
**Figure 5.** Flexural tests for six slate samples, each line corresponds to a tested slate sample.

To characterise slate, flexural and Charpy impact tests were conducted. Slate is a heterogeneous material with a lot of irregularities on its surface and with possible internal delamination, which increased the dispersion in the tests. Additionally, since it is a ceramic material, it shows brittleness, which can be seen in its high flexural strength and very low deformation (Table 3 and Figure 5). Therefore, slate also has little resistance when subjected to impact, with a resilience of  $0.29 \text{ J/cm}^2 \pm 0.19$  (Figure 6).

Slate is a natural ceramic material known for its brittleness, with a flexural modulus of 27 GPa and a flexural strength of 56 MPa (Table 3 and Figure 5). It is even more rigid than some construction materials that have been studied in recent research. For instance, Alomayri [72] investigated geopolymers containing 2% Al<sub>2</sub>O<sub>3</sub>, which exhibited a flexural modulus of 0.330 GPa and a flexural strength of 4.5 MPa. Similarly, Soltani et al. [73] explored ordinary Portland cements enhanced with clinoptilolite and silica fume, achieving a maximum flexural modulus of up to 7 GPa with a 30% cement replacement. Additionally, slate's resistance to impact (Figure 6) is also low, with a resilience of 0.27 J/cm<sup>2</sup>, which confirms its fragility.

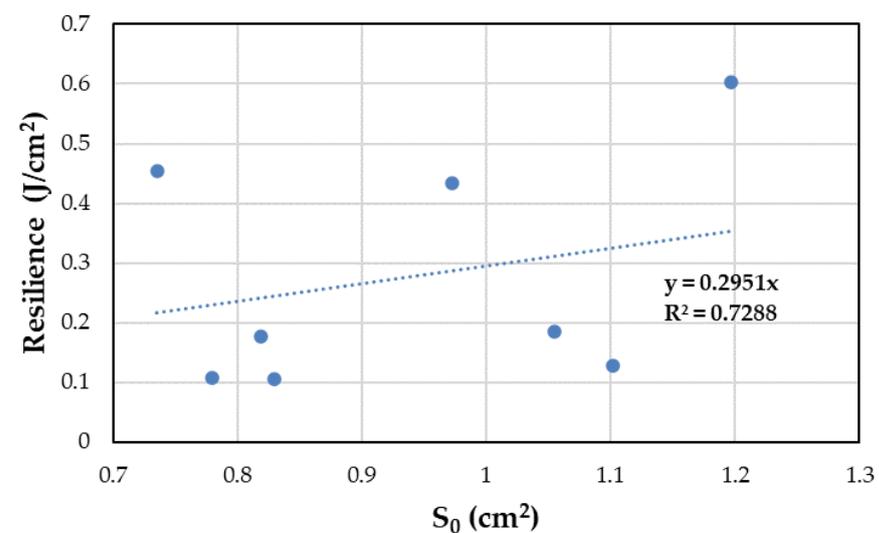
**Figure 6.** Charpy impact tests for eight slate samples at room temperature.

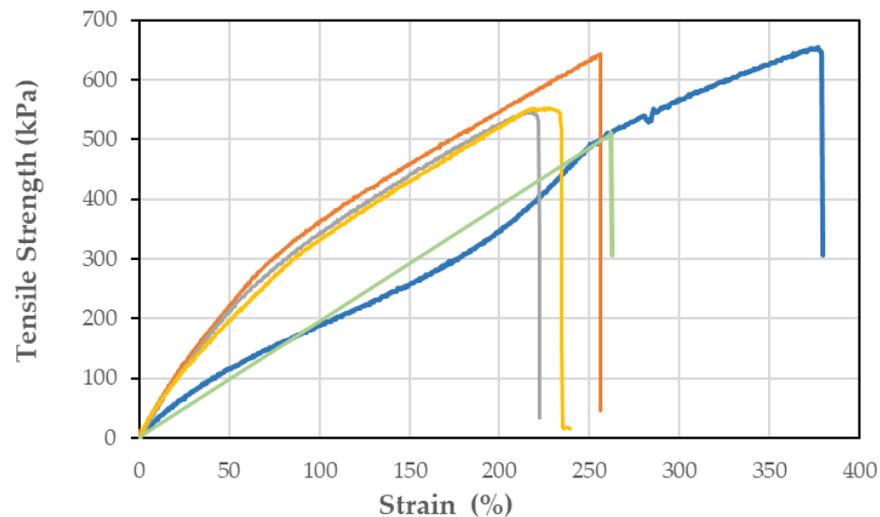
**Figure 7.** Tensile tests for five silicone samples, each curve corresponds to a tested silicone sample.

When studying silicone's adhesive properties, according to the results in Table 4 and Figure 7, it is classified as a viscoelastic material with a tensile strength and Young's modulus of 597 MPa and 54 MPa, respectively, and a high tensile strain (267%). Both the strength and strain of the material show considerable deviations, probably because of the presence of small air bubbles trapped within the samples. These bubbles are likely formed during the skin formation process, preventing the air from escaping.

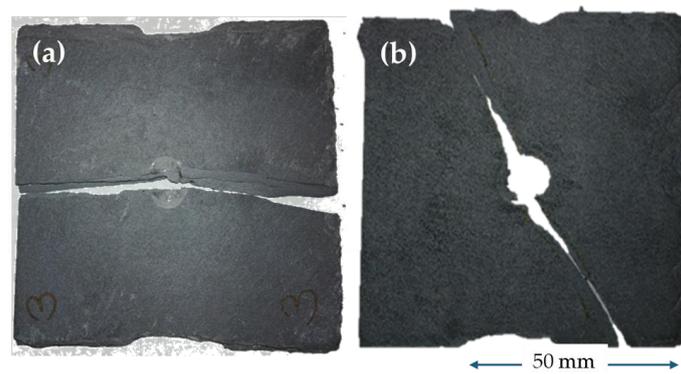
**Figure 8.** Drop weight impact tests. (a) Broken slate after three impacts. (b) Delaminated slate after two impacts.

As previously mentioned, slate is known for its brittleness, making it prone to delamination and breakage after just a few impacts. Indeed, upon conducting the experiments, it was observed that all of the slate samples exhibited signs of damage after enduring three to six impacts (Figure 8a). Notably, some of the samples even experienced delamination after just two impacts (Figure 8b). Despite these challenges, the adhesive used in the experiment proved to be remarkably effective in maintaining the cohesion of the sandwich structure (Figure 9a). Remarkably, none of the materials separated during three drop impact tests, highlighting the adhesive's ability to uphold structural integrity, as evidenced in Figure 9b, showcasing both slate (front—F) and cork (back—B).

The drop impact test further highlighted the fragility of slate, which is prone to fracturing or delamination after impacts (Figure 8a,b). The composition of slate consists of layers with abundant metallic minerals, attributed to its natural origin [78]. As these layers start to separate, the delamination process occurs. This phenomenon can occur due to impacts, ageing, or harsh weather conditions affecting the slate [20].

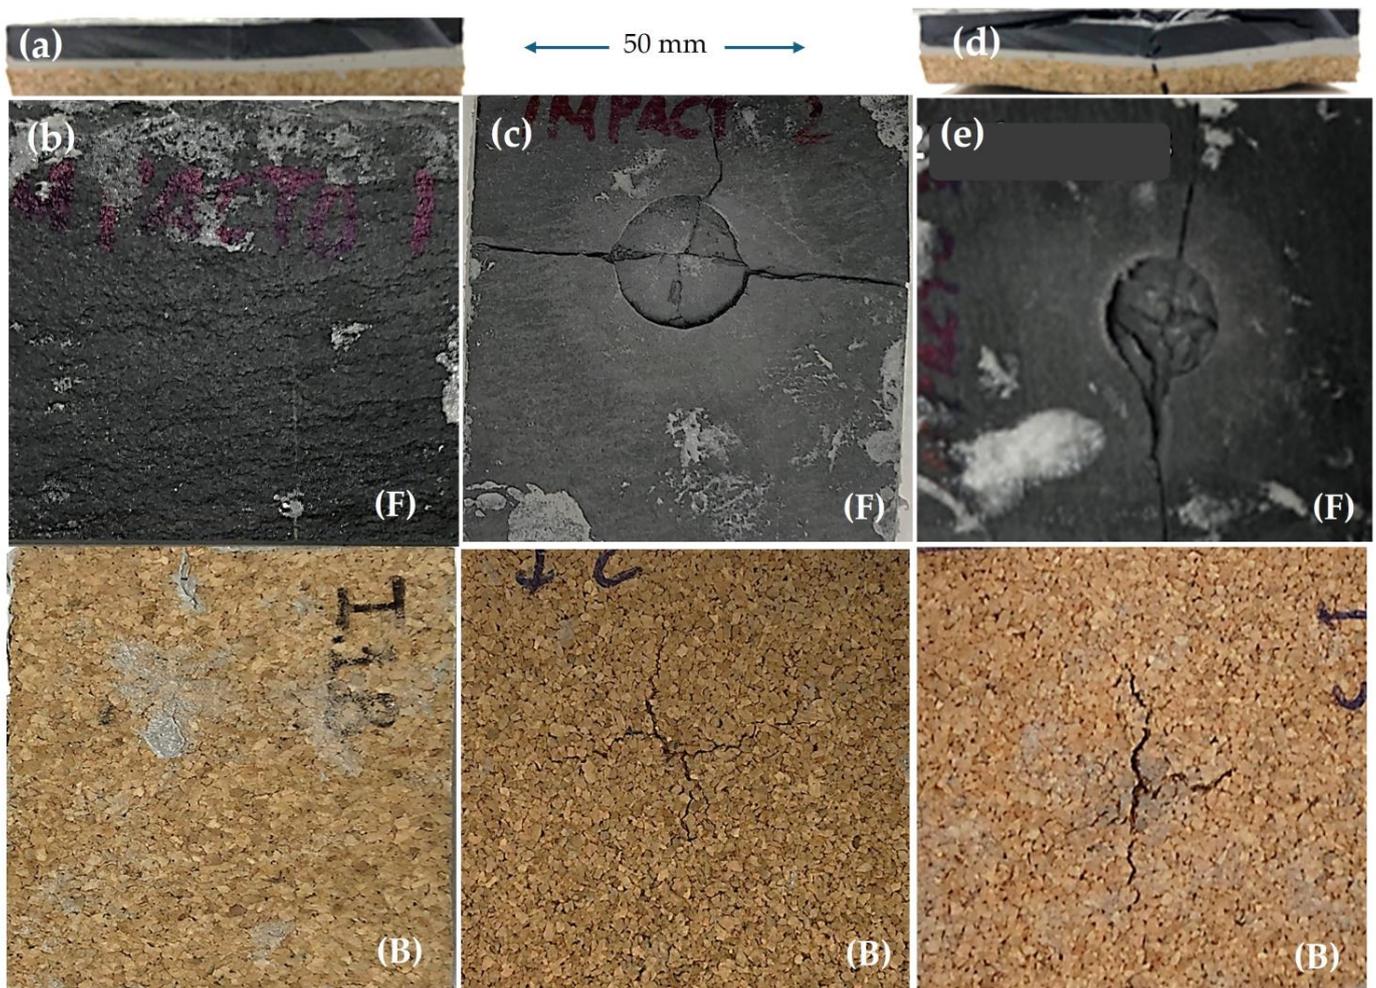
**Figure 9.** Drop weight impact tests for sandwich structure. (a) Sandwich structure profile before impact; (b) sandwich structure after two impacts: (F) front side and (B) back side. (c) Sandwich structure after twenty-five impacts: (F) front side and (B) back side. (d) Sandwich structure profile after two hundred and fifteen impacts. (e) Sandwich structure after two hundred and fifteen impacts: (F) front side and (B) back side.

Furthermore, it was observed that even after enduring 25 impacts, the sandwich structure did not exhibit signs of delamination or breakage (Figure 9c). Impressively, even after subjecting the sample to 215 impacts, no detachment was observed (Figure 9d,e), depicting both the front (F) and back (B) sides.

In summary, despite the inherent brittleness of slate, the adhesive used in the sandwich structure (Figure 9a) demonstrated remarkable effectiveness in enhancing cohesion and durability (Figure 9b,d,e). This was evident in the resilience of the laminate even after enduring numerous impacts, underscoring its suitability for various applications requiring robust materials.

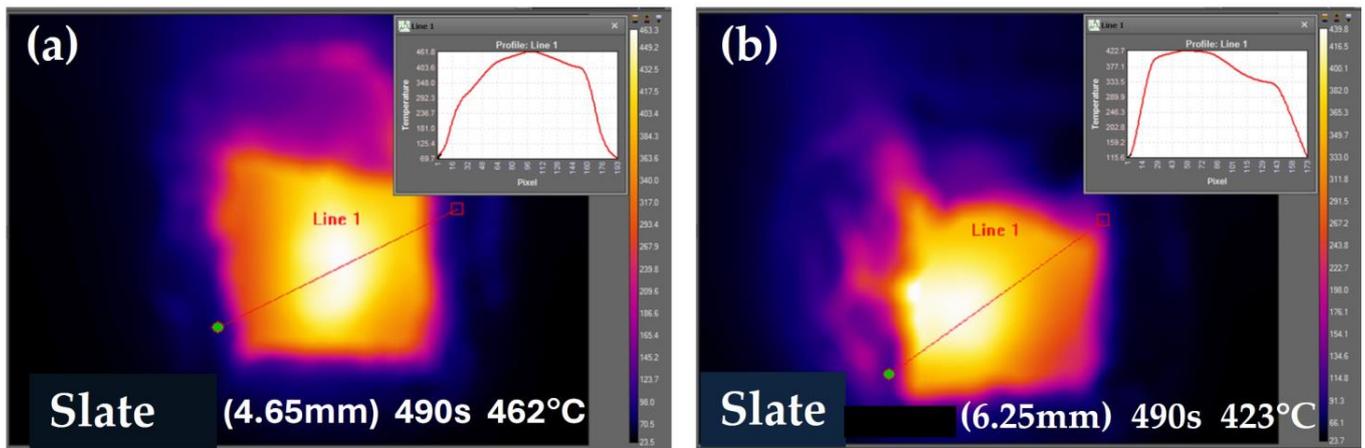
Figure 10. Thermographs corresponding to (a) 4.65 mm thick slate and (b) 6.25 mm thick slate.

The results of the fire test for the sandwich structure depicted in both Figures 10 and 11 unveil an intriguing relationship between temperature and slate thickness. Notably, thinner slate exhibits a greater propensity for temperature transmission through its surface. For instance, in the case of a 4.65 mm thick slate, the temperature soared to 462 °C (Figure 10a),

whereas for a 6.25 mm thick slate, the temperature peaked at 423 °C (Figure 10b). This discrepancy highlights the influence of slate thickness on its thermal behaviour.

The fire test was conducted on both slate (Figures 10 and 11) and the sandwich structure (Figures 12 and 13). It is noted that thermal conductivity typically rises with temperature [52]. If there is an increase in thermal conductivity within the slate, it could significantly impact the sandwich panel. However, based on the fire test conducted solely on the slate (Figure 11), the temperature on the opposite side at the flame reached 400 °C in three minutes and steadily climbed to 500 °C by 10 min, stabilising for the remainder of the test. This gradual increase could be attributed to a change in the thermal conductivity. According to Boutinguiza et al. [22], the thermal conductivity of slate, calculated by thermal diffusivity ( $2.27 \pm 0.30 \text{ mm}^2/\text{s}$ ) and a heat capacity ranging from 25 °C to 500 °C (mean value of  $0.96 \pm 0.04 \text{ kJ/kg K}$ ), was  $2.00 \pm 0.20 \text{ W/m K}$ , which is a value similar to that obtained at 25 °C.

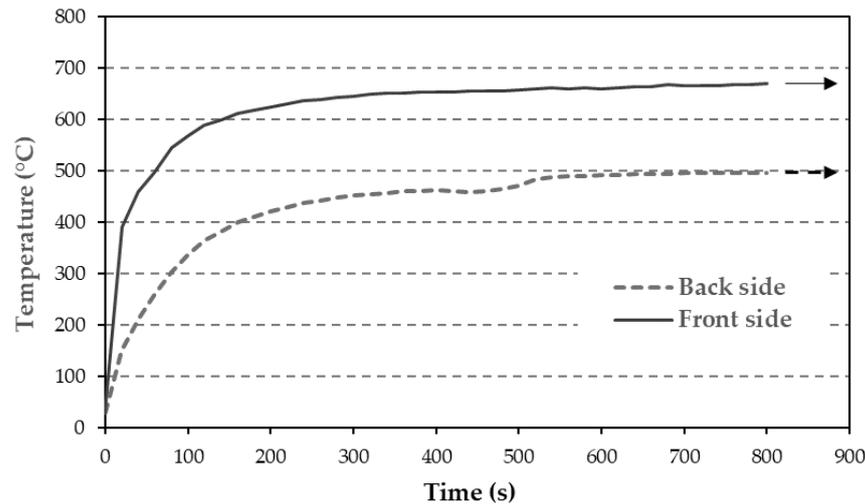
Figure 11. Fire test for 5 mm thick slate, back side and front side (face where flame hits directly). The arrows indicate the test can continue at the same temperature.

Interestingly, while the face directly exposed to the flame registered temperatures reaching around 700 °C, the opposite face recorded a maximum temperature of approximately 500 °C. This stark contrast underscores the thermal insulation properties of slate. Over a period of 14 min, the slate can reduce the temperature by 200 °C, which is a phenomenon that was particularly evident in the 5 mm thick slate (Figure 11).

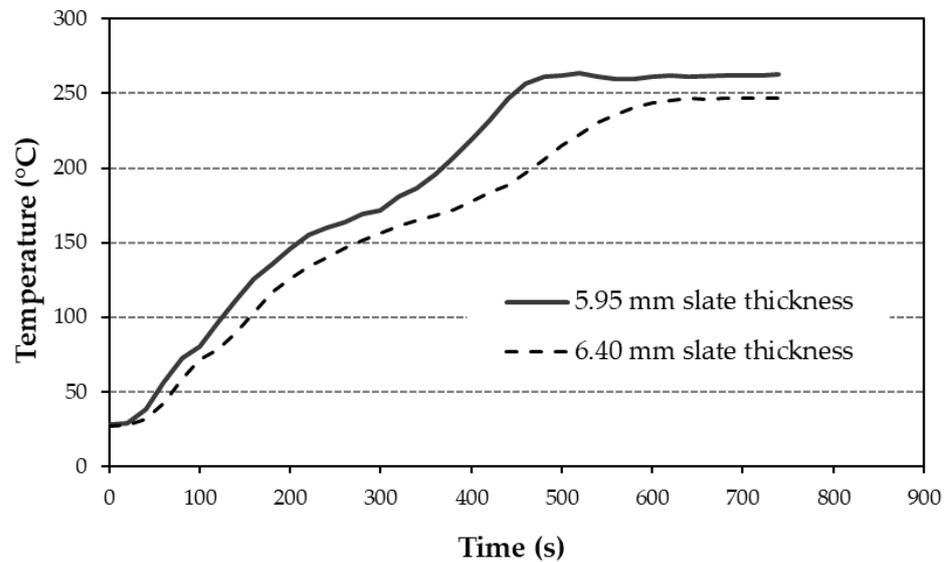
**Figure 12.** Fire tests for sandwich structures with 5.95 mm and 6.40 mm slate thicknesses. The temperature corresponds to the back part where the cork is located.

In the case of the sandwich structure, temperature increase occurs more gradually (Figure 12). The temperature rise during the initial minutes of the test is slower in specimens with thicker slate. Conversely, thinner slate results in a higher maximum test temperature being reached more rapidly.

On the other hand, in the fire test conducted on the sandwich panel, the cork began to deteriorate at 260 °C after 11 min (Figure 12). When the test continued, the cork only darkened (without burning, as shown in Figure 13d) when the silicone debonded, which occurred at nearly 350 °C. Consequently, an increase in the thermal conductivity of the cork would not significantly affect the test results.

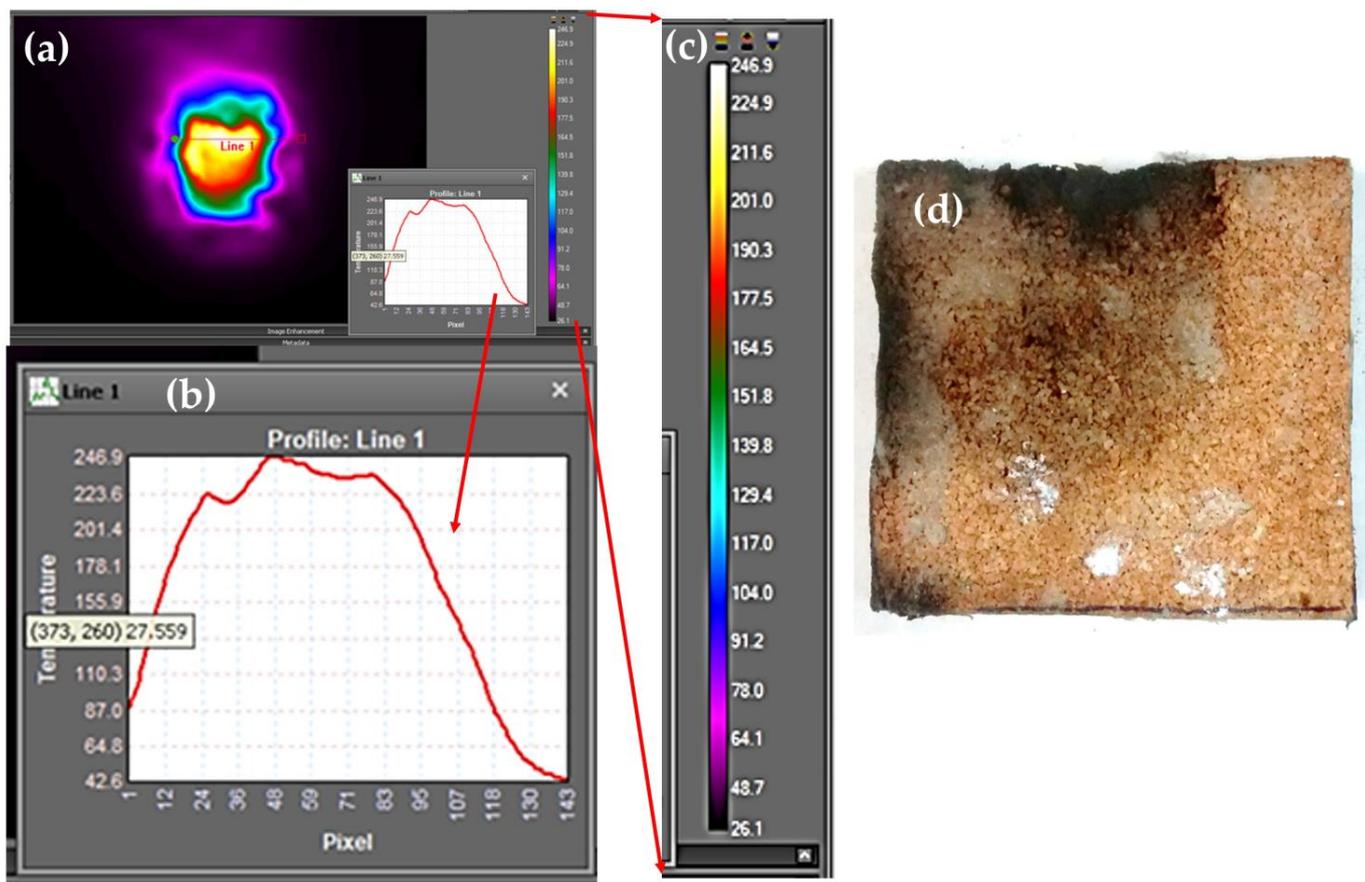
**Figure 13.** (a) Thermographs corresponding to cork at 600 s of test. (b) Temperature profile in line 1 of thermographs (a) with maximum temperature of 246.9 °C, (c) temperature scale in relation with the hot area, and (d) cork macrograph after 600 s of test.

The maximum temperature reached on the opposite face of the flame was approximately 260 °C, as depicted in Figure 13a–c. Figure 13a corresponds to the thermograph, Figure 13b displays the temperature profile along the straight line of Figure 13a, and Figure 13c provides a magnified view of the temperature scale observed on the right side of Figure 13a. As the specimen was heated up, progressive ballooning of the cork plate was observed (Figure 13d). Testing concluded upon the observation of cork degradation. The darkened part of the cork resulted from the smoke generated in the final moments before extinguishing the flame, approximately at 15 min. At this point, degradation and

debonding of the adhesive were observed at a temperature exceeding 325 °C, which caused the termination of the tests at 12 min.

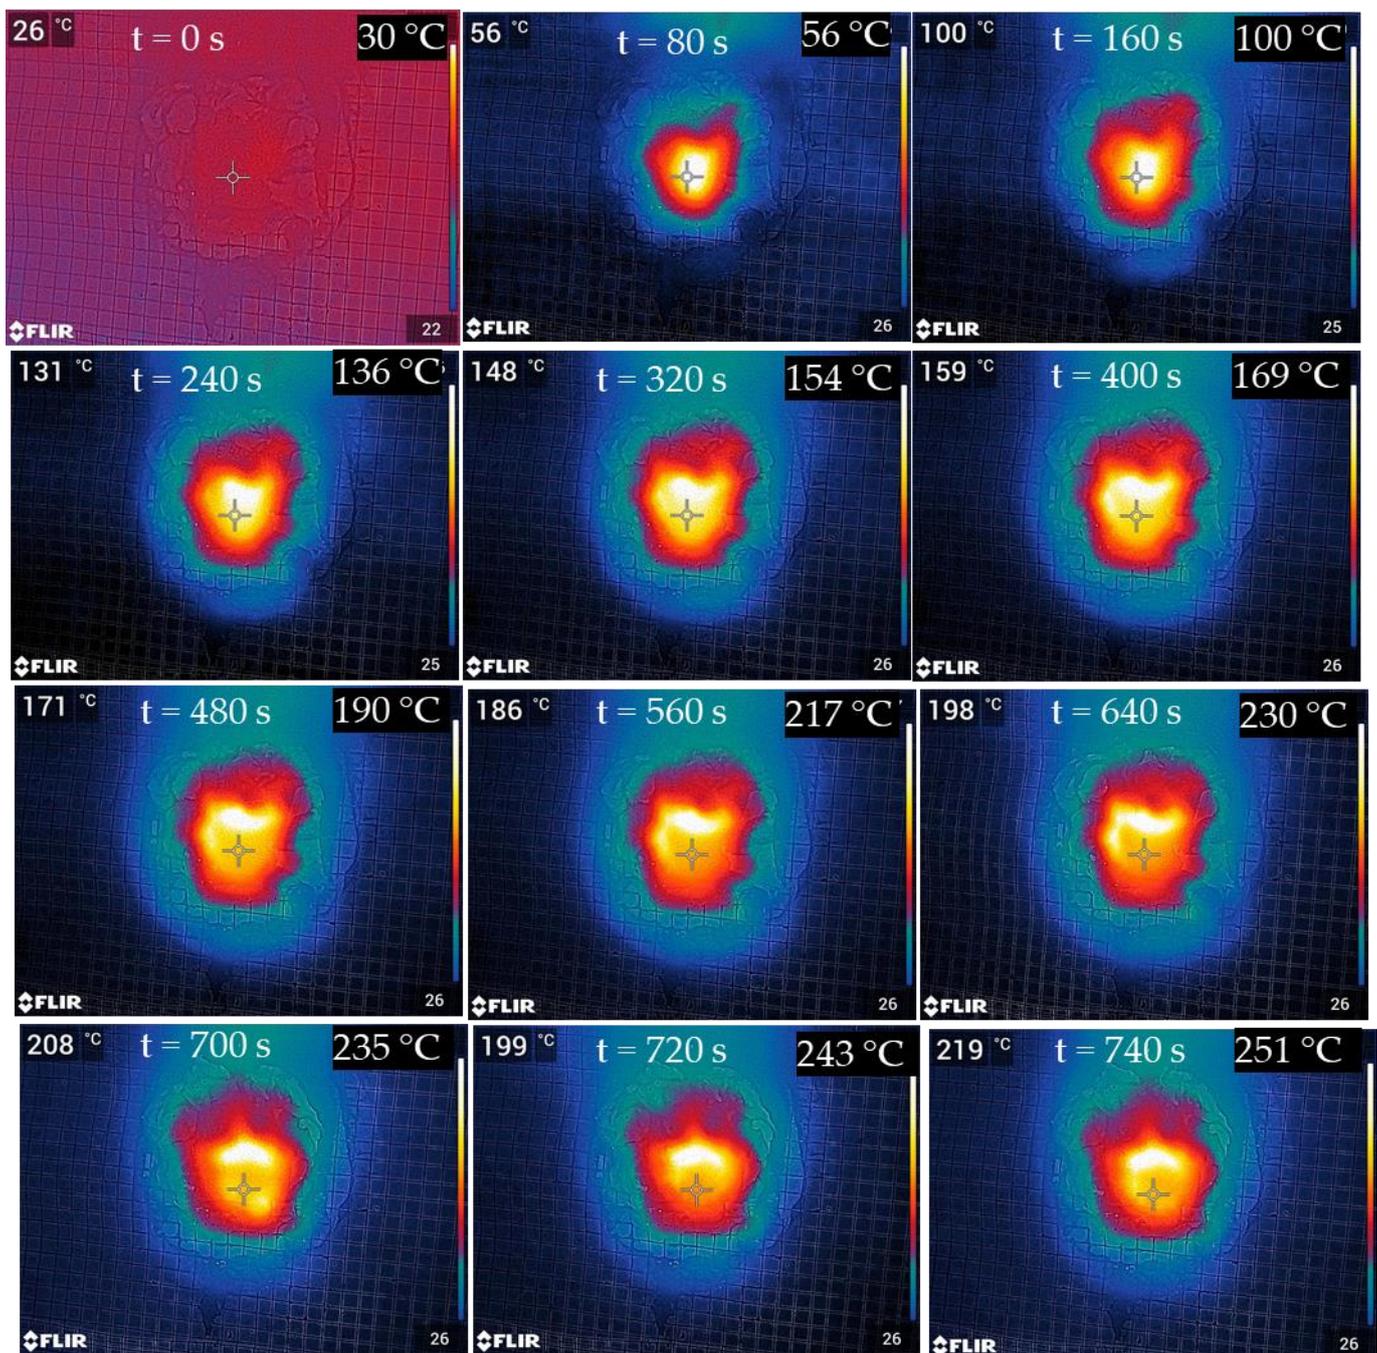
**Figure 14.** A sequence of thermographs corresponding to the opposite side of the fire test conducted on the cork. The temperature at the top left corresponds to the temperature of the cross in the centre of the sample, and the temperature at the top right is the temperature of the brightest part in the hottest area.

Figure 14 displays a series of thermograms captured at various test times on the cork section, specifically at the rear of the flame incidence. The temperature indicated in the upper left corner of each thermogram corresponds to the location marked by a cross. The maximum temperature on the plate is represented in the upper right corner and aligns with the brightest region of the cork surface. The sequence illustrates the progressive increase in temperature, which was initially rapid and later slowed down, which is consistent with the observations made from Figure 12. This test lasted for 12.30 min (740 s), reaching a maximum temperature of 251 °C.
