Article

Assessing the Damage Tolerance of Out of Autoclave Manufactured Carbon Fibre Reinforced Polymers Modified with Multi-Walled Carbon Nanotubes

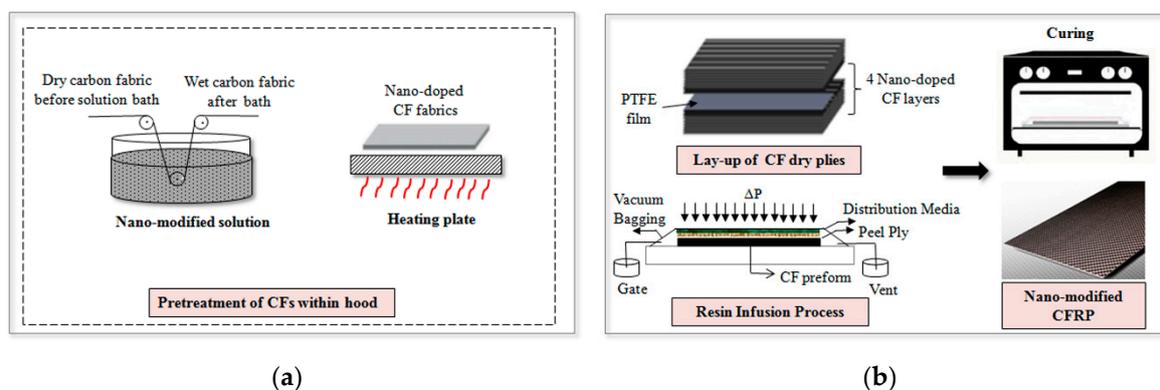
Figure 1. The step by step manufacturing process of nano-modified carbon fibre reinforced polymer (CFRP) laminates. (a) The pre-treatment of dry carbon fabrics to produce nano-modified reinforcement, (b) The production of CFRP laminates using infusion process (VARTM).

Quasi isotropic [(+45/−45)/(0/90)]_{5s} carbon fibre reinforced laminates (CFRPs) 350 × 350 mm² were manufactured using twenty plies by Vacuum Assisted Resin Infusion process (VARI). The step by step preparation of doped CFRP laminates is schematically depicted in Figure 1. In the case of nano-doped laminates, the aforementioned water based nano-modified suspension was used for the pre-treatment of all dry carbon fabric layers in a closed hood equipped with the appropriate nano-filters under slight under-pressure. The fabric reinforcement was passed through the solution at a given rate and slightly compressed at the output of the solution bath with a view to produce pre-treated fabrics. Then, the nano-modified wet fabrics were left to dry using a heating plate in a closed hood equipped. To calculate the amount of final CNTs deposited on the carbon fabrics and therefore the received CNT content, the CF plies were weighed before and after deposition. Then, dry nano-modified carbon fabric layers were stacked on a tool, covered by a highly permeable medium and sealed with vacuum bag. The epoxy resin was infused through the preform under vacuum of 660–710 mmHg and the laminates were left to cure in a conventional oven at 80 °C for 4 h followed by post-cure profile at 140 °C for 4 h according to manufacturer guidelines.

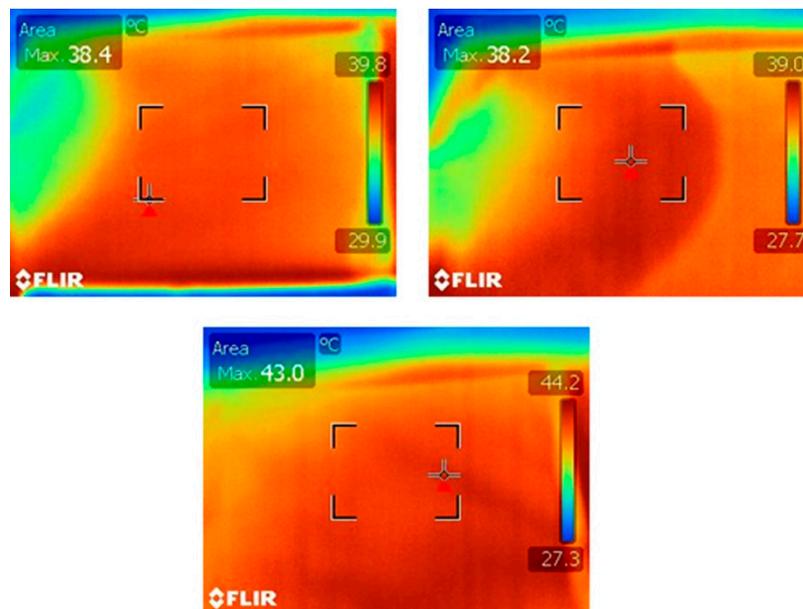
Figure 2. Infrared camera image of resin injection during infusion process.

The infusion stage was processed at the same temperature conditions for each type of laminates, as depicted in Figure 2. FLIR infrared camera (type T335, FLIR, Taby, Sweden) monitored the heating process during the resin injection. The reference laminates were also produced without the pre-treatment step of carbon fibre preform. The fibre volume fraction and thickness of all produced laminates was around 57% and 4 ± 0.03 mm, respectively, as mentioned in Table 1. In total, nine specimens of 150×100 mm² were extracted from the panels for each material type.

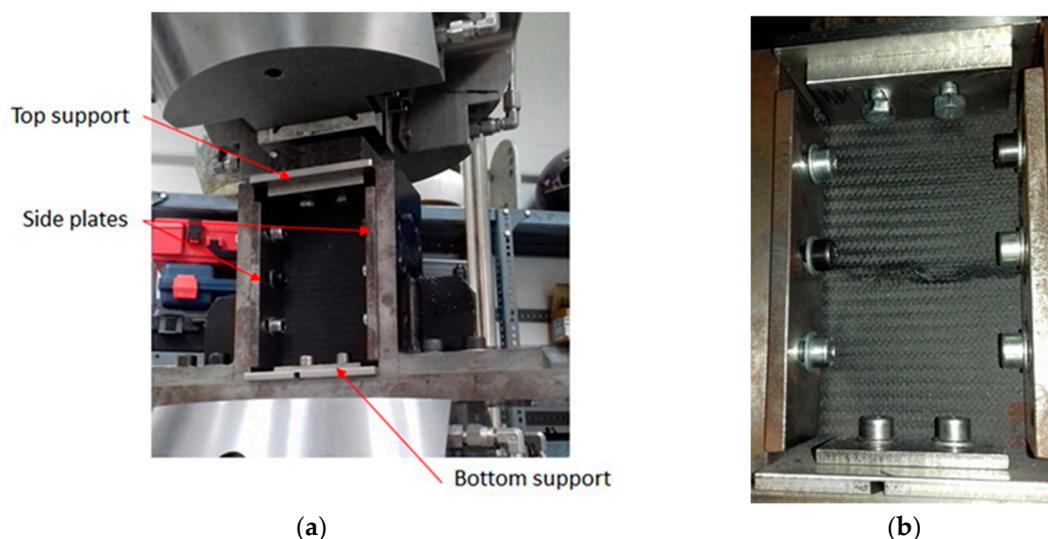
Figure 3. Illustration of (a) Compression after impact test fixture with a specimen positioned in place and (b) a valid broken specimen after the damage tolerance after impact (CAI) test.

Subsequently, all impacted specimens were subjected to compression after impact (CAI) tests according to ASTM D 7137 standard [31]. For this purpose, an anti-buckling jig was employed to support the specimen edges and to prevent from out-of-plane displacements. An Instron hydraulic universal testing machine (Instron 8802, Athens, Greece) with a 250 kN load cell was used and a constant crosshead speed was kept at 0.5mm/min, until failure. For the compression test, the specimen was placed in the fixture and a compressive force was applied until a maximum force was reached and then the load suddenly drops. This fixture plays an important role for the compression after impact test results as it minimizes the specimens' buckling during test, Figure 3a. The load drop was related to the final failure of the specimen in its centre area where the impact event place, as depicted in Figure 3b.

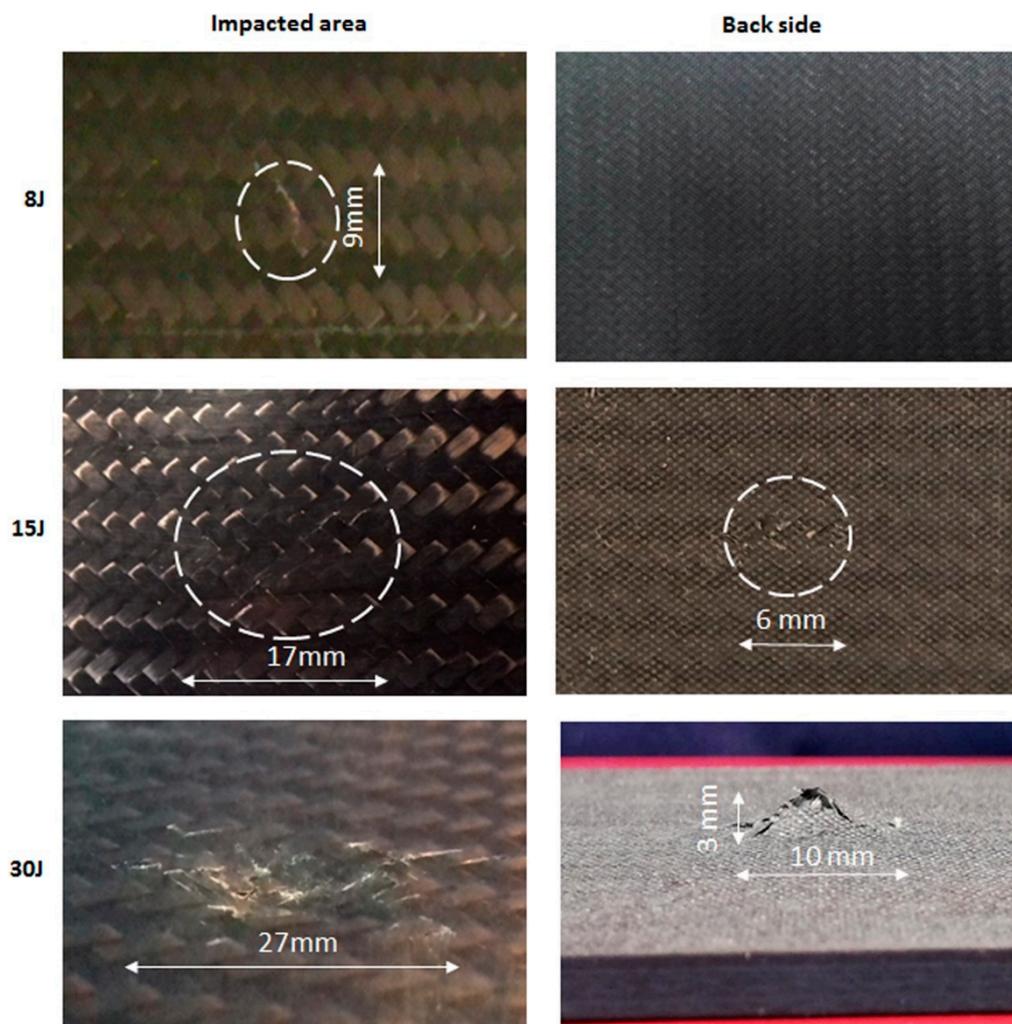
Figure 4. Failure modes after low velocity impact test at impacted and back side of nanomodified specimens with 1.5wt.% multi-walled carbon nanotubes (MWCNTs) at three energy levels.

The dominant failure modes, such as delamination, matrix cracking and fibre breakage, were observed in the composites after the low velocity impact test where these deformations are visible through naked eye. A similar type of damage is exhibited in both of two materials, reference and nano-modified specimens. Figure 4 depicts the damage areas of doped samples for all energy levels from the impacted and the back side of specimens. The visible observation by naked eye of the damage on the specimen surface indicated that all samples of each material type fractured in a similar way. The damaged areas of specimens after impact were measured by an image analysis software (Image J, 1.52a, Bethesda, Rockville, MD, USA) [32] in order to quantify the extent of damage areas in the front and the back side of specimens for each impact energy level, as shown in Figure 4. It is well observed, as the impact energy level was increased, the damage area was increased. Specifically, a visible dent has been formed in the cases of 15 J and 30 J on the front side, which the impactor came in contact with the sample during impact. In the case of impact energy of 15 J there was a visible minor dent depth at the front side of specimen while extensive front and back-face damage was observed at 30 J. On the back side, fibre breakage was obvious only in the cases of 15 J and 30 J impact energies. Samples impacted at 8 J did not show discernible damage in the front and back side, when visually inspected with naked eyes but ultrasonic inspection revealed a small damage at the point of impact. It has to be noted that the damaged area was increased when the impact energy was increased for each material system and it was generally much larger in the back side than in the front one, as expected. These failure modes corresponded very well to the review work of Richardson and Wisheart [2].

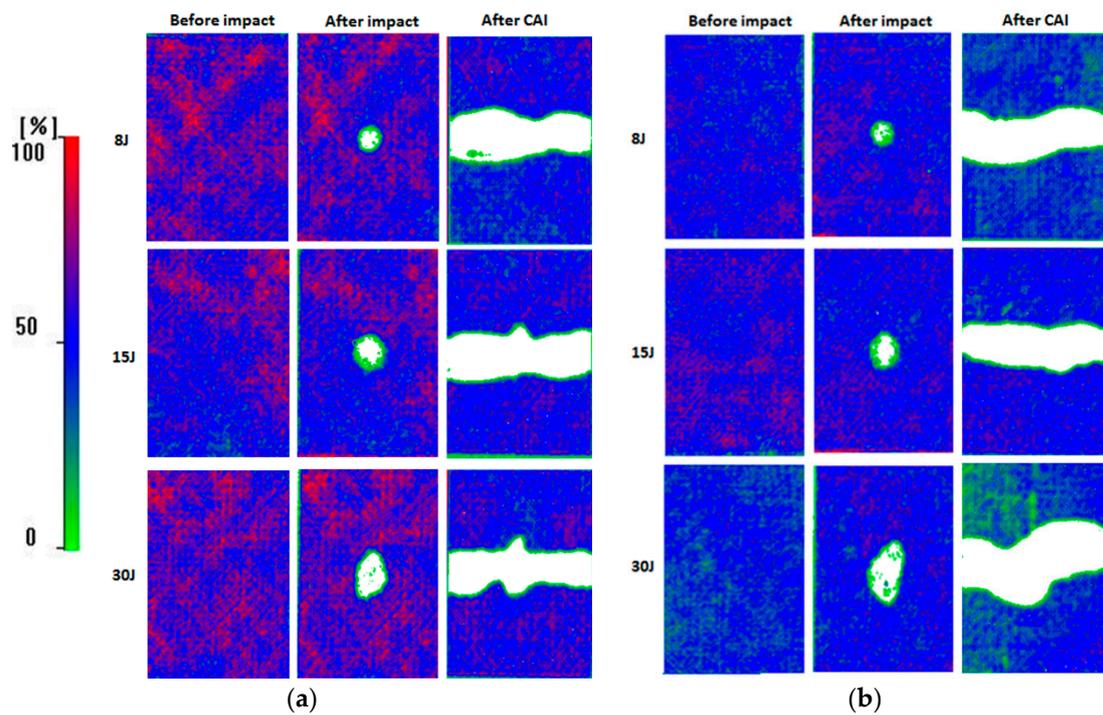
Figure 5. C-scan inspection images before, after impact test and after compression after impact for all energy levels for (a) reference material and (b) nano-modified with 1.5 wt.% MWCNTs concentration.

After the impact, the induced damage was evaluated both for the reference and nano-modified specimens with 1.5 wt.% MWCNTs by non-destructive testing (C-scan) using the same equipment and the parameters described earlier to assess the extent of damage. To evaluate the C-scan results and to quantify the delamination areas, an image analysis software (Image J) [32] was utilized to post-process the C-scan images. According to the quantification of the damage assessment, each damage size can be correlated to the residual strength of the material. The maximum damage length and width were measured in order to determine the impact damage area. Figure 5 illustrates the delaminated areas

of a reference as well as a nano-doped specimen before and after impact test. The white regions in the centre of each specimen represent the damaged area induced by the low velocity impact event. These results were verified using the post-processing image software, where the damaged area of each specimen was measured, as depicted in Figure 6. In the case of nano-modified material, the measured delaminated areas tend to be smaller compared to the reference material both for impact energy levels of 8 J and 15 J. The reduction of damage area can directly be related to the contribution of MWCNTs exhibited more resistance to delamination in the direction of maximum interlaminar shear (45°), where maximum delamination is expected to occur. On the other hand, in the case of the higher impact energy, the extent of delamination detected by C-scan runs of the CNT-enriched composites is larger than one would expect from the visible surface damage but results showed large standard deviations. These observations are in agreement with the results reported by Siegfried et al. [14], where similar damage condition was observed for neat and CNT-modified CFRP composites at the same energy level. According to the author, the reason for the increased damage area is due to the presence of agglomerates which act as stress concentrations and initiation sites for delamination.

C-scan runs after compression-after-impact tests both for reference and nano-modified specimens were carried out, respectively, in order to assess the contribution of nano-particles on the damage failure of composites after compression-after impact test. As can be seen in Figure 5, C-scan runs after CAI tests for each material type and for all energy levels present that the failure caused by the impacts. As can be illustrated, the failure in composites’ sides close to grips was not observed thus it was concluded that the global buckling of composites was avoided. The failure propagation path of the reference specimens was located at the centre impact area of specimens alongside of specimen’s width. On the other hand, the failure propagation path of nano-modified specimens was observed in different manner. The fracture did not become across the entire width of the nano-modified specimens,

as observed in the reference material. The C-scan images indicated that the propagation path of nano-doped specimens was located close to the maximum interlaminar shear direction due to the additional energy dissipation mechanism that introduced by the presence of carbon nanotubes. Thus, in this direction, the lower delamination resistance of the nano-modified specimens was revealed.

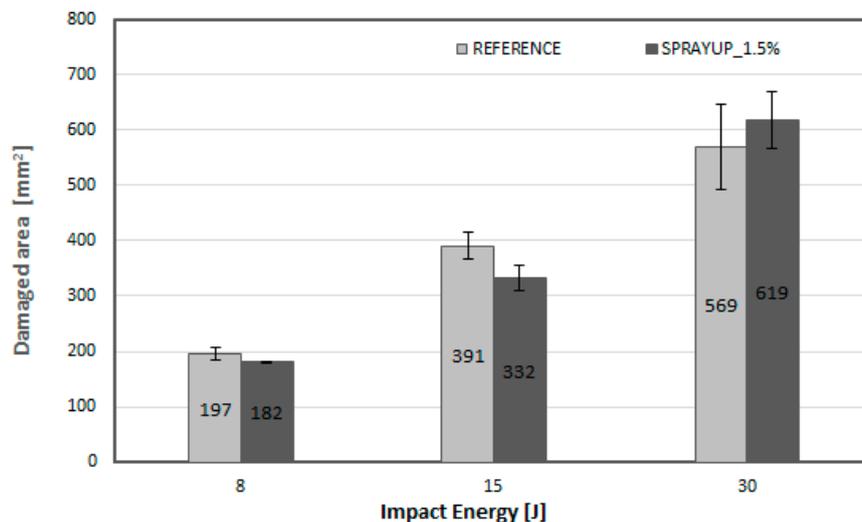
Figure 6. Delamination area versus impact energy levels for both the reference material and the nano-modified with 1.5 wt.% MWCNTs concentration.

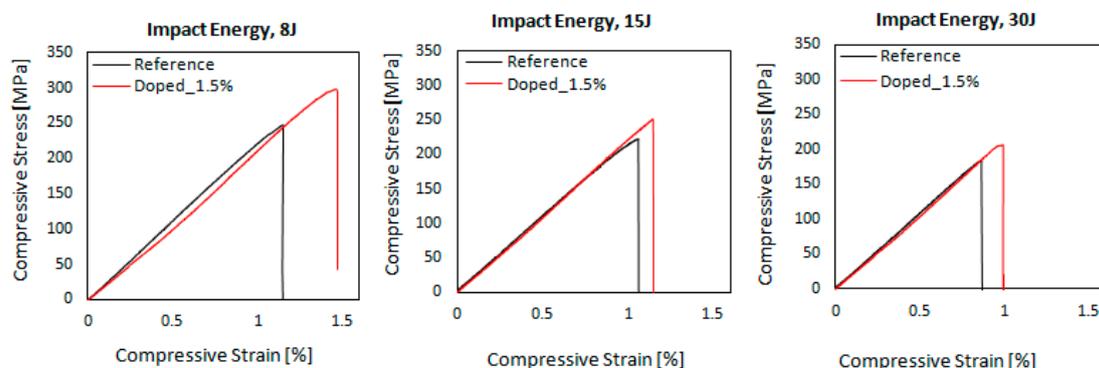
Figure 7. (a) Typical compressive stress versus compressive strain (%) curves resulted from CAI test for three energy impact levels (8, 15, 30 J) both for reference and nano-doped CFRPs with 1.5 wt.% MWCNTs concentration, (b) Maximum compressive residual strength versus impact energy of the reference and modified CFRPs and (c) Compressive modulus vs impact energy of the reference and modified CFRPs.

Figure 7a illustrates the typical compressive stress-strain curves for reference and nano-modified CFRP specimens with 1.5 wt.% MWCNTs concentration under compression for each energy impact event (8, 15, 30 J). In the compression after impact test, all specimens in each material type behave similarly and dramatic differences were not observed. The Instron machine was set to stop the test after the sudden drop during compression test which is obtained with a linear drop of the curves after the maximum load was reached. This drop is related to the final failure of the specimen which is triggered by the impact event and is developed across the centre of the specimen in the lateral direction. According to these results, it is concluded that the nano-modified CFRP composites exhibited a small decrease of the compression stiffness at a rate of 3.3% and only 0.8% at impact energy of 8 J and 30 J, respectively compared to reference material and a negligible increase in the case of 15 J, as depicted in Figure 7b.

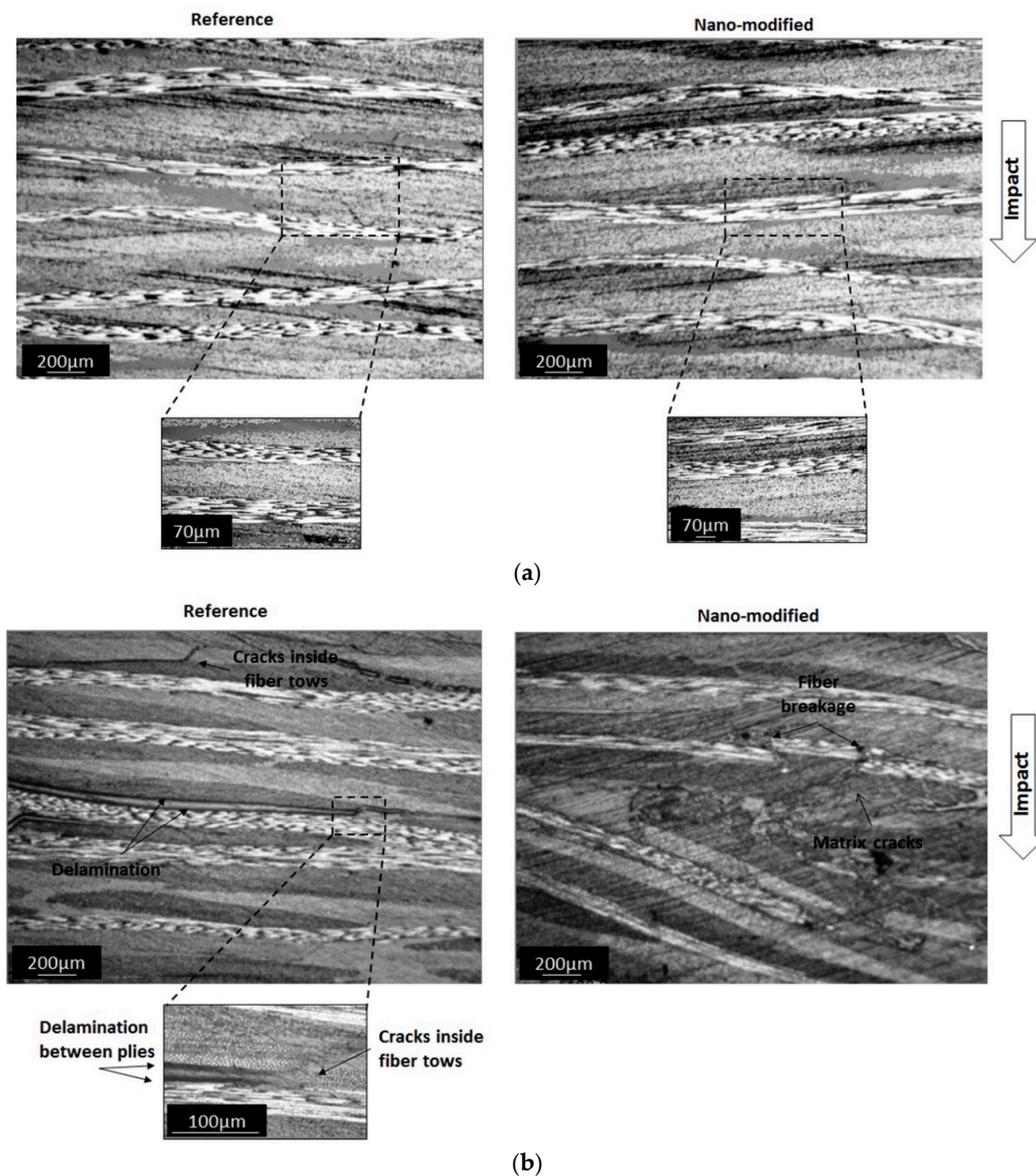
Figure 8. Optical microscope images (a) after impact and (b) after CAI of reference and nano-modified enriched with 1.5 wt.% MWCNTs specimens at the centre area of impact and at an energy level of 8 J.

The damage morphology inspection of the two material systems was carried out using an optical microscopy for all energy levels. The examined area of interest is the centre cross section of specimens where the impact strike has taken place, as Figure 8 depicts. OM analysis was examined both for the cross sections after impact and compression after impact tests, as shown in Figure 8a,b, respectively. Specifically, OM examination for CFRP samples of centre cross section after impact tests present that no damage was detected close to the impacted side of specimens both for two material systems (i.e., fibre fracture, matrix cracks etc.), as depicted in Figure 8a. In general, the impact energy mainly absorbed in the form of elastic and plastic deformation and from other failure modes. More precisely, it is worth to mention that the deformation was not observed for composite materials.

In the case where the optical microscopy assessment was done after the compression after impact test, the main failure modes (delamination, matrix cracks and fibre breakage) are more visible, as shown in Figure 8b. Additionally, each specimen was examined in the area out of the boundary of the impact where matrix cracks could not be found. For that reason, it could be concluded that these matrix cracks are damage due to the impact event and not a result of the compression test. In terms of the reference material, multiple delaminations between plies, matrix cracks and extensive cracks inside tows were found. These matrix cracks were inclined at about 45° and followed the conical shape of the impact damage. In terms of the nano-modified specimens, only extensive fibre breakages and a lesser presence of matrix cracks were observed compared to the reference material. Based on this situation, we can conclude that the matrix of the reference material is weak under a compressive load caused by the impactor. In addition, it is worth to mention that the matrix cracks observed by optical microscopy have no severe effect on the compressive stiffness of the laminates but they also act as an initiation mechanism for the delamination. Additionally, it could be reported that the impact resistance of the nano-modified composites could be improved by the addition of carbon nanotubes on to the carbon fabric surface for all impact energy levels because of the absence of the extensive matrix cracks and

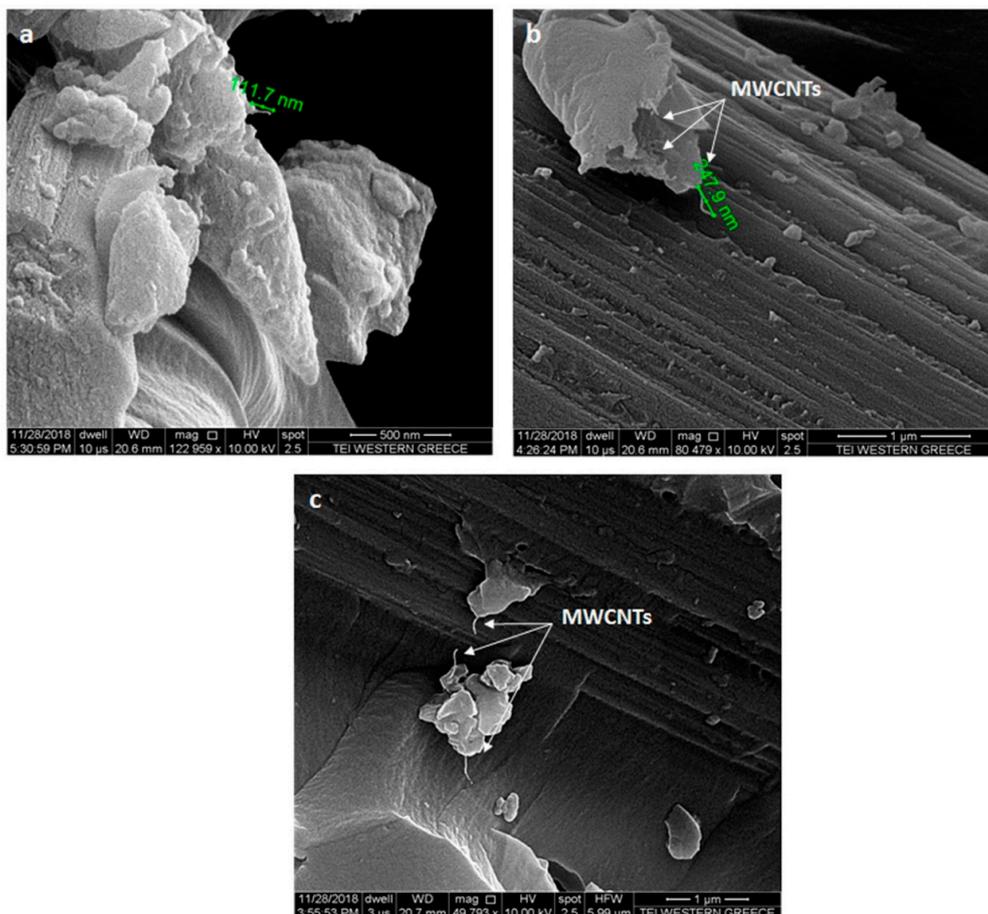
Figure 9. Scanning electron microscope (SEM) micrographs of impacted specimens with 1.5 wt.% MWCNTs at different magnifications at three impact energy levels (a) 8 J, (b) 15 J and (c) 30 J.

All specimens were examined close to the centre area where the impact event took place, after CAI test. SEM analysis was used in order to confirm the additional energy dissipation mechanisms introduced by MWCNTs that were responsible for the improvement of after impact properties and therefore the performance of composites. Figure 9 presents the failure mechanisms that were observed in the cases of three energy levels of the nano-modified specimens with 1.5 wt.% MWCNTs concentration. By analysing the micrographs captured at different magnifications, carbon nanotubes were distributed uniformly into the material's structure without the presence of MWCNT agglomerates. The white arrows in these figures indicate the pull-out toughening mechanisms that were activated with the introduction of CNTs at all energy levels. In the area with nanotubes, the fracture surfaces appear to be rougher, indicating an additional energy dissipating mechanism. Carbon nanotubes provide a large interface area, absorbing larger amounts of energy than the reference material resulting in a reduced delamination area for the impact energies of 8 and 15 J. In the case of impact energy of 30 J, a possible explanation for the situation of the larger damaged area of nano-doped specimens could be a lesser extent of MWCNTs, as it is clearly seen in Figure 9c. Concluding, the increased damage severity caused by the impact has not resulted in a reduction of CAI strength and stiffness for the nano-modified material, as previously noted.
