External Corrosion Behavior of Steel/GFRP Composite Pipes in Harsh Conditions

Abstract: In this study, we report on the corrosion behavior of hybrid steel/glass fiber-reinforced polymer (GFRP) composite pipes under harsh corrosive conditions for prolonged durations. Specimens were immersed in highly concentrated solutions of hydrochloric acid, sodium chloride, and sulfuric acid for durations up to one year. Detailed qualitative analysis using scanning electron microscopy (SEM), X-ray diffraction analysis (XRD), and energy-dispersive X-ray spectroscopy (EDX) is presented. It is shown that the hybrid pipes have excellent corrosion resistance with a corrosion rate of less than 1% of the corrosion rate for conventional steel pipes. That low corrosion rate can be attributed to the formation of pores in the GFRP layer due to increased absorption and saturation moisture in the material with increased soaking time. This can be reduced or even prevented through a more controlled process for fabricating the protective layers. These promising results call for more utilization of GFRP protective layers in novel design concepts to control corrosion.

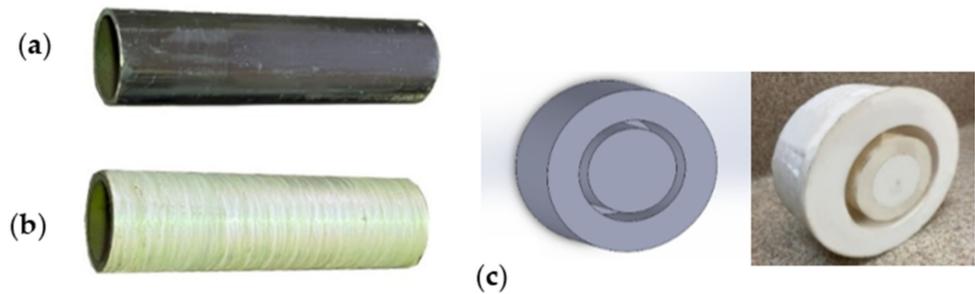
Figure 1. The prepared specimens, (a) steel pipe, (b) GFRP overwrapped steel pipe, and (c) Teflon cups, to close the two ends of the pipes.

The carbon steel pipes had a 6 cm outer diameter, a thickness of 3 mm, and 20 cm for each tested specimen (Figure 1a). The five-axis filament-winding machine was used to overwrap the steel pipes with the glass FRP material. The filament winding machine is the most utilized fabrication method in overwrapping steel pipes [50]. The fibers' orientation angle in all the samples was unidirectional at 90° (Figure 1b). The average thickness of the GFRP layer in all the specimens was 2.5 mm ± 0.1 mm, consisting of eight layers. The pipe specimens were closed and sealed using Teflon cups (Figure 1c) and chemical-resistant sealing to prevent leakage to the inner steel layer and ensure that the contact is only between the GFRP composite and the corrosive solution. The cups were designed

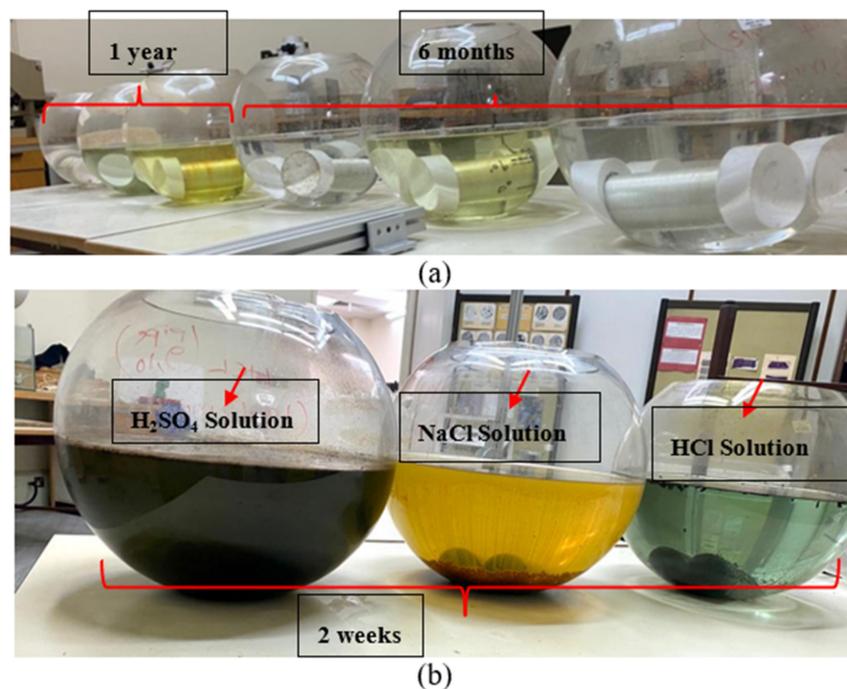
Figure 2. (a) GFRP/steel pipes after one year and six months, (b) steel pipes after two weeks of immersion in acidic environments.

To evaluate the performance of hybrid composite/metallic pipes and their corrosion properties under harsh corrosive conditions, GFRP/steel specimens were prepared and immersed in different corrosive environments. GFRP/steel pipes' corrosion aspects were evaluated in hydrochloric acid 37%, sodium chloride, and sulfuric acid 95% solutions with 0.5 M concentration. The specimens were closed and sealed using Teflon cups and chemical resistant sealing to prevent leakage to the inner steel layer and ensure that the contact is only between the GFRP composite and the corrosive solution. The GFRP/steel pipes were immersed in a glass container containing the corrosive solutions and monitored for six months and one year (Figure 2a). Simultaneously, the steel pipes without any coating were immersed for two weeks (Figure 2b).

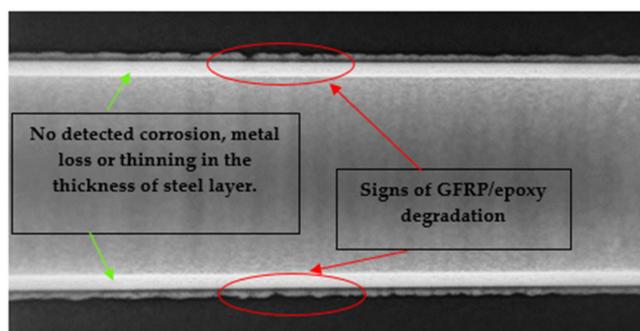
Figure 3. Gamma-ray radiography for the GFRP/steel pipe immersed in HCl solution for 1 year.

Table 4 shows the photos for immersion test containers for all the specimens. Some yellowing signs have been observed at the surface of the GFRP/steel pipes immersed in the HCl solution. Gamma-ray radiography was used to investigate the FRP layer in this specimen and check any sign of corrosion in the steel layer before peeling off the GFRP layer (Figure 3) (diffusion channel). The radiography images revealed no detected corrosion, metal loss, or thinning in the thickness of the steel layer. However, some degradation for the FRP layer and dissolving of epoxy was observed due to the long-term interaction with the highly concentrated hydrochloric acid solution. According to Krauklis et al. [52], the cause of yellowing in the epoxy layer could be related to the irreversible aging mechanism. When the color of the epoxy surface becomes yellow, there is oxidation in the epoxy resin chains [53].

- The radiography images revealed no detected corrosion, metal loss, or thinning in the thickness of the steel layer.
- For GFRP/steel pipes immersed in NaCl solution, no weight loss was detected after one year immersion, indicating that the GFRP layer eliminated any possible corrosion in the base metal.

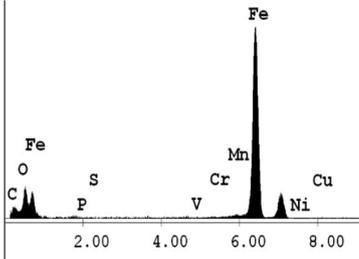
GFRP/steel pipes immersed for six months in NaCl solution after removing the GFRP layer

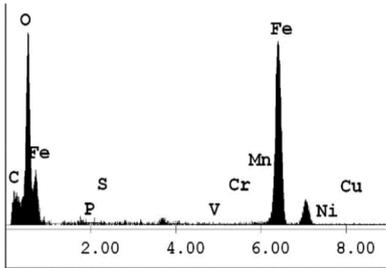
GFRP/steel pipes immersed for six months in H ₂ SO ₄ solution after removing the GFRP layer

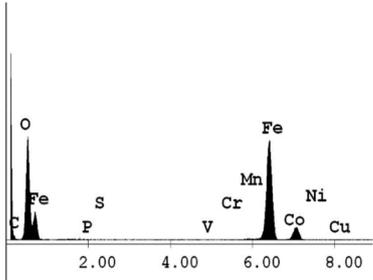
GFRP/steel pipes immersed for six months in HCl solution after removing the GFRP layer

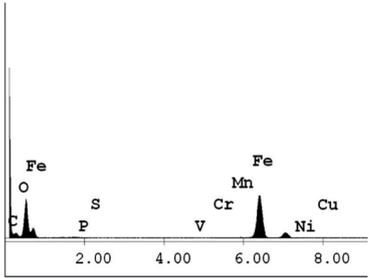
Specimen	SEM	EDX
GFRP/steel pipes immersed for one year in NaCl solution after removing the GFRP layer

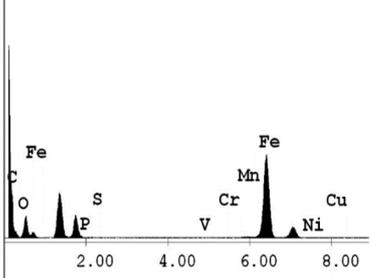
GFRP/steel pipes immersed for one year in H ₂ SO ₄ solution after removing the GFRP layer

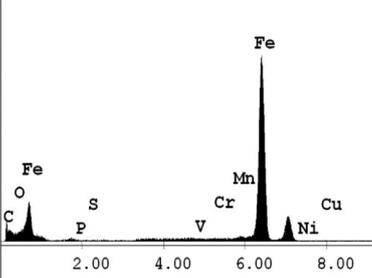
GFRP/steel pipes immersed for one year in HCl solution after removing the GFRP layer

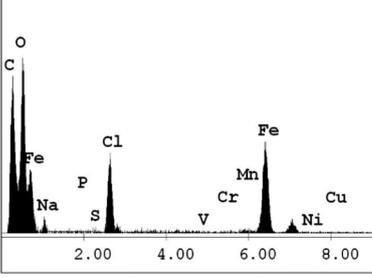
Steel pipes immersed for two weeks in NaCl solution

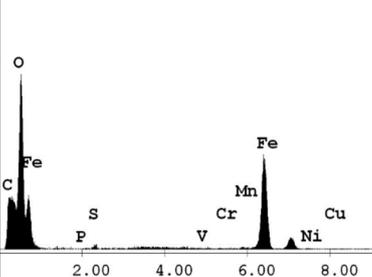
Steel pipes immersed for two weeks in H ₂ SO ₄ solution

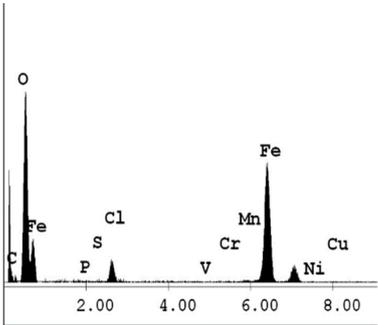
Specimen	SEM	EDX
Steel pipes immersed for two weeks in HCl solution

- The porous lamellar structure was detected in all the immersed uncoated steel specimens, resulting from the pitting corrosion feature.
- X-ray diffraction analysis was applied on all immersed specimens, and the corrosion products' formation on the surface was detected and characterized. The patterns revealed that the crystalline phases detected in the coated steel specimens are mainly iron Fe1. It was also found that the corrosion products for the exposed steel specimens consist mainly of magnetite, cohenite, goethite, and hohmannite.

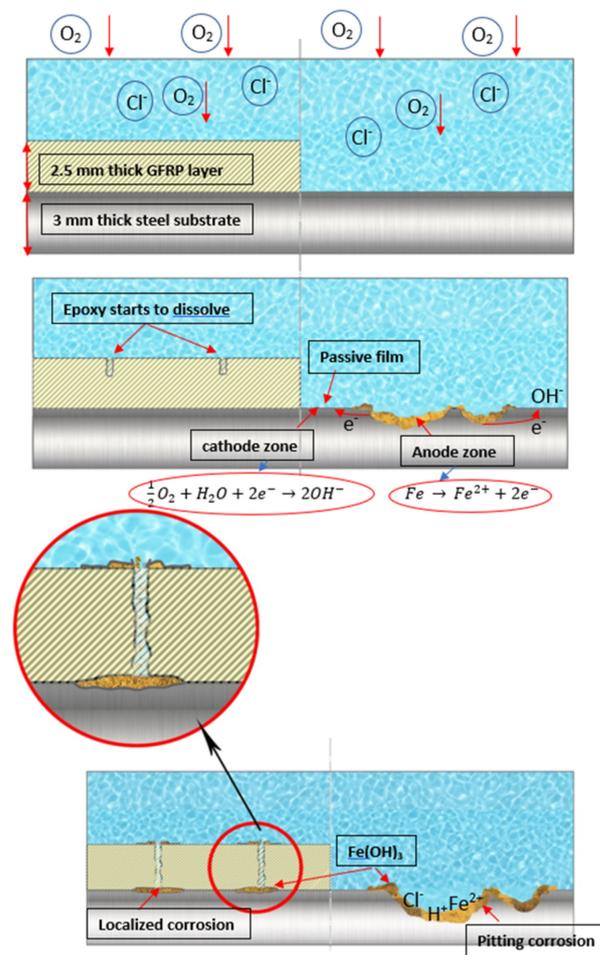
Figure 4. Schematic for the development of corrosion on uncoated steel vs. GFRP/steel in corrosive solution.

is chloride ion reactions. The adsorbed chloride ions on the metal surface will break down the steel’s passivity and consequently upturn the corrosion rate [57]. Figure 4 presents a schematic diagram that demonstrates the pitting corrosion mechanism of pipeline steel in the corrosive environment containing chloride ions, where the negative ions of chloride attract the hydrogen protons to the pitting areas, causing hydrogen protons to accumulate, driving a more significant cathodic reaction outside the pitting and accelerating anodic reaction inside the pitting.

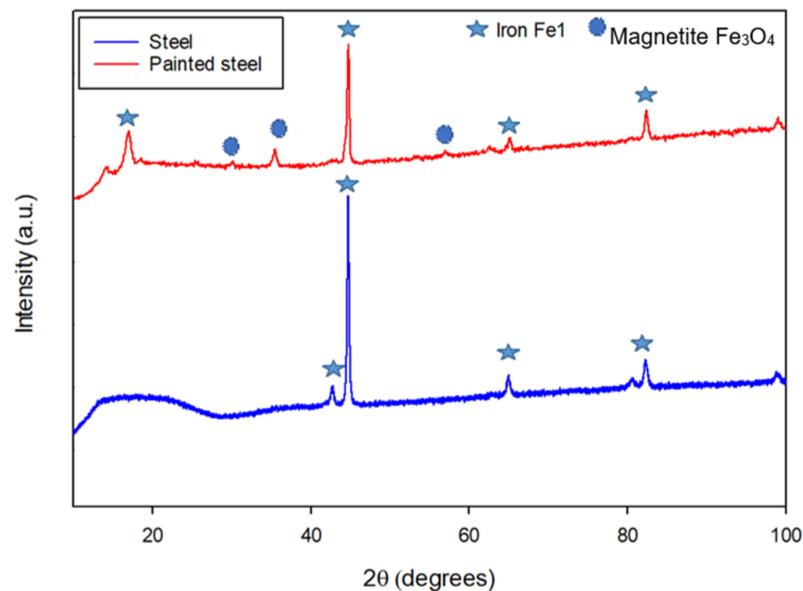
Figure 5. XRD pattern for the steel surface before immersion.

Standard methods for identifications and characterizations of iron oxides have traditionally used X-ray diffraction (XRD). X-ray diffraction analysis was applied to all immersed specimens to detect and characterize any corrosion products' formation on the surface. Figures 5–8 show the XRD patterns representing the signal intensity against 2θ collected from the carbon steel surfaces at the end of each immersion experiment for the three corrosive solutions. Figure 5 patterns reveal that the only crystalline phase detected on the

polished steel surface was Iron (Fe) and some low peaks of iron oxide phase as magnetite compound (Fe_3O_4) for the painted steel specimen, and no other phases were detected. The most intense peak for both patterns was observed at $2\theta = 44.79^\circ$, and the presence of iron oxide compounds results from the typical oxidation in nature, where the painted pipes were tested as received from the industry without any polishing.

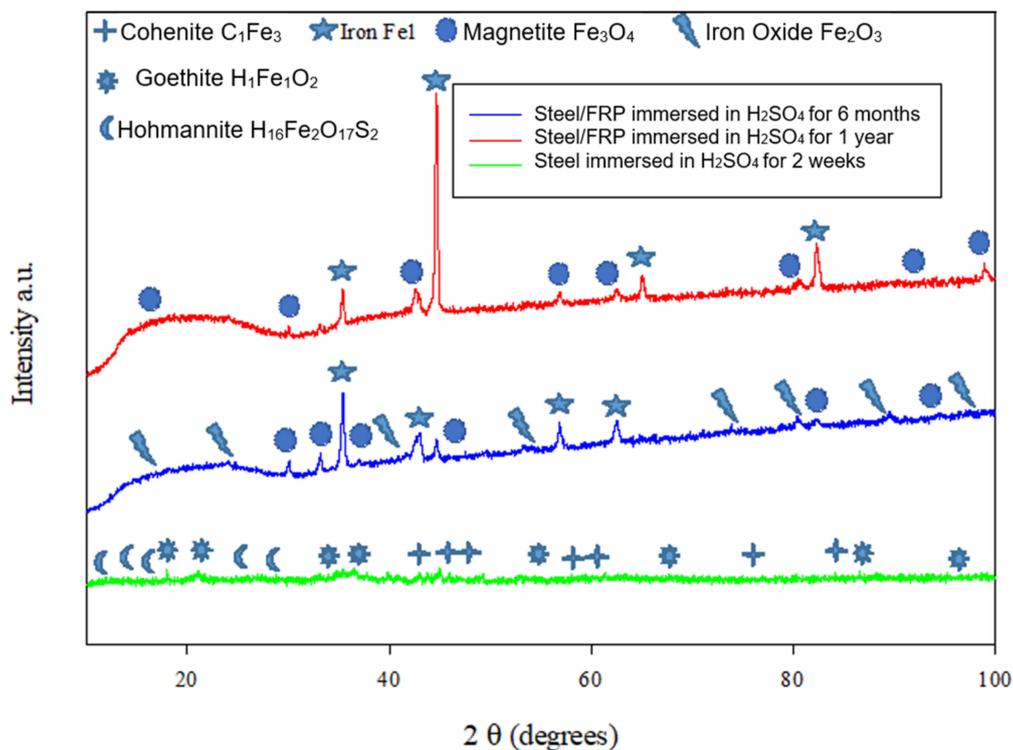
Figure 6. XRD patterns for the steel surfaces after immersion in H_2SO_4 solution.

Figure 6 patterns for the steel pipes were overwrapped with a GFRP layer and immersed in sulfuric acid, hydrochloric acid, and sodium chloride solutions for six months and one year. The patterns reveal that the crystalline phases detected are mainly iron Fe1, where the most intense peak in almost all the specimens was observed at $2\theta = 44.79^\circ$, the same as in the new steel specimen. It is also observed that iron oxide compounds were detected in small peaks as magnetite and hematite in all the patterns. Some researchers studied the transformation of iron oxides. They found that it begins with nucleation and growth of goethite (FeOOH), followed by dehydration to hematite (Fe₂O₃), and then reduction to magnetite (Fe₃O₄) [58]. Simultaneously, the XRD analysis for the uncoated steel that was immersed for two weeks in sulfuric acid solutions exposes that the corrosion products consist mainly of cohenite, goethite, and hohmannite, all of which are compounds that are usually found in iron corrosion scales. Goethite (FeOOH) is an iron oxyhydroxide, and it is the main component of rust [59]; those compounds are predominately present in iron corrosion scales of corroded iron pipe in water distribution systems [60].

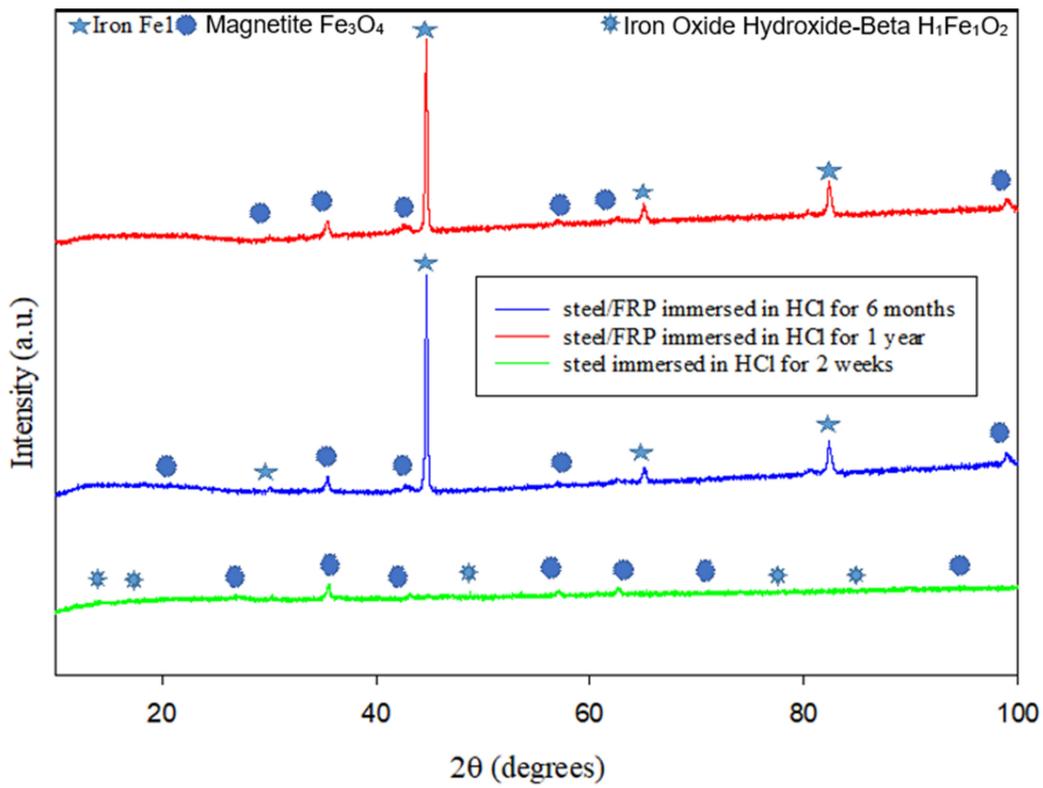
Figure 7. XRD patterns for the steel surfaces after immersion in HCl solution.

Figure 7 reveals that the uncoated steel's corrosion products immersed in HCl solution consist of magnetite and goethite for two weeks. Iron corrosion is an anoxic atmosphere that usually proceeds via goethite (FeOOH) through hematite and magnetite [61]. Magnetite is a familiar kind of iron oxide that forms at room temperature in crevices at steel alloy, where the oxidation product of Fe₃O₄ is either γ -Fe₂O₃ or α -Fe₂O₃, depending on the oxidation temperature [62]. Meanwhile, Figure 8 reveals that the crystalline phases detected for the uncoated steel that was immersed for two weeks in NaCl solution are mainly iron Fe1 with the presence of compounds that consists of halite (Cl₁Na₁), sodium peroxide (Na₁O₂), and tetrachloromethane (C₁Cl₄). Halite is a form of isometric crystals known as rock salt [63] accumulated on the surface of the steel pipe when immersed in sodium chloride solution. Simultaneously, sodium peroxide is produced as the reaction of sodium with oxygen that crystallizes with hexagonal symmetry [64].
