Article

Effect of Weathering on Surface Functional Groups of Charred Norway Spruce Cladding Panels

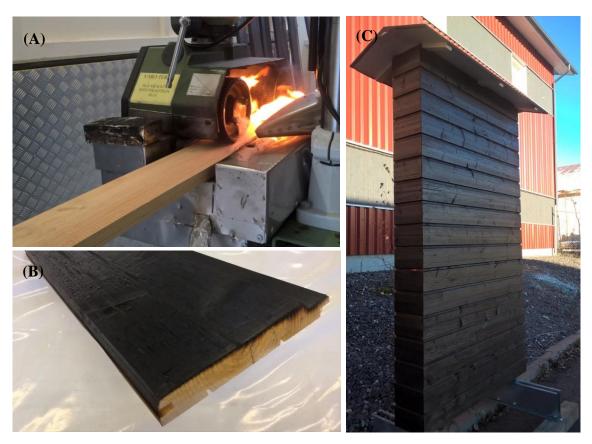
Figure 1. (A) The prototype charring device; (B) a charred spruce panel; (C) the experimental wall.

The experimental wall was constructed from the charred UTV-panels at the end of year 2017 (Figure 1), using horizontally laid boards in three directions. The front was positioned towards south. The process time (0.8–1.3 m/min) for front wall boards was generally longer than the process time used for the sides, i.e., the front wall boards had a slightly thicker char layer than those on the sides. The boards were charred at $400-520~^{\circ}$ C. The boards on the left side were modified at a median temperature of $477~^{\circ}$ C (range $430-510~^{\circ}$ C), the front at $440~^{\circ}$ C (range $400-520~^{\circ}$ C) and the right at $480~^{\circ}$ C (range $410-500~^{\circ}$ C).

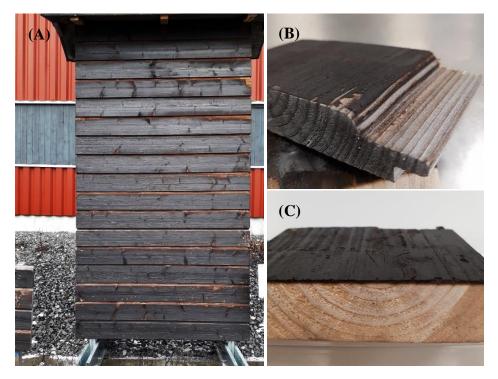
Figure 4. (**A**) The wall in January 2020, 2 years into weathering experiment. The examined panel is situated highest in the left corner; (**B**) detail of the tongue of the panel; (**C**) surface on a cut-out of the same panel showing intact, well-preserved char layer and underlying, unmodified wood.
