Automated Sensing of Wave Inundation across a Rocky Shore Platform Using a Low-Cost Camera System

Abstract: Rocky coastlines are frequently used for recreation, however, they are often highly exposed and hazardous environments resulting in high risk to visitors. Traditional approaches to managing human safety in coastal settings (such as the surf lifesaving clubs that have proven effective on beaches) are not necessarily transferable to rock platforms due to their often remote and fragmented distribution and the different recreational uses. As such, a different approach is required. To address this, we present a low-cost camera system to assess the wave hazard on a high-visitation rocky shore platform: the Figure Eight Pools Rock Platform, New South Wales, Australia. The camera system is shown to be highly effective and allows identification of both the distance and frequency of wave inundation on the platform using a novel pixel analysis technique. Nearshore wave height is shown to be the primary factor driving inundation frequencies along the cross-platform transect investigated with some influence from wave period. The remotely sensed camera data are used to develop a prelimina

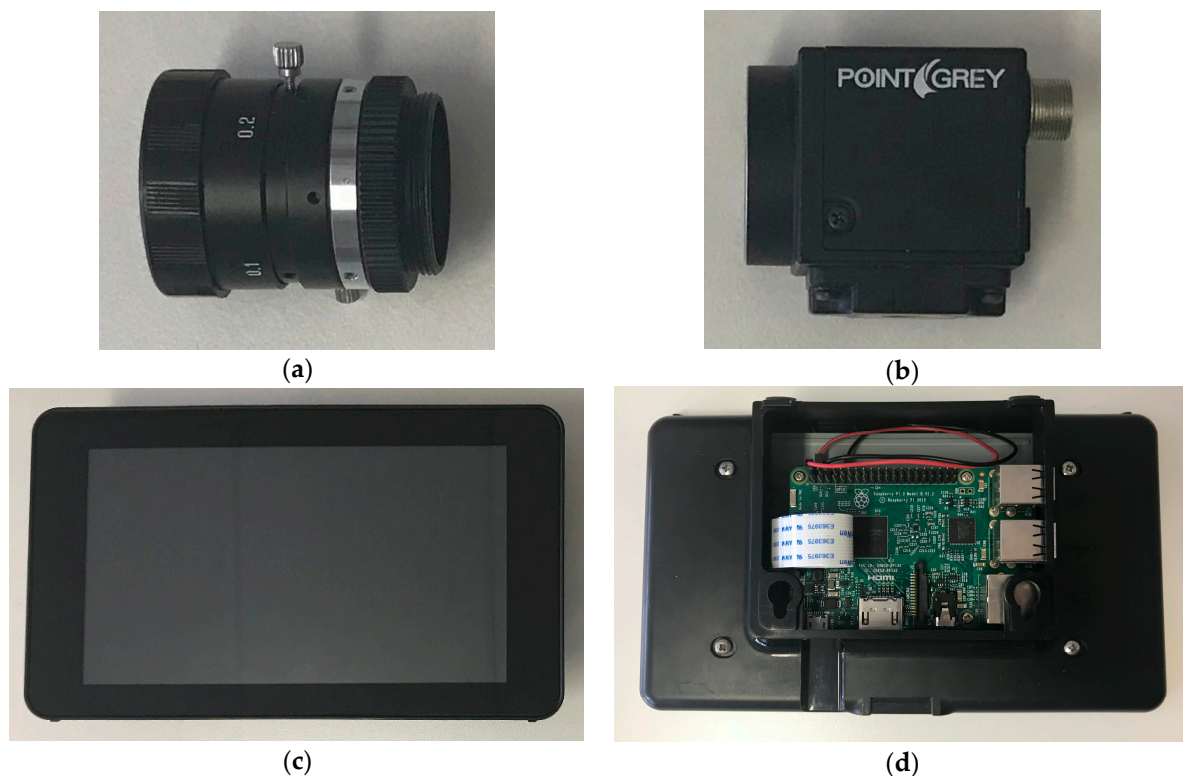
Figure 4. Components of the camera system: (a) camera lens, (b) camera, (c) Raspberry Pi computer touch screen, and (d) Raspberry Pi computer and case.

Given the challenges of collecting in situ field data describing wave overwash hazards on rocky shore platforms, camera remote sensing is an ideal alternative for data collection. To investigate overwash hazards at Figure Eight Pools Rock Platform, we developed a low-cost remote sensing system comprising two camera systems, to obtain full coverage of the area of interest (Figure 2). Each system consists of a 3.2 megapixel FLIR (formerly PointGrey) Flea3 color image camera fitted with a Fujinon 6 mm lens (Figure 4a,b respectively). Camera image capture is controlled by a Raspberry Pi computer (Figure 4c,d) using custom C++ and Python code to control capture frequencies and data storage. We captured images at 1 Hz for the first 20 min of each daylight hour, to balance data storage with image analysis needs; however, these values are programmable in the software code and could be adapted to suit other purposes. Captured images were stored on site using a 128 GB USB flash drive connected to each Raspberry Pi computer, which could store approximately 325 20-min capture cycles (at 1 Hz), amounting to between 25 and 36 days of image capture based on 10–14 daylight hours. The USB sticks were retrieved and replaced every 2–4 weeks to collect the image data for subsequent analysis. The itemized cost of the camera system (as of the time of writing) is shown in Table 1.

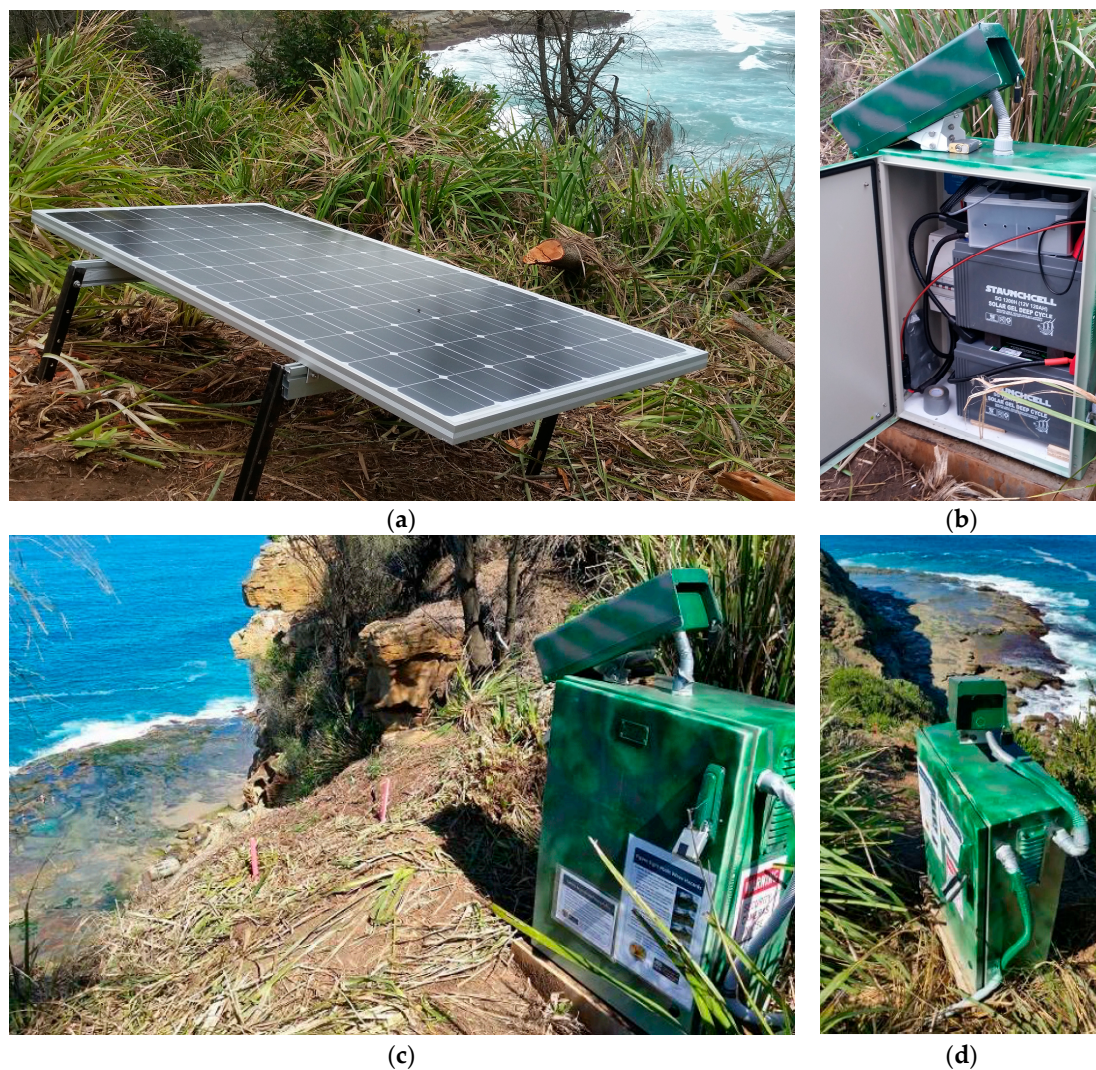
Figure 5. Camera setup on site showing (a) the solar panel; (b) the gel batteries, solar regulator, and power converters; and the cameras mounted in the security camera housings and the battery housing box for (c) the north camera and (d) the south camera.

Another challenge was the lack of mains power at the camera sites. As such, each camera system is powered by a 200 W 24 V solar panel (Figure 5a) connected to a 15 A solar regulator and two 12 V 138 Ah gel batteries (Figure 5b), with 12 V to 5 V converters to supply power to the camera and computer at the required voltages. The system was designed to contain sufficient backup power to cover periods of poor weather and low incident sunlight even during the winter months, with sufficient power from fully charged batteries to cover eight days with no battery recharge from the solar panels. The camera sites are situated near the edge of the coastal cliff and are exposed to high winds and salt spray. To protect the camera and power system components, all electronics are stored in a standard, ventilated steel locker, with the cameras mounted in standard security camera housings (see Figure 5c,d). The computer components were further sheltered from moisture and salt spray by a plastic box inside the steel locker (Figure 5b). The electronics lockers and camera housings were painted to further minimize the low visual impact of the camera systems on the natural aesthetics of the site.

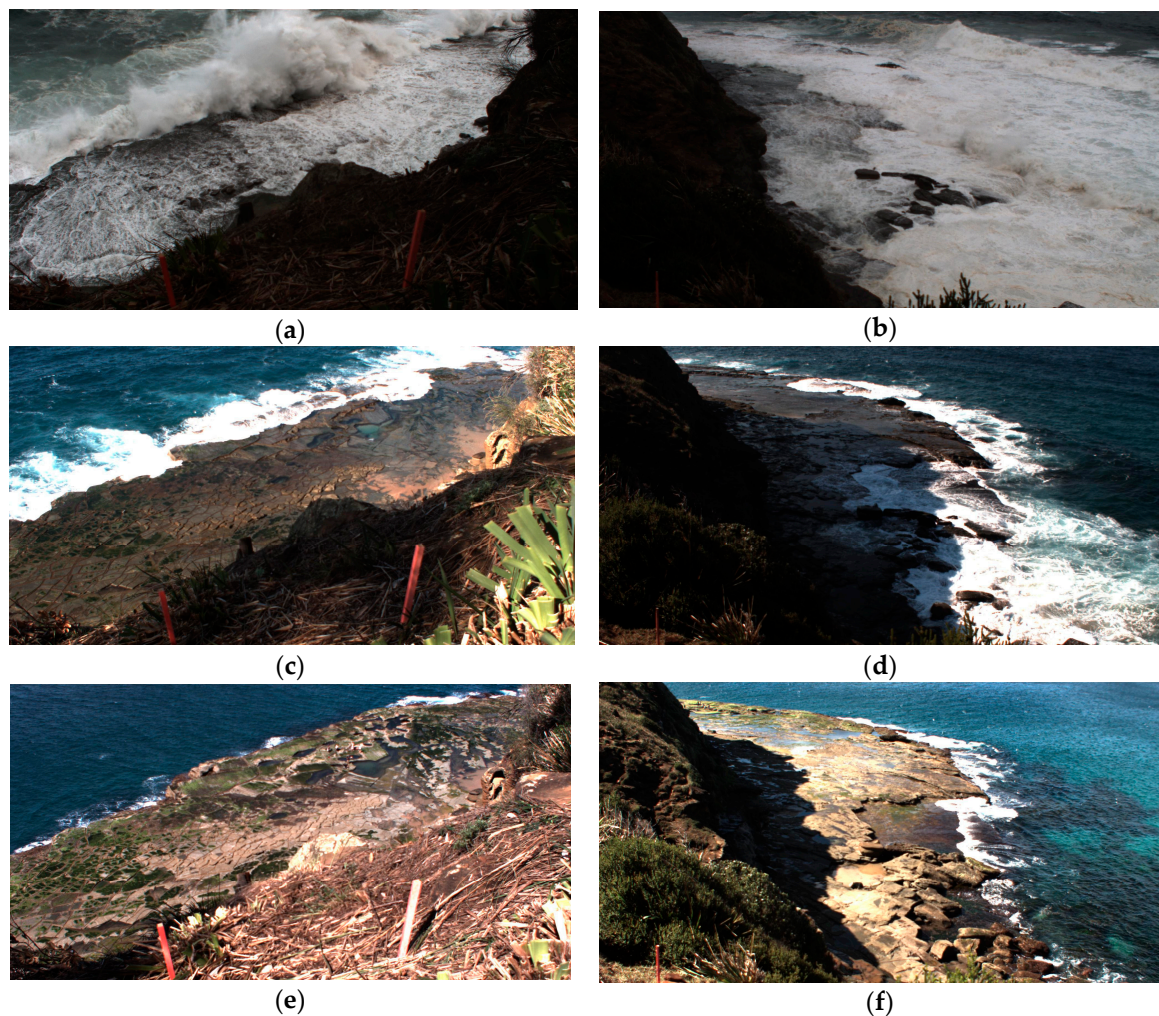
Figure 6. Examples of frames collected by the camera system under different conditions: high energy conditions ($H_s = 3.12$ m, $T_{m01} = 9.2$ s, $D_p = 160^\circ$) on 27 April 2017 at 17:00 at (a) the north camera and (b) the south camera; moderate energy conditions ($H_s = 1.41$ m, $T_{m01} = 6.62$ s, $D_p = 150^\circ$) on 11 May 2017 at 10:00 at (c) the north camera and (d) the south camera; and low energy conditions ($H_s = 0.47$ m, $T_{m01} = 4.8$ s, $D_p = 100^\circ$) on 10 April 2017 at 11:00 at (e) the north camera and (f) the south camera.

The cameras captured a wide range of conditions on and adjacent to the rock platform, from very calm and benign, to storm conditions with nearshore significant wave heights up to $H_s = 4.73$ m. Example oblique images showing the range of conditions captured are shown in Figure 6. Rectified timex and variance images, derived from the full 1200 images captured in each cycle, are shown in Figure 7. The timex images clearly identify regions of wave breaking (light/white pixels) and are useful for quickly identifying instances of high wave overwash on the platform. The variance images highlight regions of pixels with high variance through time, such as regions of wave breaking, but also changes in light intensity, such as the impact of varying cloud cover on the rock platform (see Figure 7a, right panel, where close to the cliff at approximately 319,245 m E, 6,214,535 m N, high variance is observed but no overwash is observed in the timex).

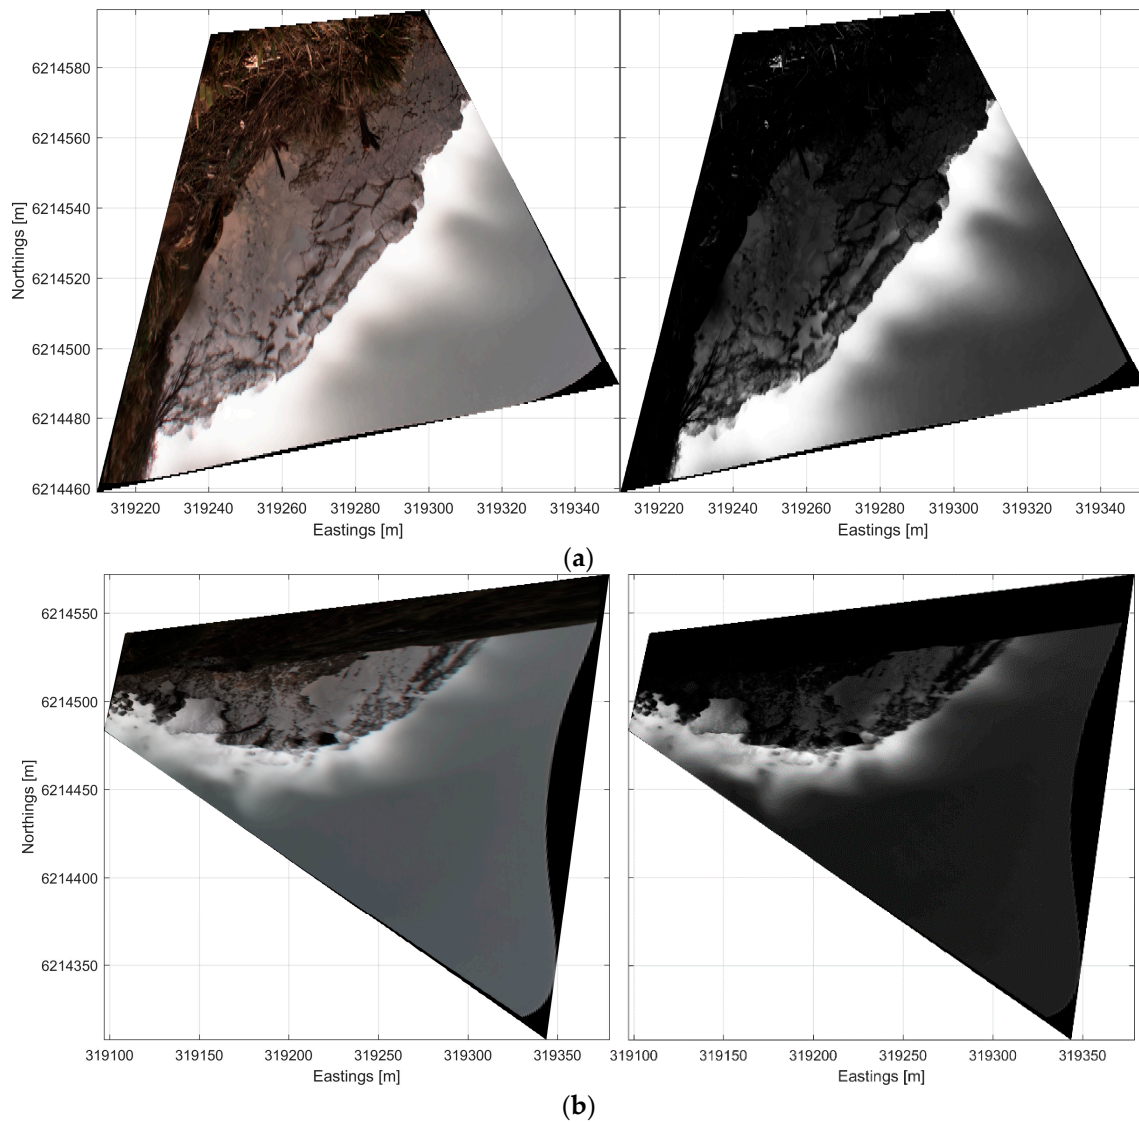
Figure 7. Example timex (left panels) and variance (right panels) images created from the camera data for (a) the north camera and (b) the south camera 12:00 on 23/03/2017. Eastings and northings correspond to the coordinate system GDA94 MGA Zone 56.

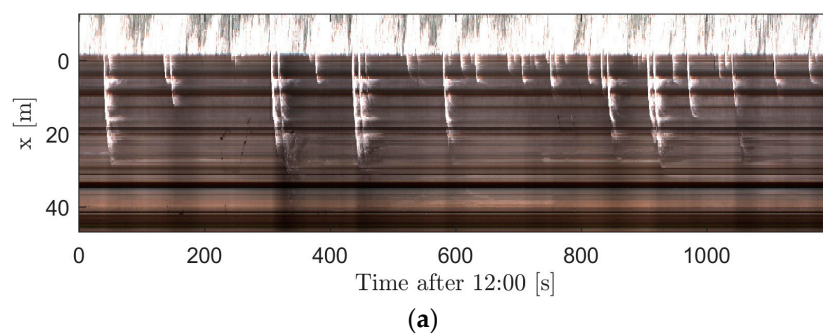
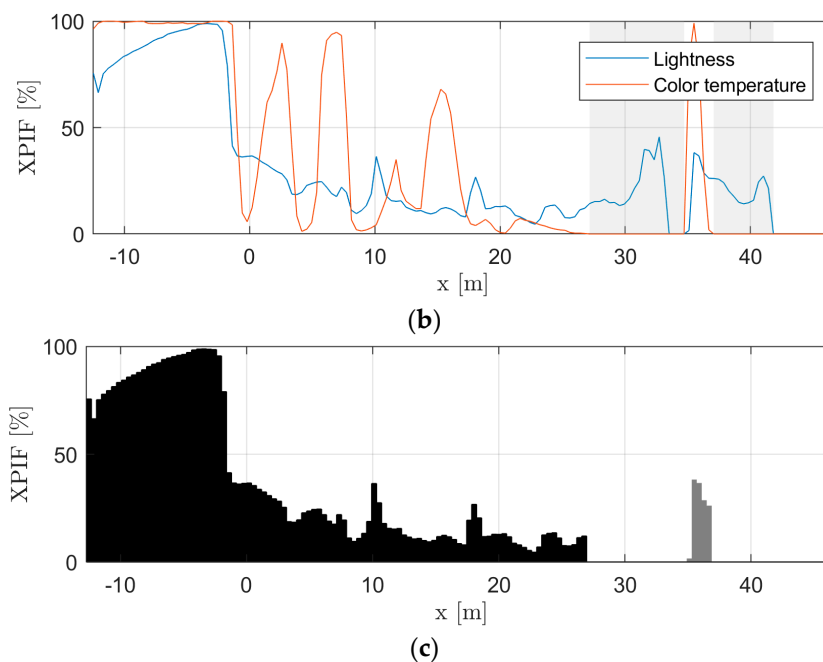
Figure 8. Cont.

Figure 8. (a) Example timestack from transect N2 taken at 12:00 on 23/03/2017 showing intermittent overwashing on the rock platform at this location, (b) cross-platform inundation frequency (XPIF) as defined by the pixel lightness metric and the pixel color temperature metric, and (c) resultant combined XPIF profile (grey and black bars) with the grey bars removed via automatic quality control processes to obtain the final XPIF profile (black bars). See Figure 2 for transect location.

An example 20-min timestack, obtained from transect N2 during a period of intermittent overwashing, is shown in Figure 8a. Near continuous wave breaking seaward of the platform edge can be seen by the white pixels at $x < 0$ m for the full duration of the timestack. Intermittent wave overwashing can be seen throughout the length of the timestack (white wave paths running in near vertical lines down the timestack from the platform edge at $x = 0$ m). The majority of overwash events are relatively small, only inundating the seaward edge of the platform to $x \sim 7$ m; however, nine events extend significantly further on to the platform, to $x \sim 24$ m. This timestack describes intermittent overwash conditions of variable magnitude.

Using the method described in Section 3.2, pixel values in the timestack were converted to lightness values and color temperature values, which were used to calculate the frequency of inundation. The cross-platform values of these two metrics for the example timestack are shown in Figure 8b with the final combined metric shown in Figure 8c. The pixel analysis metrics yield high frequencies of inundation (close to 100%) seaward of the platform edge which corresponds well to the observations of the timestack that suggest near continuous wave breaking seaward of the platform edge (Figure 8a,b). Landward of the platform edge, the frequency of inundation drops to below 40% and continues to decrease as distance onto the platform increases, as per the observations of the timestack, indicating decreasing frequency of intermittent overwashing. The use of color temperature to disregard erroneous overwash is demonstrated at $27 < x < 34$ m and $37 < x < 47$ m (shown by the grey shaded areas in Figure 8b and the final inundation frequencies in Figure 8c). Small peaks in XPIF between the edge of the platform and the landward limit of inundation correlate with pools and slight changes in elevation across the platform (Figure 8c). The erroneous spike at $x \sim 35$ m, which is due to high pixel lightness and color temperature potentially caused by standing water on the

platform (grey bars in Figure 8c), was removed by automated quality control methods to obtain the final cross-platform inundation frequency profile (black bars in Figure 8c).

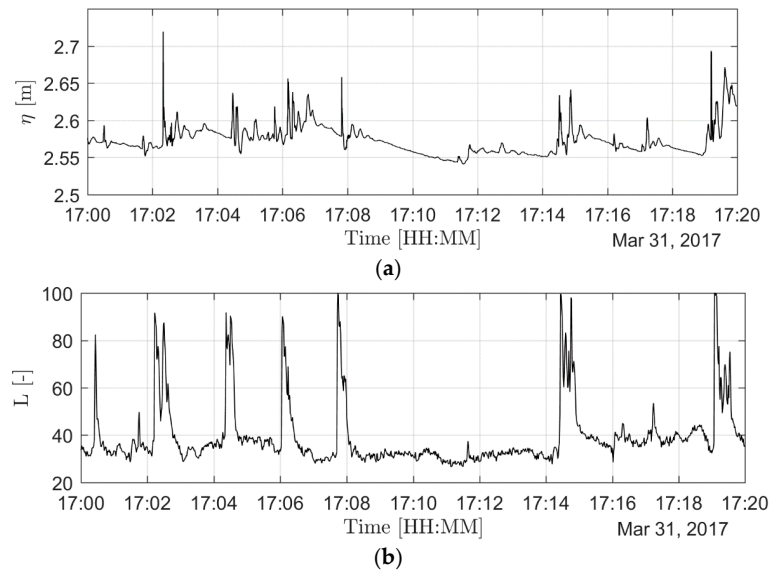
Figure 9. Comparison of (a) water surface elevation time series derived from the pressure transducer data (η), and (b) the pixel lightness metric (L) from the pixel at the transducer deployment location obtained from the rectified camera imagery from 31 March 2017. Water surface elevations are shown relative to the PT location at the bottom of the pool on the rock platform that had a depth of ~ 2.5 m. The PT location shown here was the northeast PT of the two deployed on 29 March 2017 (319,261 m E, 6,214,520 m N). See Figure 2 for location.

To assess the use of the pixel lightness values from the camera data as a proxy for wave overtopping on the rock platform, pixel time series were extracted from the rectified camera imagery at the location of the pressure transducers, and the pixel lightness time series were compared to the water surface elevation time series derived from the PT data. An example of these two paired time series is shown in Figure 9. It is clear from comparison between the measured (transducer) and the remotely sensed (camera) data, that the peaks in the measured water surface elevation time series are accompanied by simultaneous peaks in the pixel lightness time series. Despite a strong correspondence between the peaks in the pixel lightness and those in the water surface elevation time series, the peaks in the pixel lightness time series are typically of longer duration than the corresponding peaks in the water surface elevation time series. This has the potential to result in overestimation of the duration of inundation; however, for the purpose of this project, this measure was deemed to be fit for purpose. This is discussed further in Section 5. Equivalent assessments were performed for PT and pixel paired time series for other PT locations and other times and similar observations were made. These data indicate that pixel lightness values are a suitable proxy of the occurrence of wave overwashing at positions across the platform, and thus can be used to classify the overwash hazard level measured as the distance and frequency of platform overwashing.

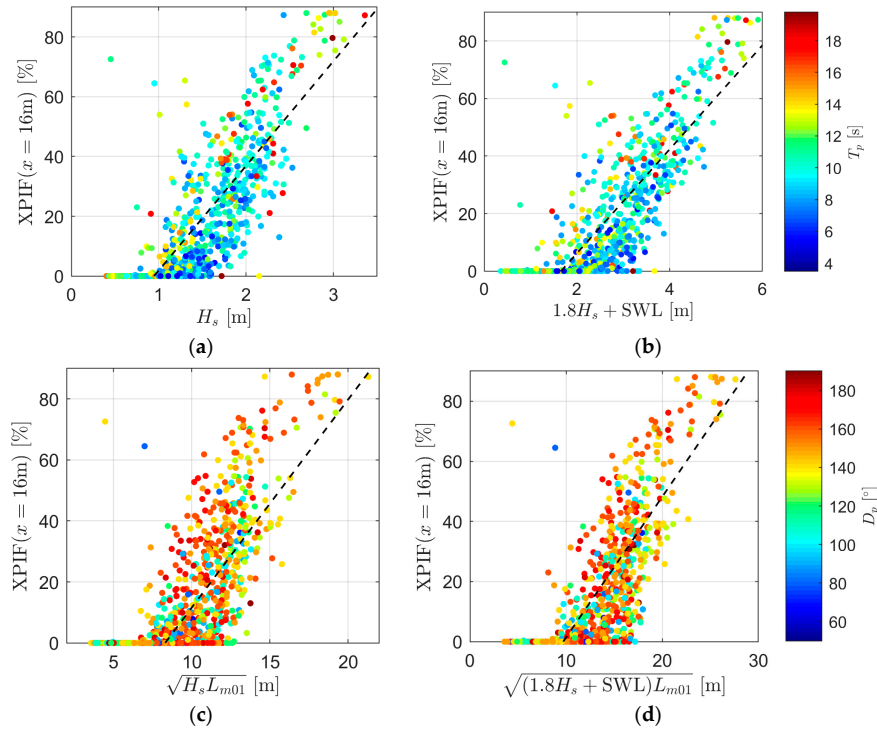
Figure 10. Comparison of inundation on the platform at the Figure Eight Pool location (XPIF at $x = 16$ m on transect N2, see Figure 2 for location) with: (a) significant wave height (H_s); (b) $1.8H_s$ plus tidal still water level ($1.8H_s + SWL$); (c) square root of significant wave height times wavelength derived from the spectral mean wave period ($\sqrt{H_s L_{m01}}$); and (d) $\sqrt{(1.8H_s + SWL)L_{m01}}$. The points in panels (a,b) are colored by peak wave period (see color bar in panel (b)). The points in panels (c,d) are colored by peak wave direction (see color bar in panel (d)). Linear regression lines calculated using data with XPIF $\geq 1\%$ are shown in each panel and correspond to: (a) XPIF = $35.0 H_s - 33.1$, $R^2 = 0.55$; (b) XPIF = $18.1(1.8 H_s + SWL) - 30.0$, $R^2 = 0.57$; (c) XPIF = $6.3\sqrt{H_s L_{m01}} - 45.0$, $R^2 = 0.48$; (d) XPIF = $4.7\sqrt{(1.8 H_s + SWL)L_{m01}} - 45.4$, $R^2 = 0.51$. All linear regression equations have $p < 0.001$.

Cross-platform inundation frequency at the Figure Eight Pool (XPIF at $x = 16$ m) was strongly correlated with the local hydrodynamic conditions with XPIF increasing with increases in all four hydrodynamic parameters with significant positive correlations (Figure 10). Nearshore H_s and $1.8 H_s + \text{SWL}$ (Figure 10a,b) had the highest coefficients of determination of 0.55 and 0.57 respectively. Lower, but still statistically significant, correlations were observed for $\sqrt{H_s L_{m01}}$ and $\sqrt{(1.8 H_s + \text{SWL}) L_{m01}}$ (0.48 and 0.51 respectively; Figure 10c,d). In general, XPIF ($x = 16$ m) remained close to XPIF = 0% until $H_s > 1$ m (exceeded 66.5% of the time) or $1.8 H_s + \text{SWL} > 0.5$ m after which XPIF increased rapidly with the Figure Eight Pool approaching very high levels of inundation (XPIF > 60%) for $H_s > 2$ m (exceeded 13.8% of the time) or $1.8 H_s + \text{SWL} > 2.5$ m. For a given wave height, larger peak wave periods (point colors in Figure 10a,b) are more likely to be associated with greater frequencies of inundation but with significant variability.

The influence of wave period (through wavelength) on platform inundation was assessed by the use of $\sqrt{H_s L_{m01}}$, which is commonly used in wave runup investigations on sandy beaches (e.g., [26,27]), as well as a modified version that incorporates SWL, $\sqrt{(1.8 H_s + \text{SWL}) L_{m01}}$. XPIF at $x = 16$ m remained close to XPIF = 0% for low values of $\sqrt{H_s L_{m01}}$ and $\sqrt{(1.8 H_s + \text{SWL}) L_{m01}}$ then increased rapidly with increasing $\sqrt{H_s L_{m01}}$ and $\sqrt{1.8(H_s + \text{SWL}) L_{m01}}$ (Figure 10c,d). The coefficients of determination

for the comparison of XPIF ($x = 16$ m) with $\sqrt{H_s L_{m01}}$ and $\sqrt{(1.8H_s + SWL)L_{m01}}$ were 0.48 and 0.51 respectively, lower than those of H_s and $1.8H_s + SWL$ but still statistically significant. No clear trends were observed with respect to the influence of peak wave direction on inundation frequency (see point colors in Figure 10c,d).

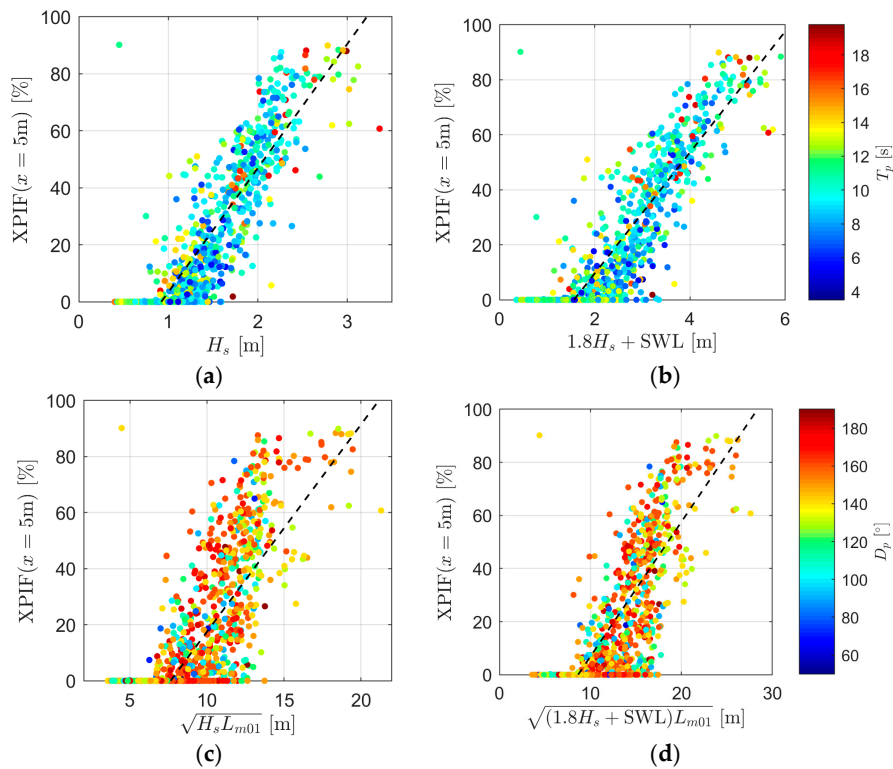
Figure 11. Comparison inundation on the platform at $x = 5$ m on transect N2 (see Figure 2 for location) with: (a) significant wave height (H_s); (b) H_s plus tidal still water level ($1.8 H_s + SWL$); (c) square root of significant wave height times wavelength derived from the spectral mean wave period ($\sqrt{H_s L_{m01}}$); and (d) $\sqrt{(1.8 H_s + SWL) L_{m01}}$. The points in panels (a,b) are colored by peak wave period (see color bar in panel (b)). The points in panels (c,d) are colored by peak wave direction (see color bar in panel (d)). Linear regression lines calculated using data with $XPIF \geq 1\%$ are shown in each panel and correspond to: (a) $XPIF = 43.5 H_s - 40.1$, $R^2 = 0.69$; (b) $XPIF = 22.0(1.8 H_s + SWL) - 34.4$, $R^2 = 0.70$; (c) $XPIF = 6.8 \sqrt{H_s L_{m01}} - 43.7$, $R^2 = 0.46$; (d) $XPIF = 6.2 \sqrt{(1.8 H_s + SWL) L_{m01}} - 36.6$, $R^2 = 0.48$. All linear regression equations have $p < 0.001$.

Cross-platform inundation frequency at $x = 5$ m was also strongly correlated with the local hydrodynamic conditions (Figure 11) with XPIF increasing with increases in all four hydrodynamic parameters with significant positive correlations. Nearshore H_s and $1.8H_s + SWL$ (Figure 11a,b) had the highest coefficients of determination of 0.69 and 0.70 respectively. With a few exceptions, XPIF remained close to XPIF = 0% until $H_s > 0.8$ m (exceeded 83.2% of the time) or $H_s + SWL > 0.6$ m. XPIF increased rapidly relative to both parameters with the platform approaching near complete inundation (XPIF $> 60\%$) for $H_s > 1.8$ m (exceeded 19.7% of the time) or $H_s + SWL > 2.3$ m. For a given wave height, larger peak wave periods (as per the point colors in Figure 11a,b) are more likely to be associated with greater frequencies of inundation, however, there is significant variability.

As with the comparisons of XPIF($x = 16$ m) with $\sqrt{H_s L_{m01}}$ and $\sqrt{(1.8H_s + SWL)L_{m01}}$, XPIF($x = 5$ m) remained close to XPIF = 0% for low values of $\sqrt{H_s L_{m01}}$ and $\sqrt{(1.8H_s + SWL)L_{m01}}$ then increased rapidly with increasing $\sqrt{H_s L_{m01}}$ and $\sqrt{(1.8H_s + SWL)L_{m01}}$ (Figure 11c,d). The coefficients of determination for the comparison of XPIF($x = 5$ m) with $\sqrt{H_s L_{m01}}$ and $\sqrt{(1.8H_s + SWL)L_{m01}}$ were 0.46 and 0.48 respectively, lower than those of H_s and $1.8H_s + SWL$ but still statistically significant.

No clear trends were observed with respect to the influence of peak wave direction on inundation frequency (see point colors in Figure 11c,d).

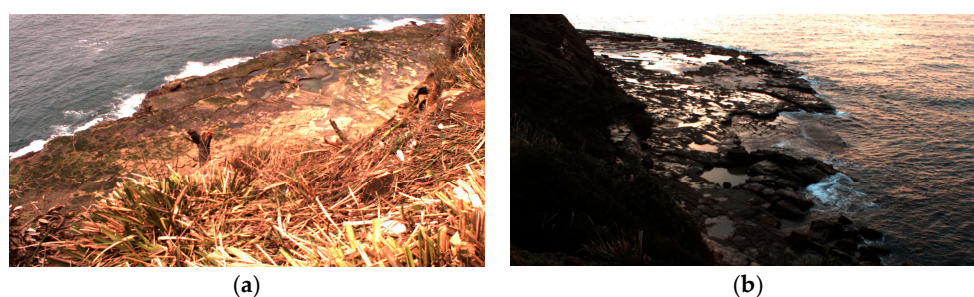
Figure 12. Still images from the cameras showing instances where the lighting and pixel color was challenging for automated inundation analysis: (a) north camera at 12:00 on 22 March 2017 showing very bright pixels on the landward edge of the rock platform, and (b) south camera at 07:00 on 22 March 2017 showing high levels of sun glint from both the ocean and the standing water on the platform.

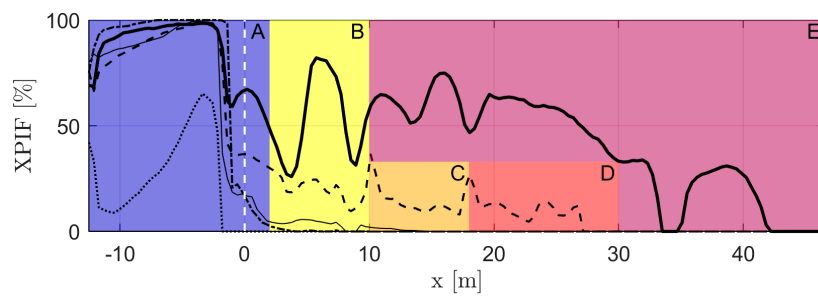
Figure 13. Five examples of XPIFs recorded at transect N2 under different conditions that meet the criteria for the five hazard categories (Table 2): Category A recorded on 22/03/2017 at 12:00 (dotted line), Category B recorded on 26/03/2017 at 16:00 (dash-dot line), Category C recorded on 26/03/2017 at 11:00 (thin solid line), Category D recorded on 23/03/2017 at 12:00 (dashed line), and Category E recorded on 04/04/2017 at 17:00 (thick solid line). The shaded areas represent the five hazard categories defined for transect N2: Category A (blue), Category B (yellow), Category C (orange), Category D (red), and Category E (purple). A profile line terminates (i.e., XPIF goes to 0) in the shaded area of the hazard category to which it belongs, e.g., the dashed line (representing an example XPIF profile for Category D) terminates in the red shaded area at $x \sim 27$ m. The white dashed line represents the edge of the platform at $x = 0$ m. See Section 5.3 and Table 2 for additional detail on the hazard categories.

The XPIF profiles from the dataset described here are being applied to develop a wave overwash hazard rating system for the Figure Eight Pools Rock Platform. Figure 13 provides an example of how the XPIF profile space for transect N2 (see Figure 2 for location) can be classified to distinguish between five overwash hazard levels for the vicinity of the Figure Eight Pool. Five example XPIF profiles associated with different wave and tide conditions are shown, which represent five different hazard levels. Category A (dotted line) represents low overwash hazard (although allows for wave splash

at the edge of the platform), where inundation is absent or restricted to less than 2 m landward from the seaward edge of the platform. Category B (dash-dot line) represents minimal overwash hazard, where inundation is restricted to the raised rampart. Category C (thin solid line) represents moderate overwash hazard, where wave inundation may infrequently (<33% of the time) reach the region of the Figure Eight Pool. Category D (dashed line) represents major overwash hazard, where wave inundation infrequently (<33% of the time) extends past the Figure Eight Pool but not across the entire platform. Category E (thick solid line) represents extreme overwash where wave inundation frequently (>33% of the time) reaches the Figure Eight Pool and/or extends across the whole platform. See Table 2 for further detail on the hazard category definitions. Hazard levels can also be distinguished by the shaded areas in Figure 13, which categorize the wave inundation distance-frequency space. A profile line is designated as belonging to a particular hazard category if the XPIF line terminates within the corresponding shaded area in the distance-frequency space. The five hazard levels can be used to describe the relative risk posed by wave overwash to visitors at the rock pools during each daylight hour captured in the camera dataset. While the hazard categories defined here are site specific, a similar approach could be used to define wave hazards at other rock platform sites.
