# Analysis of Impact Characteristics and Detection of Internal Defects for Unidirectional Carbon Composites with Respect to Fiber Orientation

**Abstract:** With the increasing use of carbon fiber reinforced plastics in various fields, carbon fiber composites based on prepregs have attracted attention in industries and academia research. However, prepreg manufacturing processes are costly, and the strength of structures varies depending on the orientation and defects (pores and delamination). For the non-contact evaluation of internal defects, the lock-in infrared thermography was proposed to investigate the defects in the composites subjected to the compression after impact test (CAI). The drop-weight impact test was conducted to study the impact behavior of the composites according to fibers orientation for composite fabricated using unidirectional (UD) carbon fiber prepregs. Using CAI tests, the residual compressive strengths were determined, and the damage modes were detected using a thermal camera. The results of the drop weight impact tests showed that the specimen laminated at 0° suffered the largest damage because of susceptibility of the resin to impact. The specimens with

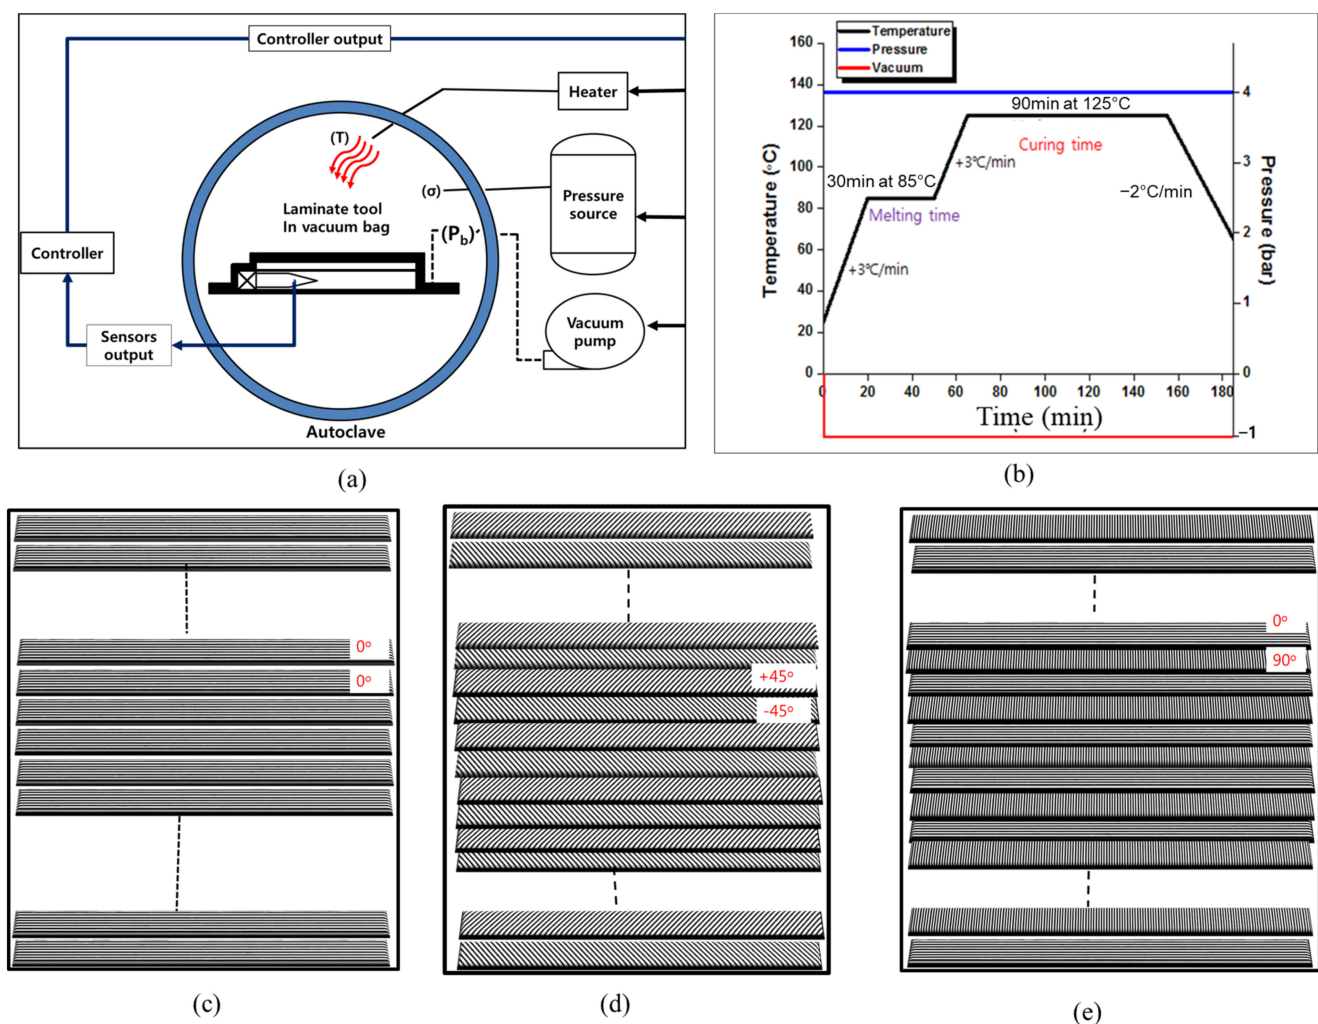
**Figure 1.** Molding process; (a) Flow diagram of autoclave molding method; (b) Cycle of molding and curing conditions, (c–e) Stacking sequence diagram of  $[0^\circ]_{36}$ ,  $[0^\circ/90^\circ]_{18}$ ,  $[+45^\circ/-45^\circ]_{18}$ , respectively.

The material used in this study was UIN200C, which is a unidirectional carbon fiber prepreg purchased from SK Chemical, Seongnam-si, Korea. The laminated prepreg was manufactured using the autoclave molding process, as shown in Figure 1a,b presents the cycle of molding and curing conditions, and Table 1 presents the physical properties of the material. The following three configuration of composites with different orientation of the fibers were fabricated (Figure 1c,d): a composite with 36 plies unidirectional prepreg at  $[0^\circ]_{36}$ , a composite with 34-ply prepreg cross-laminated at  $[0^\circ/90^\circ]_{18}$ , and a composite with 36 plies prepregs cross-laminated at  $[+45^\circ/-45^\circ]_{18}$ . For each lamination configuration, the composite plate with dimensions of 450 mm  $\times$  420 mm were fabricated. For the material properties testing, the test specimens were cut from the fabricated composite plate. Four specimens for each composite were tested to evaluate the impact and compression after impact behavior of the composites.

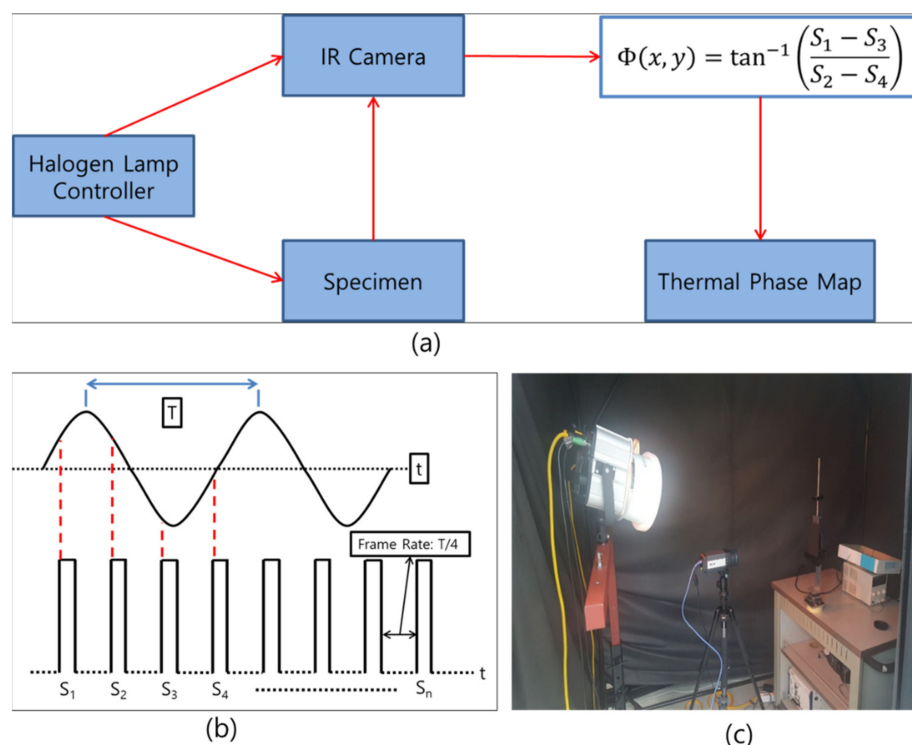
**Figure 4.** Lock-in method: (a) flowchart; (b) diagram and (c) experimental Setup.

The lock-in method was considered in this study for non-destructive inspection (Figure 4), which is referred to as lock-in IR thermography. This method was employed to obtain the response signal of the object by synchronizing a halogen lamp (heat source) with the IR detection element of the thermal imaging camera, and to realize the detection based on the changes in the infiltrated heat source signal. In this case, the one-dimensional heat conduction Equation (2) in the solid was used as follows [7,14]:
