Article

Changes in Vegetation and Geomorphological Condition 10 Years after Riparian Restoration

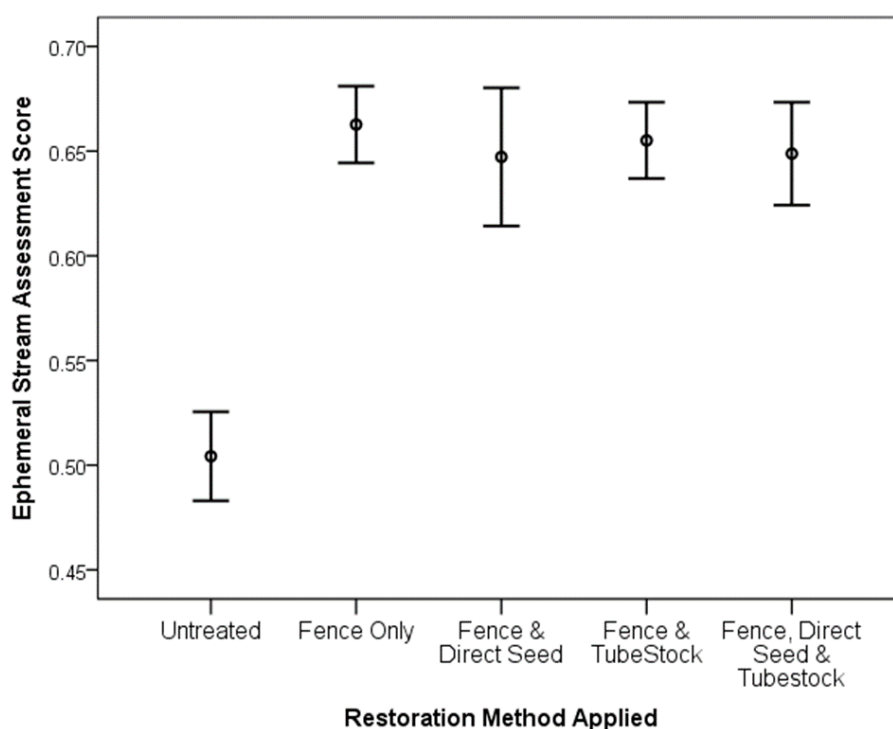
Figure 6. The mean ephemeral stream assessment (ESA) condition scores 10 years after restoration for sites restored as part of the Bidgee Banks Restoration Project (BBRP) using four restoration methods. Untreated site scores are provided as a comparison. Error bars represent \pm SE. The maximum achievable ESA score is 1.

The mean ephemeral stream assessment (ESA) scores across all restoration methods were significantly higher at $0.69 \pm 0.01\text{SE}$, compared to 0.52 ± 0.03 for untreated sites ($F = 8.45$, $df = 4,33$, $p < 0.001$; Figure 6). While there was no significant difference between restoration methods (Figure 6), differences were observed between the seven individual ESA indicators (Figure 7), five of which were significantly higher for the treated sites than for untreated sites: vegetation on the drainage-line floor ($\chi^2 = 6.18$; $p = 0.012$; Figure 7a), vegetation on the drainage-line wall ($\chi^2 = 8.46$; $p = 0.004$; Figure 7b), nature of drainage-line material score ($\chi^2 = 9.15$; $p = 0.002$; Figure 7e), the shape of cross section ($\chi^2 = 13.27$; $p < 0.001$; Figure 7f), and lateral flow regulation ($\chi^2 = 18.46$; $p < 0.001$; Figure 7g).
