Effects of the Hot Isostatic Pressing Process on Crack Healing of the Laser Repair-Welded CM247LC Superalloy

Abstract: This study investigated the effects of the hot isostatic pressing process on the crack healing, microstructure, and mechanical properties of the laser repair-welded CM247LC precipitation-hardened superalloy. To ensure the strength of the repair-welded area, this study used the direct re-melting approach, and simulated the repair welding with the filler addition, which has a chemical composition matching that of the base superalloy. As expected, different types of cracks, including the solidification crack in the weld fusion zone and various types of liquification cracks in the heat-affected zone, were observed. Through a proper hot isostatic pressing healing process, all cracks in the weld fusion zone and the heat-affected zone of the repair-welded pieces were healed. At the same time, some nano- and micro-sized carbides tended to form discontinuously along the healed crack trace. A micro-hardness test was conducted in the repair-welded area, and the results were similar to that of the as-cast material.

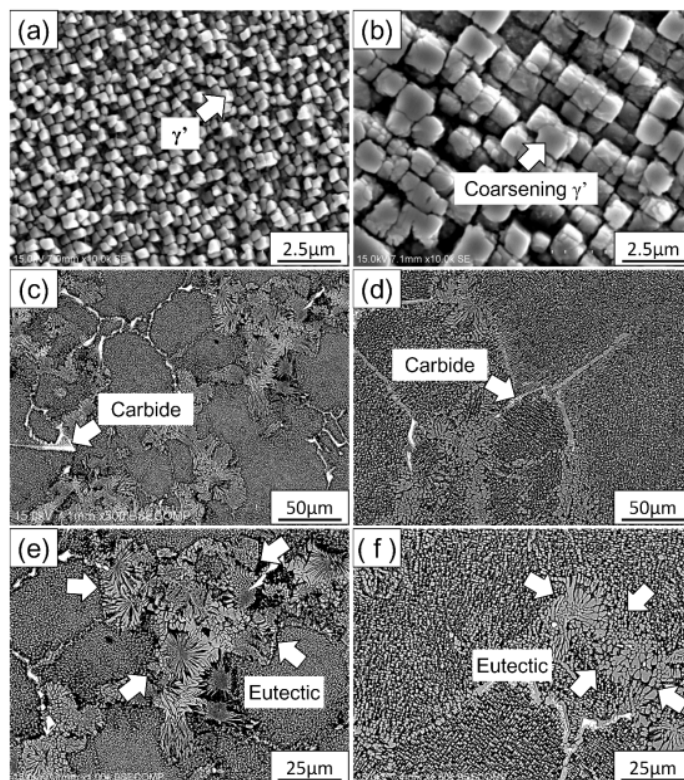
Figure 1. Microstructure of as-cast CM247LC before or after the HIP process: (a,b) are γ' s, (c,d) are carbides, and (e,f) are eutectics. Here, (a,c,d) are obtained before the HIP process, while (b,d,f) are obtained after the HIP process.

The microstructure of the as-cast CM247LC consists of the precipitation-strengthened phase γ' , γ phase, carbides, and non-equilibrium eutectic $\gamma+\gamma'$ [19]. When the CM247LC is treated by HIP, an obvious coarsening of the γ' structure is observed, and the size increases from 0.3~0.5 μm (Figure 1a) to 1.0~1.5 μm (Figure 1b). As the HIP operating temperature does not exceed the solid solution temperature [17] of the material, and the temperature is reduced slowly by furnace cooling, the γ' particles grow [20].

The carbon content of the as-cast CM247LC is only 0.07 wt %, and thus there are relatively fewer carbides. The EDS compositional analysis shows that carbides in the as-cast CM247LC are predominantly the MC type (Figure 1c), enriched in Hf and Ta. After HIP healing, the originally concentrated blocky carbide is gradually decomposed into smaller fine needles (Figure 1d).

The $\gamma+\gamma'$ eutectic phase in the as-cast CM-247LC (Figure 1e) is usually the product of micro-segregation in the final solidification process of casting, which is distributed on a grain boundary. With the combination of high pressure and high temperature during the HIP process, the proportion of the eutectic structure (Figure 1f) is gradually reduced.

After the HIP process, in the HAZ the γ' particles (Figure 4f) are larger than those before HIP (Figure 4c). Moreover, when compared with the γ' in the PM (Figure 1b), γ' in the HAZ is irregular and disordered.

After HIP, while the cracks are healed, the γ' in the PM (Figure 1b) and HAZ (Figure 4f) is further coarsened, so that the hardness of the two zones is slightly lower than that before HIP. The microstructure change after HIP in TWfZ and BWfZ is not obvious, and thus the hardness of the two zones is changed slightly, as compared with that before HIP. However, the hardness of WFZ-UMZ markedly increases, as WFZ-UMZ contains elements similar to the original PM CM247LC (Figure 5c,d). After the subsequent HIP treatment, the γ' grains are precipitated, presenting a finer and more complete cubic morphology than that of PM. Hence, the WFZ-UMZ hardness is much higher than that before HIP.

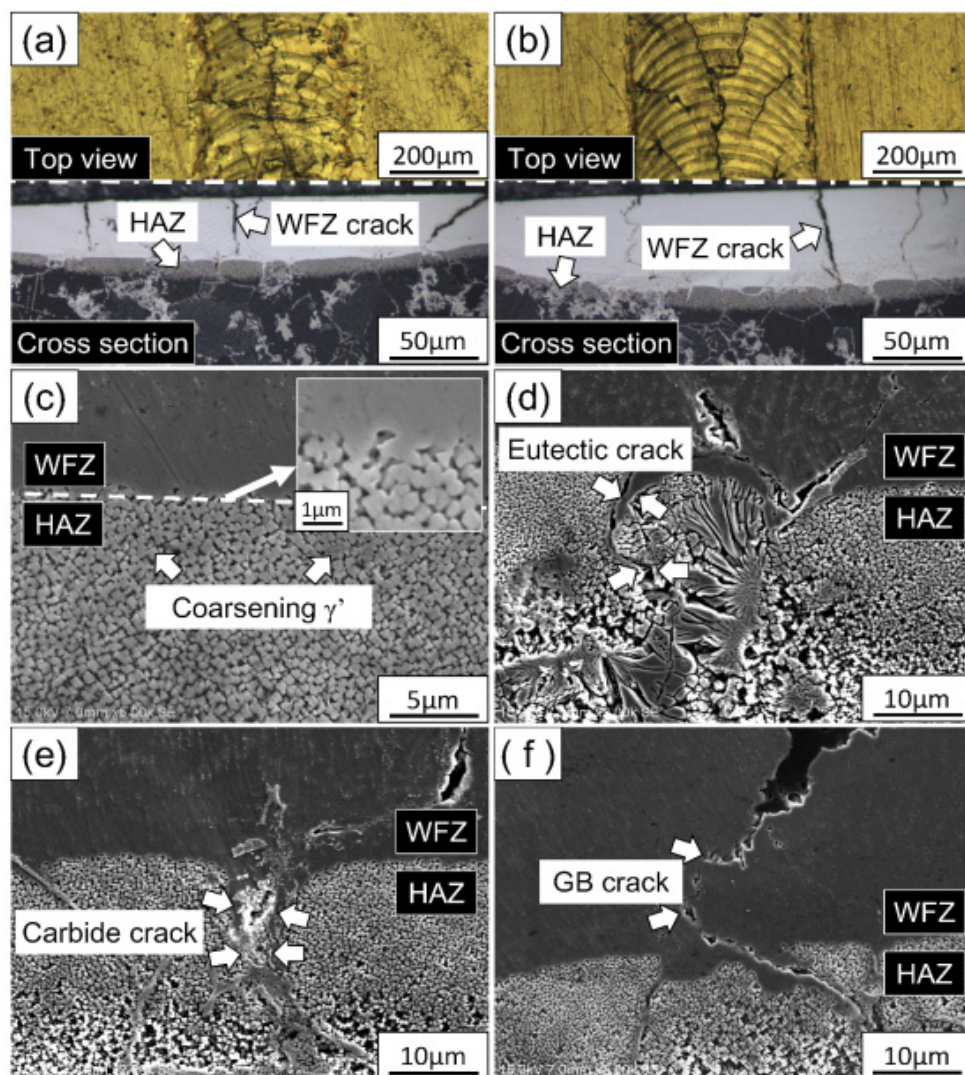
Figure 2. Crack observation on the surface and cross-section of (a) Condition B, (b) Condition C, and (c) HAZ observation of Condition B. Various liquation cracks, including (d) eutectic, (e) carbide, and (f) grain boundary cracks, are observed in HAZ of Condition B.

CM247LC is a precipitation-strengthened nickel base superalloy that has an Al+Ti content exceeding 6 wt %. When a laser direct melting is conducted, various cracks (Figure 2a–f) are likely to occur during the solidification process. It is observed that in Figure 2a,b in Condition B or C, there are varying degrees of surface cracks and solidification cracks in WFZ, and that partial solidification cracks extend along the grain boundary from HAZ which penetrate directly through WFZ to the surface layer.

In terms of HAZ, it is observed that the γ' particles in the zone are slightly coarsened (Figure 2c). Moreover, the γ' particles have a preliminary edge liquation and merge, which may influence the mechanical properties.

As stated above, the Nd:YAG laser is characterized by low energy input and high energy density. When the laser process ends, under the effect of quick cooling and an excessive temperature gradient, the HAZ cracks involved in the various liquation cracks derived from the eutectic phases (Figure 2d), MC-type carbide (Figure 2e), and the intergranular phase (Figure 2f) are easily found in the welds.

Before HIP, influenced by the high temperature of the laser process, the γ' particles in the HAZ are slightly coarsened, and there is initial liquation and then a merger of the irregular shapes (Figure 2c). Therefore, the HAZ hardness is slightly lower than that of the PM. BWfZ and WFZ-UMZ are the original CM247LC laser re-melting zones; BWfZ is displayed in a columnar grain structure along the heat flow and WFZ-UMZ has a very high cooling rate. Thus, the strengthening structure of the γ' phase does not have enough time to precipitate completely. Therefore, in comparison to PM, the hardness values of the two zones are further reduced. TWfZ is composed of the IN-625 solid solution-strengthening filler wire. In this zone, whether before or after (see Figure 5a) the HIP process, in addition to the γ phase matrix, only small-size [16] carbides were observed. This suggests that the zone has a minimum hardness.

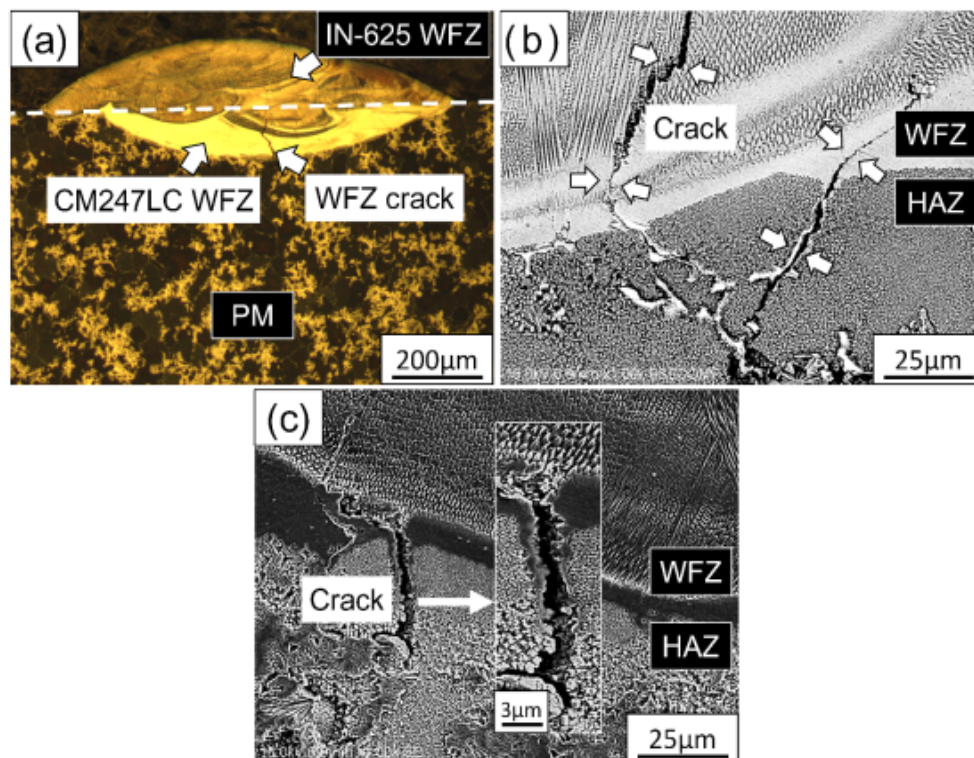
Figure 3. (a) IN-625 sealing on the top. Various cracks were still observed in (b) bottom of WFZ, or in (c) HAZ.

In this study, the IN-625 filler wire is used to seal the surface of the CM247LC WFZ. According to the microscopic cross-section observations, such as in Condition B (Figure 3a), a small part of the IN-625 and the original CM247LC are mixed, and no surface cracks are found on the top of WFZ (TWFZ). However, in this stage both the original CM247LC solidification crack at the bottom of the WFZ (BWFZ) (Figure 3a,b) and the liquation crack in the HAZ (Figure 3b,c) still exist, which will be eliminated by the subsequent HIP healing technique.

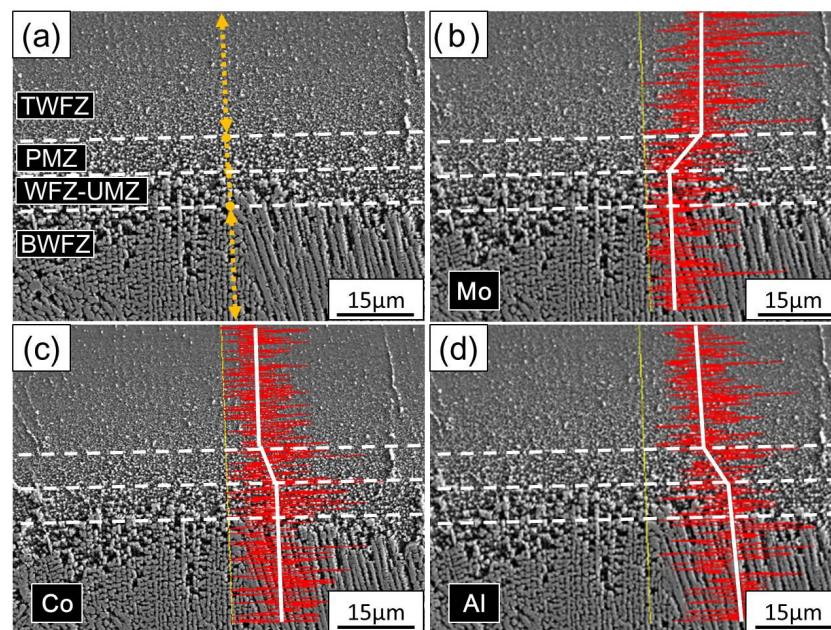
Figure 5. (a) EDS line scan across the various regions in WFZ, with composition profiles including (b) Mo, (c) Co, and (d) Al.

Figure 5a–d shows EDS linescan (including Mo (Figure 5b), Co (Figure 5c), and Al (Figure 5d) composition profiles) across BWFZ, WFZ-UMZ, PMZ, and TWFZ, suggesting the WFZ-UMZ unmixed the IN-625 filler wire.

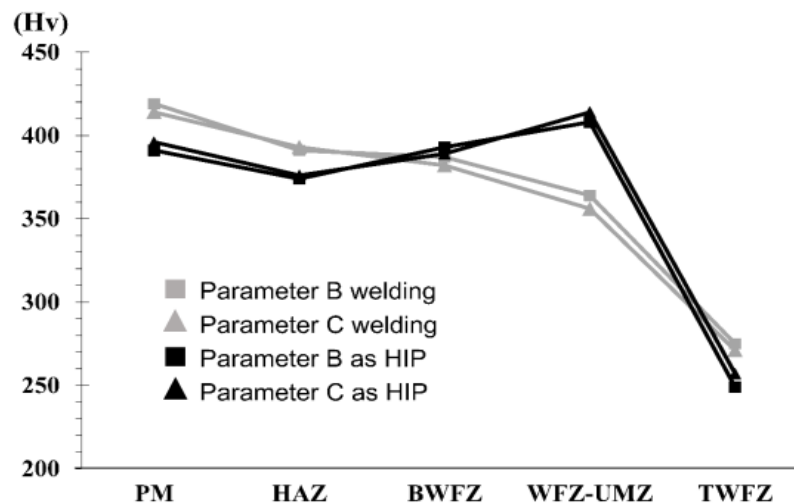
Figure 6. Hardness in the various regions of the repaired welds before and after the HIP processes (Hv).

Figure 6 shows the micro-hardness test for the PM, HAZ, BWfZ, WFZ-UMZ, and TWfZ on the cross-sections of the Condition B and C samples. It is observed that the hardness values of the Condition B and C samples exhibit a similar tendency as the measurement position changes, which is discussed as follows.

According to the aforementioned hardness test results, after HIP, BWfZ and WFZ-UMZ approach 400 Hv, or are higher than 400 Hv, which is very close to the PM strength. If the subsequent post-weld heat treatment [24] is conducted, it may further improve the mechanical properties of the repair-welded piece. However, during the post-weld heat treatment, the risk of the stain age cracking [25] can be an additional concern. To fully ensure the feasibility of the proposed repair-weld approach, post-weld heat treatment of the HIP-healed samples should be considered as the future work.
