Article

Fatigue Behavior of the Rare Earth Rich EV31A Mg Alloy: Influence of Plasma Electrolytic Oxidation

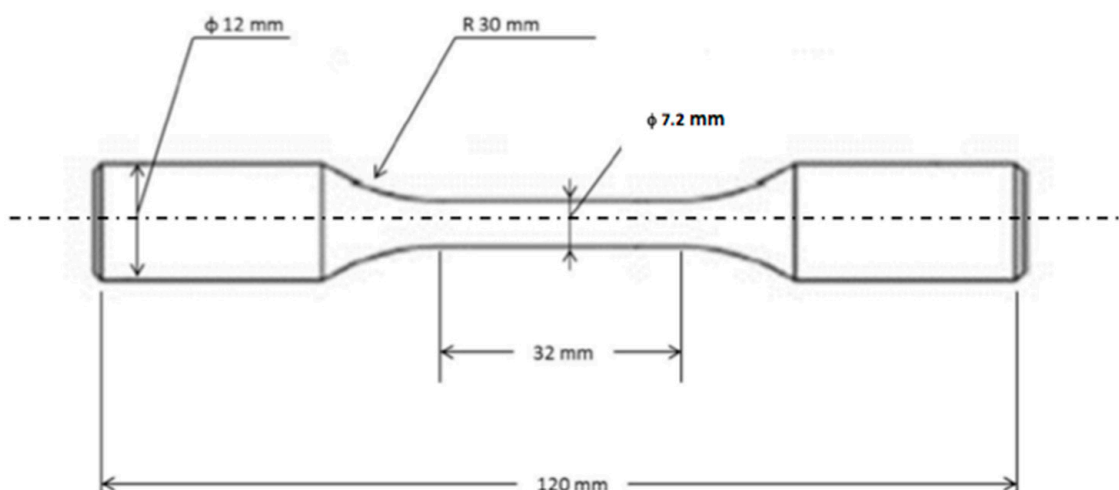
Figure 1. Geometry of rotating bending fatigue specimens.

Fatigue test samples were machined from sand castings to the final geometry reported in Figure 1 according to ISO-1143 [31] and then were T6 heat-treated according to standard conditions (solutionising at 520 °C for 8 h; quenching in water at 70 °C; and aging at 200 °C for 16 h). These treatment conditions were defined on the basis of the results of previous work, carried out by the authors, focused on the influence of heat treatment on the microstructure and tensile strength of this alloy.

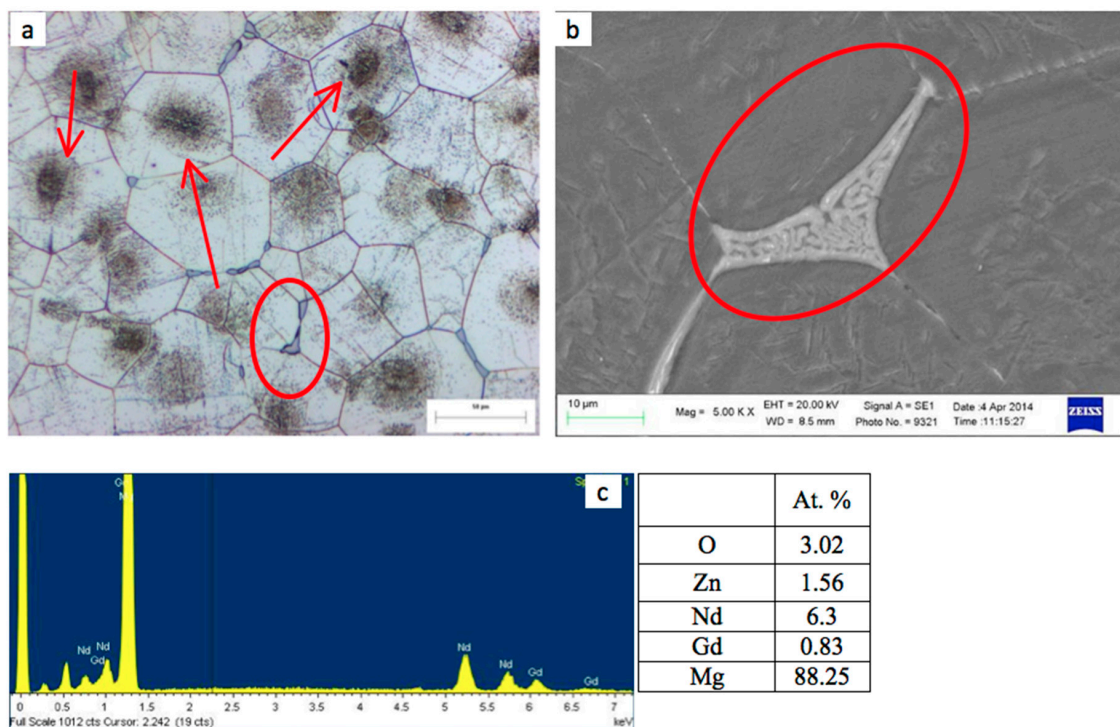
Figure 2. Optical microscopy (OM) image of EV31A etched with 2% Nital: (a) Zr-Zn cluster and eutectic compounds highlighted respectively by red arrows and red circles and (b) SEM image of the eutectic compound at the grain boundaries with (c) corresponding energy dispersive spectroscopy (EDS) analysis.

OM and SEM images of the EV31A-T6 alloy are reported in Figure 2. The microstructure is composed of equiaxed grains, with an average size of $45 \pm 2 \mu\text{m}$ (Figure 2a). The T6 heat treatment did not completely dissolve the ternary eutectic compound $\text{Mg}_{12}\text{Nd}_x\text{Gd}_{(1-x)}$ located at the grain boundaries, as highlighted in Figure 2b and SEM-EDS of Figure 2c. Moreover, clusters of nanometric and micrometric Zr-Zn precipitates are clearly visible only at the grain centre, as shown by SEM-EDS analysis reported in Figure 3 (spectra 3, 4 and 5). A more detailed microstructural investigation on the strengthening precipitates, formed by the aging treatment, has previously been reported by the authors [34].

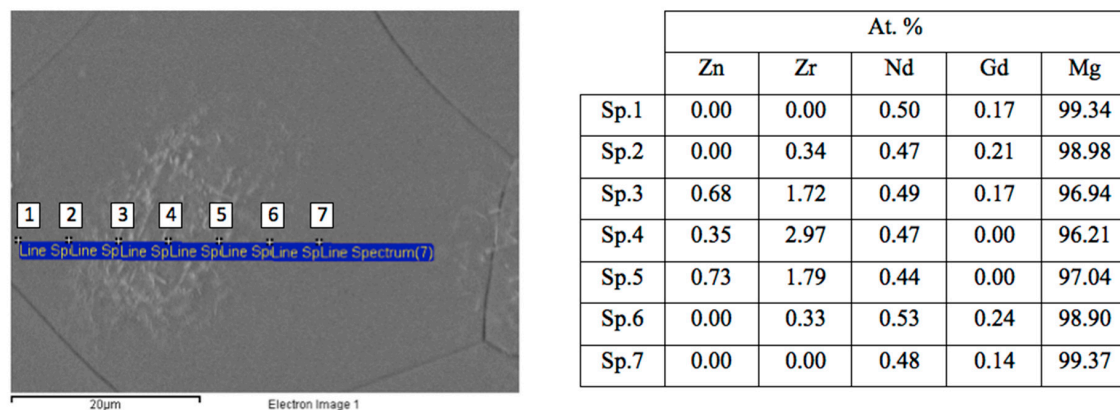
Figure 3. Scanning electron microscopy (SEM) image and EDS analyses in different points inside a grain. Zr-Zn intermetallic precipitates are located at the grain core, as shown by EDS results in spots 3, 4 and 5.

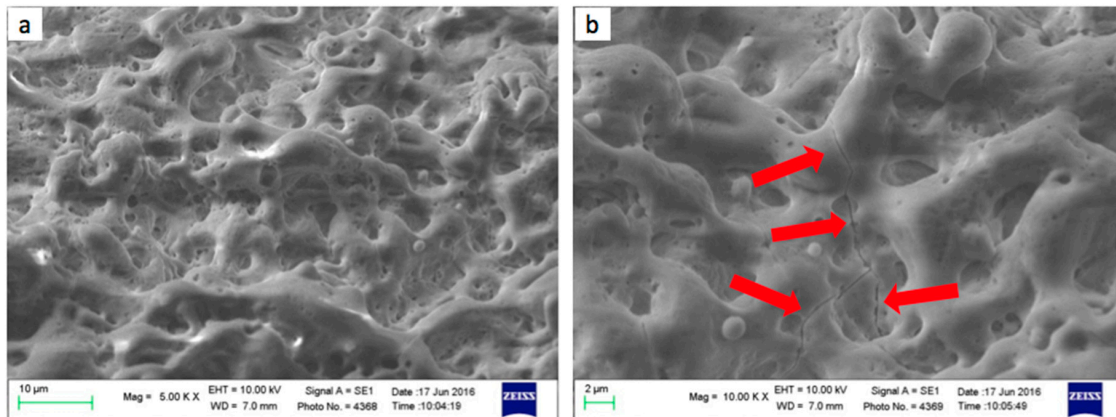
Figure 4. SEM images at different magnification of the surface of plasma electrolytic oxidation treated (PEO-treated) and sandblasted fatigue specimens: (a) smooth surface with (b) very few small cracks through the pores.

SEM images on the outer surface of the PEO-treated and sandblasted fatigue samples are shown in Figure 4. The sandblast process led to a relatively smooth surface, with a significant reduction of the typical cracks and microcracks present on the outer surface of the PEO layer. However, some of the small cracks through the pores are still present, as shown at higher magnification in Figure 4b.

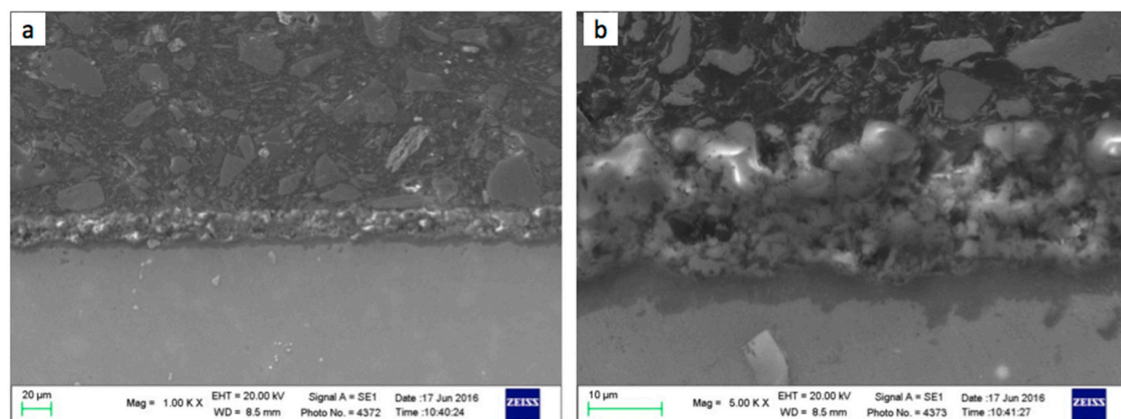
Figure 5. SEM images of a plasma electrolytic oxidation (PEO) layer cross-section: (a) low and (b) high magnification.

Representative SEM micrographs of the cross-section of the PEO-treated alloy are reported in Figure 5a,b. The conversion layer was about $23 \pm 3 \mu\text{m}$ in thickness and appears uniform and compact, with low density of pores and cracks, thus confirming that the sandblasting process was effective in removing the outer region of the PEO layer.

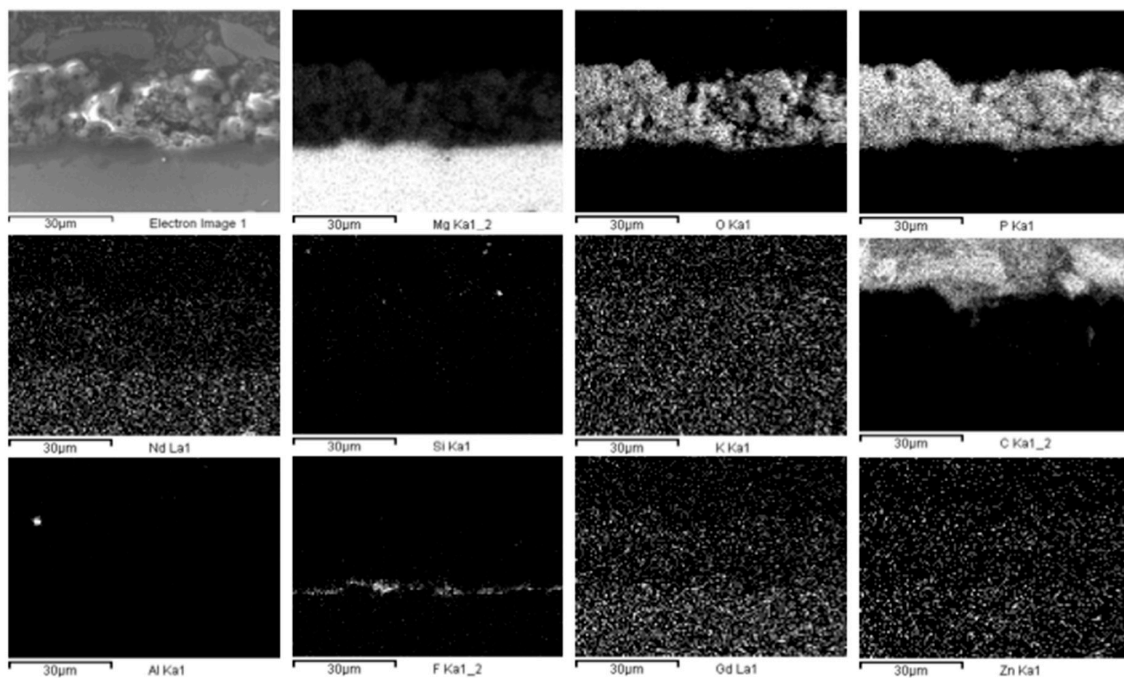
Figure 6. SEM–EDS cross section maps of the PEO layer.

SEM-EDS element maps on the cross-section, shown in Figure 6, revealed a homogenous distribution of phosphorous, potassium and oxygen due to the phosphate, silicate and potassium fluoride present in the electrolytic bath. A thin fluorine-rich layer at the interface between the PEO layer and substrate can also be detected. According to the authors of [37], this layer consists of MgF_2 and plays an important role during the PEO process, reducing electrolyte conductivity, thus decreasing the working voltage. Moreover, fluoride addition helps to obtain a more compact layer,

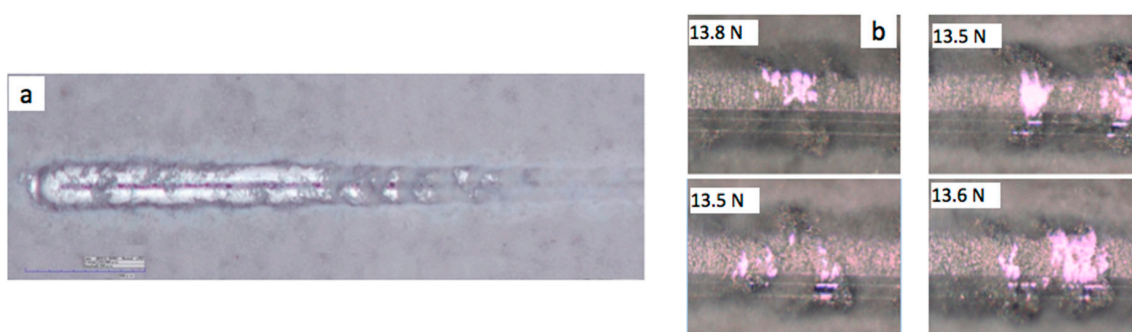
Figure 7. (a) OM scratch test image; (b) OM images of the failure area for different scratch tests with corresponding failure load.

PEO treatment on Mg alloys could be classified as a hard coating on a softer substrate material [41]. Scratch testing is a commonly used method to evaluate the adhesion of thin hard coatings. Failure depends on both substrate and coating properties, namely hardness and microstructural characteristics. A representative image of a scratch test performed on the PEO-treated EV31A alloy is shown in Figure 7a at a relatively low magnification, whereas more detailed images of the failure induced by the scratches are reported in Figure 7b.

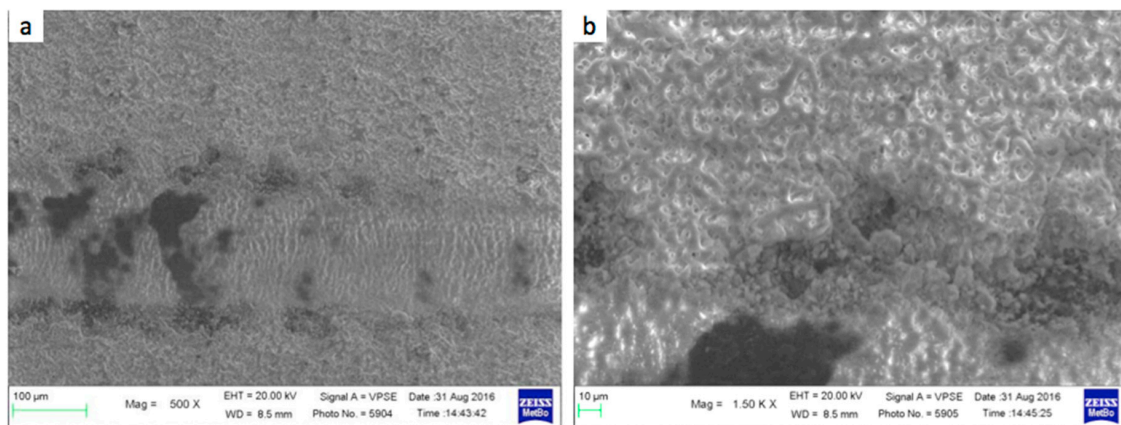
Figure 8. SEM images of the scratch test track at different magnifications.

Reproducible results, in terms of failure mode and critical load, were obtained. SEM images at different magnifications of a representative scratch are shown in Figure 8a,b, with corresponding EDS X-ray maps in Figure 9. Buckling and spallation failure are both present in Figure 8a,b, where coating detachment from the substrate can clearly be seen.

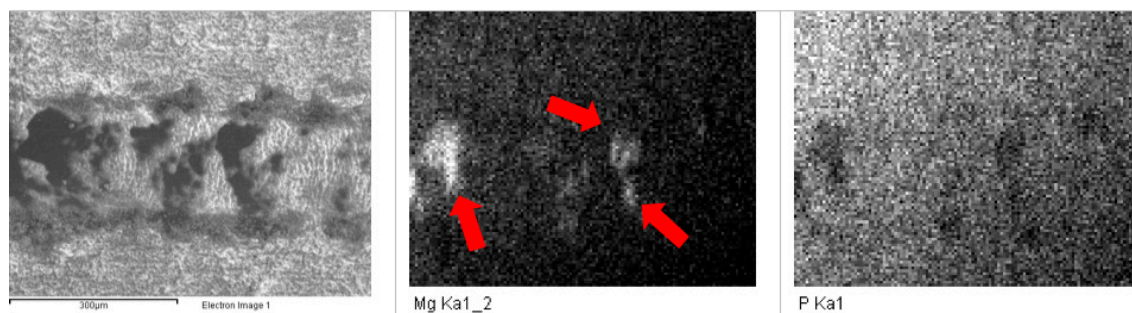
Figure 9. Representative SEM-EDS maps of the scratch tests, with the substrate highlighted by red arrows.

The EDS maps confirmed adhesion failure of the PEO coating, since the Mg substrate was detected at the bottom of the scratch, as shown in Figure 9. Buckling failure occurs in response to the compressive stresses generated ahead of the moving indenter and typically occurs for a coating thickness less than 10 µm. Spallation occurs due to compressive shear stresses ahead of the indenter through the coating, resulting in crack nucleation that could propagate through the thickness. The continued forward motion of the indenter leads to an interfacial crack and consequent coating failure [41]. Additionally, in this case, where the PEO layer is about 20 µm and the EV31A substrate is relatively soft, buckling and spallation are the main failure modes.

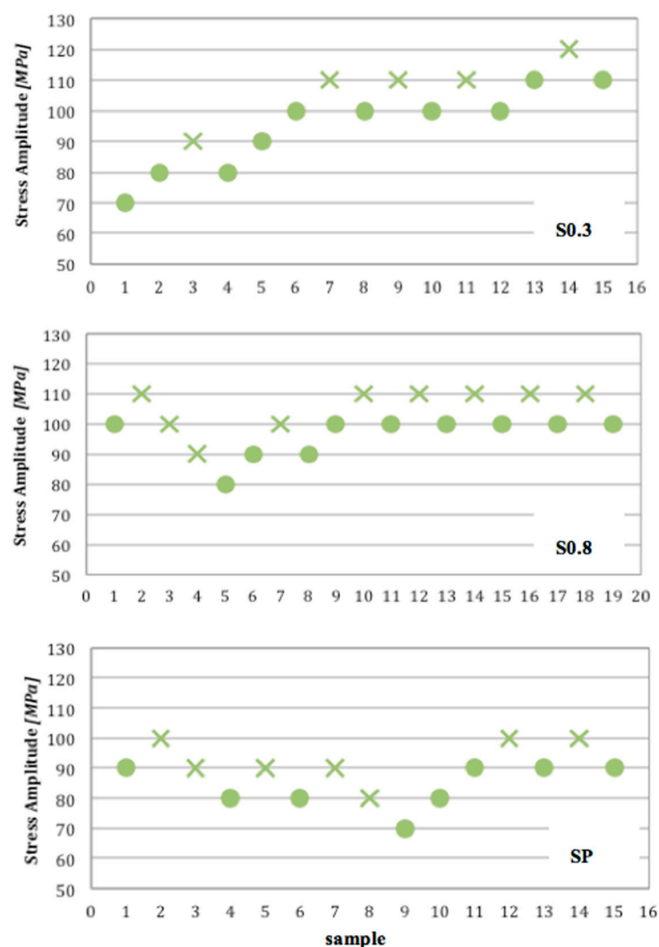
Figure 10. Stair case data for: S0.3, S0.8 and SP series (X Failures, O Survivals). Tests were carried out according to UNI 3964 [34].

The results of the rotating bending fatigue tests carried out on the untreated sand cast EV31A Mg alloy with different surface roughness (S0.3 and S0.8 samples), and on the PEO-treated alloy are reported in Figure 10 and Table 2. It can be noted that the effect of surface roughness on the base alloy was negligible, since the difference in the mean fatigue strength values for the S0.8 and S0.3 samples was within 2% (103 and 101 MPa, respectively) and, as shown by the stair-case results in Figure 10, the minimum stress level at which no failure occurred was 80 MPa.

Plasma electrolytic oxidation only induced a slightly negative effect on the fatigue performance of the EV31A Mg alloy. In fact, the SP samples showed a mean fatigue strength of 88 MPa, which is about 15% lower by comparison to that of S0.3 and S0.8 (103 and 101 MPa, respectively). Moreover, in SP samples, the minimum stress level at which no failure occurred was equal to 70 MPa, instead of

80 MPa for S0.3 and S0.8 samples (Figure 10). However, by taking into account the standard deviation, the fatigue strength of bar and PEO-treated alloy appeared to be comparable.

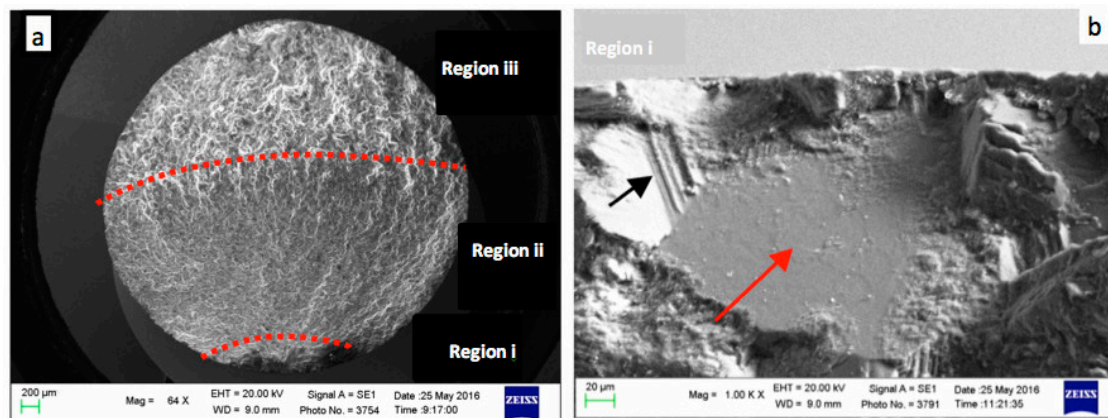
Figure 11. Representative SEM images of an untreated sample tested at 110 MPa. (a) Typical regions of fatigue failure at low magnification: initiation (i), propagation (ii) and final failure (iii); (b) high magnification of crack initiation at isolated facets of cleavage planes (red arrow), surrounded by fatigue striations (black arrow).

A representative SEM micrograph, at a relatively low magnification of the fracture surface of the untreated alloy is reported in Figure 11a. The three typical regions of fatigue failure can be clearly identified: (i) crack initiation; (ii) crack growth; (iii) final failure due to overloading.

In rotating bending fatigue tests, the surface experiences the maximum stresses, thus the cracks mainly nucleate from it. The SEM image in Figure 11b shows, at a higher magnification, the crack initiation region in the untreated alloy, where it can be clearly seen that crack nucleation occurs at the isolated facets of cleavage planes, near the free surface of the specimen. The facets are flat and smooth,

resulting from cleavage induced by the limited number of operative slip systems characteristic of HCP Mg alloys, and appear surrounded by fatigue striations. Similar crack nucleation features were observed on other magnesium alloys by Z. Li et al. [27].

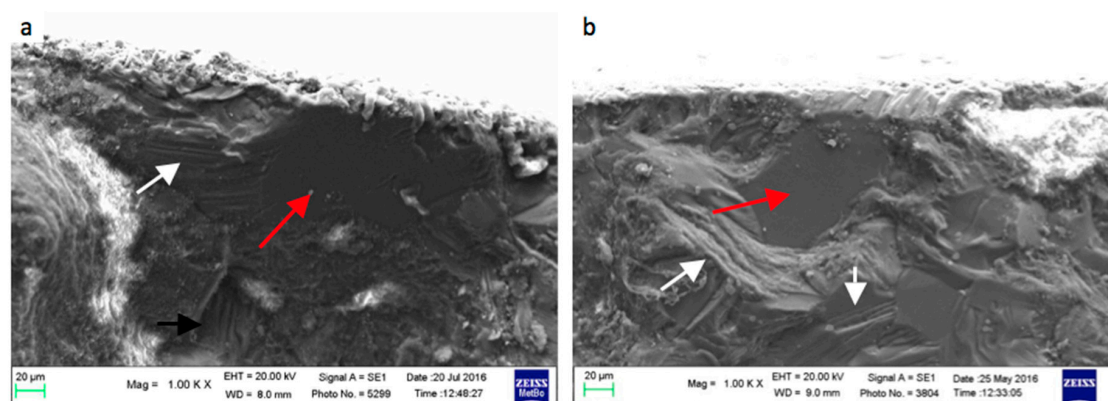
Figure 12. SEM images of crack initiation at isolated facets of cleavage planes (red arrows) surrounded by fatigue striations (white arrows) of two different PEO-treated samples, tested at stress amplitude of 90 MPa (a) and 100 MPa (b).

The PEO-treated samples showed the same crack nucleation mechanisms, as can be seen in Figure 12a,b, where cleavage facets and fatigue striations can be clearly identified.

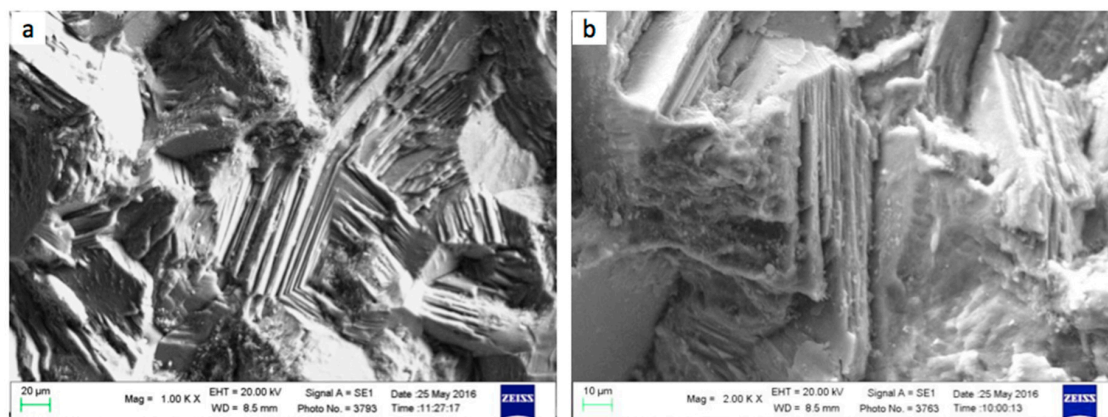
Figure 13. Representative SEM images of the crack growth region: (a) SP sample, tested at stress amplitude of 100 MPa and (b) S0.2 sample, tested at stress amplitude of 110 MPa.

Representative SEM images of the crack growth region for the PEO-treated and untreated samples are reported in Figure 13a,b, showing the presence of classic fatigue striations. In Mg alloys, their formation is generally associated with the dislocation slip and twinning mechanisms in the plastic zone ahead of the fatigue crack tip [4,6,48].

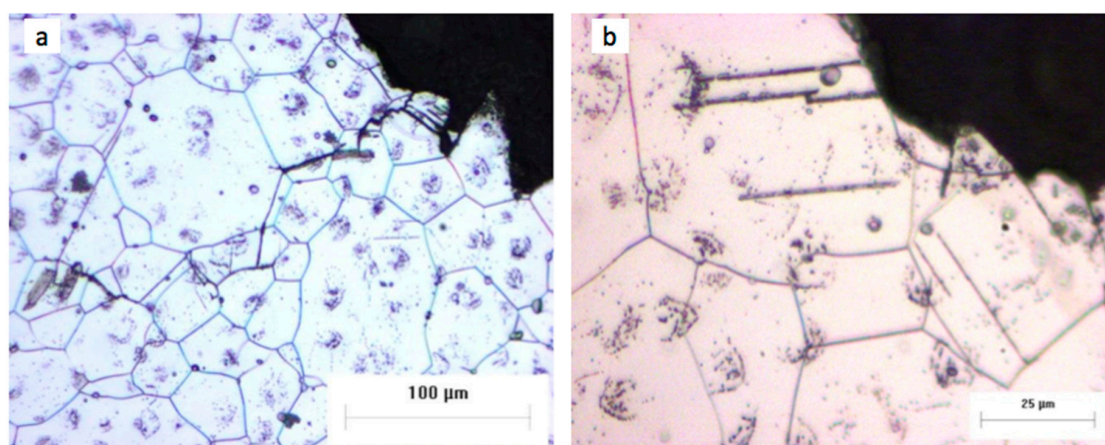
Figure 14. Representative OM images of longitudinal sections (parallel to the gauge length), of S0.2 sample (stress amplitude of 110 MPa): (a) secondary transgranular cracks and (b) slip bands inside the grains.

In this region also, secondary transgranular cracks are clearly visible, as shown by representative OM images on longitudinal sections of fatigue samples (Figure 14a); they originated from the main cracks, confirming a transgranular and intergranular mixed mode of crack propagation. Slip bands can clearly be seen inside the grains (Figure 14b), confirming the previously discussed mechanism for fatigue striations formation.

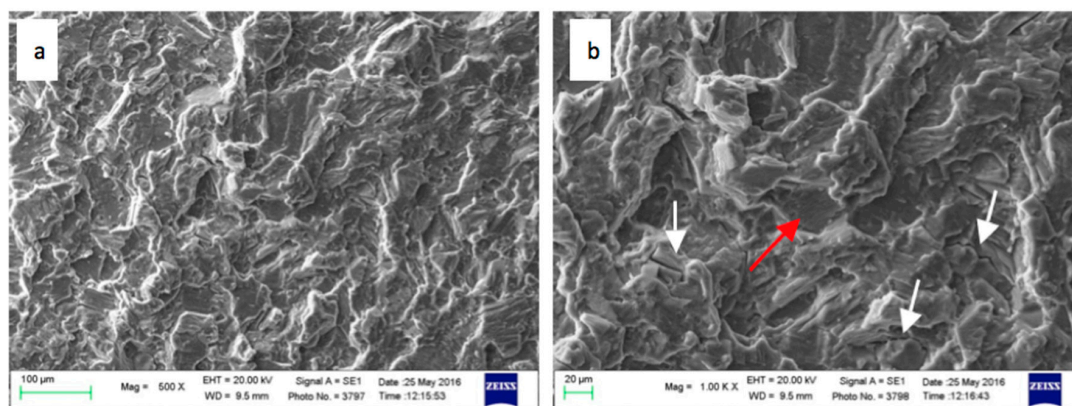
Figure 15. Representative SEM images in the overloading area, at (a) low and (b) high magnification, with cleavage planes (red arrow) and secondary microcracks (white arrows).

Finally, representative SEM images of the overloading regions are reported in Figure 15, where a typical brittle morphology, with cleavage planes and secondary cracks, can be observed.
