Effect of Turning and Surface Polishing Treatments on Surface Integrity and Fatigue Performance of Nickel-Based Alloy GH4169

Abstract: In this paper, the effects of turning and surface polishing treatments on surface integrity and fatigue properties of superalloy GH4169 were investigated. Finish turning (FT), surface circumferential polishing treatment (TCP), surface oblique texture (TCPO), and surface axial texture (TCPA) were applied to GH4169 superalloy. The surface roughness, surface topography, residual stress, microhardness, and microstructure after different processes were studied. Rotating bending fatigue tests were carried out to investigate the effects of surface integrity and surface texture direction on the fatigue performance of GH4169. The experiments reveal that the TCPA specimens present the longest fatigue life of 15.01×10^4 cycles. By comparison with the FT, TCP, and TCPO specimens, the fatigue lives of TCPA specimens are increased by 134.2%, 183.7%, and 96.2%, respectively. Single crack initiation source is observed for TCPA specimen. It is mainly attributed to the small surface stress concentration factor and surface axial texture.

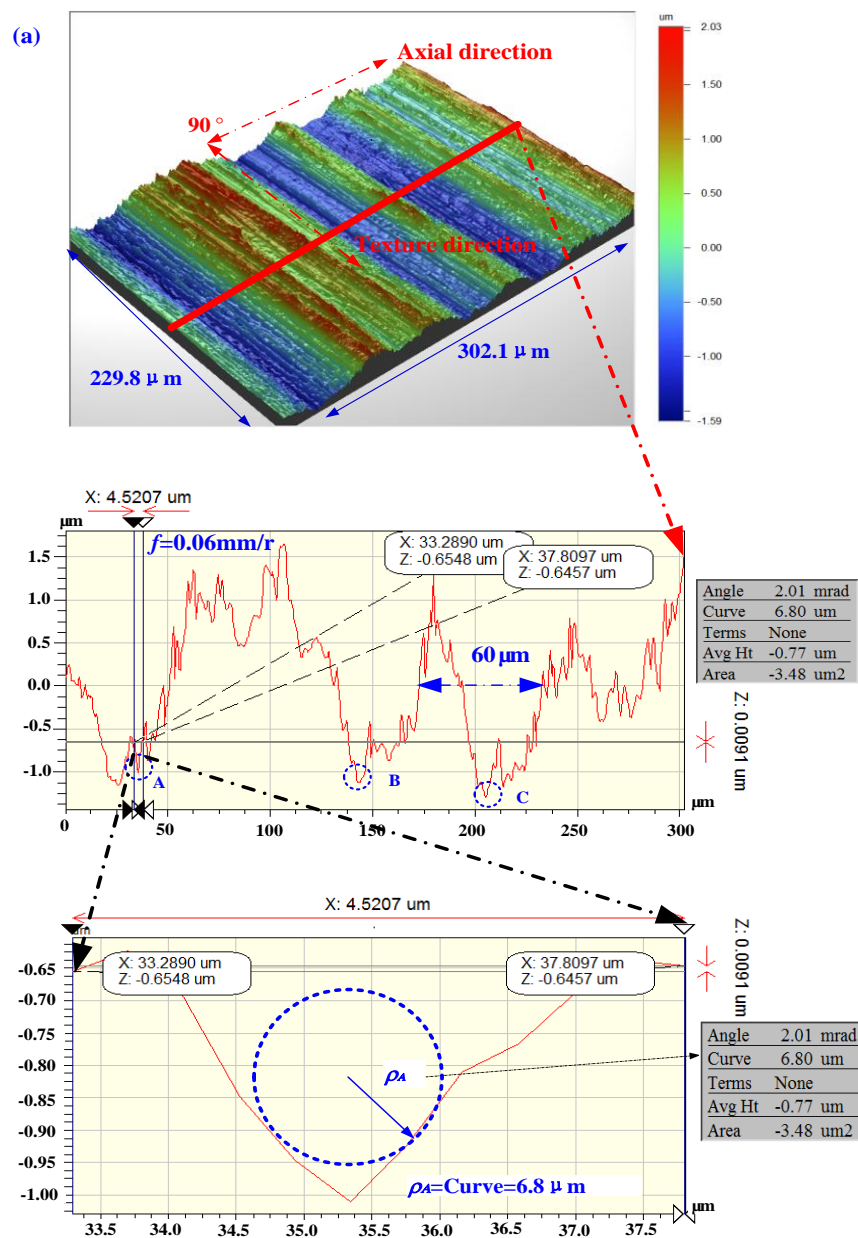
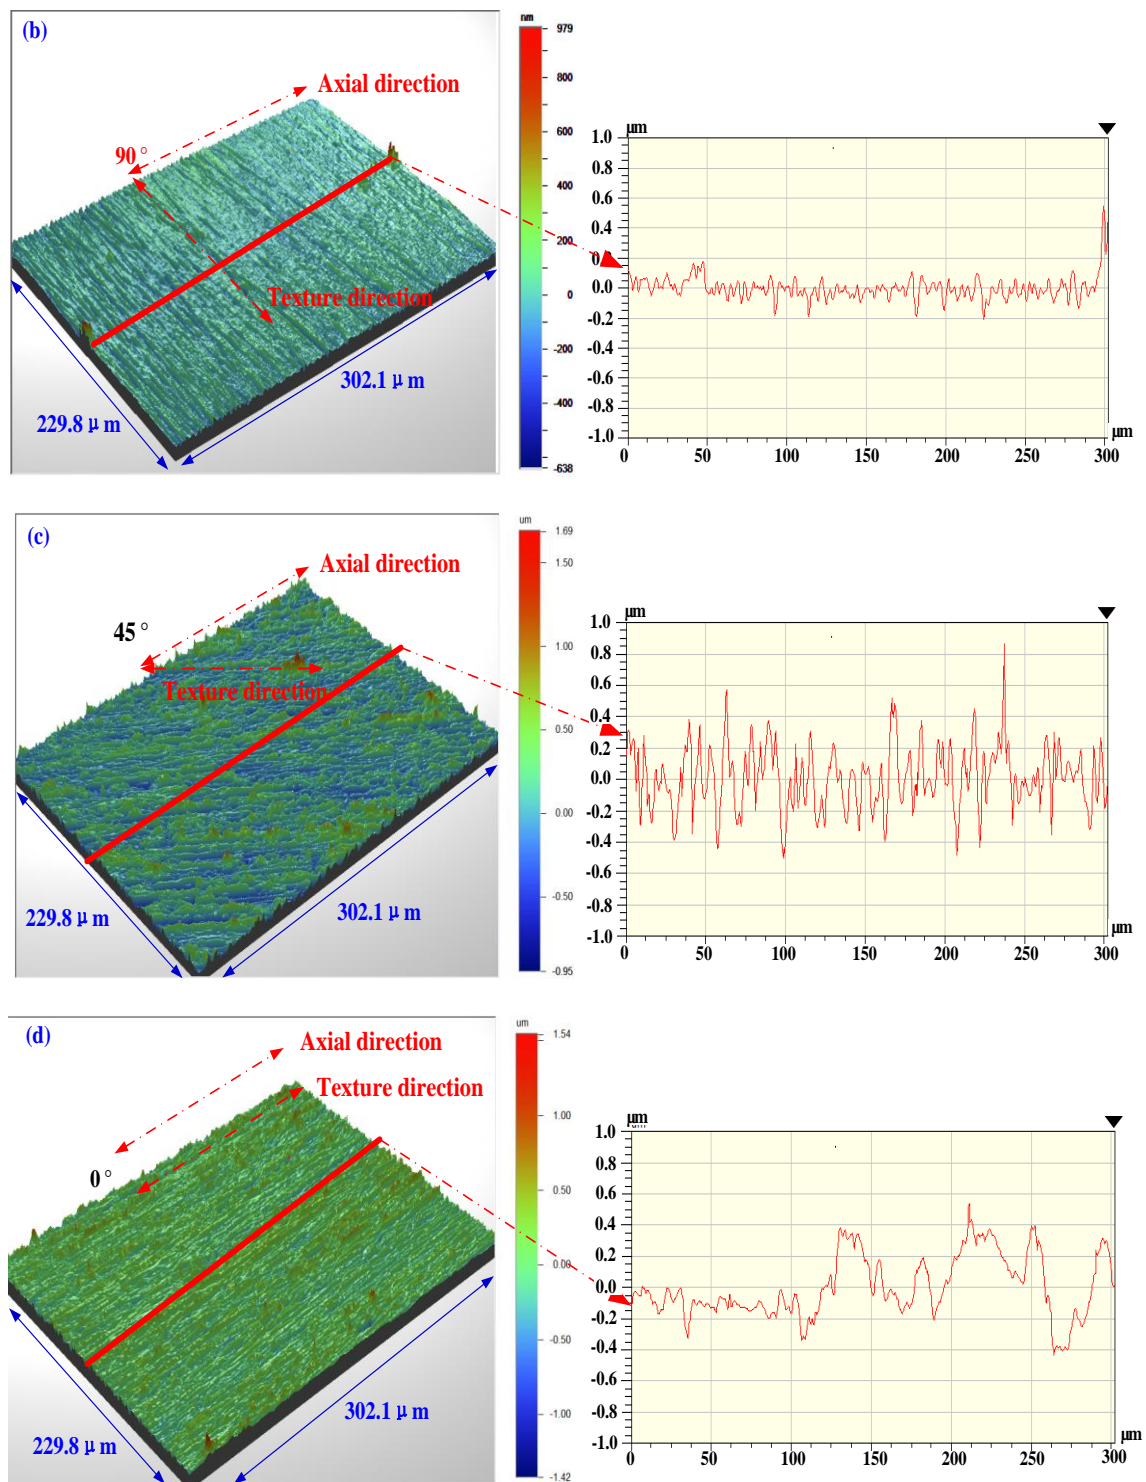
Figure 4. Surface topographies and surface profiles of GH4169: (a) FT process; (b) TCP process; (c) TCPO process and (d) TCPA process.

Surface topographies and surface profiles along the specimen axial direction are presented in Figure 4. Corresponding specific test values of surface roughness and fatigue life are listed in Table 2. Surface topography and surface profile of GH4169 alloy after FT process are shown in Figure 4a. It can be seen that the machined surface is rough, and the obvious machining marks can be observed. The corresponding surface roughness is larger, and the values of R_a , R_z , R_y , R_t , R_{sm} are 0.567 μm , 3.37 μm , 4.51 μm , 4.662 μm and 141.693 μm , respectively. The surface profile shows that the distance between adjacent peaks is about 60 μm . Grzesik et al. [18] reported that the roughness R_{sm} produced by turning is approximately equal to the turning feed. Surface topography at TCP process is presented in Figure 4b, it can be seen that the turning marks disappear, and the surface is smooth. The corresponding surface roughness is significantly reduced, and the values of R_a , R_z , R_y , R_t , R_{sm} are 0.024 μm , 0.271 μm , 0.445 μm , 0.455 μm and 77.258 μm , respectively. This is mainly attributed to the surface polishing process completely removes the turning surface texture. The surface profile of the TCP specimen shows that the texture is closely distributed perpendicular to the sample axial direction. In Figure 4c, the surface texture direction has an angle of approximately 45° with the specimen axial direction. In Figure 4d, the surface texture direction is consistent with the axial direction of specimen. The corresponding surface profile shows random peaks and valleys distribute along axial direction. In Figure 4, surface induced by FT process with feed rate 0.06 mm/r produce the highest values of peaks and valley. While the TCP, TCPO, and TCPA processes produce very small peak height and valley height, which is attributed the polishing process removal the peak-valley induced by FT process.

The acquisition process of the effective profile valley radius $\bar{\rho}$ is shown in Figure 4a (Taking FT specimen as an example). It can be seen from Figure 4a, a surface topography picture of FT specimen was obtained by wyko NT1100. Then a surface profile is randomly extracted from the 3D topography along the axial direction. The valleys A, B, and C were selected to calculate the average value of valley radius for this profile. The valley radius ρ_A for A valley is 6.8 μm , which is given directly by the wyko NT1100. Therefore, the valley radius for this profile is the average value of ρ_A , ρ_B and ρ_C . The effective valley radius $\bar{\rho}$ for the FT specimen is the average of the valley radius for several profiles. The same method can be employed to obtain the values of $\bar{\rho}$ at other different processes.

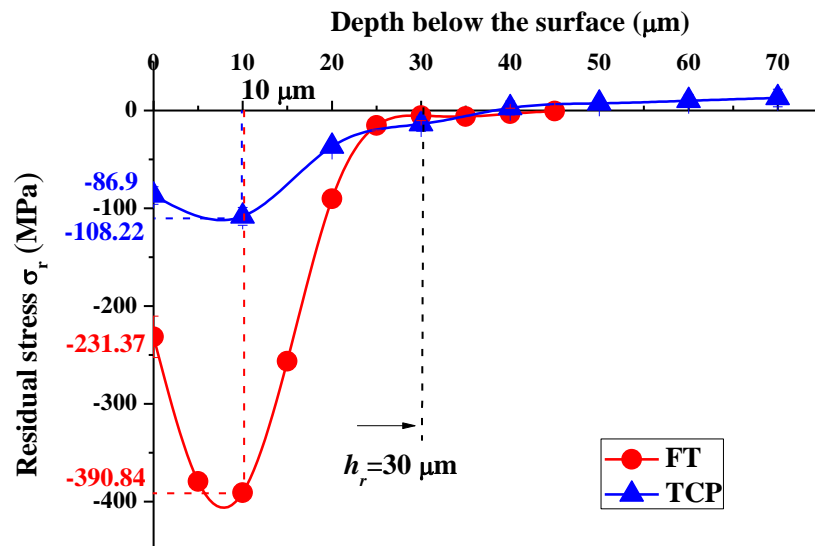
Figure 5. Residual stresses distributions.

Residual stresses distributions for FT and TCP conditions are given in Figure 5. For the two conditions, as the depth below the surface increase, the compressive residual stress rapidly increase from a lower value to the maximum value, then gradually reduce to zero stress value. The depth of compressive residual stress layers for the two conditions are all 30 μm. After FT process, surface

residual stress σ_{rsur} is -231.37 MPa. The maximum compressive stress σ_{rmax} is around -390.84 MPa, situated at $10\text{ }\mu\text{m}$ below the surface. After TCP process, surface residual stress σ_{rsur} is -86.9 MPa. The σ_{rmax} is around -108.22 MPa, situated at $10\text{ }\mu\text{m}$ below the surface. The surface residual stress σ_{rsur} and maximum compressive residual stress σ_{rmax} after TCP process is much small than that of FT process. It is attributed to a very thin layer of plastic deformation was removed by the surface polishing treatment. Similar results were presented in our previous work [14,20]. Gao et al. [21] reported that surface residual stress of grinding 40CrNi2Si2MoVA steel was -400 MPa and decreased to -80 MPa after electro-polishing.

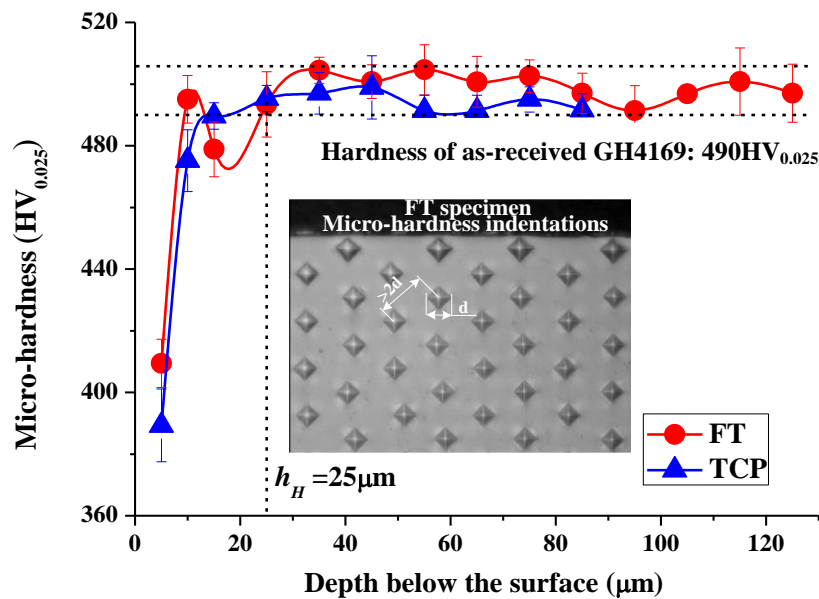
Figure 6. Microhardness distributions.

The microhardness distributions for FT and TCP conditions are given in Figure 6. Surface microhardness after FT process is around $409\text{ HV}_{0.025}$. While, the surface microhardness after TCP process is about $389\text{ HV}_{0.025}$. The hardness near the surface is smallest, and then increased with the increasing of depth. Finally, the hardness tends to a stable fluctuation range, in which the hardness of the matrix is around $490\text{ HV}_{0.025}$. Under the two processes, the machined surface has a distinct softening phenomenon. The depth of softening layer are all about $25\text{ }\mu\text{m}$. It is attributed to the small thermal conductivity of GH4169 alloy. During processing, the surface area of the material is too hot, resulting in a decrease in hardness.

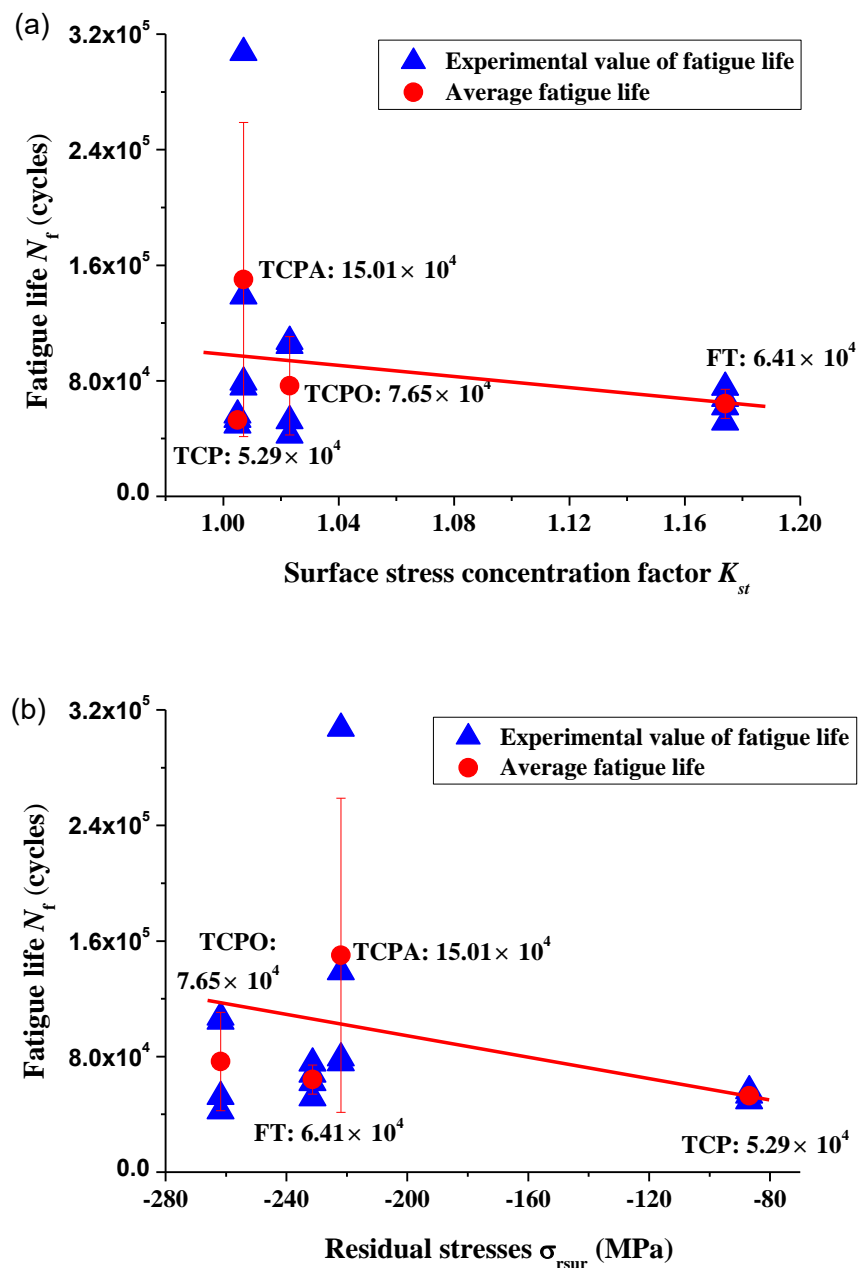
Figure 9. The effects of K_{st} and σ_{rsur} on fatigue life: (a) effect of K_{st} on fatigue life and (b) effect of σ_{rsur} on fatigue life.

The effects of K_{st} and σ_{rsur} on fatigue life are shown in Figure 9. In Figure 9a, the fatigue life decreases with the increasing of K_{st} . This is mainly because that the larger the K_{st} is, the larger the fatigue stress concentration coefficient K_f is, larger surface local stress and strain caused, and the fatigue life reduced. In Figure 9b, the fatigue life reduced with the decreasing of compressive residual stress. Which is mainly because that the effect of residual stress on fatigue life is equivalent to the effect of the average stress.

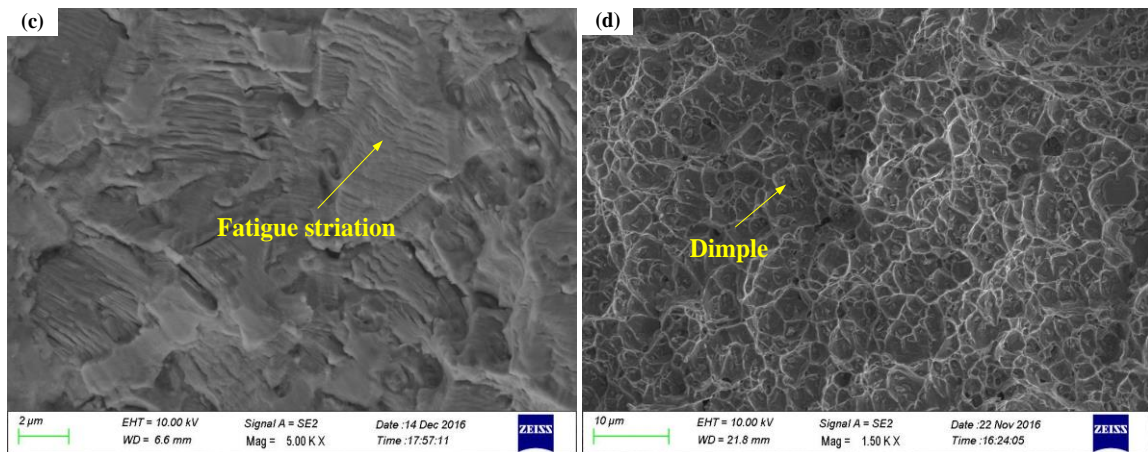
Figure 10. Fracture surface of FT specimen ($R_a = 0.567 \mu\text{m}$): (a) overview of fracture surface; (b) Crack nucleation site; (c) fatigue striations and (d) dimples.

Fatigue morphology after different processes is presented in Figures 10–13. Fractography under different processes are shown in Figures 10a, 11a, 12a and 13a. Overview of fracture surface includes crack initiation region (Region 1), crack propagation region (Region 2), and collapse fracture region (Region 3). The smooth and delicate fan-shaped small area can be observed in the Region 1. Fatigue cracks extend to the internal in multiple directions at the same time. All fatigue cracks are nucleated on the machined specimen surface. Klotz et al. [22] found that the carbide or machining marks on machined Inconel 718 surface could result in fatigue cracks. The fractographies of FT, TCP, and TCPO specimens have multi-source fatigue fracture characteristics. However, TCPA specimen has only one fatigue source. In Figure 10b, the clear and deeper machining marks appear on specimen surface ($R_a = 0.567 \mu\text{m}$), which could result in a high stress concentration factor ($K_{st} = 1.174$). In Figures 11b, 12b and 13b the fatigue specimen surfaces are smooth, and the surface roughness for those three specimens are similar ($R_a = 0.024 \mu\text{m}$ for TCP specimen; $R_a = 0.087 \mu\text{m}$ for TCPO specimen; $R_a = 0.053 \mu\text{m}$ for TCPA specimen). Single crack initiation source is obtained from the TCPA specimen. This is mainly attributed to the surface texture direction for TCPA specimen is parallel to the fatigue stress direction, which lead the cracks are not easy to initiation. The fatigue striations and dimples can be observed at all the conditions.
