Article

Comparison of Energy Dissipation, Stiffness, and Damage of Structural Oriented Strand Board (OSB), Conventional Gypsum, and Viscoelastic Gypsum Shearwalls Subjected to Cyclic Loads

Keywords: wood shearwall; seismic; gypsum; viscoelastic polymer; energy dissipation

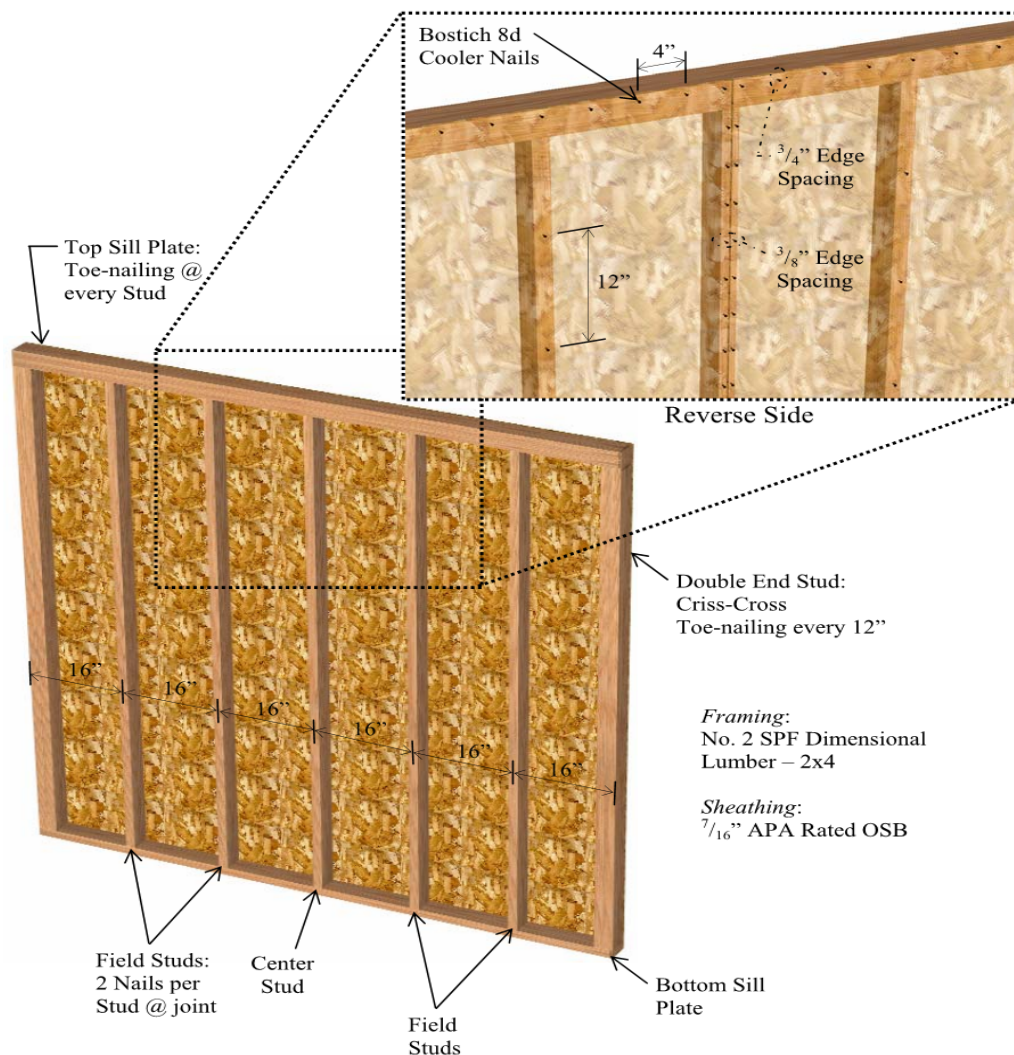
while the VEwall specimens represent a modified shear wall design. The framing of all walls consisted of Spruce-Pine-Fir (SPF) 2 in. \times 4 in. lumber. Four OSBwall specimens, shown in Figure 1, were constructed. The walls were sheathed with 7/16" OSB which was connected to the framing via Bostich 8d clipped-head cooler nails driven by a pneumatic Bostich nail gun. Nails were spaced 4" around the perimeter of each panel with an edge spacing of 3/4" along the end studs and sill plates and 3/8" along the center stud. Nails along the field studs were spaced every 12".

Figure 1. OSBwall (oriented strand board) Specimen.

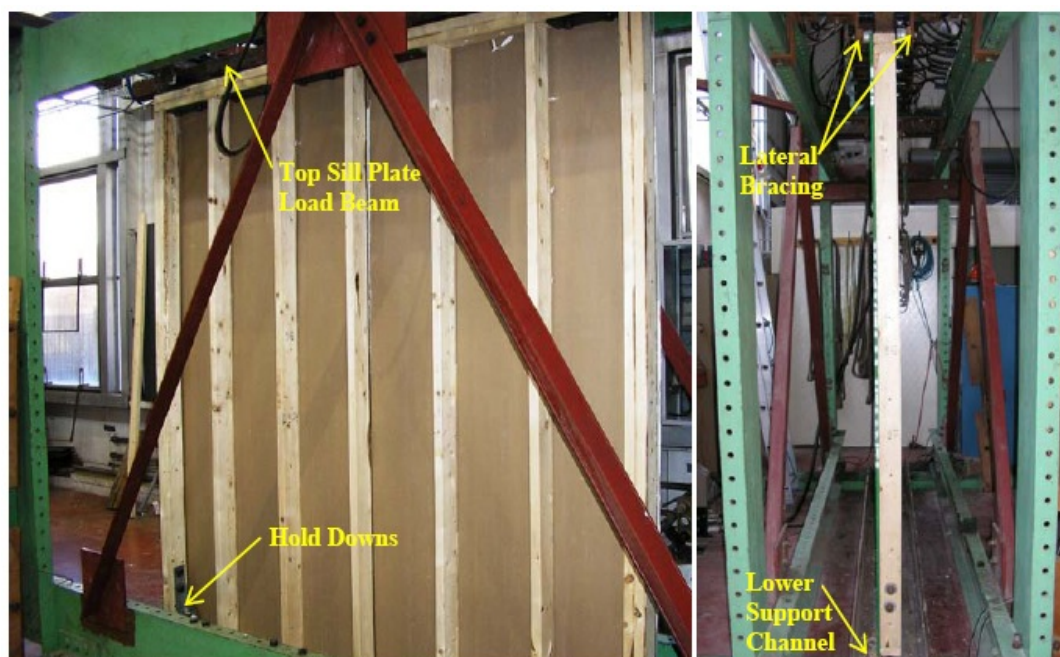
The wall specimen is installed between two load-resisting self-reacting frames, and is anchored to a lower support channel. Figure 3 shows the shear wall test frame with a GYPwall specimen installed. A horizontal displacement load was distributed along the top sill plate, while the bottom sill plate was fully braced with anchor bolts and cover plates. Lateral load is applied via a 20,000 lb hydraulic actuator with a guide beam that is bolted to the top of the specimen. Bearing rollers, oriented perpendicular to the direction of loading, were installed along the top sill plate as lateral bracing. Uplift was restrained at the end studs through the use of TDX5 hold downs manufactured by USP Connectors.

Figure 3. Shearwall test frame with specimen installed.

The data acquisition and control system simultaneously provided the hydraulic actuator with the displacement test sequence while recording measurements during its execution. Five channels of data were recorded including load from the actuator, lateral displacement of the actuator located at the top of the wall, lateral displacement at the other top corner of the wall via an independent cable potentiometer, and uplift displacements at each corner.

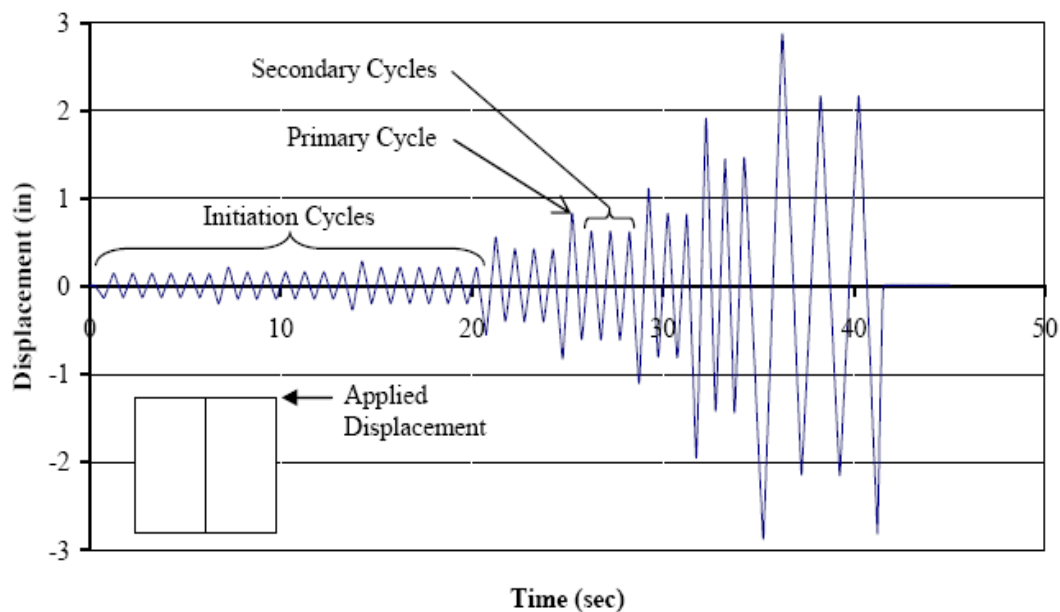
All shear wall specimens were subjected to the recommended CUREE displacement protocol for shear walls at a frequency of 1.0 Hz [19]. The maximum displacement was 2.86". The shear wall loading protocol is plotted in Figure 4. This protocol, designed to mimic the effects of an earthquake, is split into three components: initiation cycles, primary cycles, and secondary cycles. The initiation cycles simulate the cyclic loading that structures typically undergo. After the initiation cycles are sets of one primary cycle followed by several secondary cycles, which simulate earthquake loading. The primary cycles have larger amplitudes than their preceding secondary cycles, and simulate major events. Shear walls were subjected to a total of 37 cycles.

Figure 4. Shearwall loading protocol.

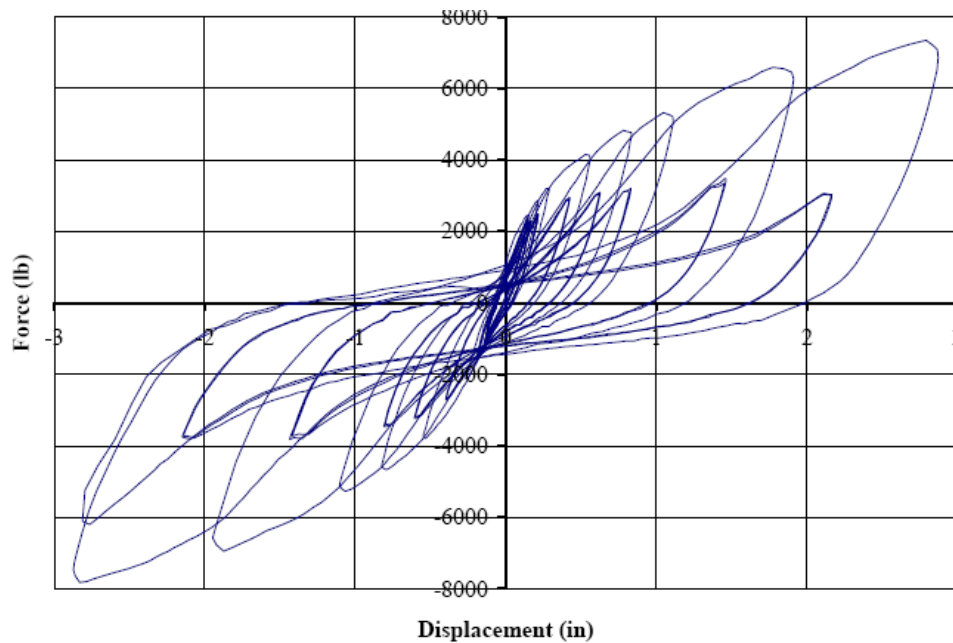
A typical hysteresis (load-displacement) plot for the four OSBwalls tested is presented in Figure 5. The area inside a single cycle hysteresis is defined as the energy dissipated in that cycle. The slope of the loop is defined as the stiffness [20–22]. The OSBwall hysteresis is characterized by a pinched region at small displacements and load degradation at constant amplitude cycling.

Figure 5. Hysteresis plot for OSBwall 1.

Figures 5–7 provide a detailed view of the cyclic response for each wall. The displacement scales for each plot are identical; however, to view the detail of the plot the load scales are significantly

energy dissipation of the secondary cycles. Had the secondary cycles been given the same amplitude as their preceding primary cycles, their hysteresis loops would be longer, their areas would be greater, and their energy dissipation would be higher. Though, it is evident from Figure 5 that there is still significant degradation after primary cycles because the pinched regions are extended for the secondary cycles. Energy dissipated during secondary cycles of constant amplitude remained fairly constant throughout the first 20 cycles. Cycle 1 (0.14") produced 124.4 lb-in of energy dissipation, and gradually declined to 119.9 lb-in for cycle 6. Energy dissipated during cycle 8 (0.15") was 163.9 lb-in, compared to 152.6 lb-in for cycle 13. Cycle 15 (0.20") generated 275.1 lb-in of energy dissipation, and decreased to 258.4 lb-in. The total energy dissipated by OSBwall1 was 83,953.5 lb-in. The greatest standard deviation was 20.2% of the average and occurred at cycle 28 (0.61"). No failures occurred among the four OSB shear walls tested.

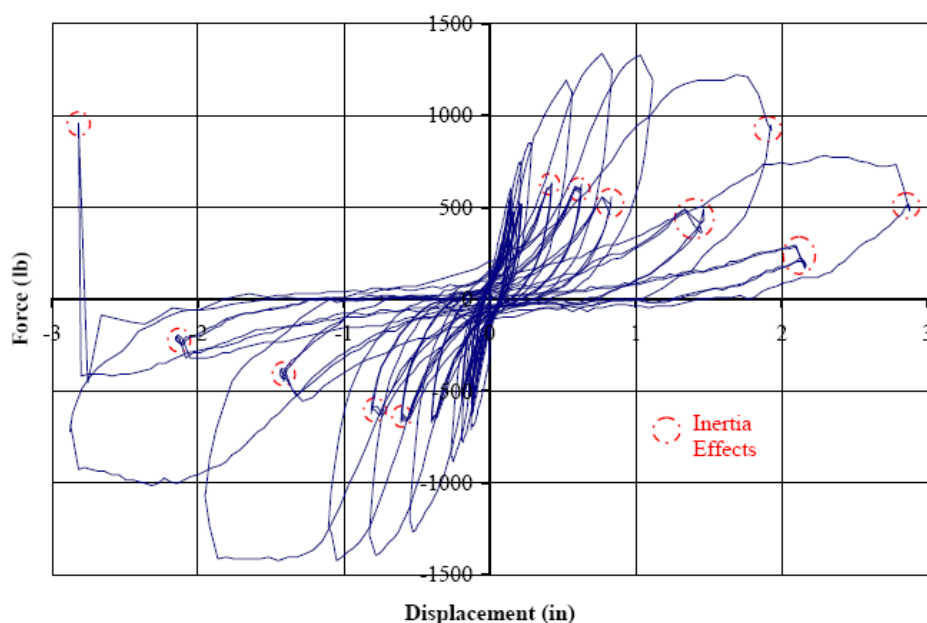
A typical hysteresis plot for one of the three GYPwall specimens tested is shown in Figure 6. Qualitatively, the hysteresis plots for the gypsum shear walls take on some but not all characteristics of the OSB walls. The most prominent characteristic is the extreme degradation between primary and secondary cycles, marked by reduced area of the hysteresis loops. The pinched region is also well-pronounced, and has virtually no thickness near the origin. However, certain characteristics of the hysteresis plots are unique to these shear walls. The primary cycles exhibit loops that are smooth and rounded, without sharp peaks or corners. This differs from both OSB shear walls and baseline gypsum connections and is an unanticipated response to the ramped loading defined by the recommended CUREE displacement protocol.

Figure 6. Hysteresis plot for GYPwall 3.

The sudden change in motion caused by ramped loading often produces abrupt changes in direction of the hysteresis plots, which are not present in the primary cycles of the gypsum shear walls. They are, however, present in the secondary cycles, which exhibit abnormalities at the extreme displacements. These abnormalities are most likely caused by inertia effects imposed by the mass of the load beam that rests atop the shear wall specimen during testing. These effects are highlighted by the red dashed circles in Figure 6. With ramped loading, the actuator changes direction very quickly, requiring maximum acceleration from the hydraulic system. This acceleration is applied to the steel load beam, which contains a significant mass and is bolted to the top of the shear wall. The inertia forces caused by the apparatus are typically neglected because they represent a slight percentage of the dynamic response of most shear walls. However, gypsum shear walls provide very weak responses, so the inertia effects represent a greater percentage of the total response.

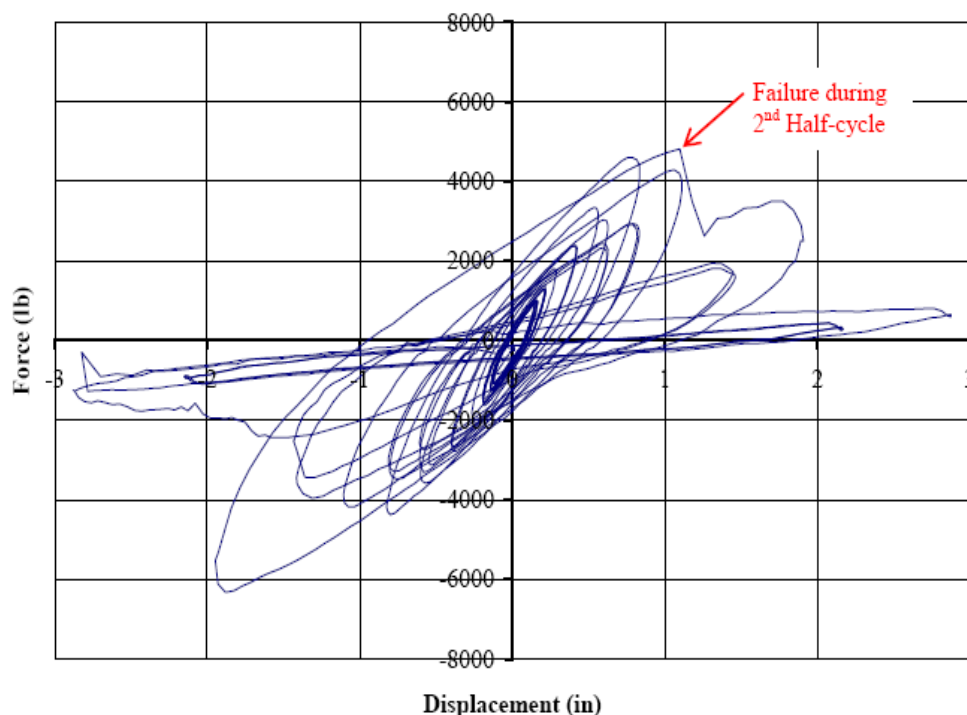
Three VEwalls were tested with very similar results. A typical dynamic response is presented in Figure 7. Investigation of the hysteresis shows that the pinched region has been eliminated and there is very little degradation between cycles. Hysteresis loops for the VE gypsum shear walls appear more as parallelograms and not ovals, similar to a hysteresis loop of a VE damper. This can be attributed to the loading protocol rather than the type of specimen. The ramped loading used for the shear wall protocol consists of regions of constant velocity. When a damper is subjected to a constant velocity it produces a constant damping force, producing a hysteresis loop that resembles a rectangle. If a spring is assembled in parallel to the damper, then the rectangular hysteresis loop would be projected onto the linear response of the spring. It is significant to note that all three VEwall specimens failed after 31 cycles.

Figure 7. Hysteresis plot for VEwall 3.

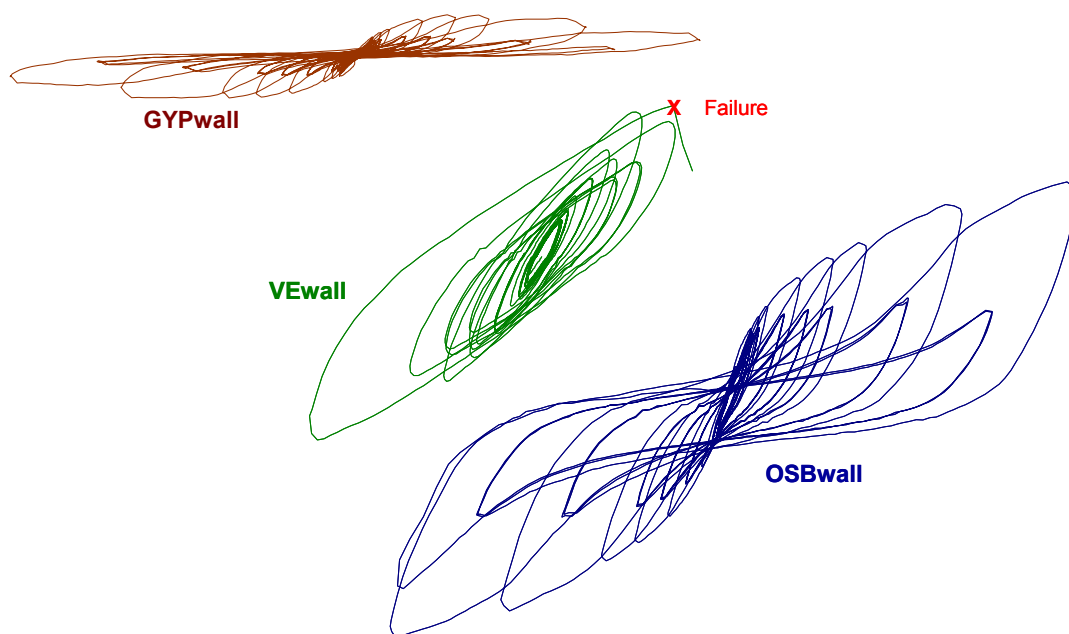
different. Figure 8 presents the three hysteresis responses shown in Figures 5–7 plotted to the same load scale. It is clear that the response of each of these wall systems to the simulated earthquake cyclic loading is dramatically different. In comparing the GYPwall with the OSBwall, both have similar forms; however, the GYPwall clearly provides substantially less load resistance than the OSBwall. The VEwall has a drastically different response as indicated by the shape of the hysteresis loops and also has a much greater cyclic load resistance when compared to the GYPwall. A general comparison of the cyclic behavior of these connections and walls has been reported [20]. Based on these significant differences in behavior between the three wall types an in- depth analysis of the energy dissipation and stiffness characteristics on a per cycle and cumulative basis is warranted. This detailed analysis is provided in the following sections.

Figure 8. Representative hysteresees plotted to the same scale.

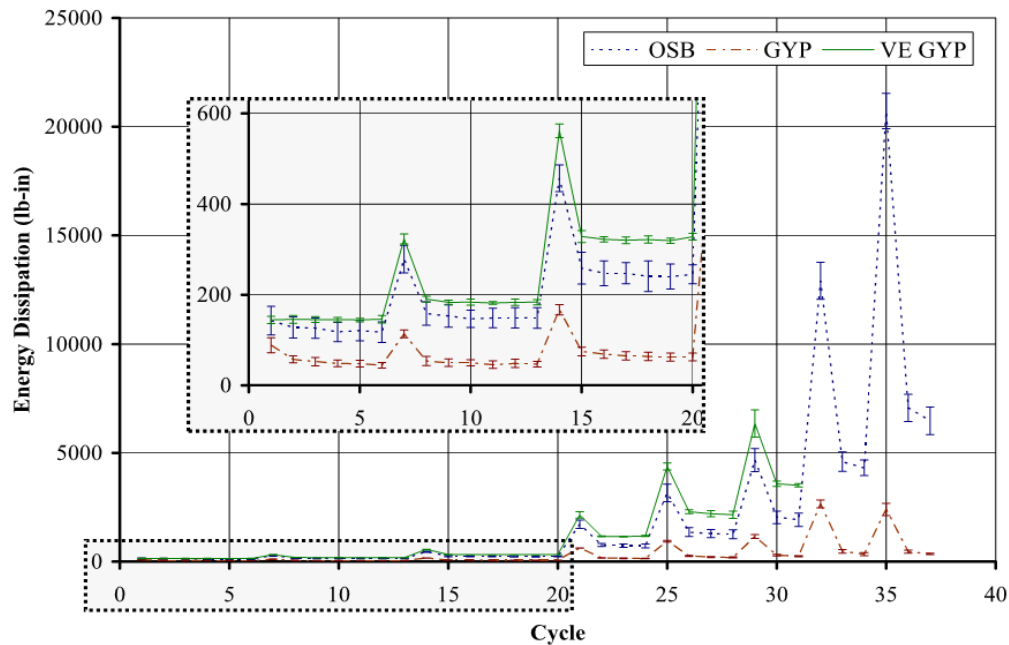
The relationship between energy dissipation and cycle number for all wall specimens is presented in a graphical format in Figure 9. Trend lines, representing the average energy dissipation, are plotted for each type of wall. Error bars are plotted along the trend lines to illustrate the standard deviation within the data at each cycle. Figure 10 presents the total energy dissipated through a given cycle for each wall type. Similar

Figure 9. Average energy dissipation vs. cycle number for all walls.

The most prominent characteristic of the energy dissipation trends for the OSBWalls is the dramatic decrease in energy dissipation between primary cycles and secondary cycles. This decrease is somewhat deceiving because it is not entirely due to degradation. From Table 1 it is clear that for the CUREE loading protocol used, the primary cycles have larger displacement amplitudes than their subsequent secondary cycles. This has a significant effect on the area of the hysteresis loops and

As shown in Table 3 and Figure 9, the values for energy dissipation were very similar for all three VEwall specimens. VEwall2 dissipated the most total energy (36,441.4 lb-in), and VEwall3 produced the lowest total energy dissipation (33,780.1 lb-in). The three specimens averaged a total energy dissipation of 34,931.6 lb-in with a standard deviation of 1,366.3 lb-in (3.9% of the average). Energy dissipated during secondary cycles of constant amplitude remained virtually constant throughout the first 20 cycles. Cycle 1 (0.14") produced an average energy dissipation of 144.4 lb-in, and increased to 146.0 lb-in for cycle 6. Energy dissipated during cycle 8 (0.15") was 190.2 lb-in on average, compared to 183.5 lb-in for cycle 13. Cycle 15 (0.20") generated an average energy dissipation of 328.7 lb-in, and decreased to 327.7 lb-in.

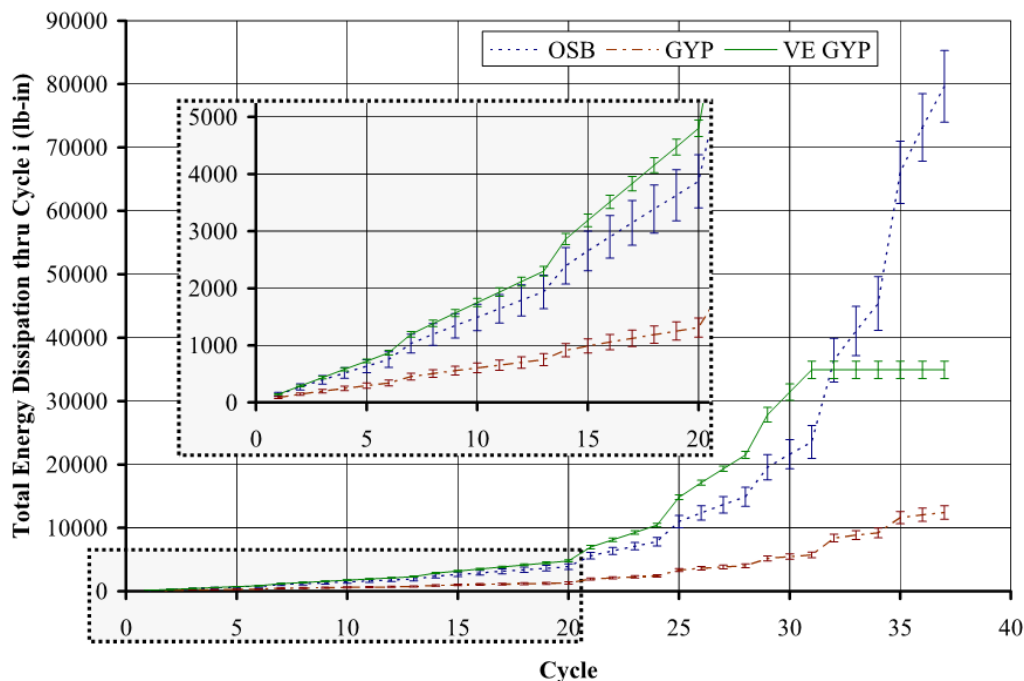
to Figure 9, trend lines, representing the average, are plotted for each wall specimen and error bars are plotted along the trend lines to illustrate the standard deviation within the data at each cycle.

Figure 10. Total energy dissipated for all wall types.

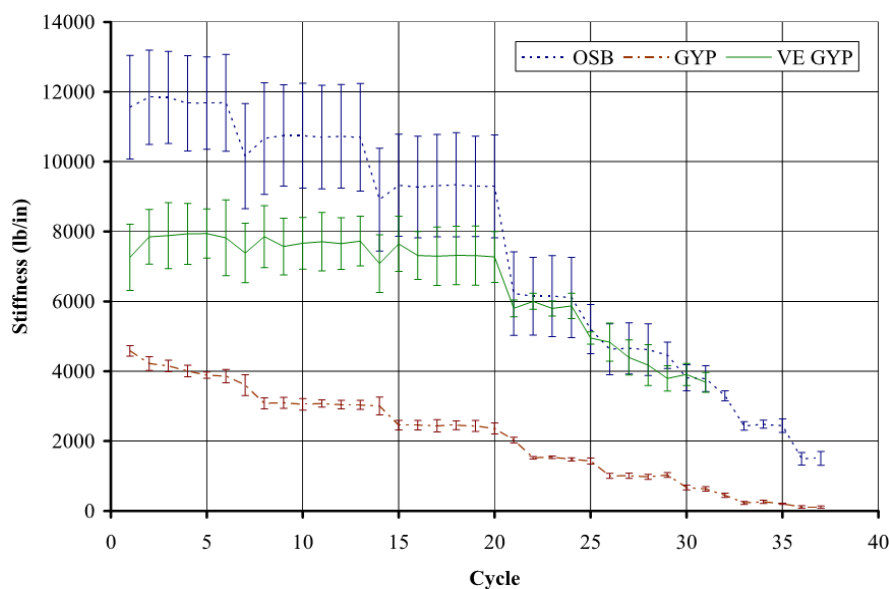
The wall stiffness is defined as the slope of the hysteresis plot and is calculated per cycle. Tables 4–6 present the stiffness data for the OSBwalls, the GYPwalls and VEwalls respectively. Similar to the energy dissipation data presented previously, the cycle number, lateral wall displacement, individual test results, averages, and standard deviations are included. Cycles are grouped in sets according to cycle displacement with the first cycle within each set defined as the primary cycle, followed by the secondary cycles. Figure 11 presents the graphical representation of stiffness per cycle for all wall types and Figure 12 highlights the percentage of total stiffness loss per cycle. For Figures 11,12 trend lines, representing the average, are plotted for each wall type and error bars are plotted along the trend lines to illustrate the standard deviation within the data at each cycle.

Figure 11. Average stiffness vs. cycle number for all walls.

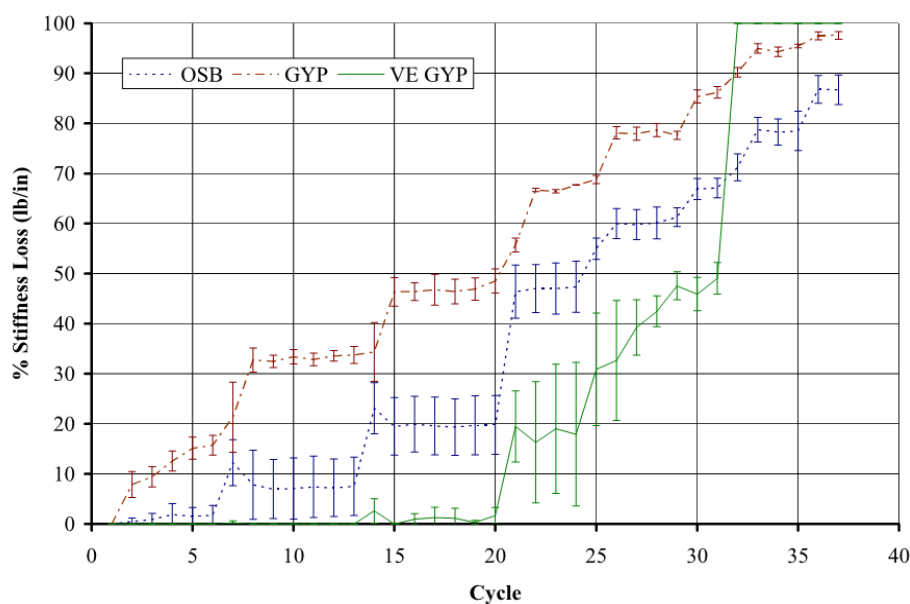
Figure 12. Average stiffness vs. cycle number for GYPwalls.

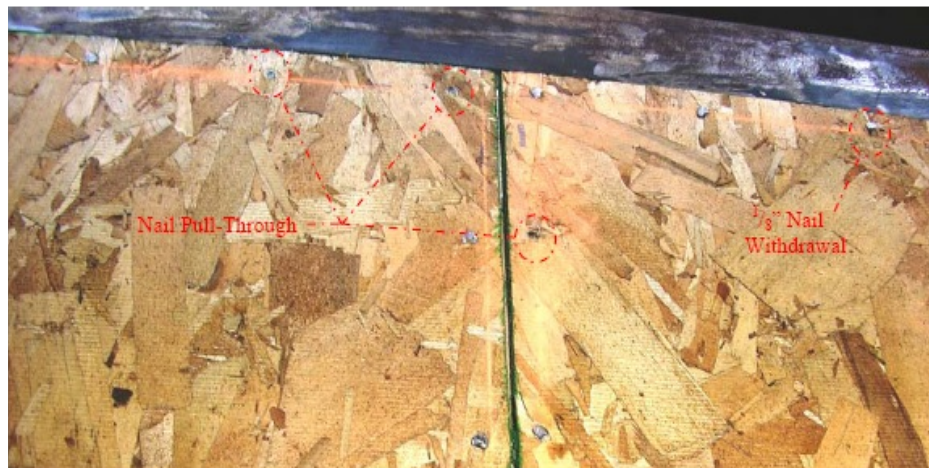
Damage to the OSBWalls was restricted to localized deformations near the sheathing connections and included nail withdrawal, nail pull-through and flaking of the OSB, as shown in Figures 13–15. In some areas, the nail withdrawal allowed the sheathing to pull away from the frame. Damage to the sheathing connections occurred along the center stud, top sill plate and double end stud (actuator side). Crushing of the wood sheathing and bending of the nails were observed similar to sheathing connections deformed in a manner similar to the nailed OSB connection specimens reported in a previous connection study [3].

Figure 13. Damage along the center stud and top sill plate.

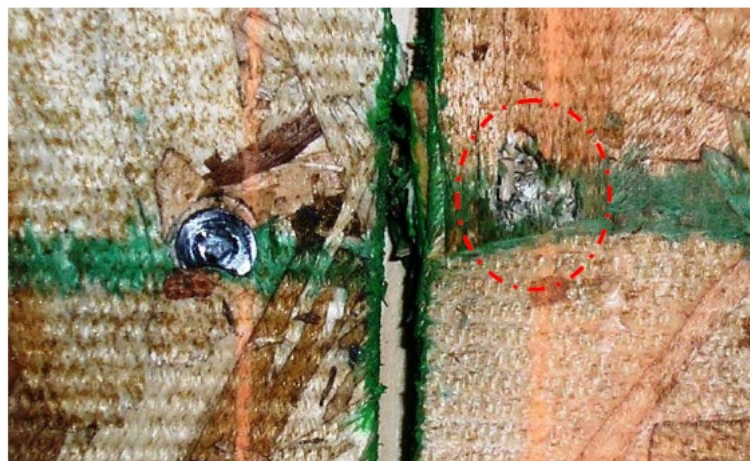
Figure 14. Nail pull-through along the center stud.

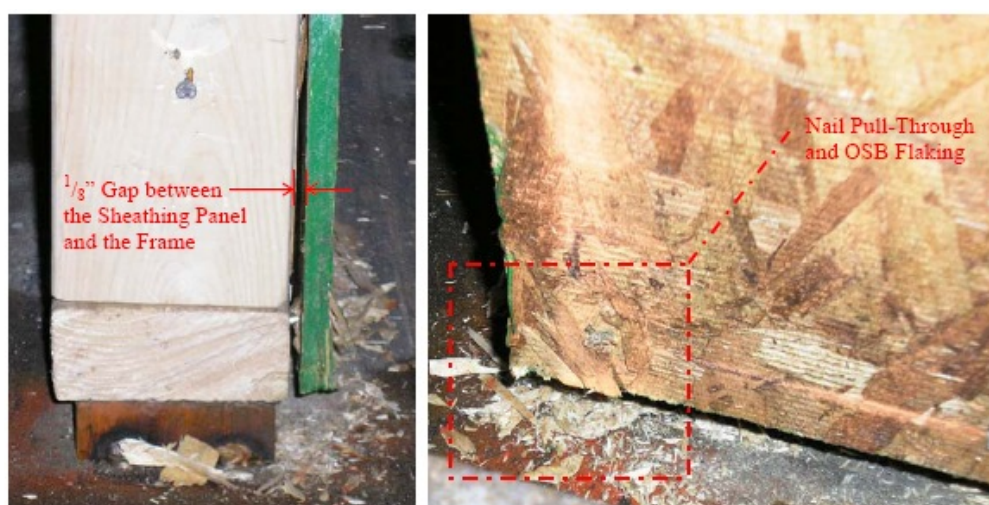
Figure 15. Nail pull-through along the center stud.

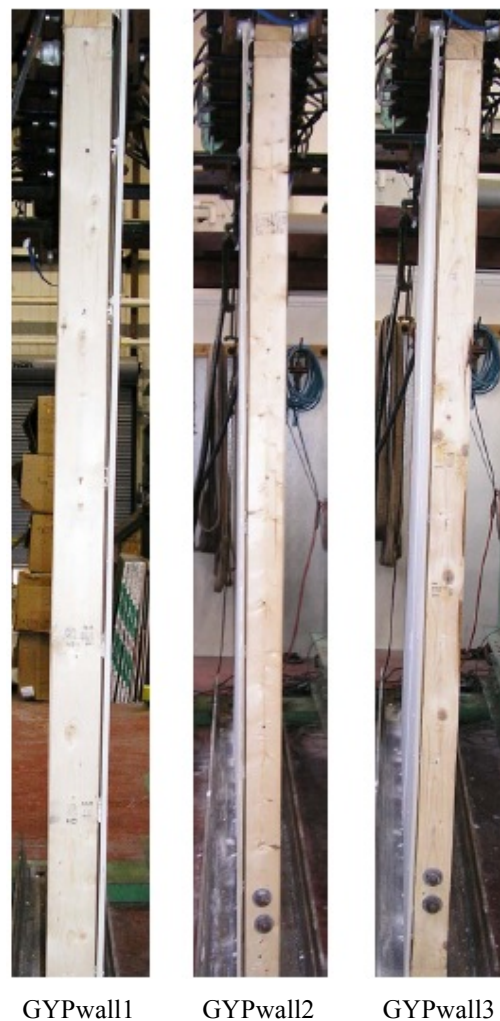
Global damage sustained by the baseline GYPwalls included separation of the wallboard panels from the wood frame, as shown in Figure 16. The separation was more severe at the top of the walls (over 3/4"), whereas the bottom of the walls did not separate more than 1/4". The separation was most likely due to localized damage sustained at the sheathing connections, which was worse at the top half of the wall (see Figure 16). The wood frames remained intact throughout all three tests.

Figure 16. Separation of Gypsum Wallboard from Wood Frame.

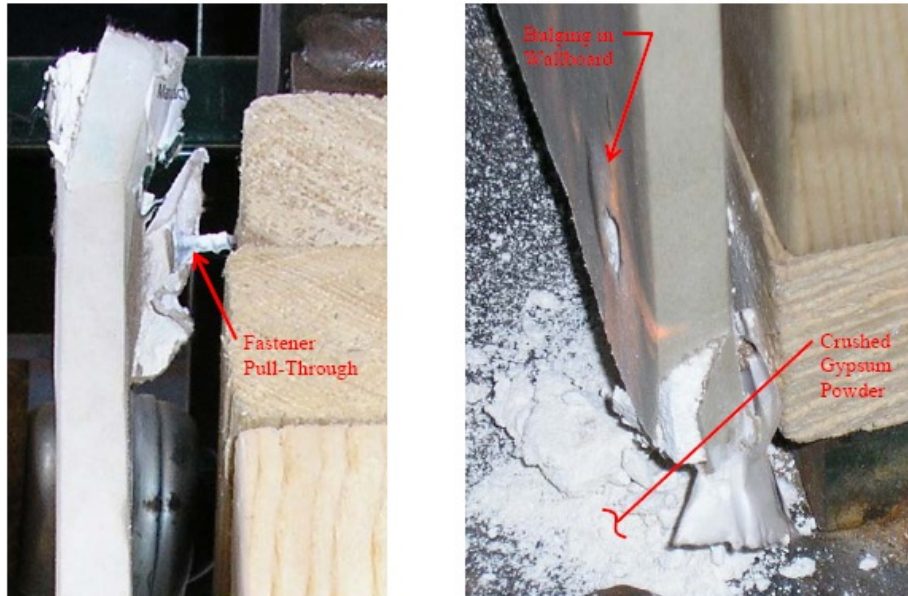
The most severe localized damage was observed near the corners of the gypsum wallboard panels. Portions of the panels were crushed and torn by the dowel-type fasteners, as shown in Figure 17. This occurred near the corners and along the bottom sill plate, where the sheathing separation was minimal. Bulging of the wallboard was also observed near the fasteners. The heads of the drywall screws, which were slightly over-driven, slid just beneath the outer veneer of the wallboard when displaced, creating a bulging effect on the sheathing surface. This occurred along the field studs and top sill plate, where fastener pull-through was more evident as shown in Figure 18. Overall, the damage observed was substantial, which can be attributed to using rigid dowel-type fasteners with easily crushable gypsum

Figure 17. Typical Damage to Gypsum Wallboard Corners.

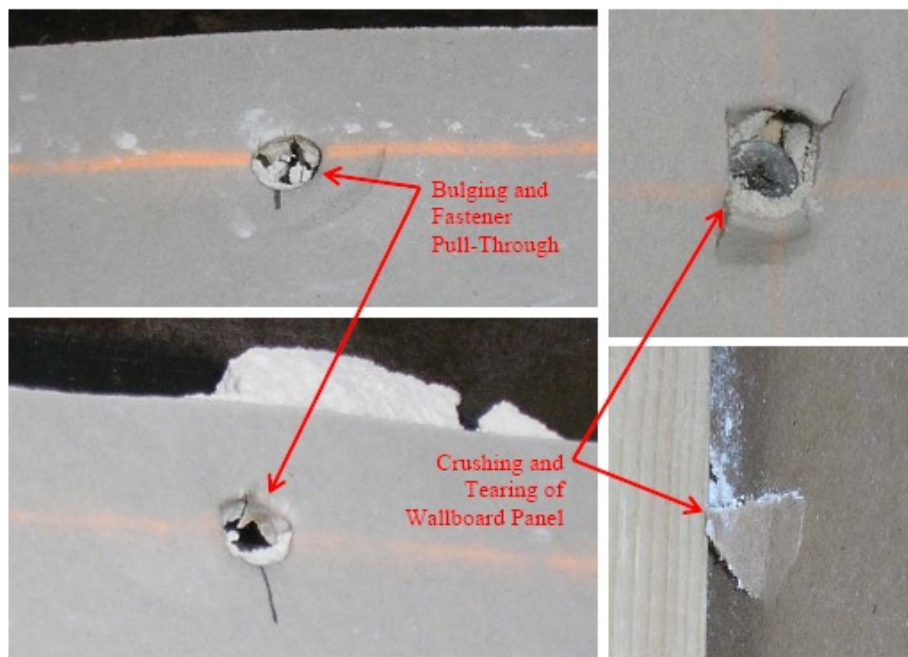
Figure 18. Typical Damage to Gypsum Sheathing Connections.

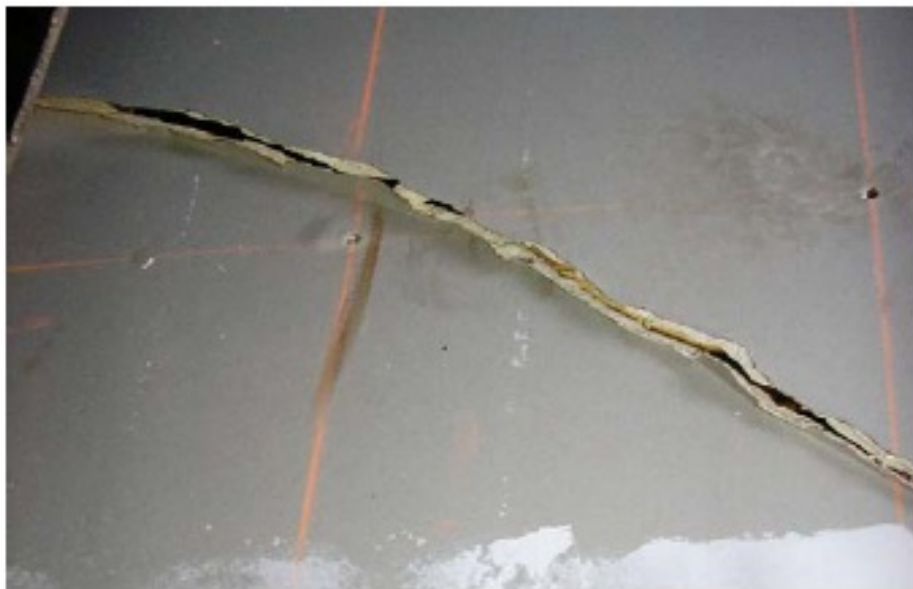
Immediately following cycle 31, all three walls failed due to excessive tensile stresses in the gypsum wallboard, leading to permanent damage of the sheathing panels, as shown in Figure 19. The damage consisted of long, diagonal cracks through the wallboard panels oriented perpendicular to the direction of the principal tensile stresses. Cracks were generally located on the lower and upper corners of the sheathing panels, and propagated along the center stud and sill plates. The failures were brittle, as there were no indications that a failure was imminent. Essentially, the integrity of the VEwalls relied on the capacity of the paper veneers on either side of the wallboard. Figures 19–23 illustrate the damage sustained by the three specimens. While the failures were unpredicted, it is essential to note that prior to a target displacement of 1.9 in, there was no visual or audible sign of damage.

Figure 19. Tension failure of gypsum wallboard.

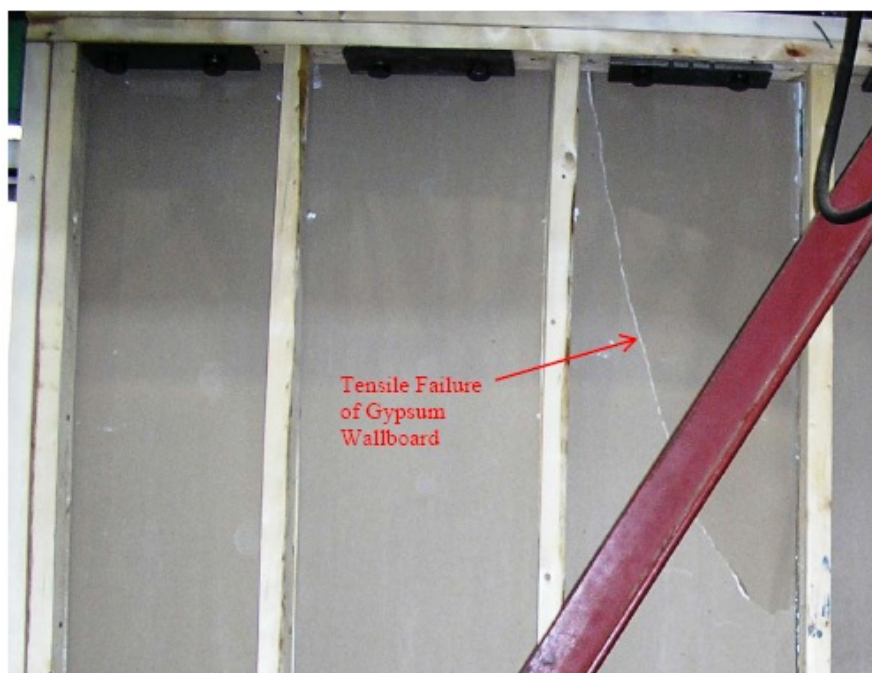
Figure 20. Damage to upper half of VEwall 1.

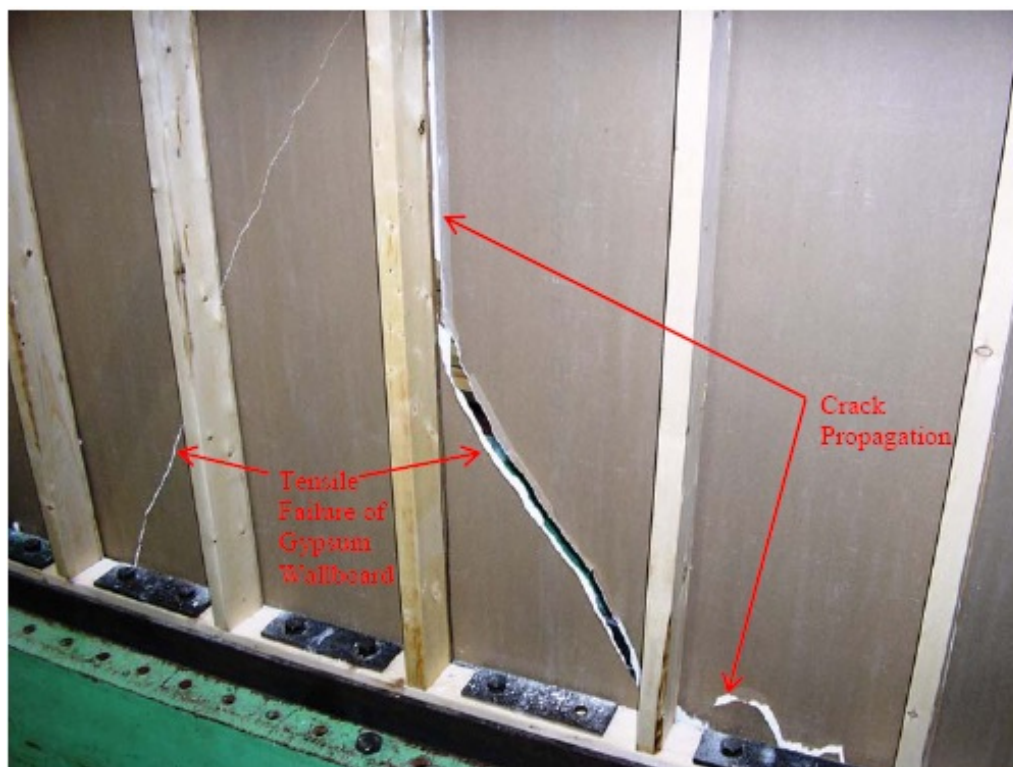
Figure 21. Damage to lower half of VEwall 1.

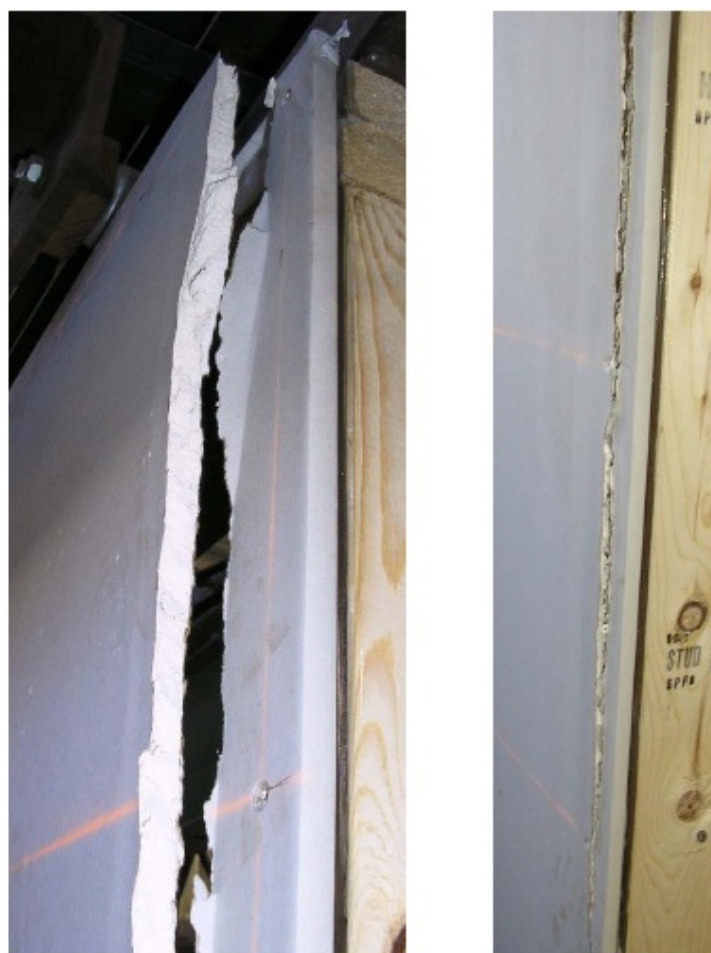
Figure 22. Crack propagation along the edge of VEwall 2.

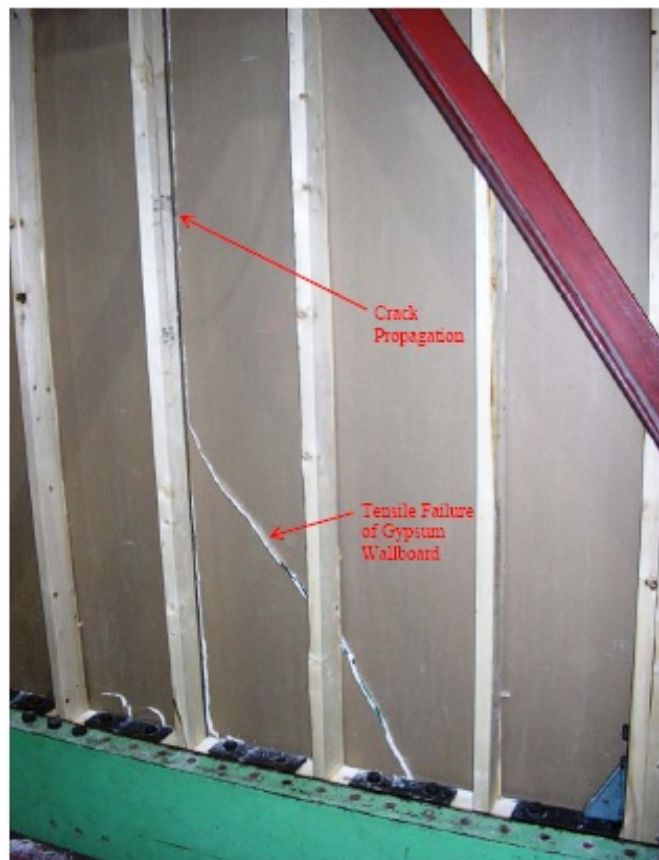
Figure 23. Damage to lower half of VEwall 3.
