# The High-Velocity Impact Behaviour of Kevlar Composite Laminates Filled with Cork Powder

**Abstract:** The literature reports benefits when the cork powder obtained from industrial by-products is used as the filler of composite laminates. For example, while the fatigue life is insensitive to the presence of cork in the resin, significant improvements are achieved in terms of low-velocity impact strength. However, in terms of ballistic domain, the literature does not yet report any study about the effect of incorporating powdered cork into resins. Therefore, this study intended to analyse the ballistic behaviour and damage tolerance of Kevlar/epoxy reinforced composites with matrix filled by cork powder. For this purpose, high-velocity impacts were studied on plates of Kevlar bi-directional woven laminates with surfaces of  $100 \times 100 \text{ mm}^2$ . It was possible to conclude that the minimum velocity of perforation is 1.6% higher when the cork powder is added to the resin, but considering the dispersion, this small difference can be neglected. In terms of damage areas, they are slightly lower when cork dust is added, especially for velocities below the minimum perforation

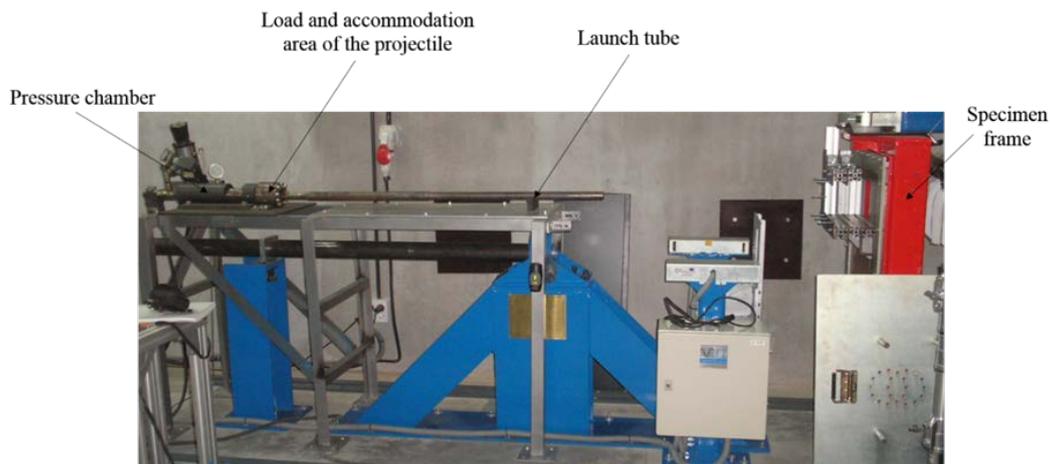
The high-velocity impacts were carried out on plates of Kevlar bi-directional woven laminates with surface of  $100 \times 100 \text{ mm}^2$ . The specimen's size was big enough that the damaged area did not reach the border of the laminate. The projectile used for impact tests was of steel with a spherical geometry of 7.5 mm diameter and a density of  $7800 \text{ kg/m}^3$ . In order to carry out the impact tests, a gas gun (Figure 1) was used to impulse the projectile at the required velocity. This gas gun consists of several clearly differentiated zones: the load and accommodation area of the projectile, the pressure chamber that impulses the projectile against the target, a launch tube and a frame where the laminate is embedded.

**Figure 1.** Photo of the equipment used in the high-velocity impact tests.

To impulse the projectile, the pressure of the gas used was regulated and two different types of gas were used: helium to achieve the highest velocities, and Stargon<sup>®</sup> a mixture of argon, carbon dioxide and oxygen manufactured by NIPPON GASES ESPAÑA, S.L.U. (Madrid, Spain) for the lowest velocities.

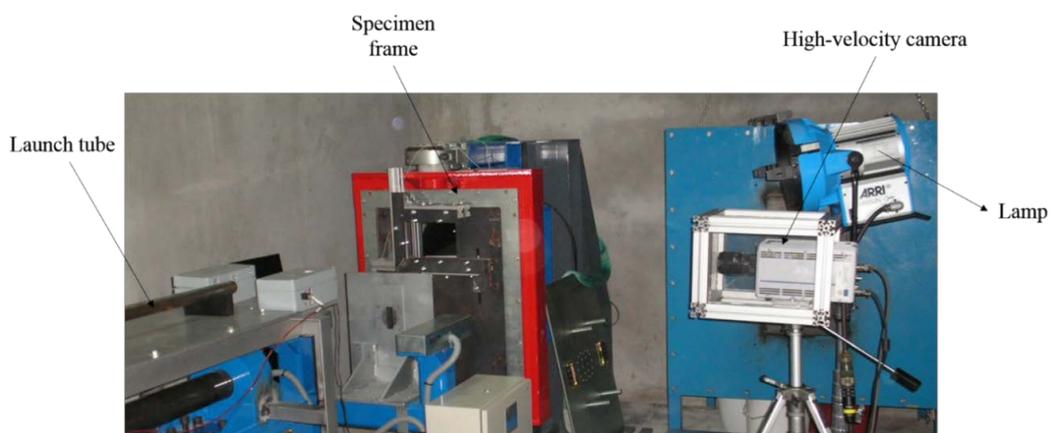
The impact tests were recorded with a high-velocity camera (Figure 2), which was used to pick up essential information such as the impact and residual velocities. The camera used was a Photron Fastcam ATX, which is able to reach 250,000 frames per second. In these tests the acquisition data velocity was 90,000 fps. The camera was placed parallel to the frame of essays. An ARRI ARRISON 12 PLUS lamp was used for lighting. This lamp has a power of 1200 W.

**Figure 2.** Photo of the high-velocity impact test setup.

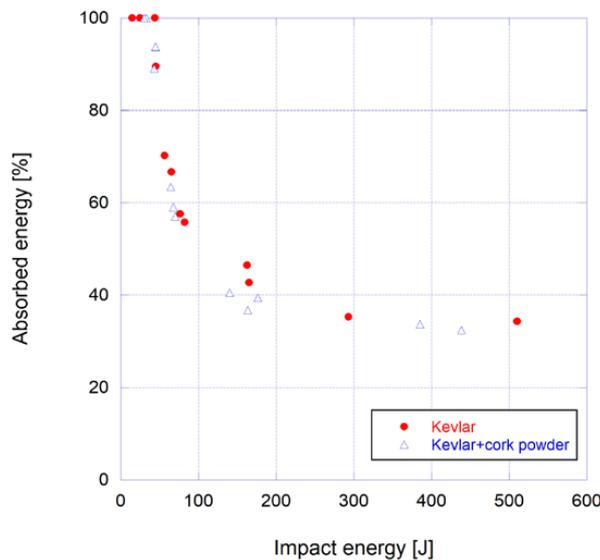
Figure 3 shows the absorbed energy regarding impact energy for all the specimens. The variation of the absorbed energy with impact energy is very similar for both type of plates. Below perforation, the plates absorb all the kinetic energy of the projectile, mainly by damage. When the impact energy increases above perforation, the absorbed energy decreases asymptotically.

Figure 3. Impact energy vs. absorbed velocity.

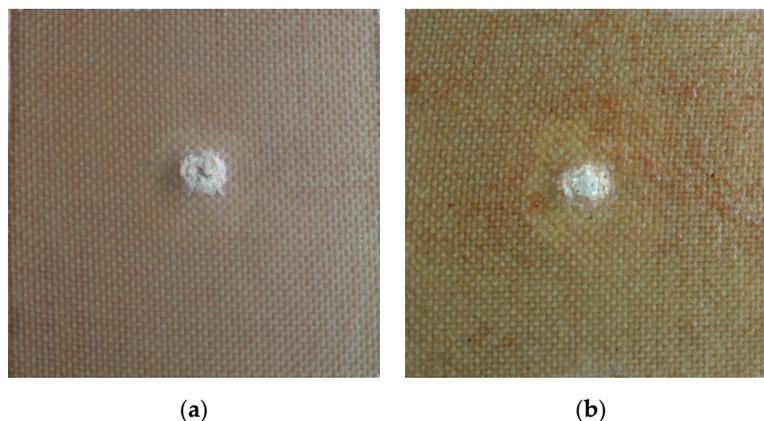
To understand these results, the failure mechanisms are shown in detail and Figures 4 and 5. They show typical images obtained from visual inspection for the back side of the plates. Figure 4 shows the specimens of Kevlar and Kevlar with cork powder impacted at similar velocities, close to the perforation velocity, while the specimens of Figure 5 were impacted at higher velocities.

**Figure 4.** Damage area of the back side. (a) Specimen of Kevlar impacted at 231 m/s and (b) specimen of Kevlar + cork powder impacted at 230 m/s.

From the visual inspections of the back sides of the plates (Figures 4 and 5), it is visible that the failure mechanisms are: fibre failure and delamination. Although matrix cracking is not possible to identify by visual inspection, this is one of the first damage mechanisms in composite laminates, and therefore, it should appear since it induces other failures modes, as delamination [45].

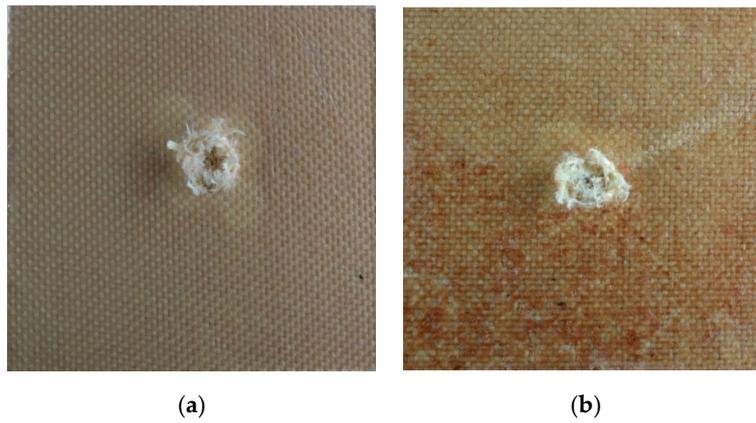
**Figure 5.** Image of damage area of the back side. (a) Specimen of Kevlar impact to 438 m/s and (b) specimen of Kevlar + cork powder impacted to 439 m/s.

The specimens impacted at higher velocities, around 300 m/s, showed fibre breakage close to the impact point, as reported in Figures 5 and 7. Simultaneously, the C-scan images clearly show that the damage caused by the bullets not only causes local damage (macro damage), but also affects the vicinity of the damaged areas clearly seen in different colours (micro damage), which agrees with the studies developed by Dhakal et al. [47]. Moreover, the extension of damage is more located around the impact point at higher velocities, as can be seen in Figure 7. In this context, the extension of damage area determined by the C-scan inspection is larger than the damage established by the visual inspection on both sides of the laminate (front and back face). Therefore, in addition to macro-damage, it is evident that the impact also induces internal micro-damage that is not visible to the naked eye, but should be considered when quantifying the damage size [47].

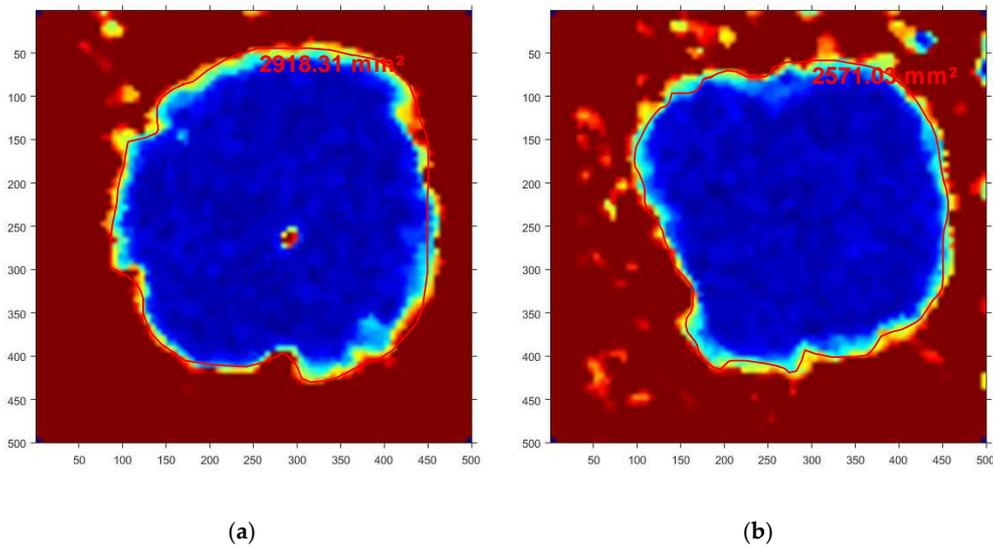
The images of the damaged area that were obtained by C-scan in the samples subjected to different impact velocities are shown in Figures 6 and 7. The impact velocities coincide with the impact velocities of the samples showed in Figures 4 and 5. In all specimens inspected by C-scan, it was possible to observe that the damaged areas had circular shapes, a behaviour that also appears in woven glass laminates [46].

**Figure 6.** Images of damage areas by C-scan. (a) Specimen of Kevlar impact to 231 m/s and (b) specimen of Kevlar + cork powder impacted to 230 m/s.

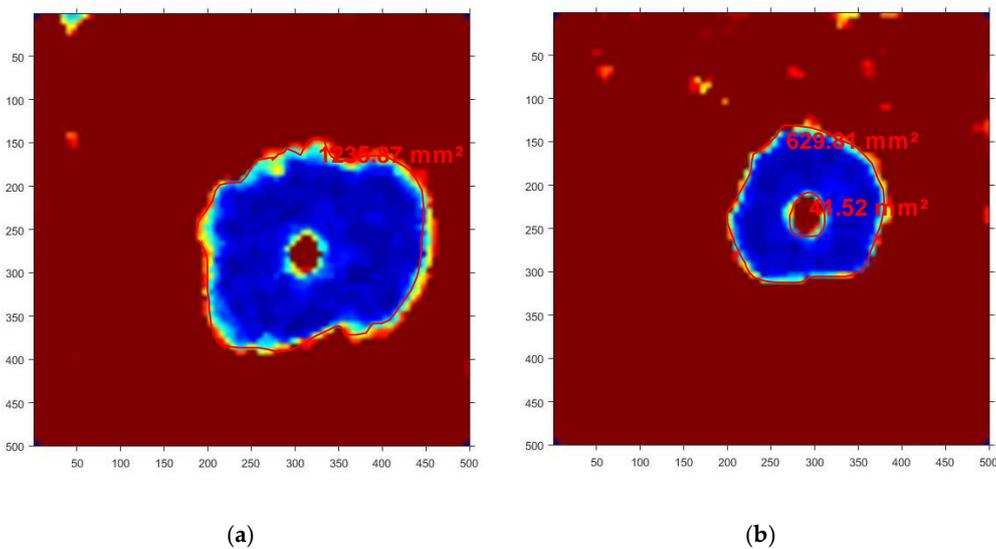
**Figure 7.** Images of damage areas by C-scan. (a) Specimen of Kevlar impact to 438 m/s and (b) specimen of Kevlar + cork powder impacted to 439 m/s.

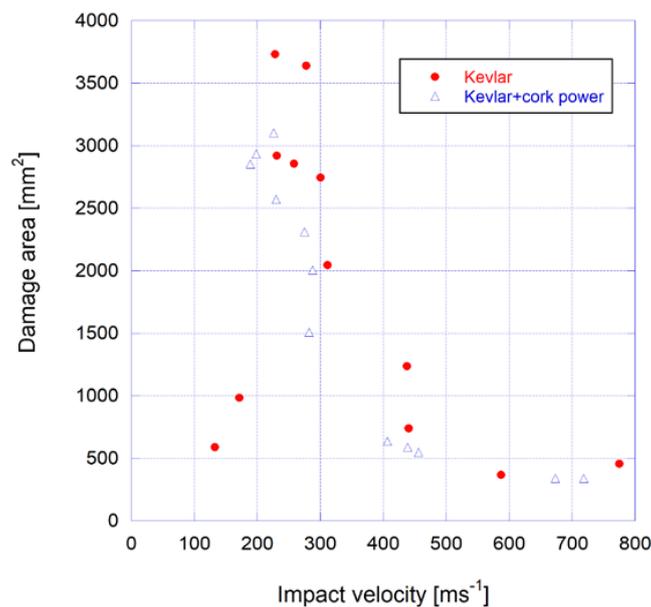
Figure 8 shows the extension of damage area for all specimens measured by C-scan. In all structures, the larger damaged area was found for velocities around the minimum perforation velocity. For velocities below the minimum perforation velocity, the damaged area increases with velocity, while for velocities greater than the perforation velocity, the damaged area decreases with increasing velocity.

**Figure 8.** Extension of damage area measured by C-scan.

This behaviour was observed by Buitrago et al. [48] for glass woven laminates, and it is produced by the bending of the plate due to the transverse wave travel, which leads to delamination. Since the contact time is maximal at the perforation velocity, the distance travelled by the transverse wave is also maximal, and thus the delaminated area is too [46,49]. On the other hand, when the damaged areas are compared between laminates with neat resin and resin filled by cork powder, in all conditions there is a clear tendency for the last ones to have smaller damaged areas. For example, comparing the damaged areas shown in Figures 6 and 7, it is possible to observe that for impact velocities around 230 m/s, they are around 11.9% lower for laminates with cork powder. However, this value was around 45.7% lower for impact velocities of 438 m/s. Nevertheless, for the highest impact velocities, the damaged areas tend to be similar. This behaviour allows one to affirm that there are changes in the energy absorption mechanisms, although there is not much change in the ballistic behaviour (Figure 3). In fact, cork has a high capacity to absorb energy, and as reported above, the response of the cork/resin composite is influenced by the number of closed cells in the cork particles. Sanchez-Saez et al. [29] observed a great capacity to absorb energy even after several consecutive impacts. In addition, Sarasini et al. [30] observed in their studies that the absorption of energy in high deformations can be quite considerable without signs of breaking of the cell walls, because an almost complete recovery of their original shape and size occurs.

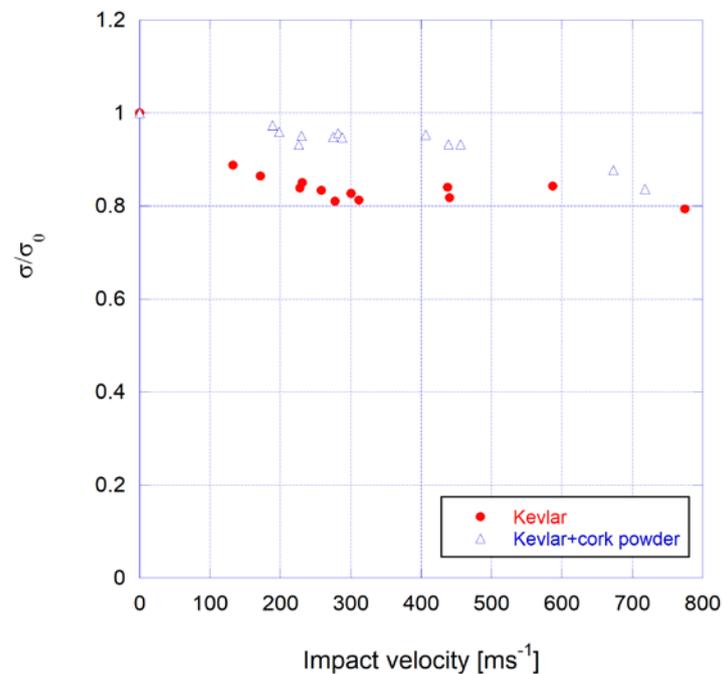
Finally, Figure 9 shows the residual bending strength, where  $\sigma$  is the average bending stress for each velocity and  $\sigma_0$  is the average bending stress obtained from the 3PB static tests for each laminate.

Figure 9. Impact velocity vs. ratio of bending stress.

Regardless of the lower static bending strength (around 13.7% less when 3 wt.% of cork powder was added to the resin), which agrees with the studies developed by Reis et al. [34], it is possible to observe that laminates incorporating cork powder are less sensitive to impact velocity than the samples with neat resin. This is explained by the lower damaged areas that were previously reported for laminates with cork powder, due to the high capacity to absorb energy from the fillers. In addition to that, Barbosa et al. [44] observed that cork particles act like obstacles to crack propagation. This evidence also explains the better bending performance obtained for laminates with cork powder. On the other hand, and independently of the laminate, it is also evident that the maximum bending strength decreases for velocities below the minimum perforation velocity, and that there is a tendency for it to remain constant for velocities greater than the perforation velocity. However, the observed decrease was more expressive for laminates with neat resin due to the greater damage areas observed (as reported above).
