Article

Artificial-Crack-Behavior Test Evaluation of the Water-Leakage Repair Materials Used for the Repair of Water-Leakage Cracks in Concrete Structures

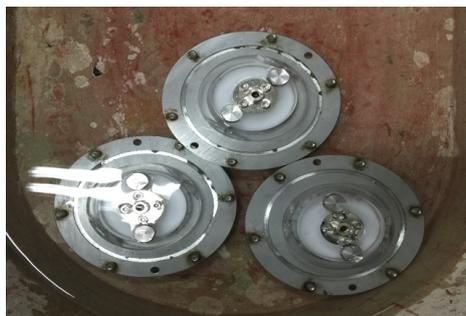
**Figure 6.** Rest in underwater condition for 1 hour.

After the completion of the assembly, 45 artificial-crack specimens were allowed to stand for one hour in water, as shown in Figure 6, and were then taken out of the water and were injected with water leakage repair materials, as shown in Figure 7. This was done to reproduce a wet environment for the artificial cracks because the underground water leakage cracks are always in a wet state. For the injection equipment, the one specified in accordance with the characteristics of each repair material and its specifications (small injector or syringe, other injection equipment available, etc.) was used. The inlet of the specimen with the injection completed was tightly covered with an inlet cover for injection ($\Phi 12$ mm), as shown in Figure 8, and the specimen was allowed to stand for 24 hours under 20 °C temperature and 65% humidity.

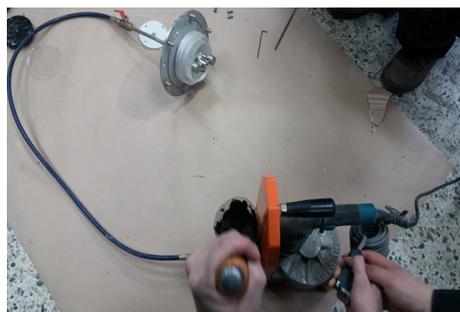
**Figure 7.** Repair material injection.

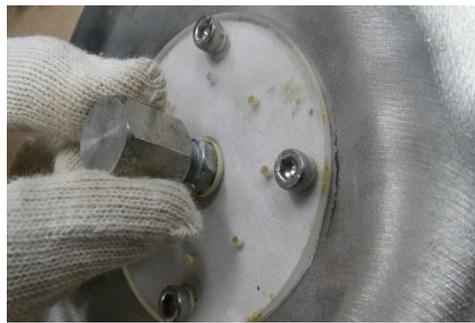
Figure 8. Inlet bar for injection Installation.

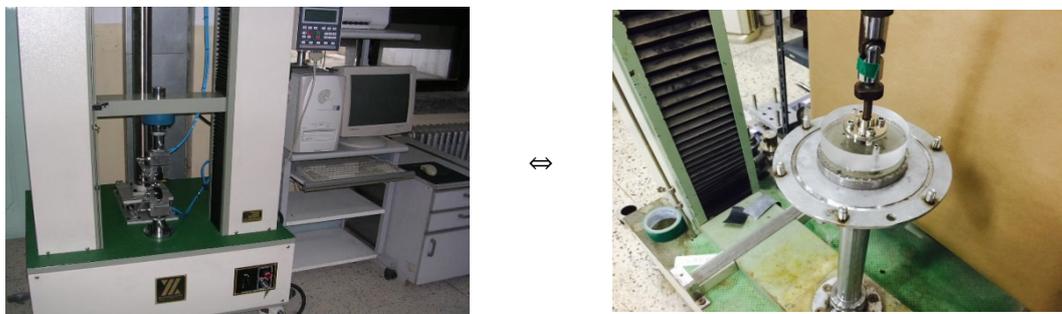
Figure 9. Universal testing machine (UTM).

The fixing jig installed on the surface of the upper substrate (Figure 3) mounted on the upper part, and the fixing bolt attached to the lower testing device, were connected to the UTM (Figure 9) and the OUTPUT permeability test device (Figure 10) for the imposition of mobility and water pressure.

From each of the specimens completed as discussed in Section 4.1, the acrylic band (release prevention band of the water leakage repair materials) was removed, and a UTM was installed as shown in Figure 9 so that up and down movements could be repeatedly applied in the crack behavior test. During the crack behavior test, the crack behavior width was 2.5 mm for 1 minute per cycle, totaling 100 cycles. The temperature conditions were the same as the laboratory temperature conditions cited in Section 4.1. During the crack behavior duration of 100 cycles, not only the leaks, tears, cracks, and dents of the repair materials but also the detachment of the adhesive surface with the repair
