Surface Quality of Staggered PCD End Mill in Milling of Carbon Fiber Reinforced Plastics

Abstract: Machined surface quality determines the reliability, wear resistance and service life of carbon fiber reinforced plastic (CFRP) workpieces. In this work, the formation mechanism of the surface topography and the machining defects of CFRPs are proposed, and the influence of milling parameters and fiber cutting angles on the surface quality of CFRPs is obtained, which can provide a reference for extended tool life and good surface quality. Trimming and slot milling tests of unidirectional CFRP laminates are performed. The surface roughness of the machined surface is measured, and the influence of milling parameters on the surface roughness is analyzed. A regression model for the surface roughness of CFRP milling is established. A significance test of the regression model is conducted. The machined surface topography of milling CFRP unidirectional laminates with different fiber orientations is analyzed, and the effect of fiber cutting angle on the surface topography of the machined surface is presented by using a digital super depth-of-field microscope and scanning electron microscope (

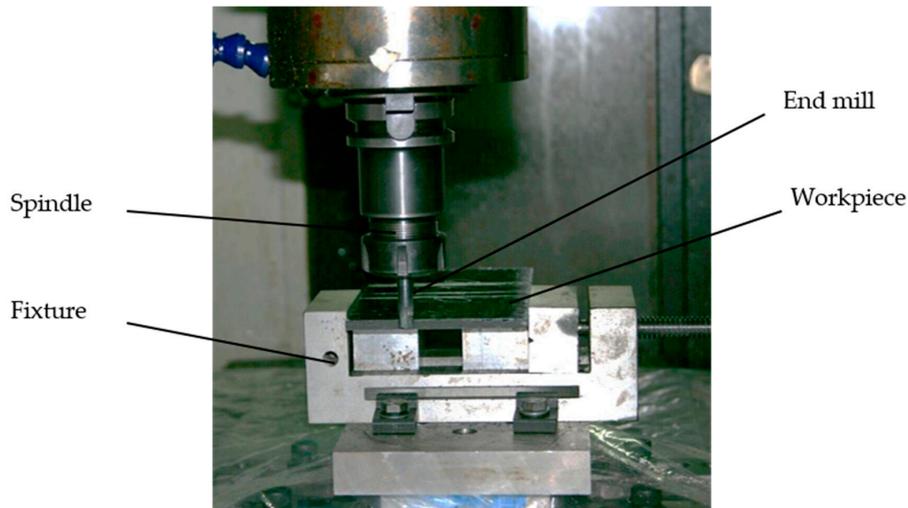
Figure 1. Experimental setup.

A series of milling tests on multidirectional CFRPs, with a newly developed staggered PCD (Polycrystalline diamond) end mill, were conducted using the three-axis CNC milling machine VDL-1000E (Dalian R&C Machinery, Dalian, China) as shown in Figure 1.

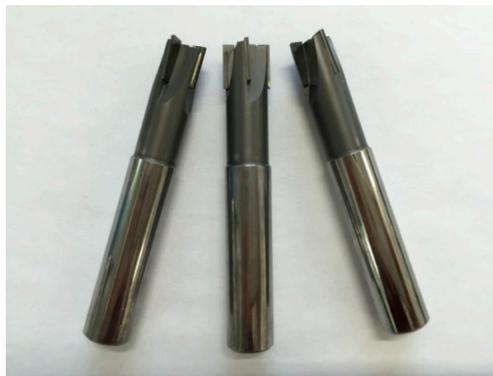
Figure 2. The staggered PCD (Polycrystalline diamond) end mills.

The staggered PCD end mills used in the experiment are shown in Figure 2, and the main structural parameters of the PCD end mill are shown in Table 1.

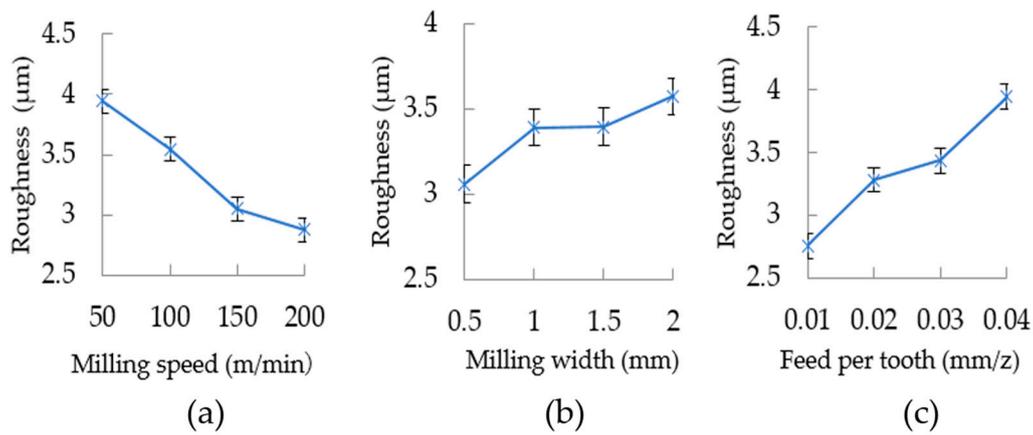
Figure 3. Influence of milling parameters on surface roughness. (a) R_a versus v ; (b) R_a versus a_e ; (c) R_a versus f_z .

According to the range analysis of surface roughness and the experimental results, the influence of the cutting parameters on the surface roughness is shown in Figure 3.

As shown in Figure 3a, the surface roughness decreases with increasing milling speed. Because the high temperature resistance of carbon fiber is higher than that of resin material, and because the temperature will rise during high speed milling, the resin material is heated and softened. The resin coating on the machined surface increases due to the heating effect of the tool. In addition, during high speed milling, the cutting time of carbon fiber is shortened, and the fiber deformation is reduced, so the surface roughness is low.

In Figure 3b, the surface roughness increases a little with increasing milling width. In Figure 3c, with the increase in feed per tooth, the surface roughness increases. When the feed per tooth increases, the amount of fiber cut by the mill in each tooth increases, resulting in more machining defects. Meanwhile, with an increase in the feed per tooth, the springback effect of carbon fiber is enhanced, the resin coating is reduced, and the fracture of carbon fiber is increased, which result in an increase in the surface roughness.

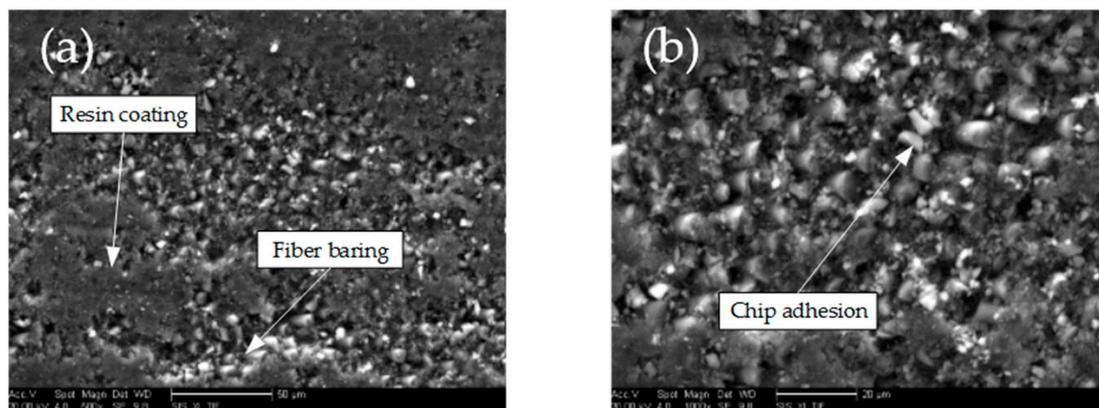
Figure 4. Machined surface topography when $\theta = 45^\circ$. (a) Resin coating and fiber baring (SEM micrograph); (b) Chip adhesion (SEM micrograph).

Figure 4a is the surface topography when $\theta = 45^\circ$. The carbon fiber material easily undergoes bending fracture and shear fracture, and the two kinds of fracture modes coexist. The fracture of the carbon fiber is perpendicular to the fiber axis, which is 45° relative to the machined surface, and simultaneously, the top of the fiber fracture is slightly broken under the squeezing of the tool flank face. The resin matrix of the carbon fiber has a typical shear failure, and the sheared matrix is pressed into debris adhered on the exposed fiber fracture surface, as shown in Figure 4b.

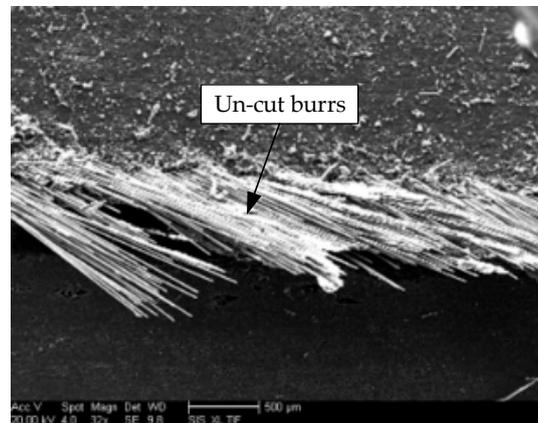
Figure 5. Surface burrs when $\theta = 45^\circ$ (SEM micrograph).

As the resin is heated and softened, it is extruded by the flank and coated on the surface fibers of the machined surface, which results in a smooth machined surface. However, when milling the CFRPs along the fiber direction, burrs on the edge of the machined surface are found, as shown in Figure 5. During milling, the surface fibers are bent by the milling force. Due to a lack of external support, the fibers are debonded under the milling force [19,20]. The stiffness of the carbon fiber is decreased, and the carbon fibers are pushed to the outside, so that they cannot be cut off by the mill over time. With the milling process, the debonded fibers are rebounded, and surface burrs are formed.

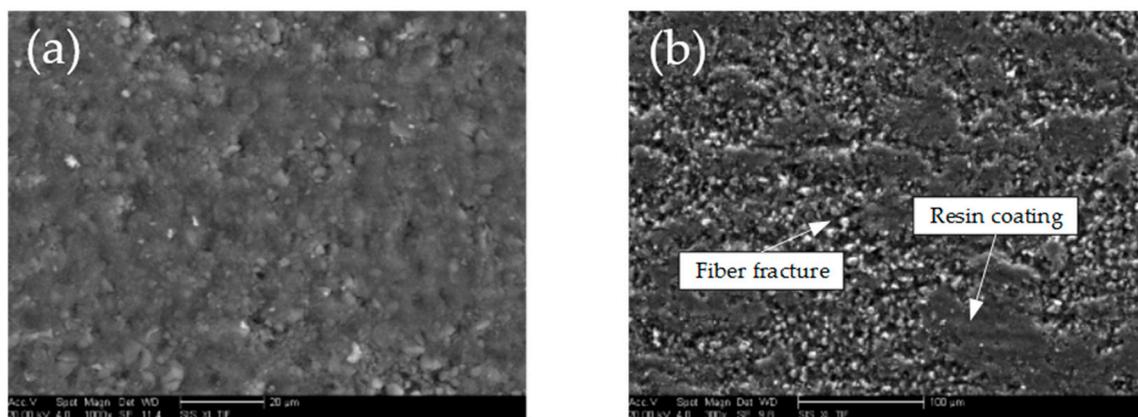
Figure 6. Machined surface topography when $\theta = 90^\circ$. (a) Serious resin coating (SEM micrograph); (b) Slight resin coating (SEM micrograph).

The machined surface topography is shown in Figure 6 when $\theta = 90^\circ$. Serious resin coating is seen in Figure 6a, and only slight fiber bareness is found, which shows a machined surface with straight-forward fiber features. Because 90° is the critical angle of the straight-forward and reversal machined surface, the carbon fiber in the cutting layer can easily undergo bending deformation. However, due to high stiffness of the carbon fiber in this direction, the bending deformation is small. After the shear fracture of the matrix, the interface is also broken by shear stress. A smooth machined surface with a small section of bare fiber appears, as shown in Figure 6b. The machined surface is further crushed under the extrusion of the tool flank, forming a fiber fracture perpendicular to the axial

direction. The fracture has no obvious fracture characteristics, and the broken fibers are scattered on the top of the fracture. The matrix is squeezed by the tool flank and adheres to the top of the fracture. Meanwhile, the matrix is softened by heating and is coated on the fiber surface, as shown in Figure 6.

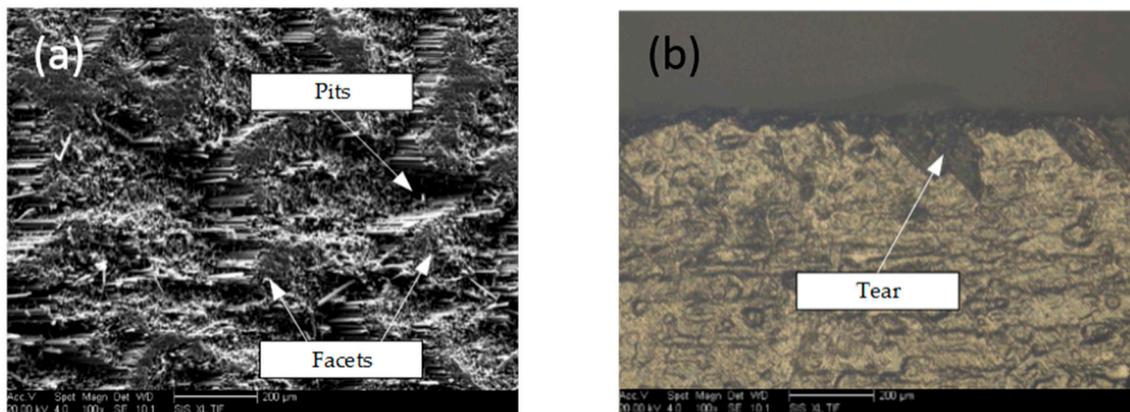
Figure 7. Machined surface topography when $\theta = 135^\circ$. (a) Machined surface topography (SEM micrograph); (b) Upper surface tearing (microscope image).

Figure 7 is the machined surface topography when $\theta = 135^\circ$. It is seen that there are bare fiber bundles on the machined surface, while many pits appear on the roots of the fiber bundles, as shown in Figure 7a. It is also observed that the lamination gaps appear in the root of fiber bundles, which is caused by the rebounding of the laminated carbon fiber. Therefore, there are pits on the machined surface, and the bottom of the pits are located at the root of the fiber bundle. The pit distribution is not continuous, and there are some cutting planes with different sizes between the pits, as shown in Figure 7a, which also appears on the machined surface topography of the multi-direction fiber laminate. For the cutting layer of the rake face, the farther away from the rake face, the lower of the deformation of the cutting layer. The large deformed cutting layer close to the rake face and small deformed cutting layer away from the rake face are simultaneously cut off during high speed machining, and pits and facets alternate on the machined surface as a sawtooth. Tear defects mainly happen at the edge of the material surface when milling CFRPs in the reverse fiber direction, as shown in Figure 7b. This is because of the surface fiber bends and fractures, and the fracture position occurs deep into the surface of the workpiece, finally forming a tear defect.

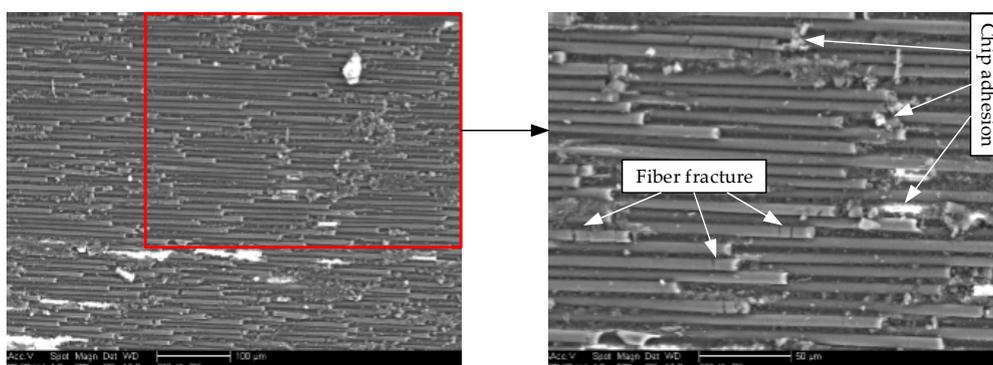
Figure 8. Machined surface topography when $\theta = 0^\circ$ (SEM micrograph).

When the fiber cutting angle $\theta = 0^\circ$, that is, the cutting direction is parallel to the fiber direction, a surface topography of a parallel tiled fiber bundle is formed with a certain direction, as shown in

Figure 8. There is almost no intact tiled fiber remaining. Tensile fracture topography along the axial direction is seen. Due to workpiece clamping, fiber ply and tool vibration, the fiber cutting angle cannot be completely zero [21,29]. The actual milling is machining with a small fiber cutting angle. When the surface springback fiber is squeezed and rubbed by the tool flank, a tensile fracture of the carbon fiber will occur on the machined surface. The resin matrix is extruded and may break to be patchily distributed in the fiber gap. The outer surface of the fiber is smooth, and only a little chip adheres on the fiber, as shown in Figure 8. This is because the position of the maximum bending stress of the layered fiber is above the cutting plane, and the position of the fractured fiber is higher than that of the machined surface.

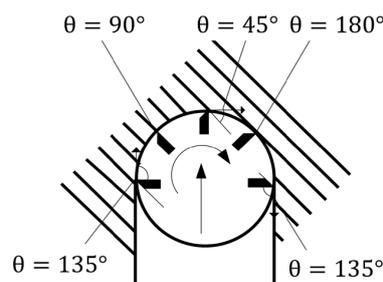
Figure 9. Diagram of slot milling cutting angle.

In the milling process, with the rotation of the end mill, the fiber cutting angle in milling is constantly varied. The fiber cutting angle is 90° , and 0° is the demarcation point between milling along the fiber direction and reverse fiber direction. In addition, 45° and 135° are typical feature points of the two kinds of milling, so the surface topography at these intervals is very important. Figure 9 shows the fiber cutting angle when the angle between the feed direction and the fiber direction is $\beta = 45^\circ$. The surface defect of the slot milling under different fiber cutting angles is presented in Figure 10, which shows the slot topographies of four fiber directions and the corresponding fiber cutting angles.

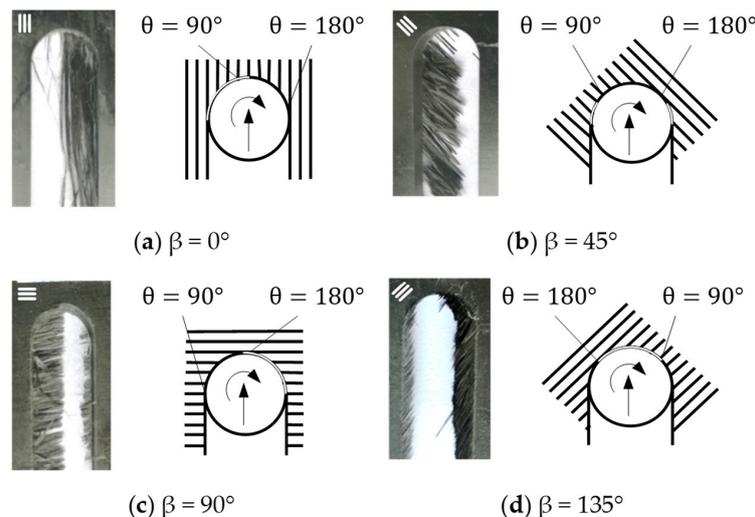
Figure 10. Slot milling topography of different fiber orientations. (a) $\beta = 0^\circ$; (b) $\beta = 45^\circ$; (c) $\beta = 90^\circ$; (d) $\beta = 135^\circ$.

When $\beta = 0^\circ$, the edge of the left half of the slot is neat and without burrs, as shown in Figure 10a, in which θ on the fiber cutting angle diagram is $180^\circ\text{--}90^\circ$, i.e., belongs to reverse fiber cutting. However,

the right half has a typical burr defect, in which θ on the fiber cutting angle diagram is $90^\circ-0^\circ$, i.e., belongs to milling along the fiber direction. Tears and burrs are mainly located on the outer layer of the surface. They are the most common machining defects of CFRPs [29,31]. Tears are caused by milling force and extend along the fiber direction of the outer layer.

Through the analysis, when β is 45° , 90° and 35° , it is seen that burrs are more concentrated in the fiber cutting angle $0^\circ-90^\circ$ (cutting along the fiber direction), as shown in Figure 10b–d. For fiber cutting angle $90^\circ-180^\circ$ (reverse fiber milling), a smooth topography with no macroscopic defects is seen. However, through the observation of the digital super depth-of-field microscope, it can be seen that tears occur. When the tool is worn, there will be burr defects in the cutting area along the fiber direction, but in the reverse cutting area, even if the tool is badly worn, there will be no burr defects, as shown in Figure 10d. Thus, it can be concluded that in the milling process, by choosing a reasonable milling path and ensuring the surface fiber is in the inverse cutting state, a worn tool can be continuously used for milling so as to promote tool life and reduce production costs.
